SUBJECT: Remediation Closure Report for the Cotton Draw Unit #294H Release (2RP-4543), Eddy County, New Mexico

Cotton Draw Unit #294H Remediation Closure Report (2RP-4543)  
April 9, 2020

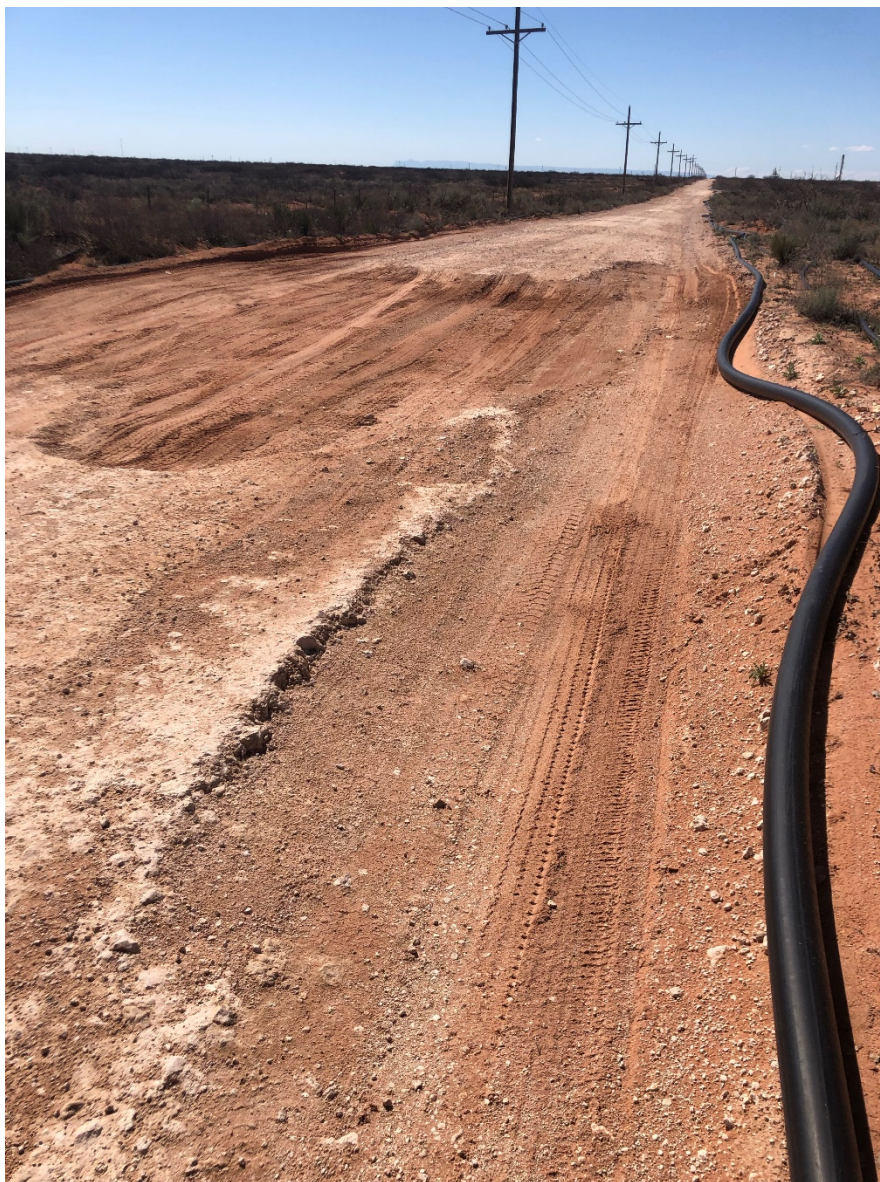
Photo #1

Facing Southwest 32.1667 -103.731

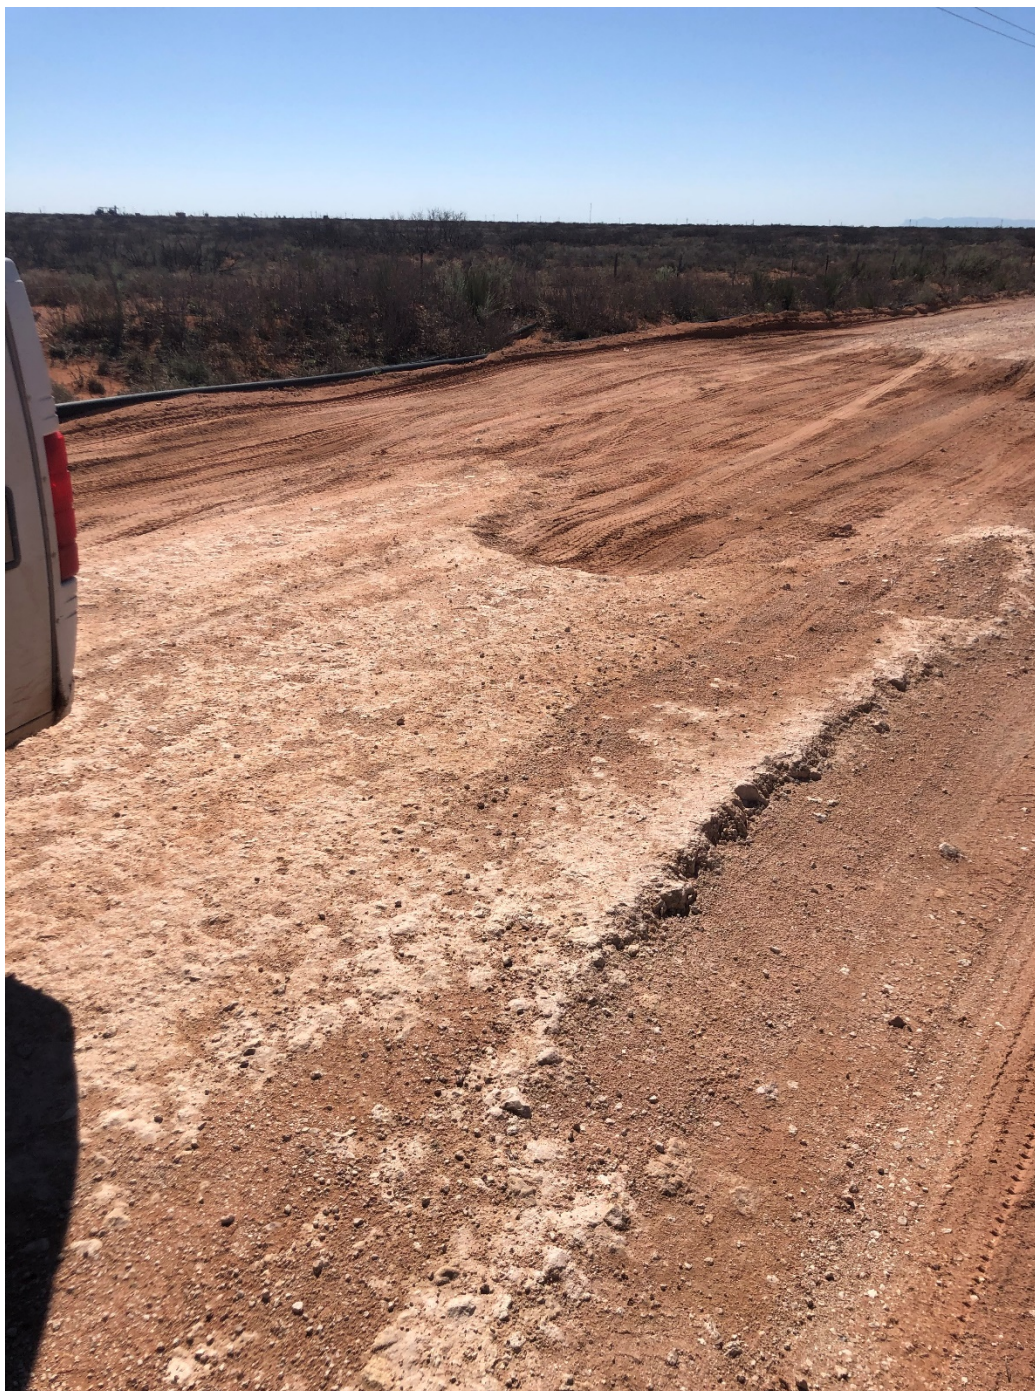
Photo #2

Facing Southwest 32.1668 -103.7321
