Site Assessment and Closure Report

Boundry Raider 6 7 Fed Com #212H
Lea County, New Mexico
API 30-025-44146
*1RP-4996

Subject: **Site Assessment and Closure Report**
Boundry Raider 6 7 Fed Com #212H
Lea County, New Mexico
API 30-025-44146
*1RP-4996

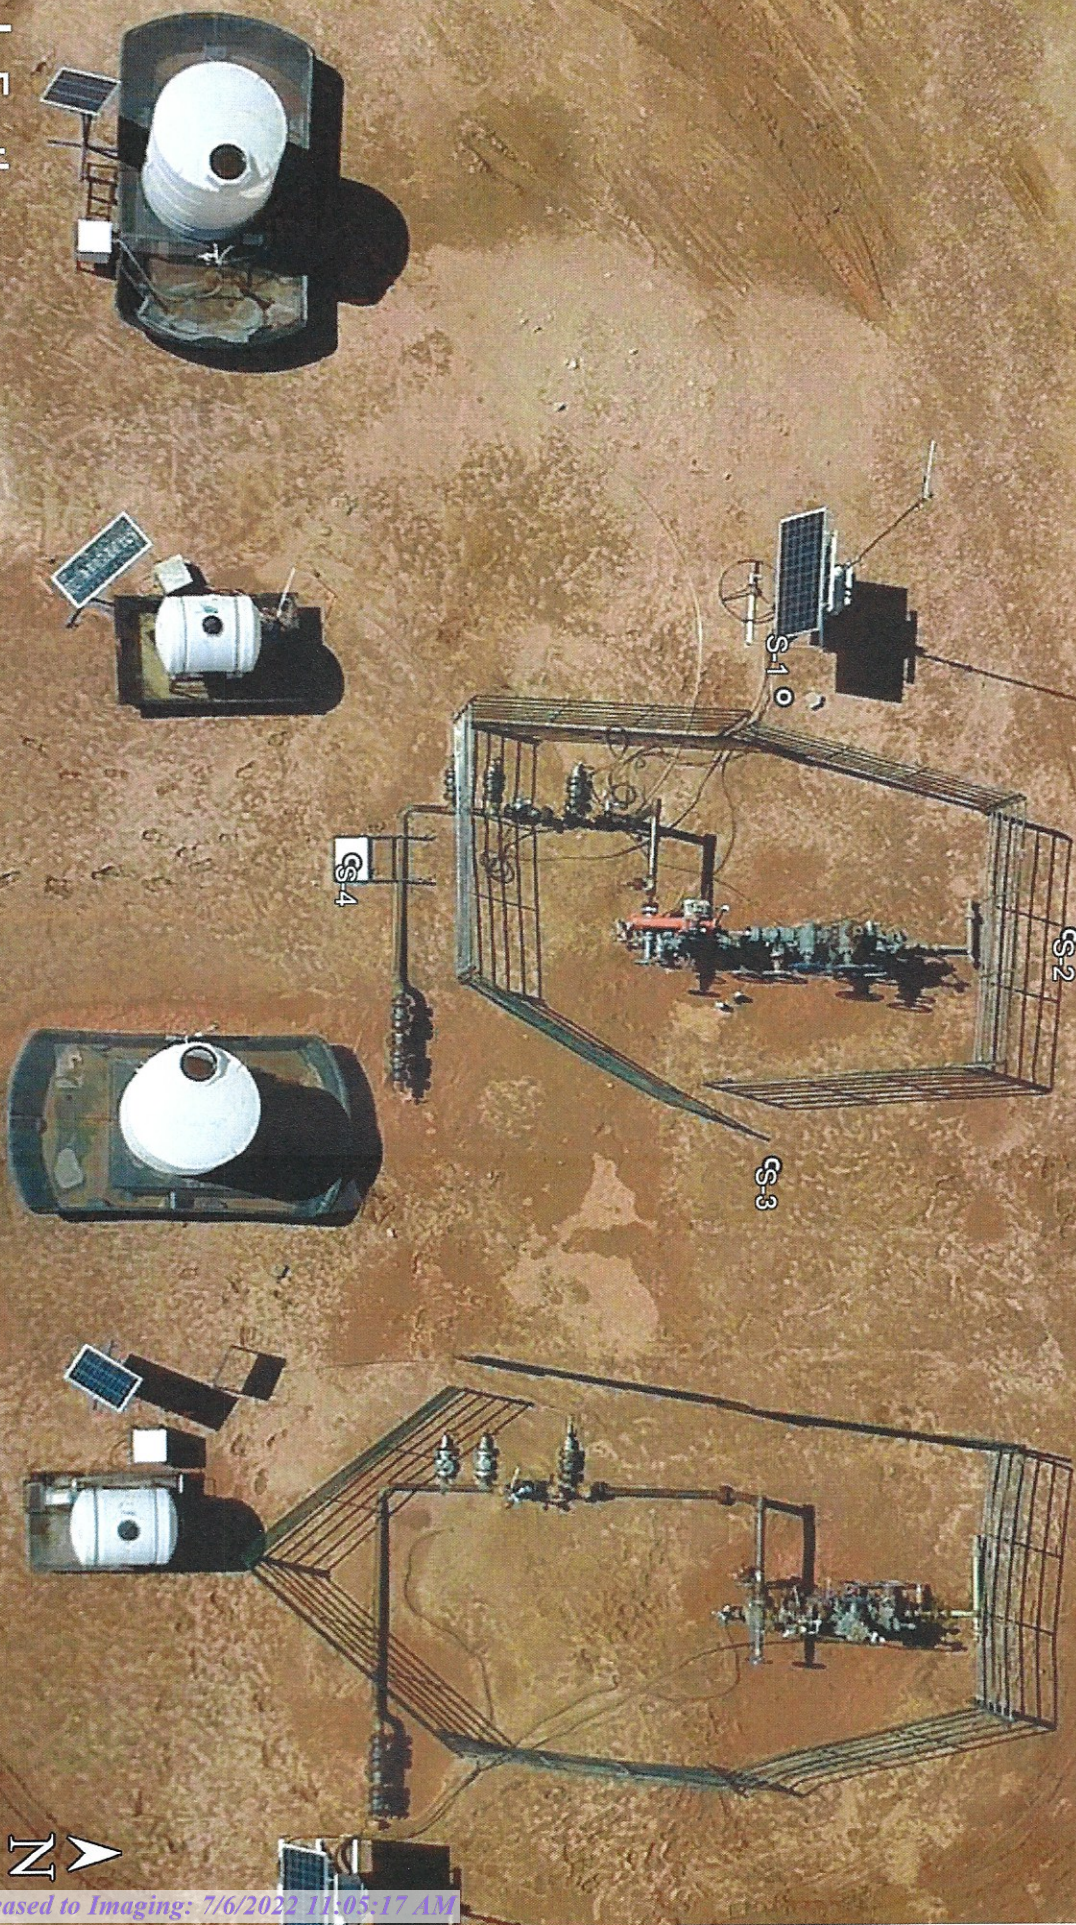
Devon Energy Production Company
API # 30-025-44146
Lea County, NM
Site Map

On March 5, 2020, Talon mobilized personnel to the site conducting a site assessment and collecting soil samples. Sample locations are shown on the attached site map and the results of our sampling event are presented in the following data table.

Legend
● Soil Sample

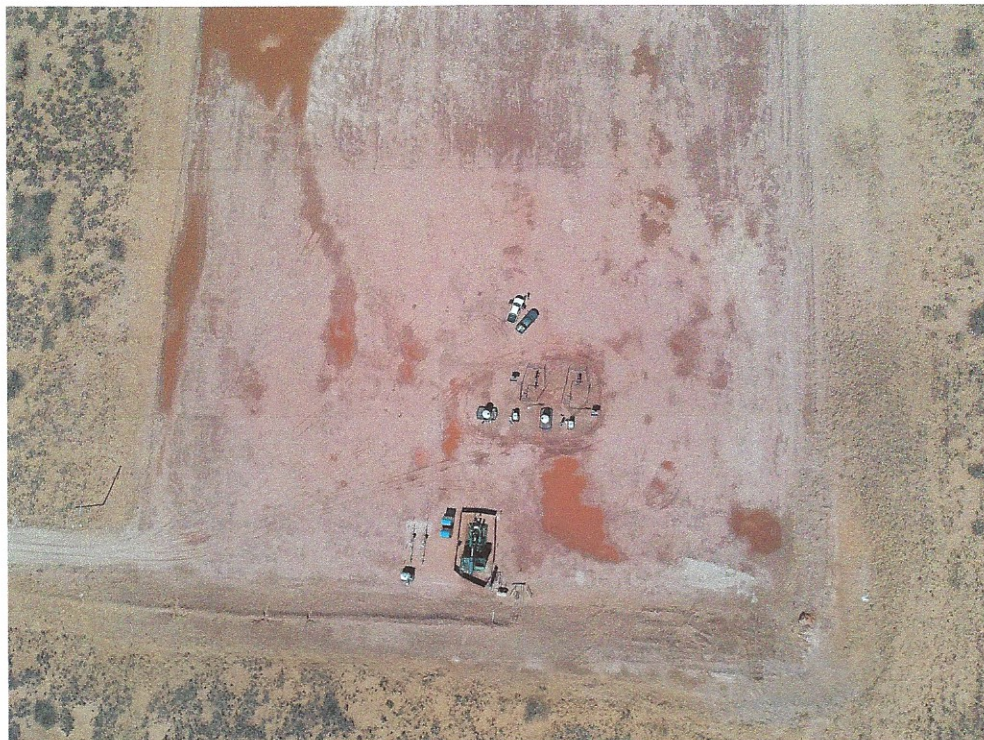
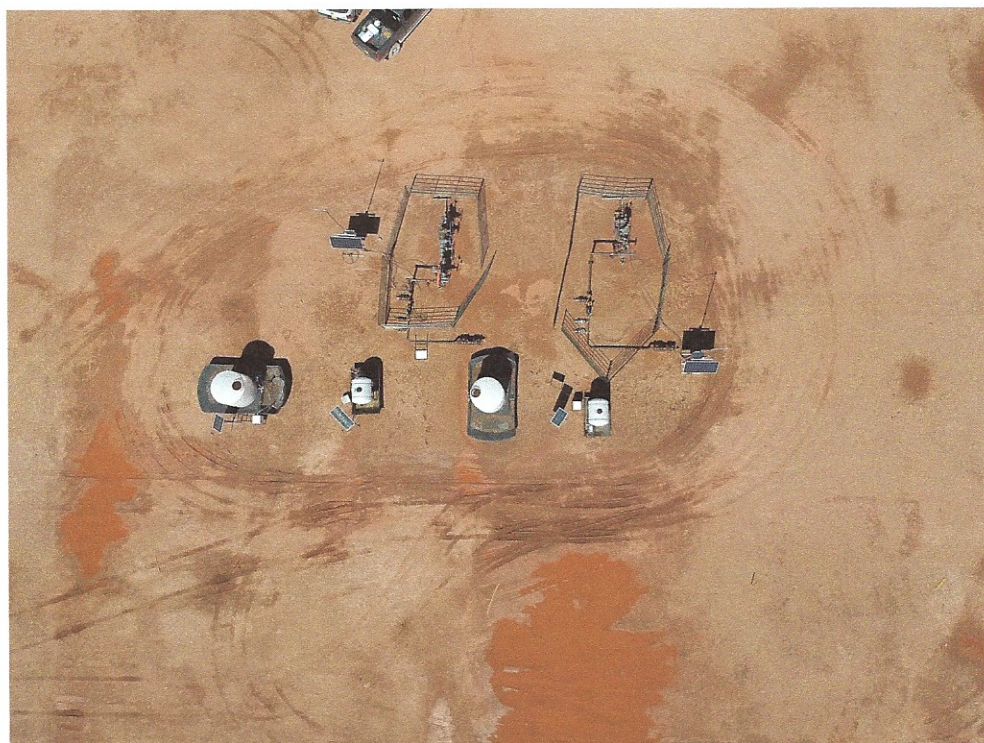
Location Photos

- Based upon the results of our sampling event, none of the analytical results exceeded the NMOCD clean up criteria for this site. Therefore there was no need for soil remediation activities.
- Based upon the photo documentation provided and the results of our sampling event, it is apparent the integrity of the battery liner is intact.

Based on this site characterization, liner inspection, and analytical results, we request that no further actions be required, and that closure with regard to the attached incident be granted.
