## Release Notification

Site Name San Juan 30-6 Unit 414	Site Type Natural Gas Production Facility
Date Release Discovered 03/31/2022 @ 09:53am MT	API# 30-039-24154

## Executive Summary

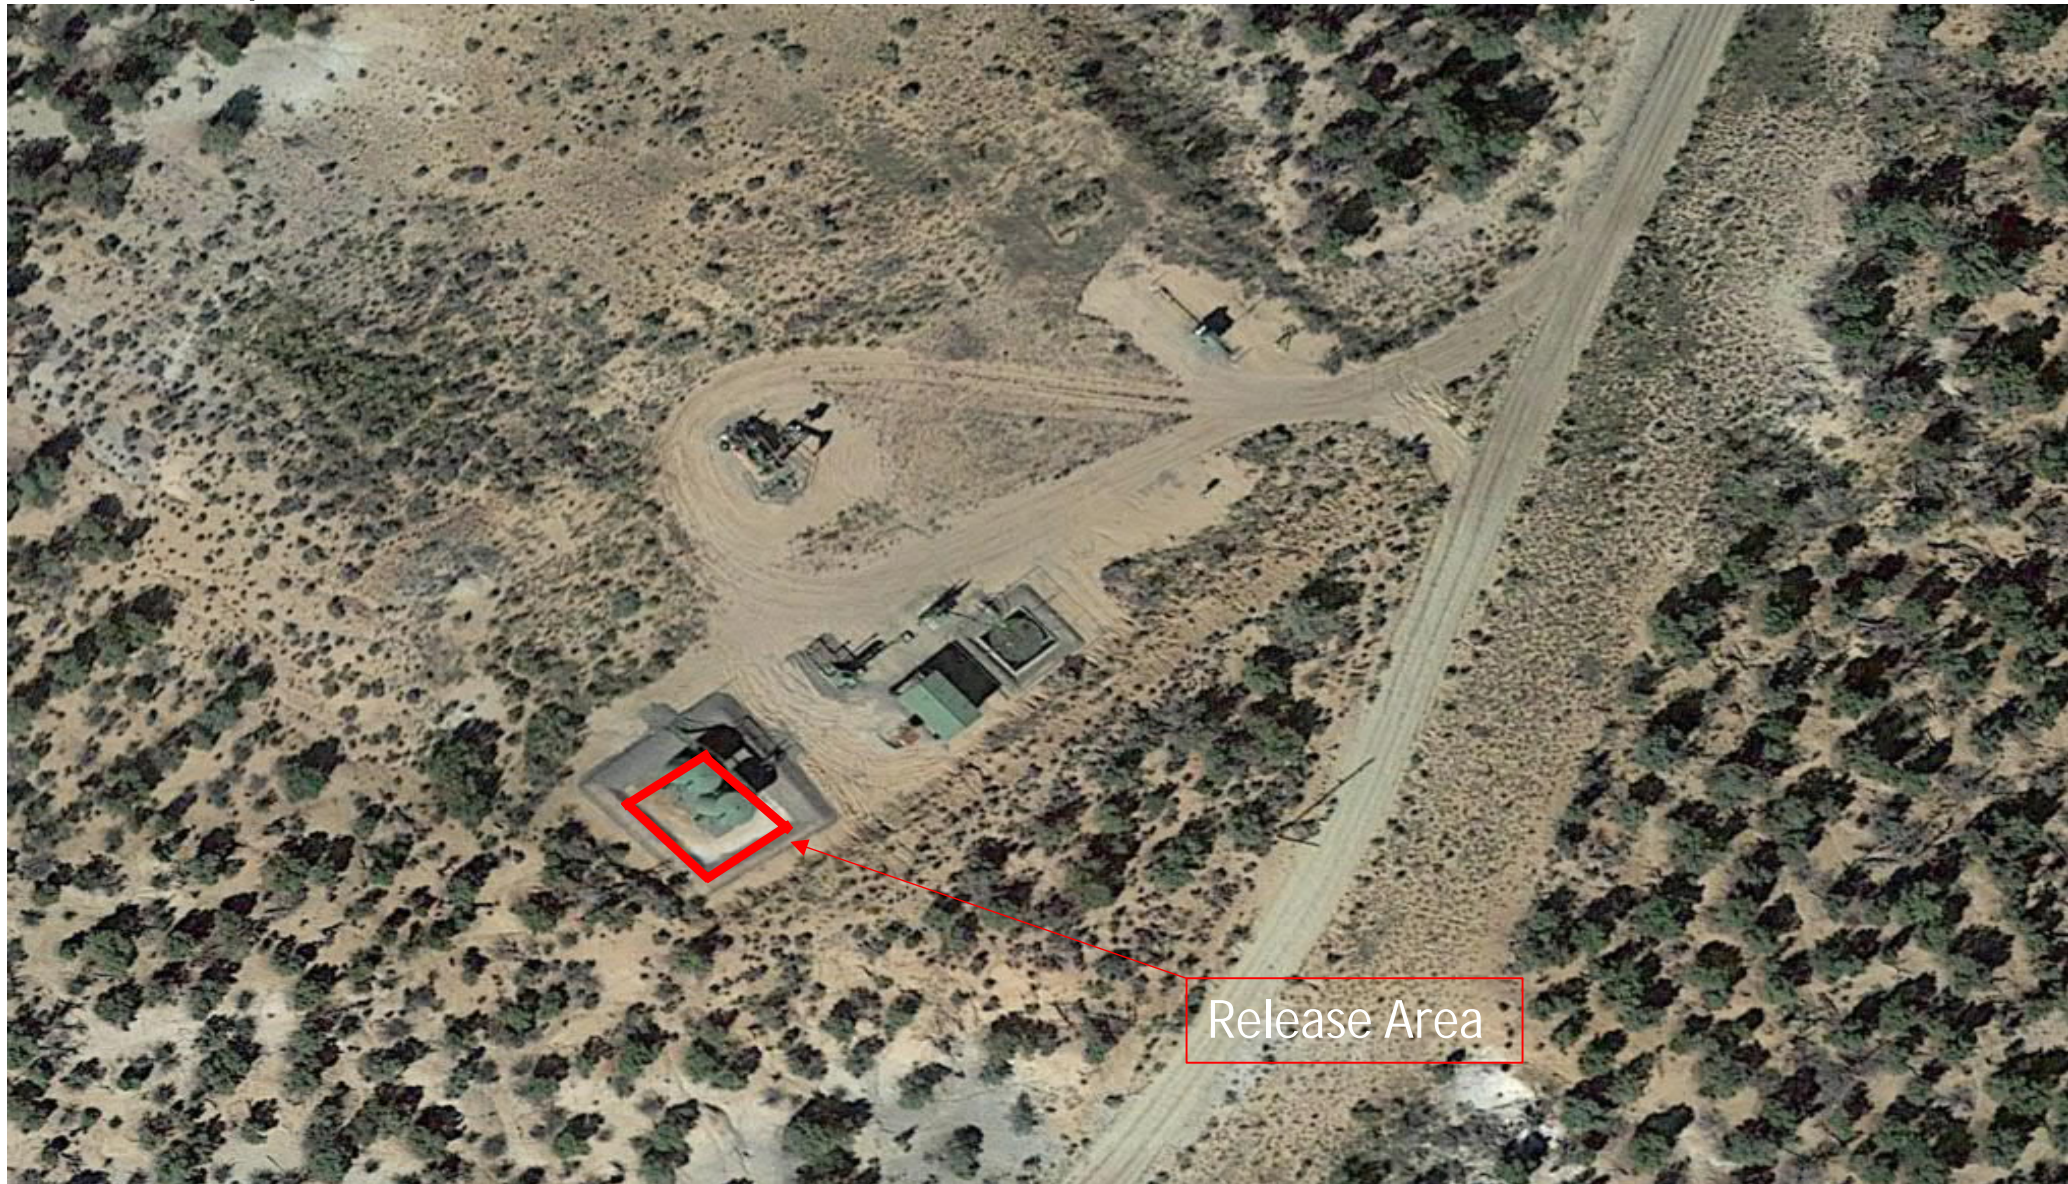
# Scaled Map

Note 1: The surface extent of the San Juan 30-6 Unit 414 release is represented by the red square shown in image above. Note that all spilled liquids remained within secondary containment.

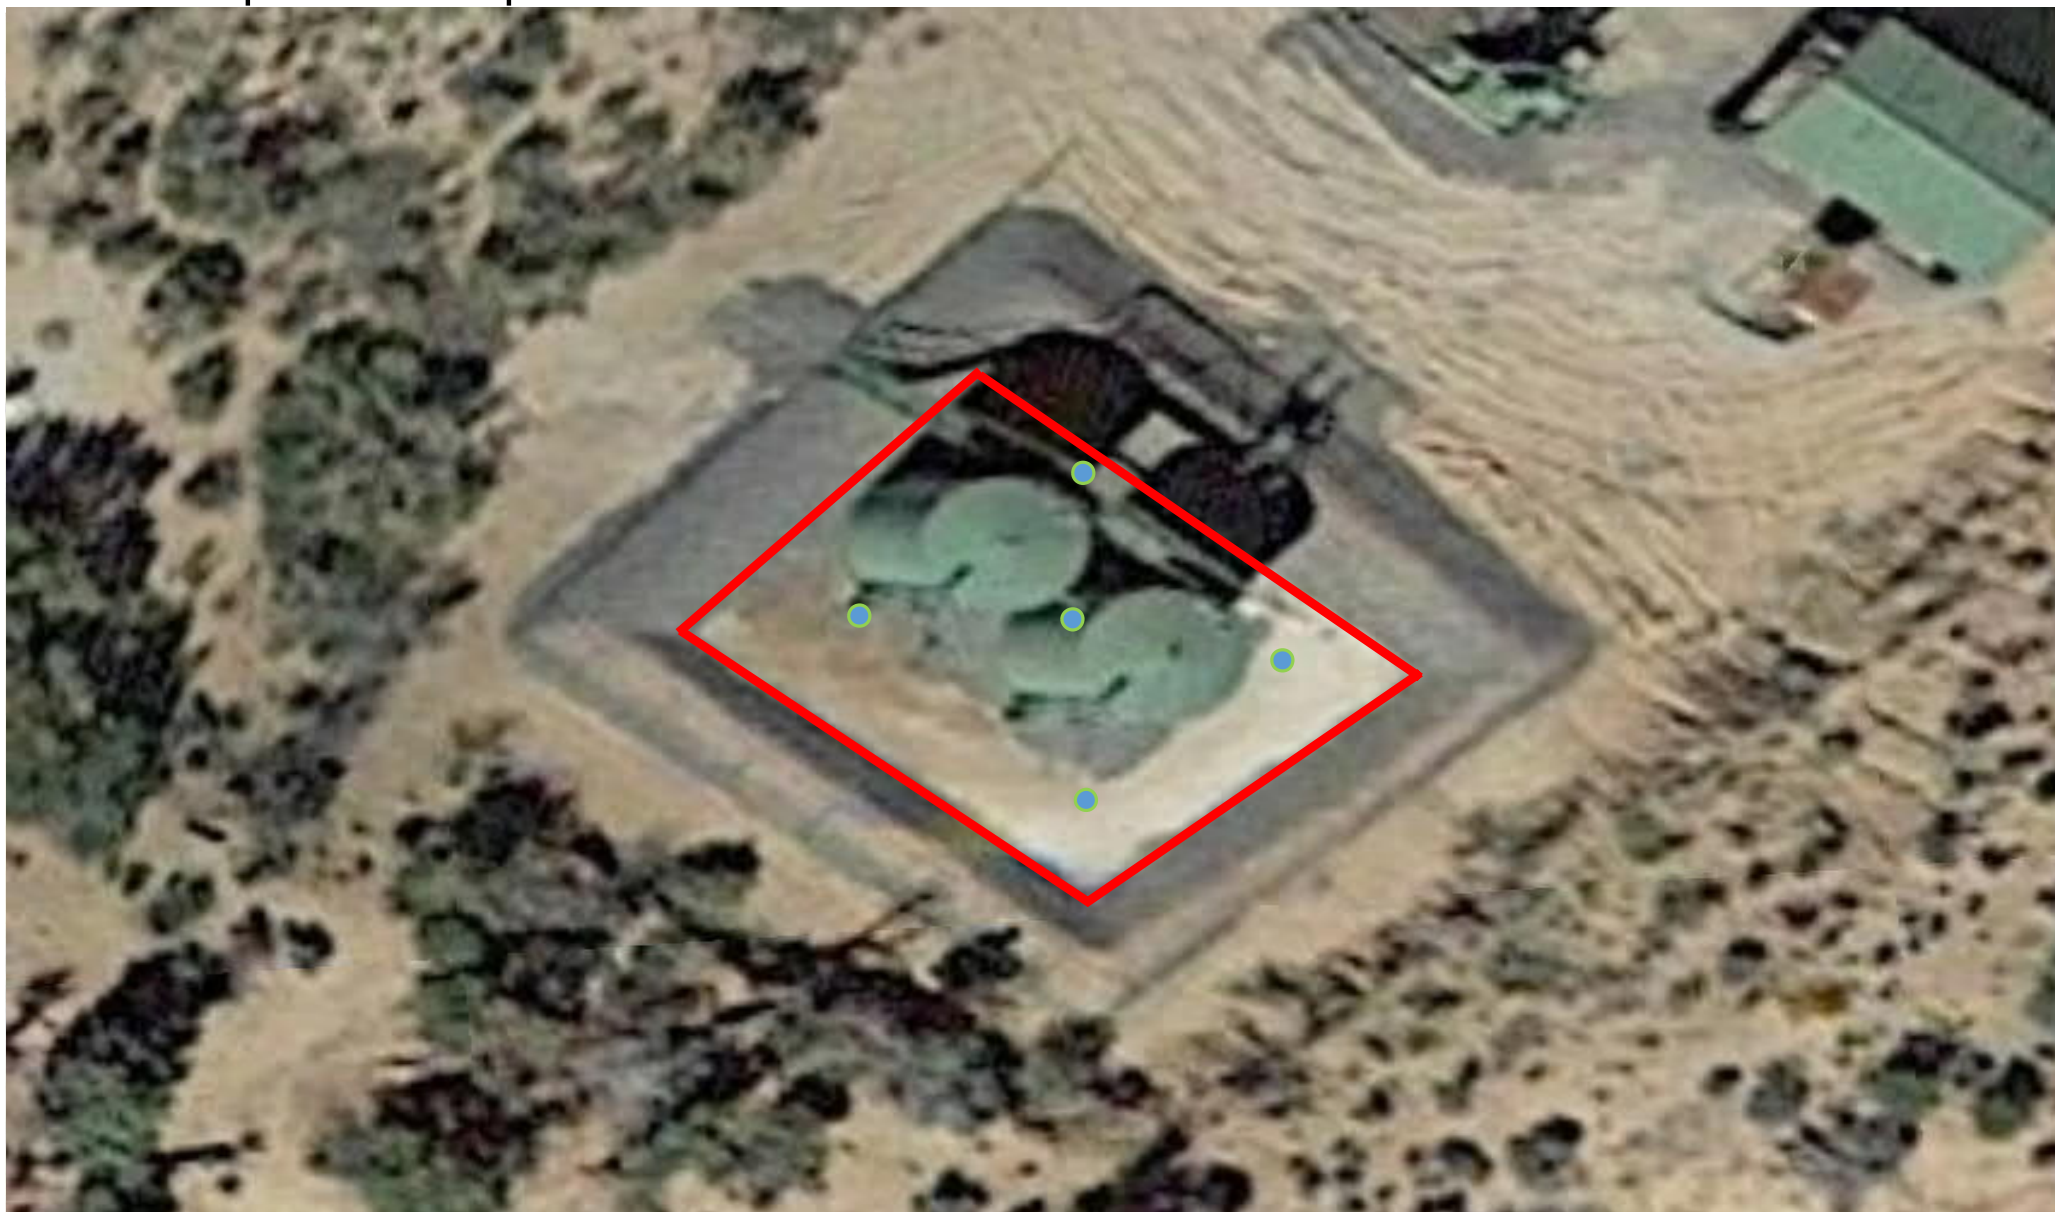
## Scaled Map – Close-up

Area of Release

Sample Locations

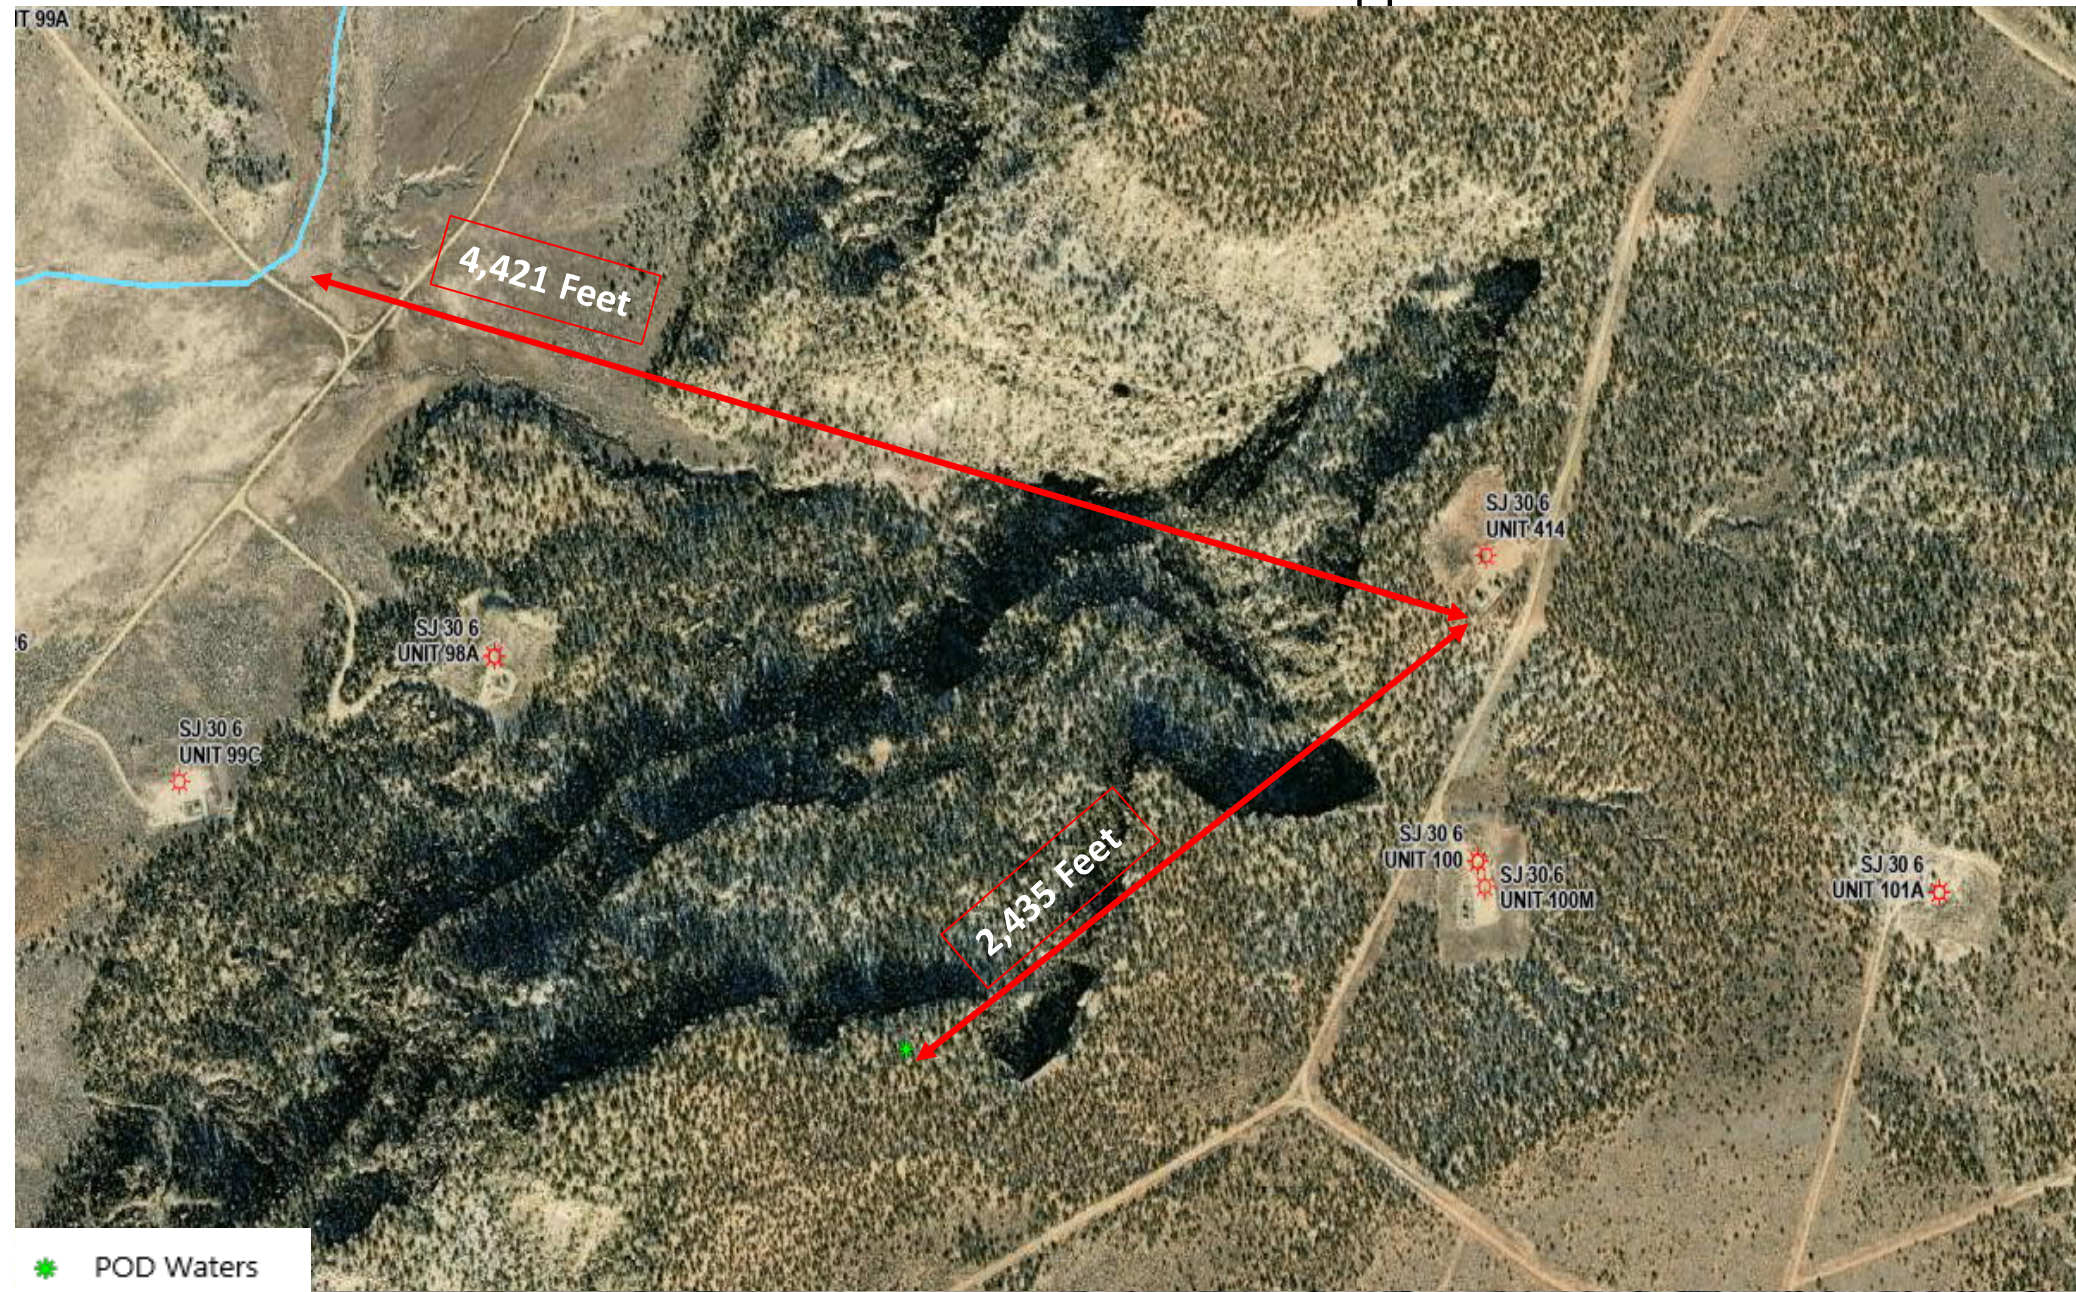
# Determination of water sources and significant watercourses within ½ mile of the lateral extent of the release/Distance to mapped water wells

Note 1: Release point not shown to be within 300 ft of a significant water course.

Note 2: The lateral extents of the release point are not shown to be within 300 feet of a mapped wetland.

Note 3: The lateral extents of the release point are not shown to be within 500 ft of a spring or domestic freshwater well used by less than 5 households (or stock watering) or within 1,000 ft of any freshwater water well or spring.

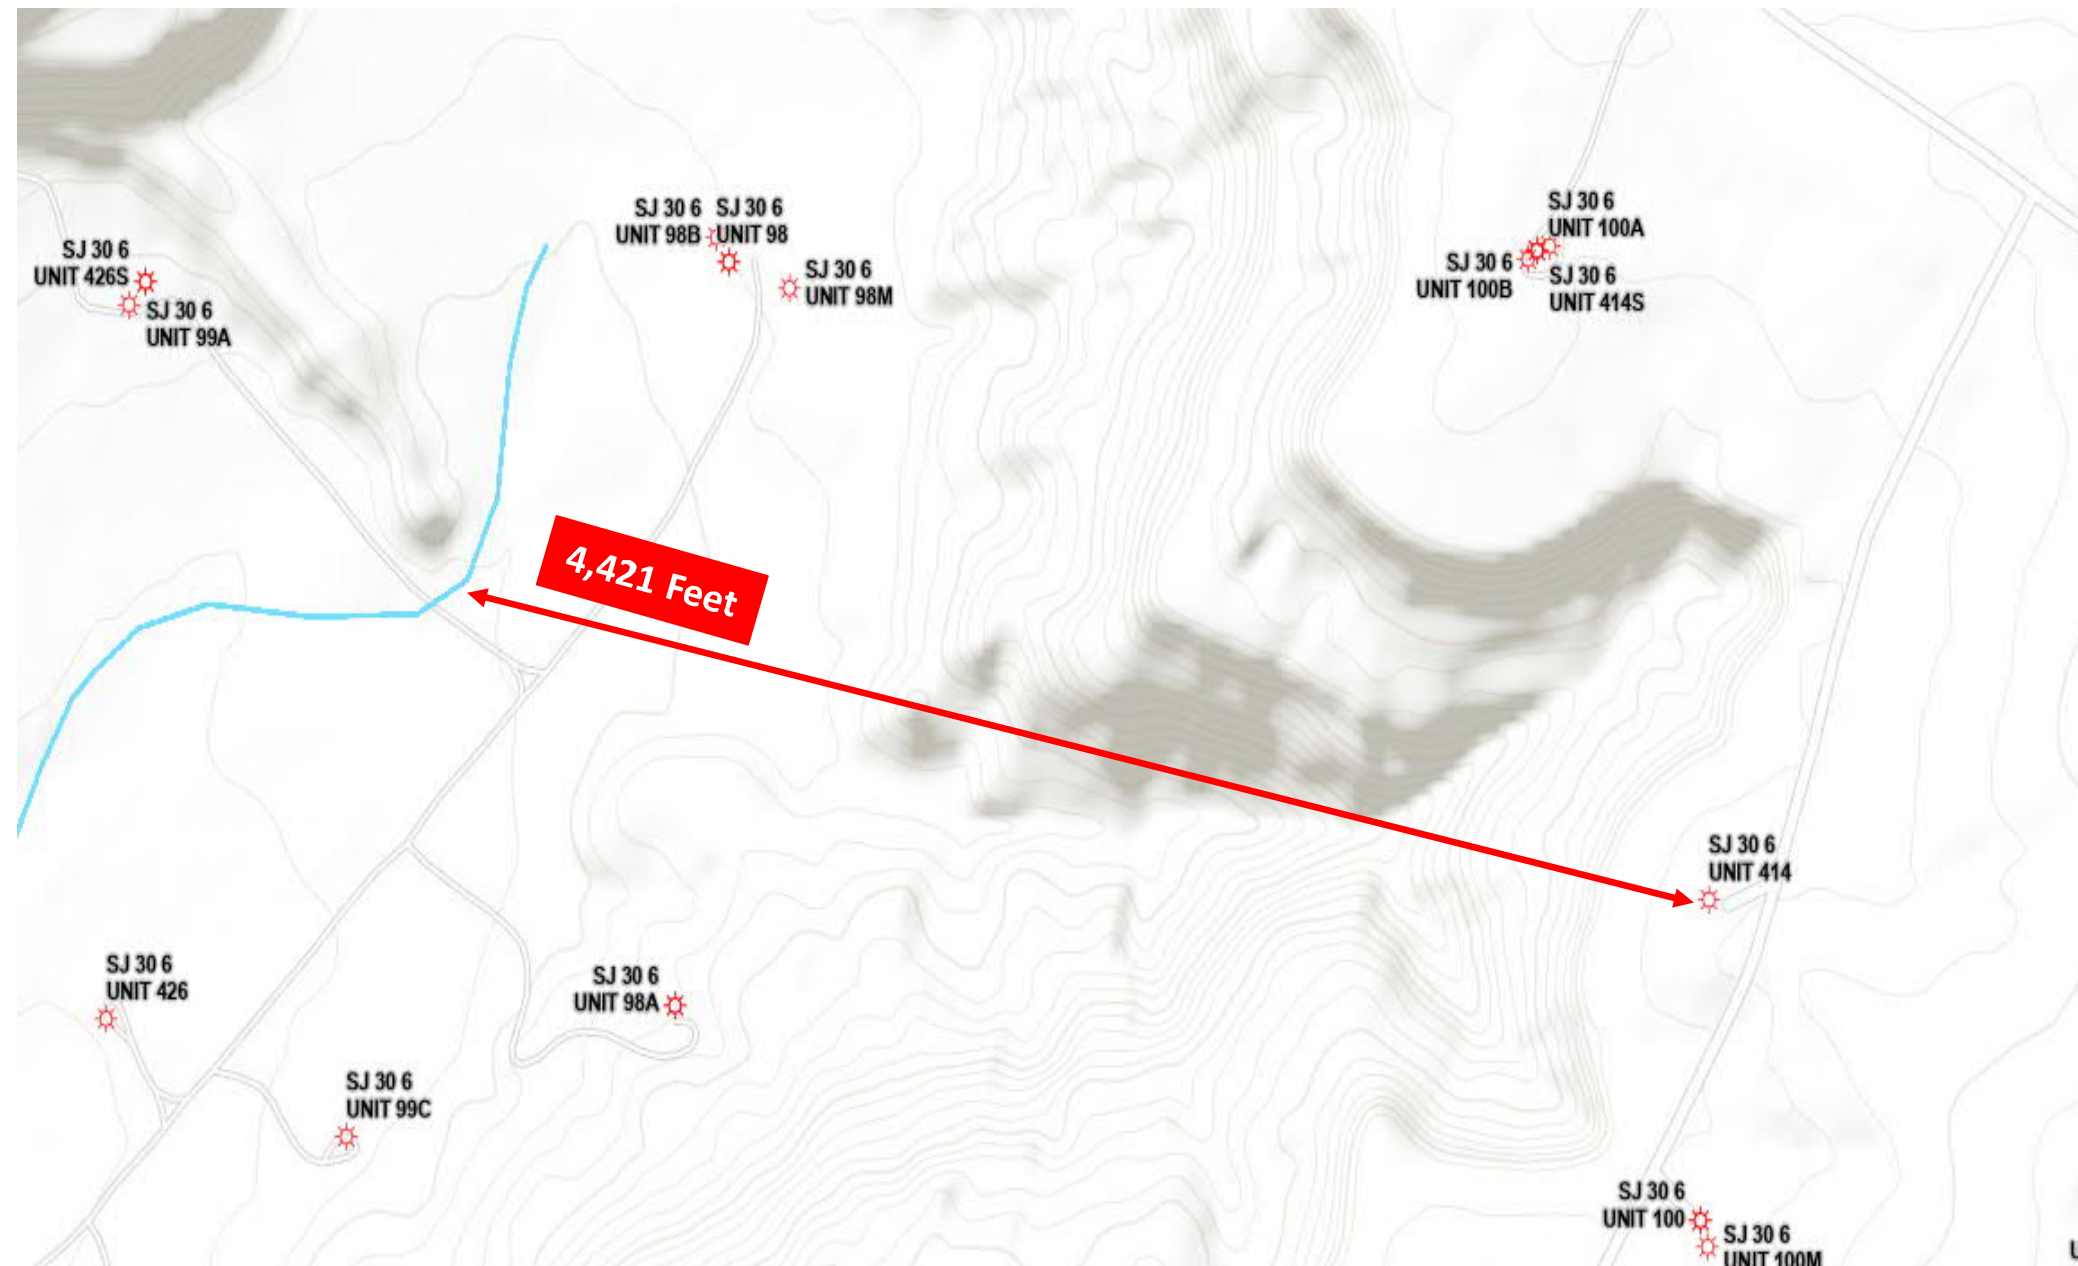
# Determination of water sources and significant watercourses within ½ mile of the lateral extent of the release

Note: Release point is not shown to be within 300 ft of a significant water course.
