## Release Notification

RE: Closure Report  
Incident ID: nAPP2213351816  
AEP #: 20220510-1648-hydrovac  
Location: Wool Head 20 State #501H "D" Pad

Incident ID: nAPP2213351816  
Wool Head 20 State #501H "D" Pad  
20220510-1648-hydrovac

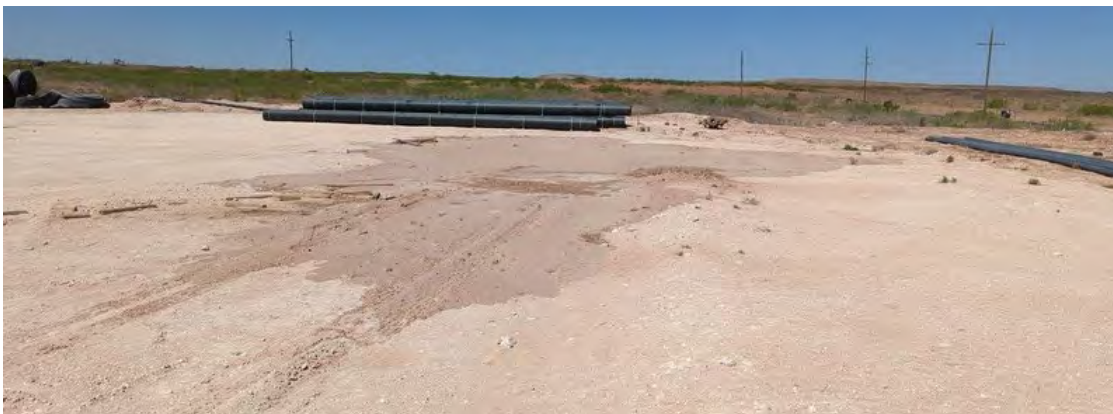
The hydrovac unauthorized discharge was discovered on May 5, 2022, near the NW corner of Wool Head 20 State #501H "D" production site. Surface is State owned. Field investigations suggest that a hydrovac discharged excavated soil (Figure 1) after performing trenching during construction activities for the installation of flowlines and electrical associated with oil and gas operations.

Figure 1: Photo of discharge viewing west-northwest from the eastern extent of the discharge area. GPS: 32.4582561 N, 103.6016919 W. Date/Time: 2022-05-05 10:51:26

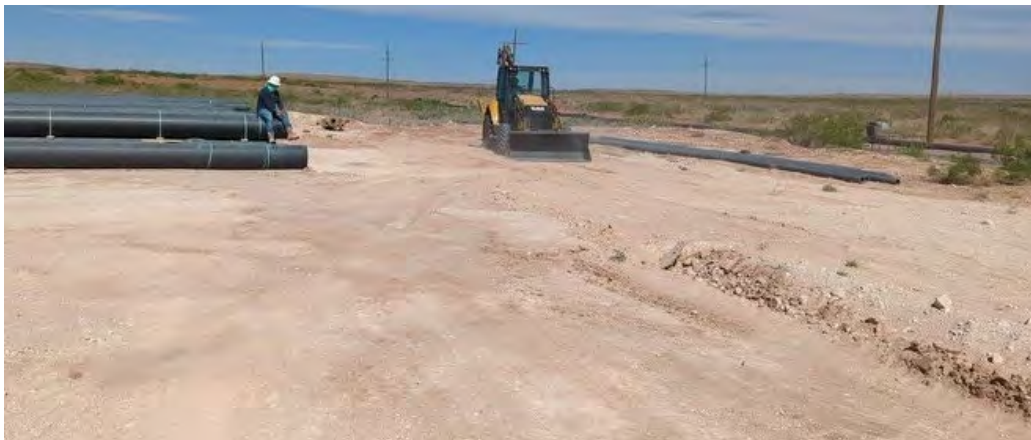
Figure 2: Restored surface viewing west-northwest from the easter extent of the discharge area.  
GPS: 32.4581286 N, 103.6024122. Date/Time: 2022-05-12 09:52:26

On May 12, 2022; approximately 8.5 cubic yards of hydrovac slurry was removed from the surface of the production site for proper offsite disposal. No subsurface excavation occurred; therefore, additional material was not needed for restoration.

The surface was graded and restored as an active production pad per 19.15.29.13.A-C NMAC (Figure 2). Final remediation and reclamation will occur when the production site is no longer in-use for oil and gas operations per 19.15.29.13.D NMAC.

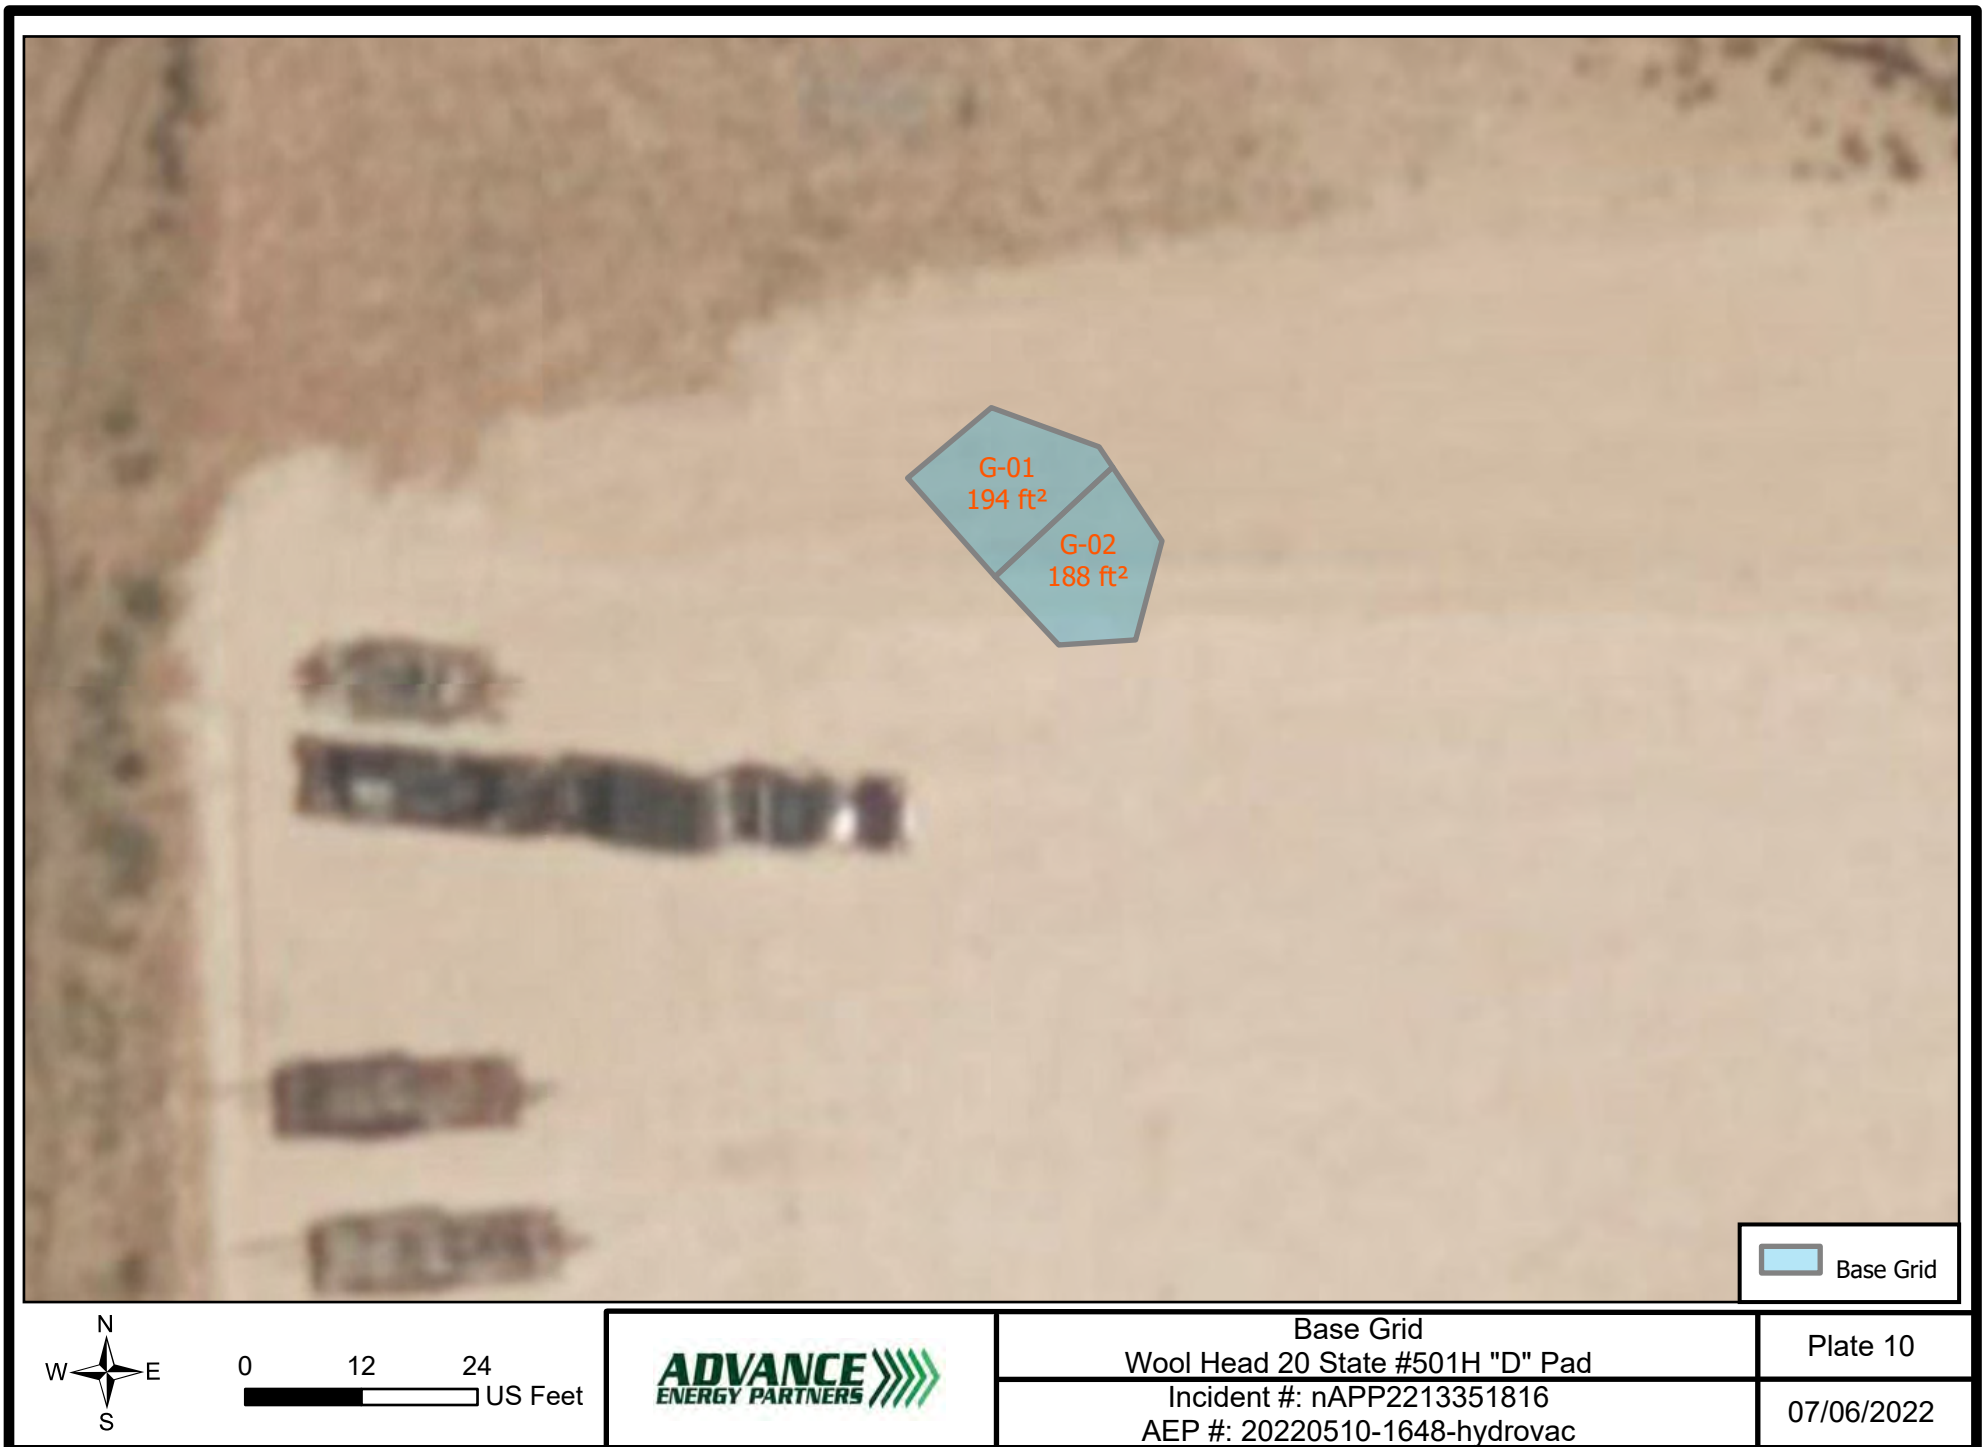
The remediated area was divided into soil sampling base grids not exceeding 200 sq ft, for the collection of confirmation samples on May 20, 2022. Plate 10 shows the base grid IDs (i.e. G-01) and square footages.

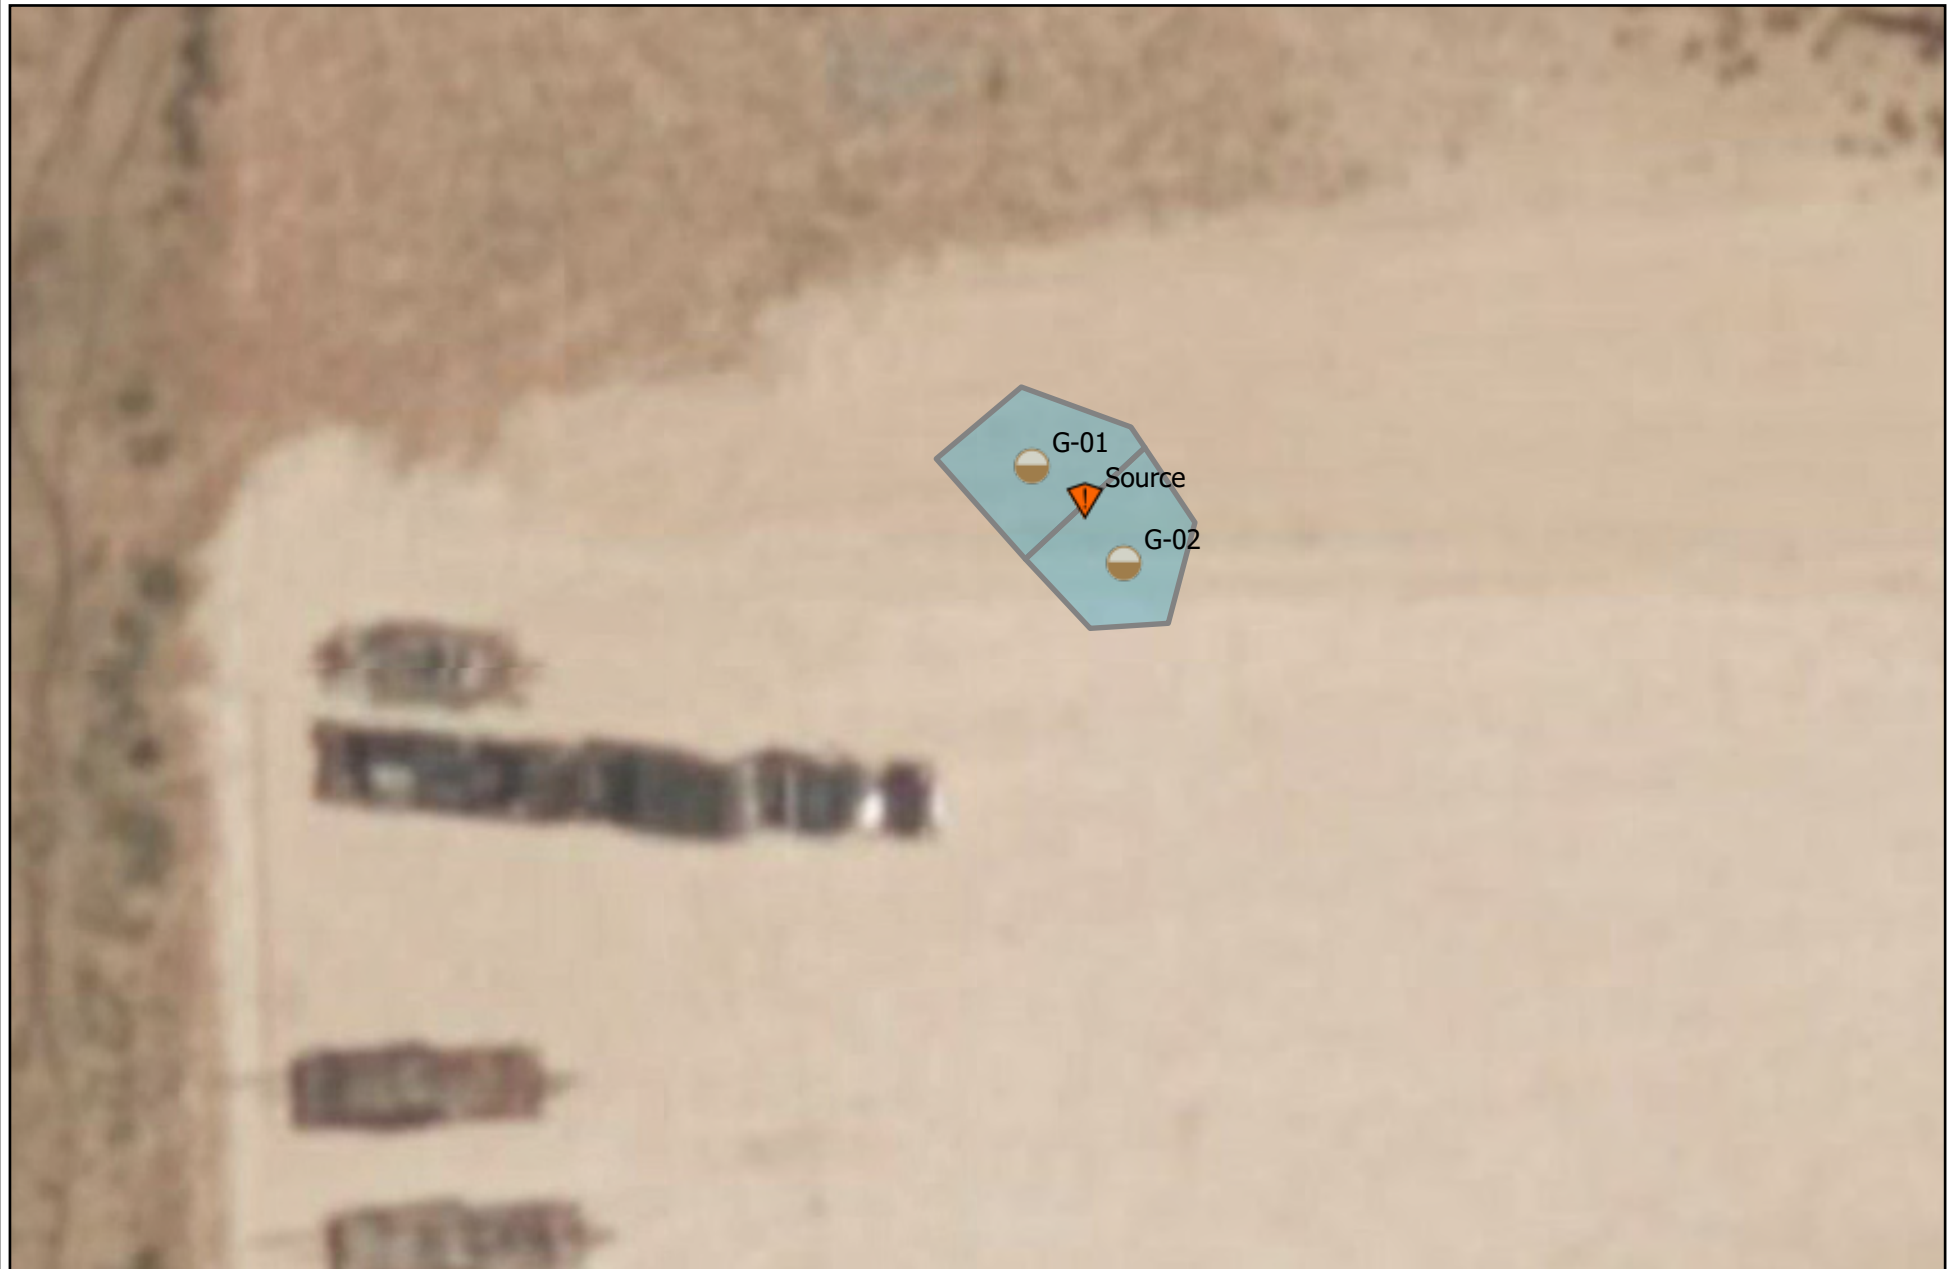
Plate 11 shows the location of the source sample, and the two confirmation samples. The sample ID (i.e. S-01) corresponds with the related base grid name. Each confirmation sample within the respective base grid represents a 3-point composite. Table A shows the sample coordinates. A summary of analytical results from the sampling program are presented in Table B.

Sample Locations  
Wool Head 20 State #501H "D" Pad  
Incident #: nAPP2213351816  
AEP #: 20220510-1648-hydrovac
