**Re: Remediation and Closure Report**  
**Ross Ranch 22 #014H**  
**API No. 30-015-45695**  
**GPS: Latitude 32.636384 Longitude -104.478333**  
**ULSTR - D-27-T19S-R25E**  
**Eddy County, NM**  
**NMOCD Ref. No. NRM2023854921**

Spur Energy Partners (Spur) has contracted Pima Environmental Services, LLC (Pima) to perform a remediation and submit this closure report for a produced water release that occurred at the Ross Ranch 22 #014H (Ross). The initial C-141 was submitted on August 25, 2020 (Appendix C). This incident was assigned Incident ID NRM2023854921, by the New Mexico Oil Conservation Division (NMOCD).

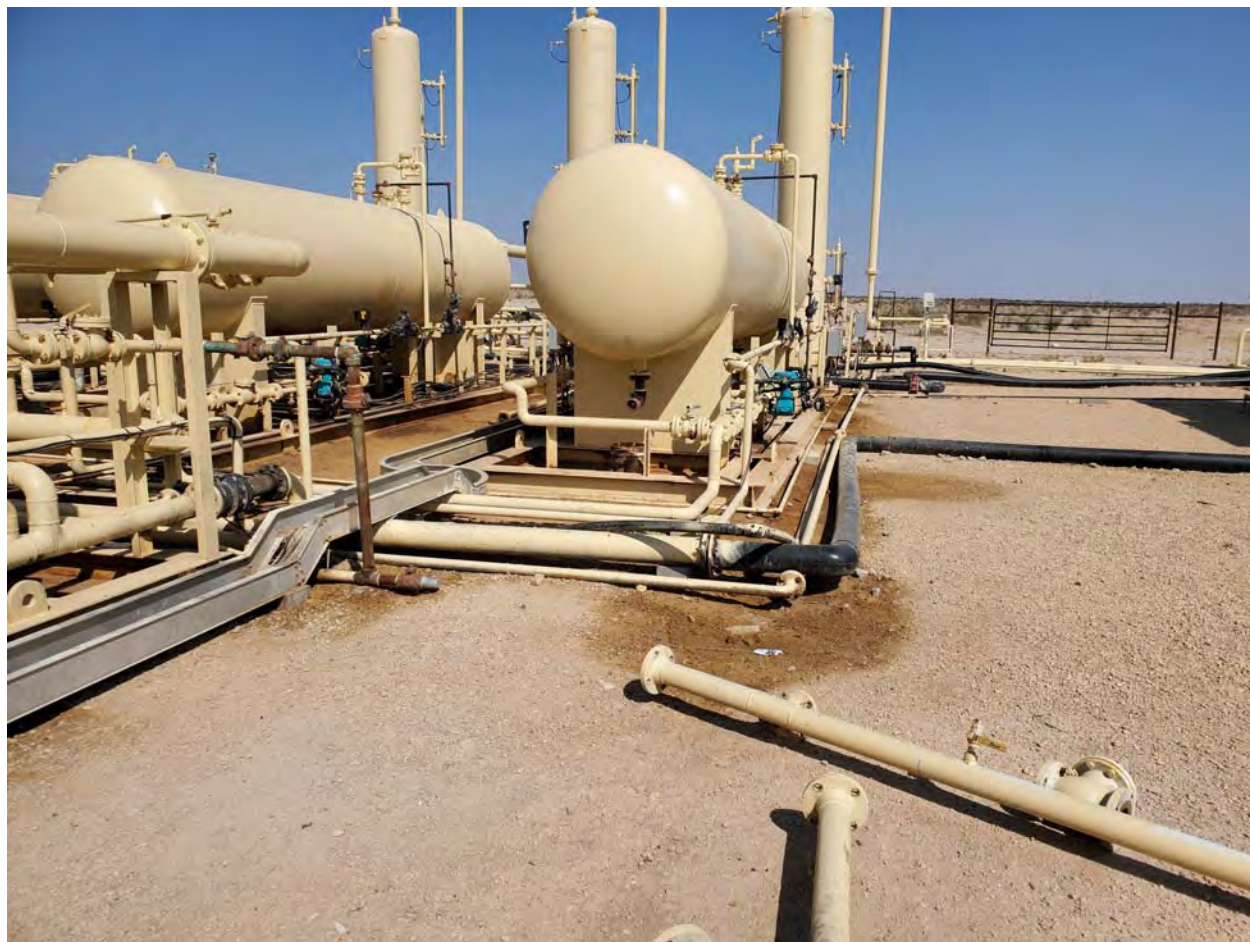
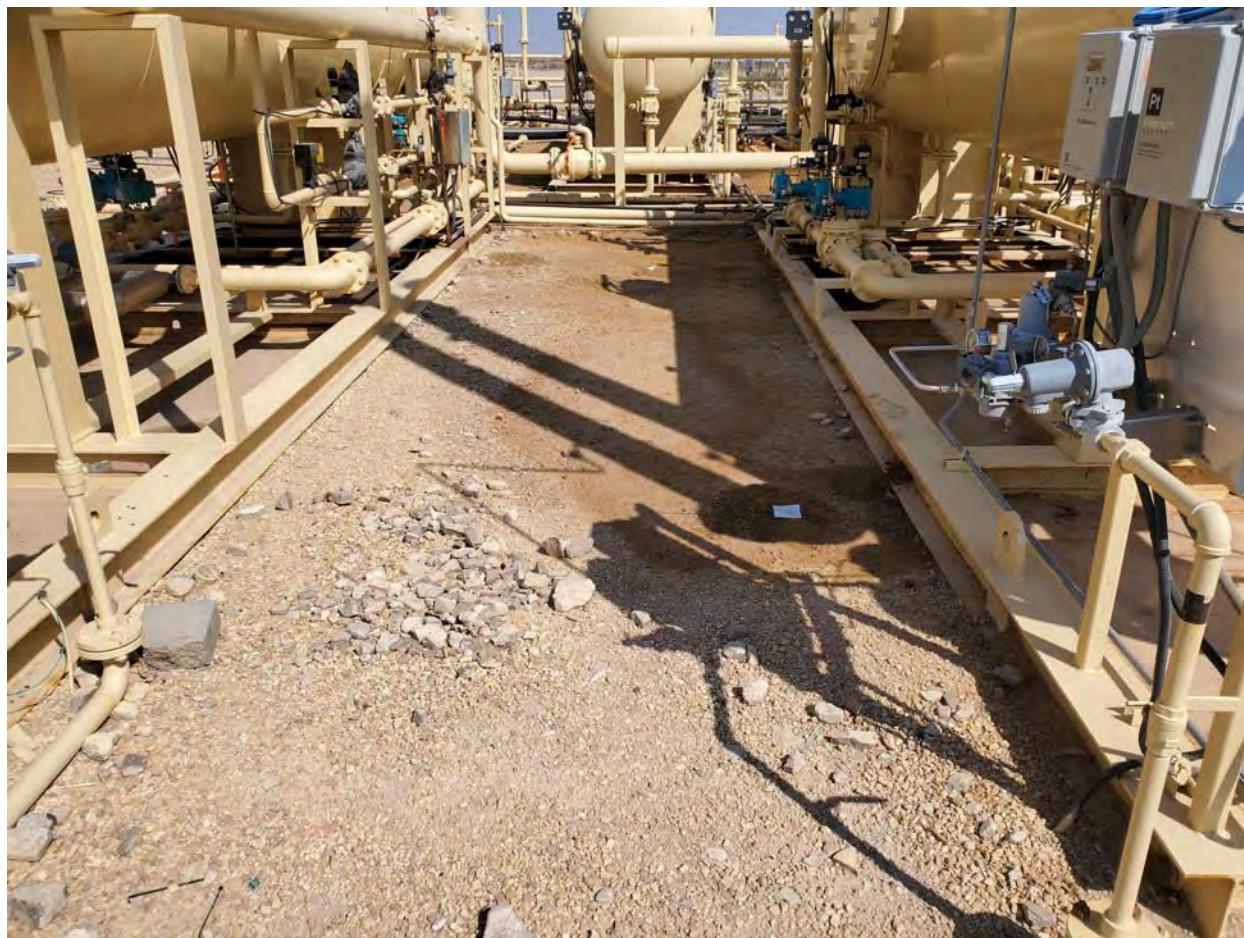
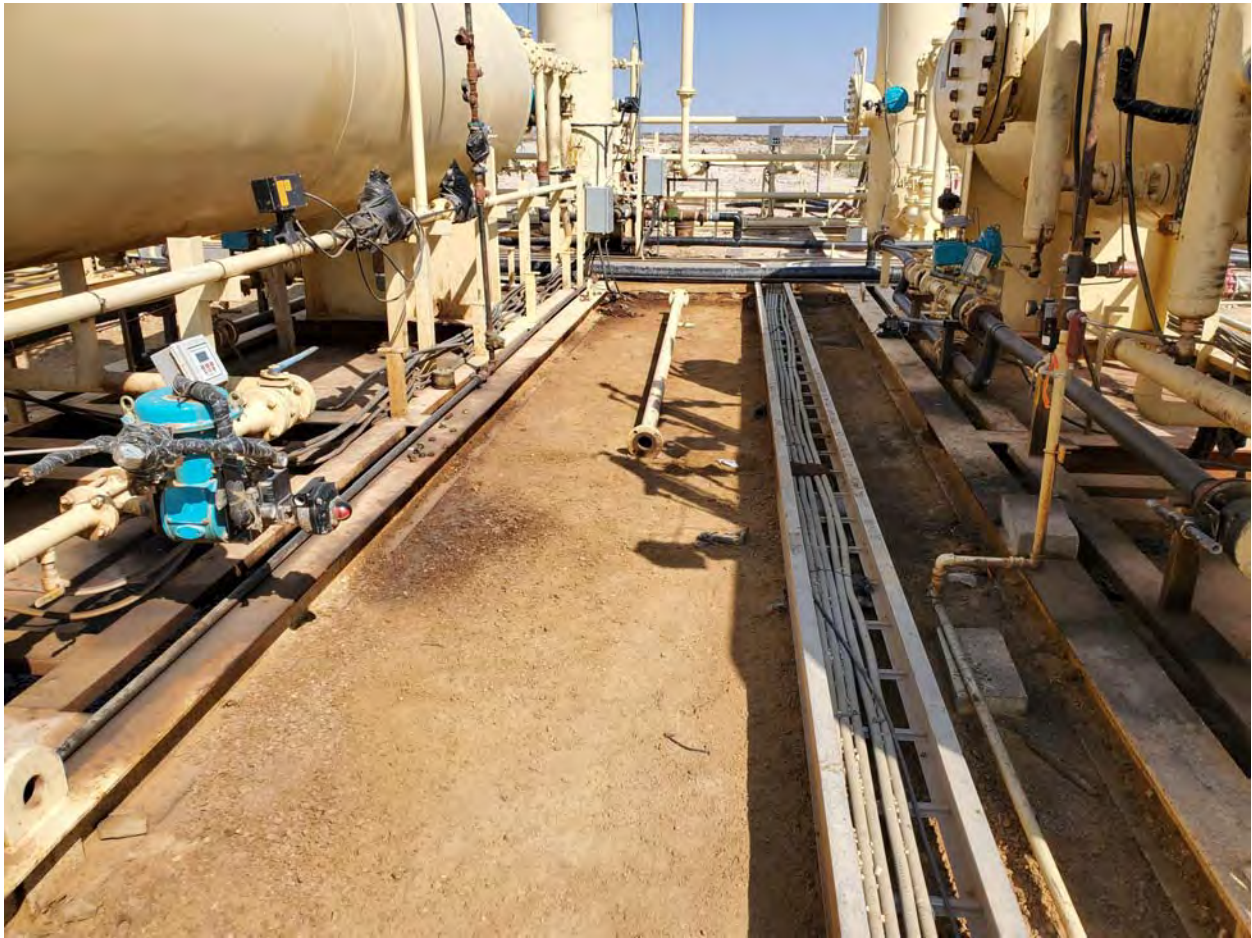
## Ross Ranch 22 14H Assessment Photographs

On October 7, 2020, Talon mobilized personnel to begin the site assessment and soil sampling activities for the construction of a work plan. Discrete surface soil samples were collected within and around the impacted area utilizing a hand auger. Further vertical delineation could not take place due to auger refusal as well as the proximity of infrastructure. Results from our sampling event are presented in the following data table. A complete laboratory report can be found in [Appendix V](#).
