**SITE CHARACTERIZATION UPDATE AND PROPOSED  
REMEDATION PLAN**

**MOBIL CI FEDERAL BATTERY  
UNIT J, SECTION 6, TOWNSHIP 19S, RANGE 25E  
EDDY COUNTY, NEW MEXICO  
32.68932, -104.52211  
RANGER REFERENCE NO. 5375**

**JULY 12, 2022**

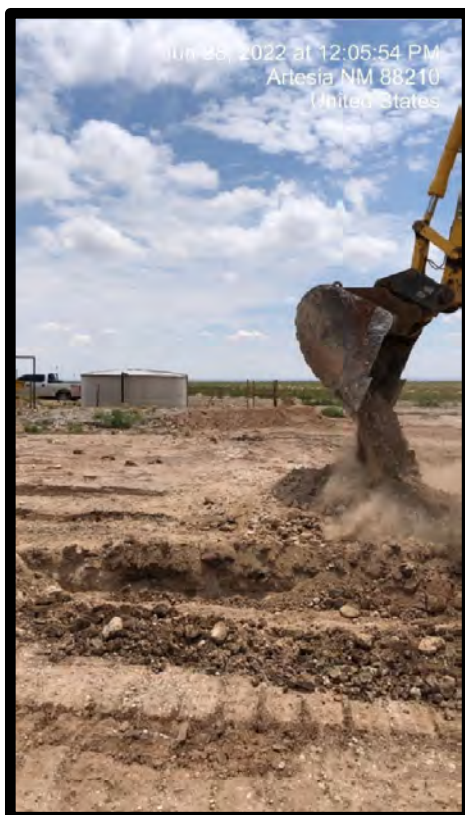
**PHOTOGRAPH NO. 1 – A view of the assessment activities on June 28, 2022 in the vicinity of test excavation “TH-1A”. The view is towards the northwest.**

*(Approximate GPS: 32.689317, -104.522176)*

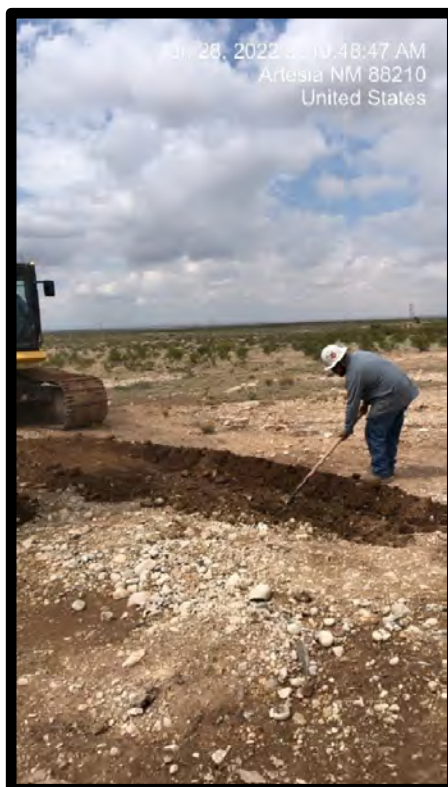
**PHOTOGRAPH NO. 2 – A view of the assessment activities on June 28, 2022 in the vicinity of test excavation “TH-8A”. The view is towards the northwest.**

*(Approximate GPS: 32.689207, -104.522111)*
