## Release Notification

Site Name	South Vacuum #274 SWD	Site Type	SWD
Date Release Discovered	6/23/20	API# (if applicable)	30-025-37122

Appendix D  
Clearwater SWD, LLC  
South Vacuum #274 SWD

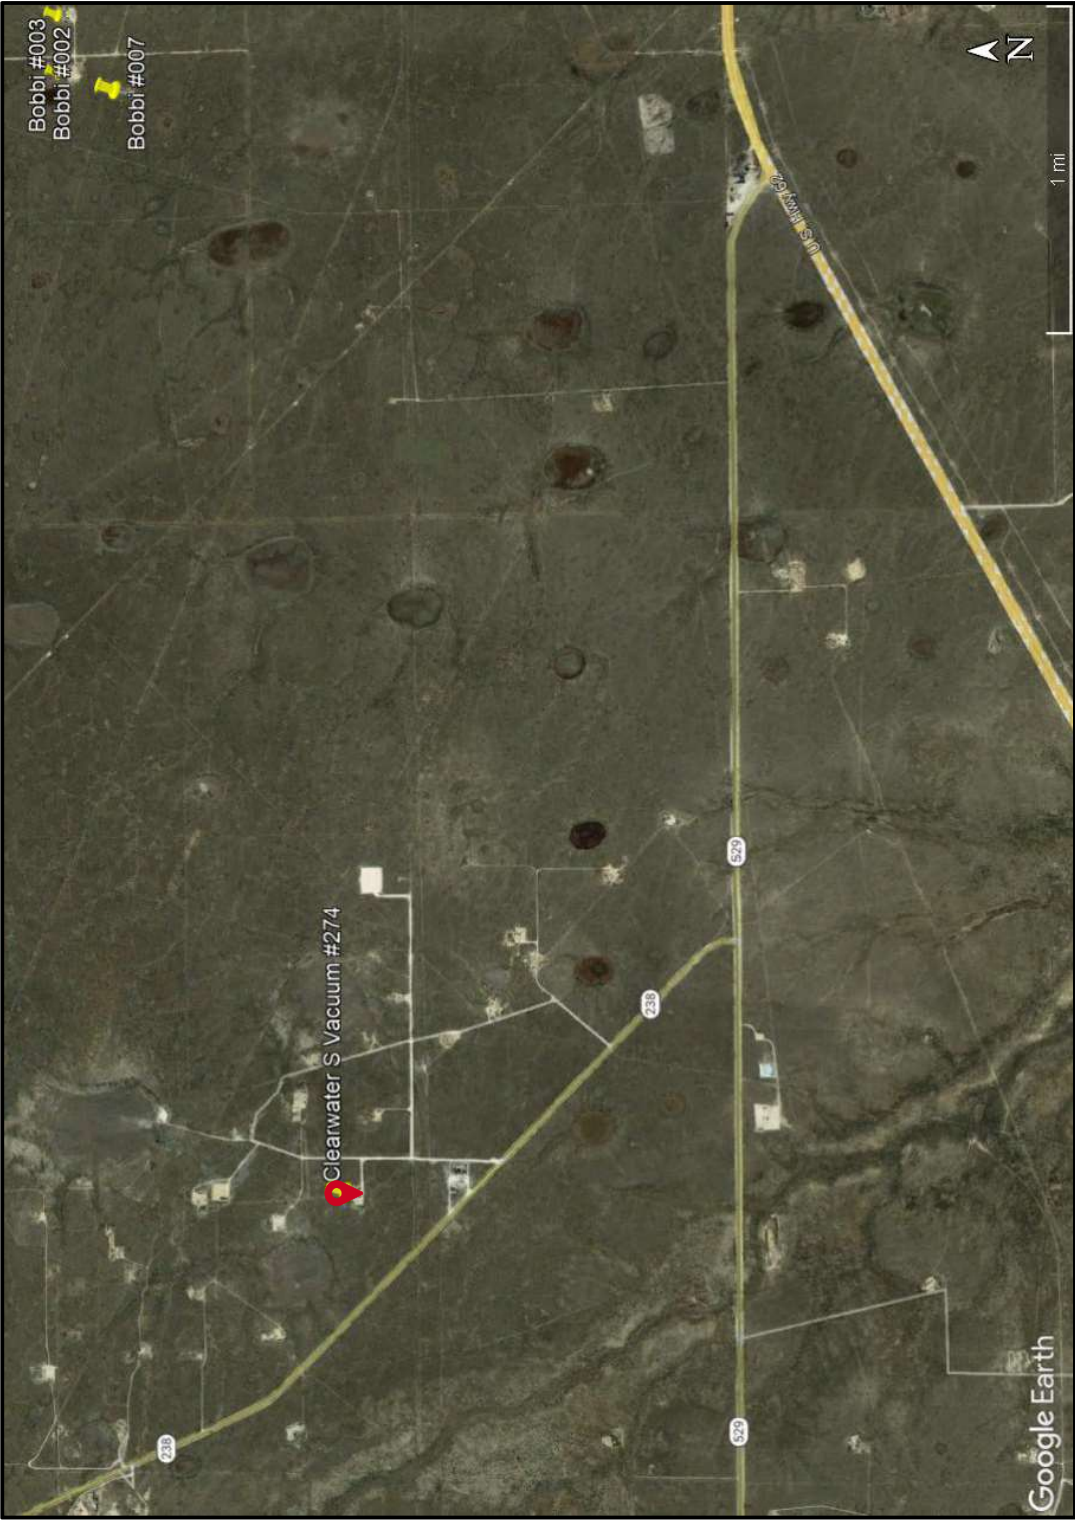
On March 14, 2022, CE conducted an initial investigation at the Site and observed an affected area measuring approximately 90' by 80' to the east and southeast of the water tank. Produced water surface impacts at the Site cover approximately 7,200 square feet. The release point and the surface extent of the produced water release are depicted on Figure 2.

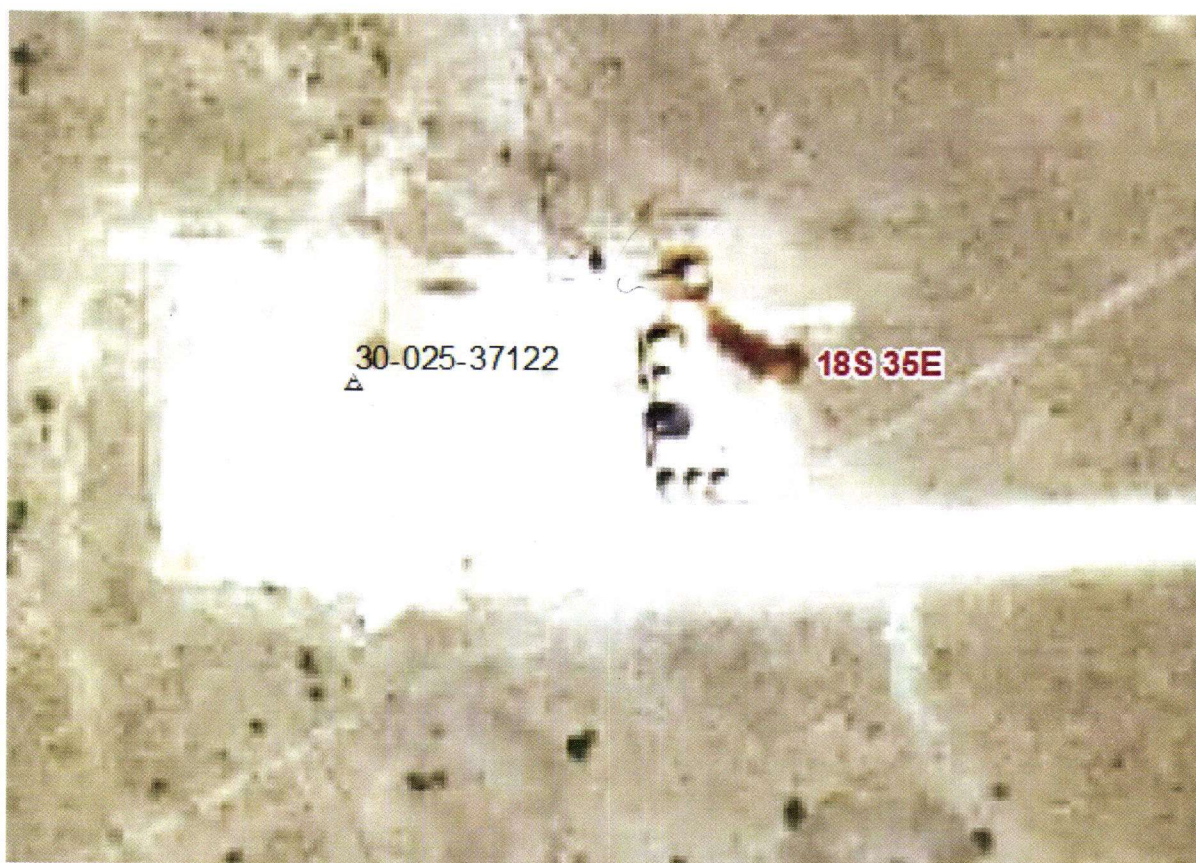
### Site Imagery

**Summary:** During a routine inspection, SLO staff found what may be a spill from the tank battery of SWD 30-025-37122 in NAIP 2018 imagery. The site has been operated by Clearwater SWD since 2/6/2016.

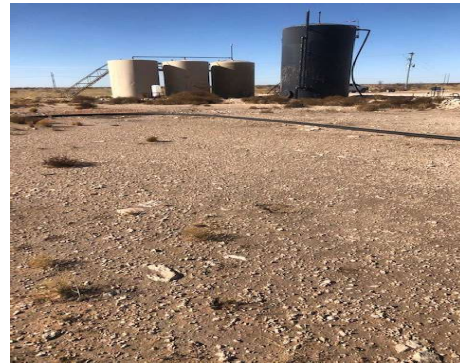
View to S of release area (3/14/22).

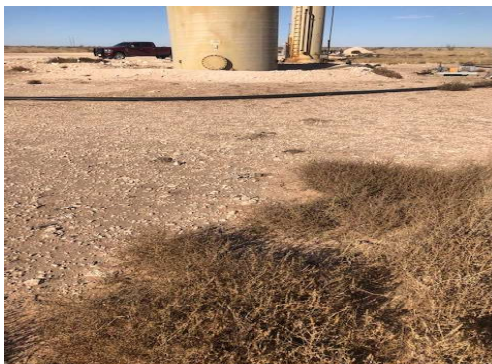
View to W of release area (3/14/22).

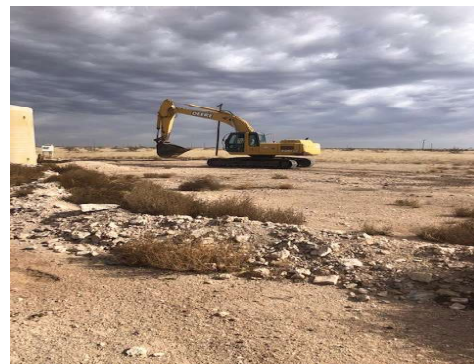
View of equipment at release area (3.14.22).

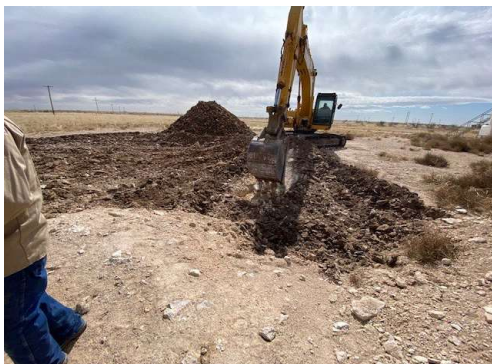
View to SE of initial investigation (3/14/22).

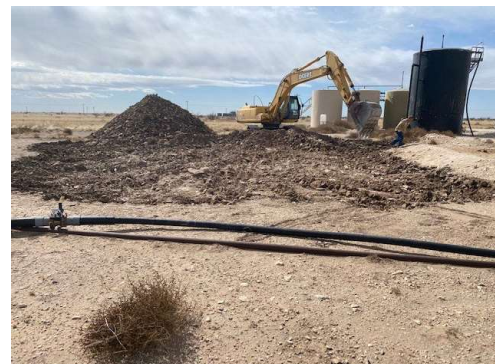
View to S of initial investigation (3/14/22).

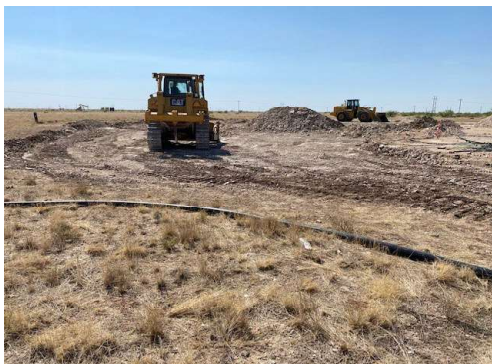
View to N of W side of excavation (5/27/22).

Approximately 600 cubic yards (yd) of excavated soil is being transported under manifest to an OCD approved disposal facility. Upon OCD approval, the excavation will be backfilled to grade with non-impacted similar material. Pursuant to 19.15.29.13 NMAC, the impacted surface areas will be restored to pre-release conditions. Surface grading will be performed to near original conditions and contoured to prevent erosion and ponding, promote stability, and preserve storm water flow patterns.

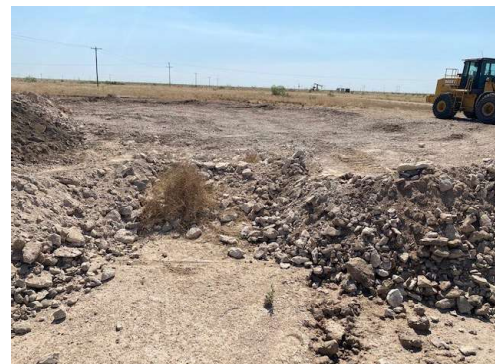
View to N of E side of excavation (5/27/22).
