Remediation Summary and Closure Request

Devon Energy Corporation

Tomcat Federal 21 Com #1

NMOCD Incident # nKJ1528146835

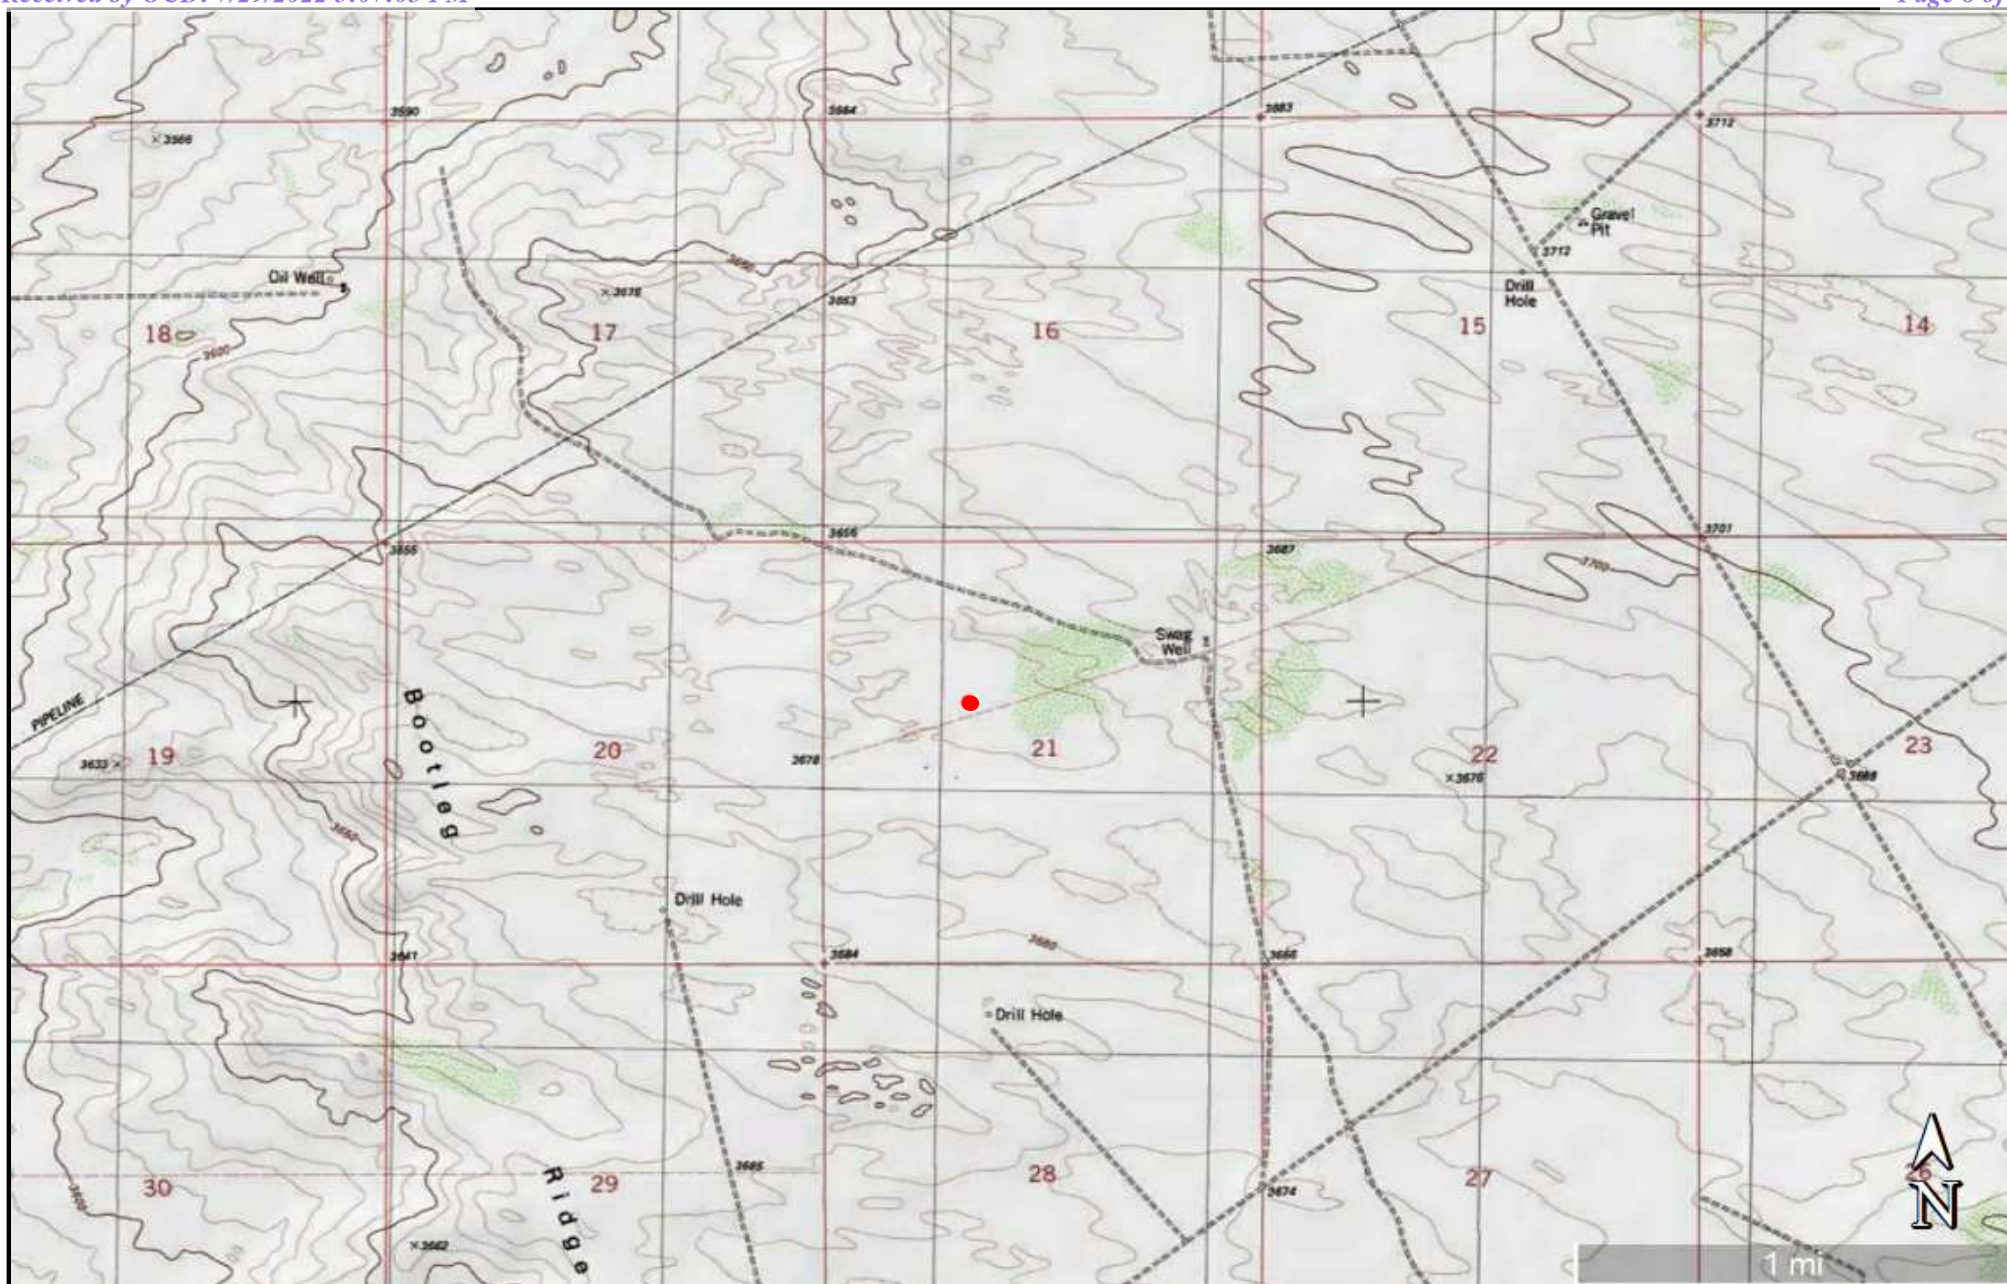
**Figure 1**

Topographic Map
 Devon Energy Corporation
 Tomcat Federal 21 Com #1
 GPS: 32.291682, -103.682428
 Lea County

The site is located in Unit Letter F (SE/NW), Section 21, Township 23 South, Range 32 East, approximately 32 miles Southwest of Eunice, in Lea County, New Mexico. The property is on Federal land. Topographic Map, OSE POD Locations Map, and USGS Well Locations Map are included as Figure 1, Figure 2, and Figure 3, respectively.

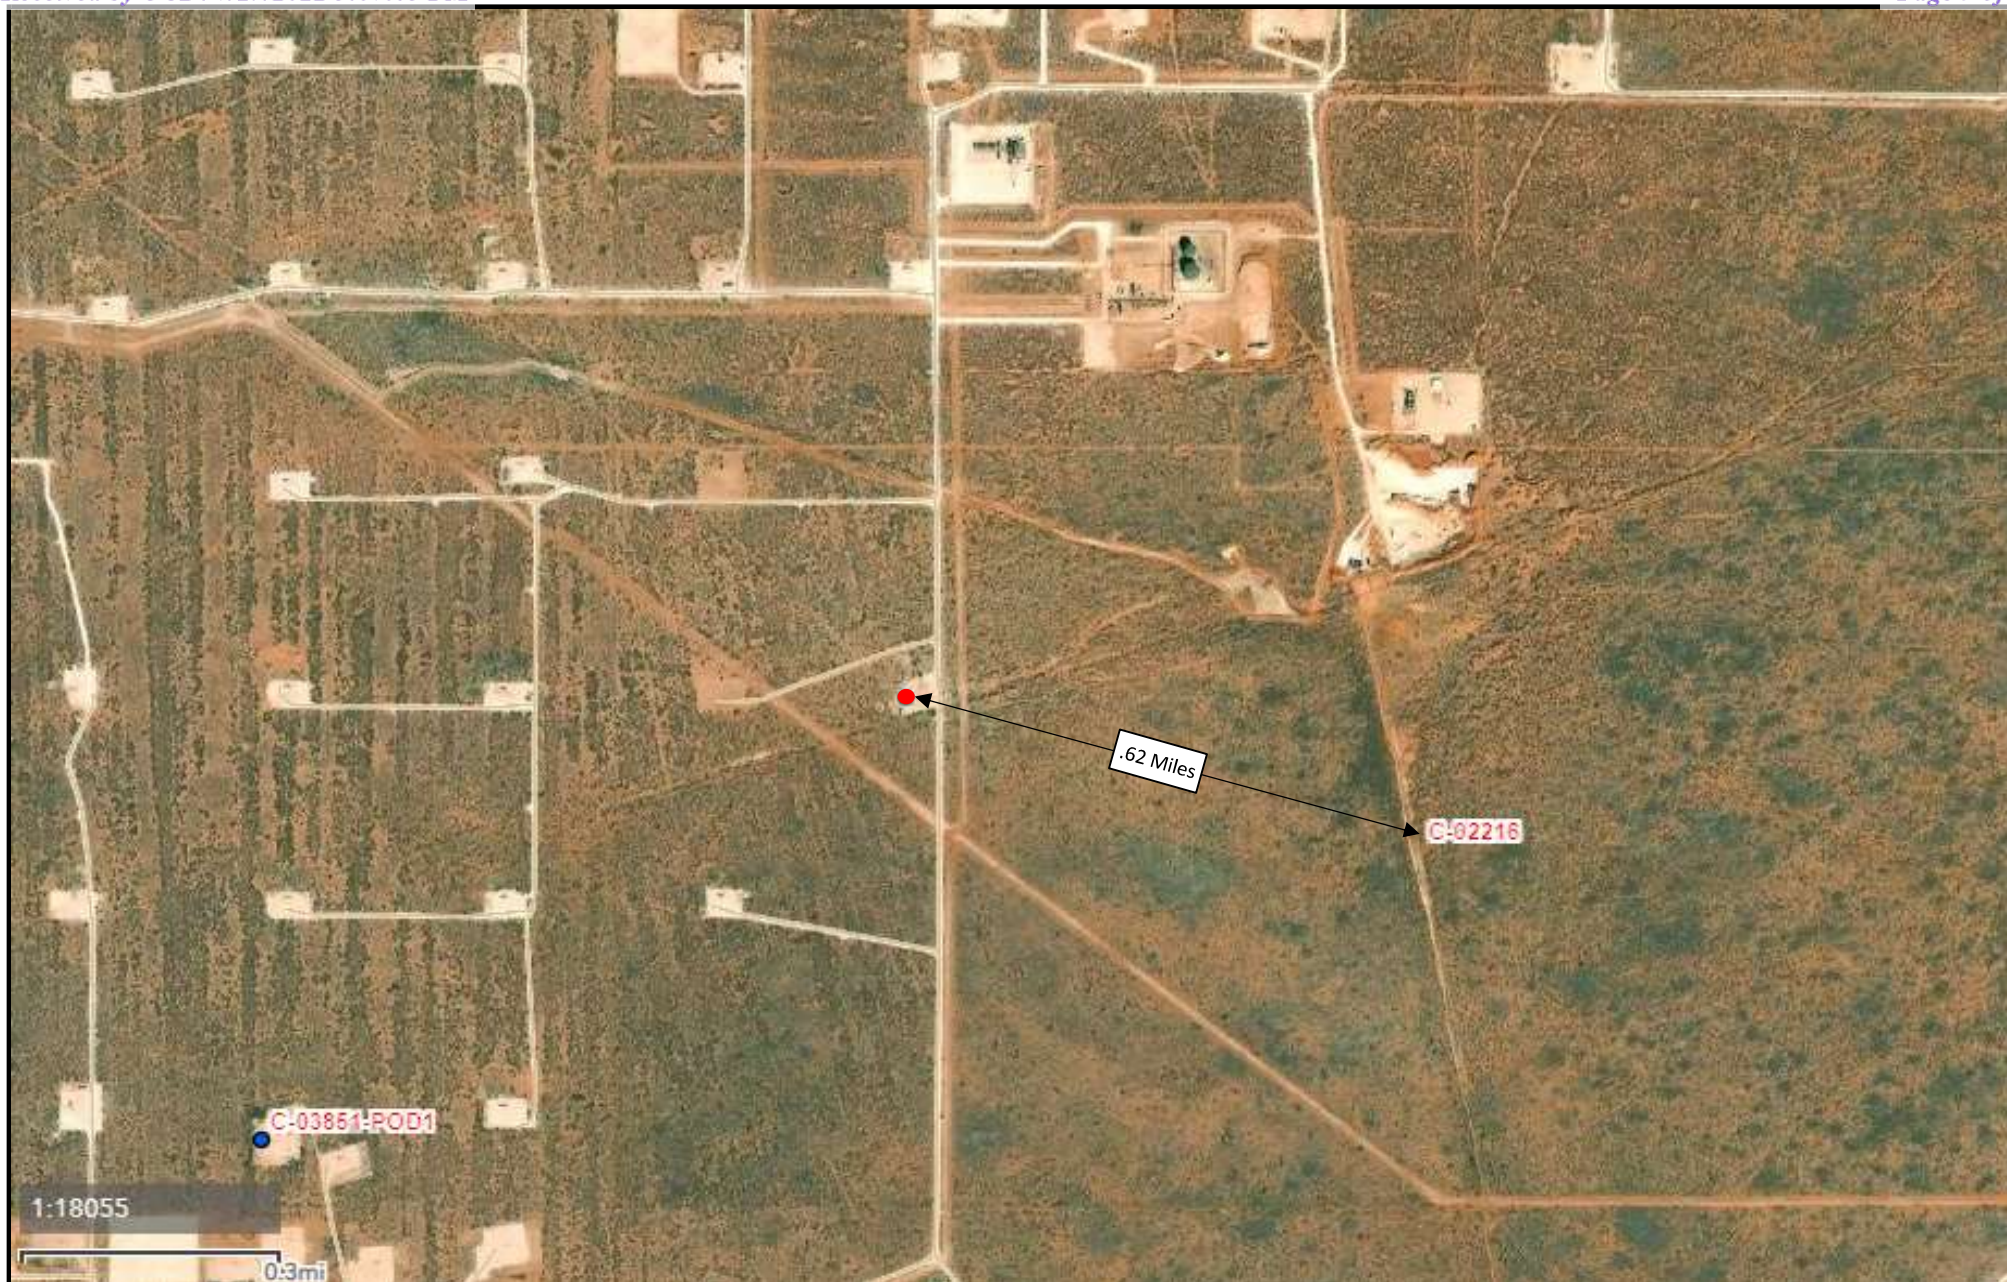
**Figure 2**

A search of the New Mexico Office of the State Engineer (NMOSE) and United States Geological Survey (USGS) groundwater databases was completed in an effort to determine the horizontal distance to known water sources within a half mile radius of the release site. Approximate depth to groundwater was determined using maintained and published water well data. Karst mapping indicates the site is not located in a Karst designated area. Depth to groundwater information is provided as Attachment III and the results are depicted on Figures 2 & 3.

OSE POD Locations Map
Devon Energy Corporation
Tomcat Federal 21 Com #1
GPS: 32.291682, -103.682428
Lea County

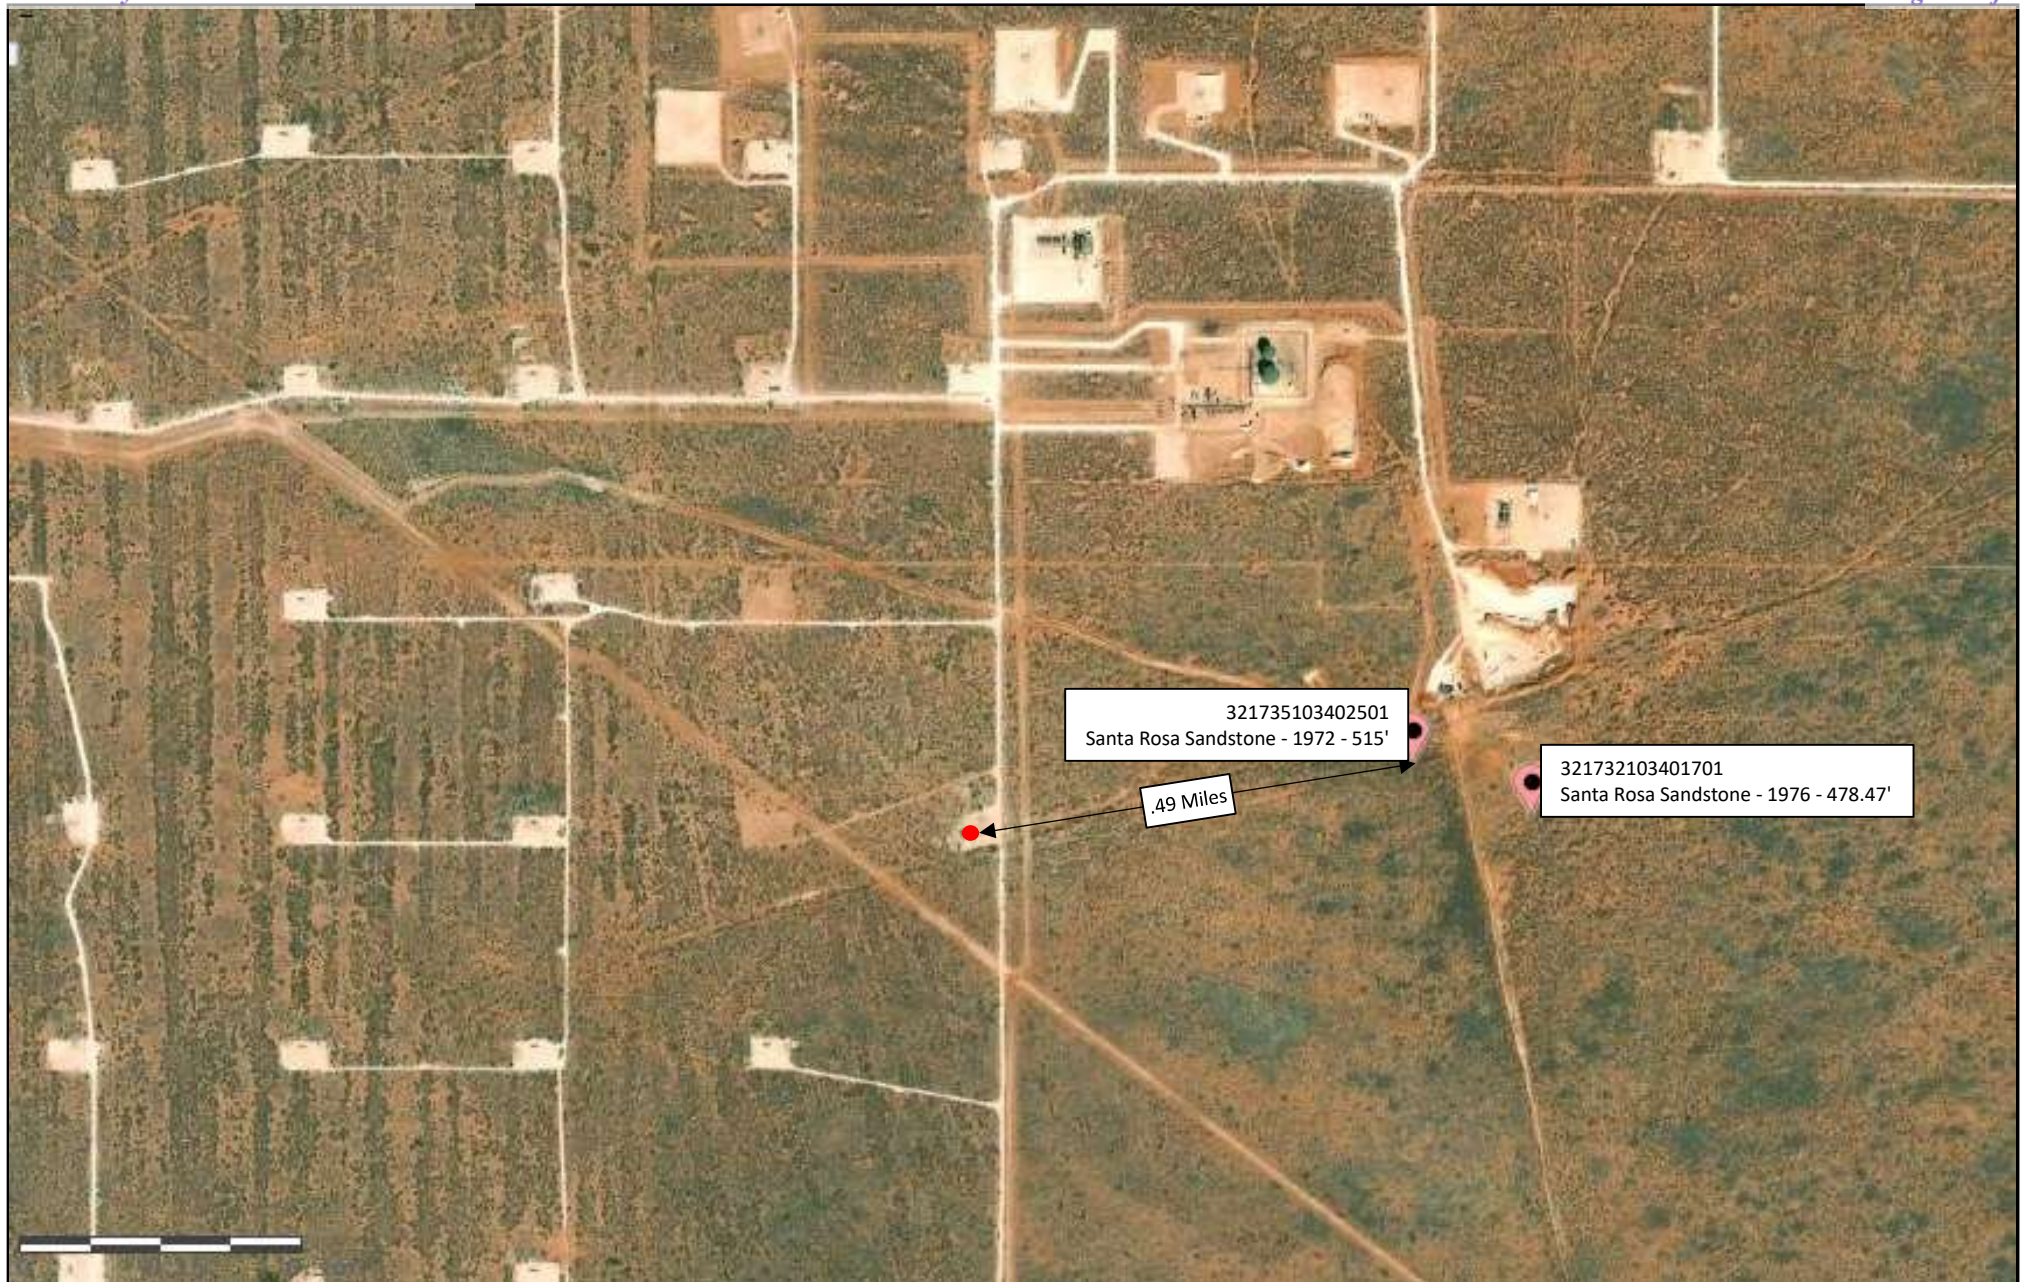
**Figure 3**

One USGS water well was located within a half mile of the release area, listing depth to water at approximately five hundred fifteen feet bgs. The Lea County Depth to Ground Water map listed depth to water at approximately four hundred feet bgs. At that time the NMOCD allowed use of these maps to estimate depth to water. Depth to water was thus determined to be greater than one hundred feet bgs at this location. Utilizing this information, the NMOCD Recommended Remedial Action Levels (RRAL's) for the Site were determined as follows:

USGS Well Locations Map
Devon Energy Corporation
Tomcat Federal 21 Com #1
GPS: 32.291682, -103.682428
Lea County

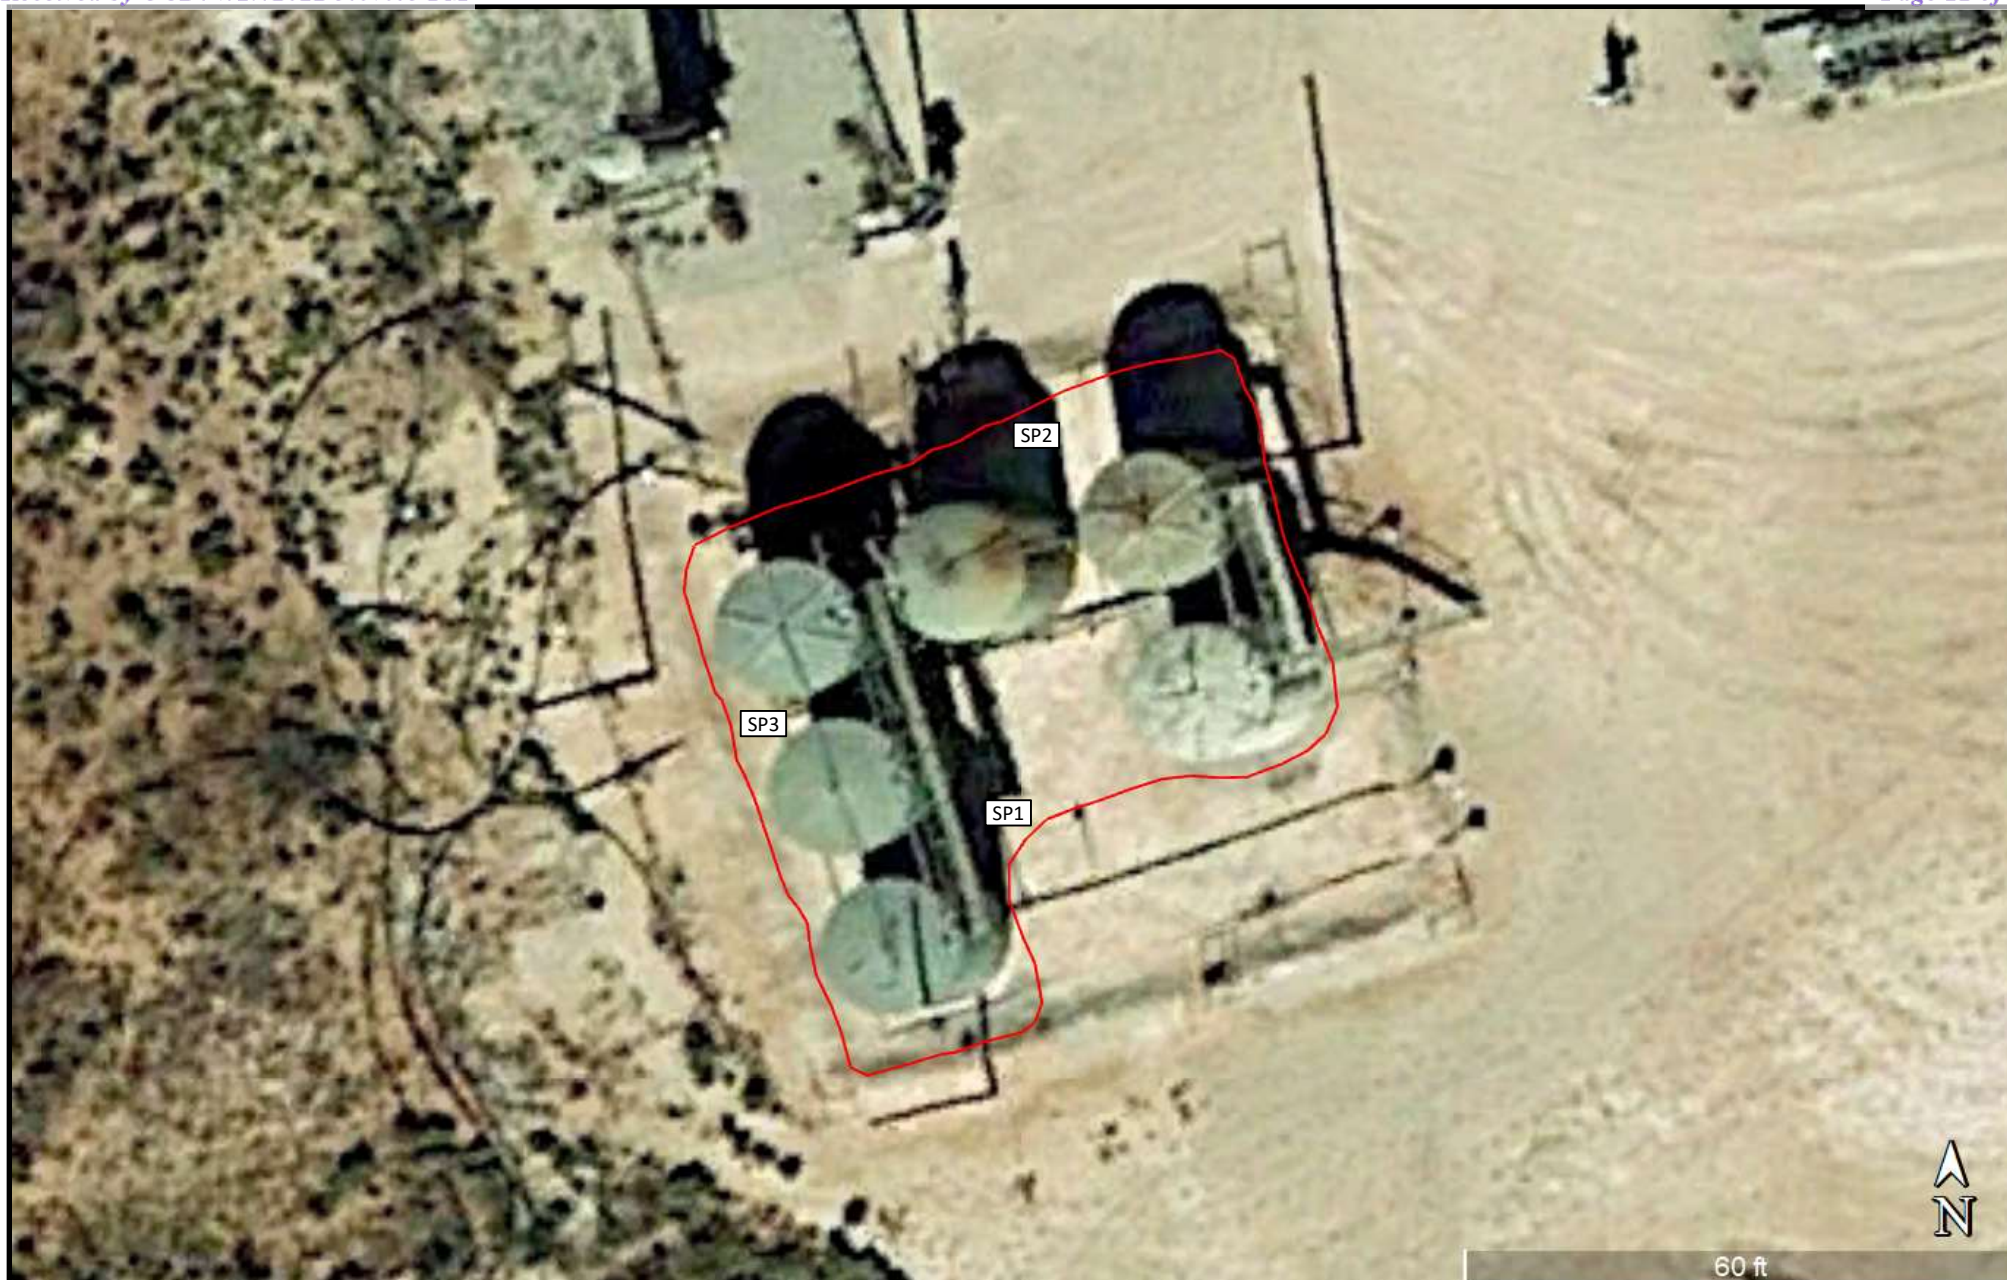
**Figure 4**

A Sample Location Map is provided as Figure 4. A Summary of Soil Sample Laboratory Analytical Results is provided as Table 1 and Laboratory Analytical Reports are provided as Attachment IV. Site Photographs are provided as Attachment II.

Sample Location Map
Devon Energy Corporation
Tomcat Federal 21 Com #1
GPS: 32.291682, -103.682428
Lea County

The release area was excavated, via hand tools, according to the approved work plan. Delineation was attempted at SP#1 in an effort to determine, the vertical extent of chloride contamination, and where chloride concentrations were less than or equal to 250 mg/kg. Due to the proximity of tanks and process equipment, delineation was conducted via hand auger. At eight feet below ground surface, auger refusal was encountered due to hard packed caliche. As deeper delineation was not possible, soil samples were collected and submitted to the laboratory for analysis of chloride.

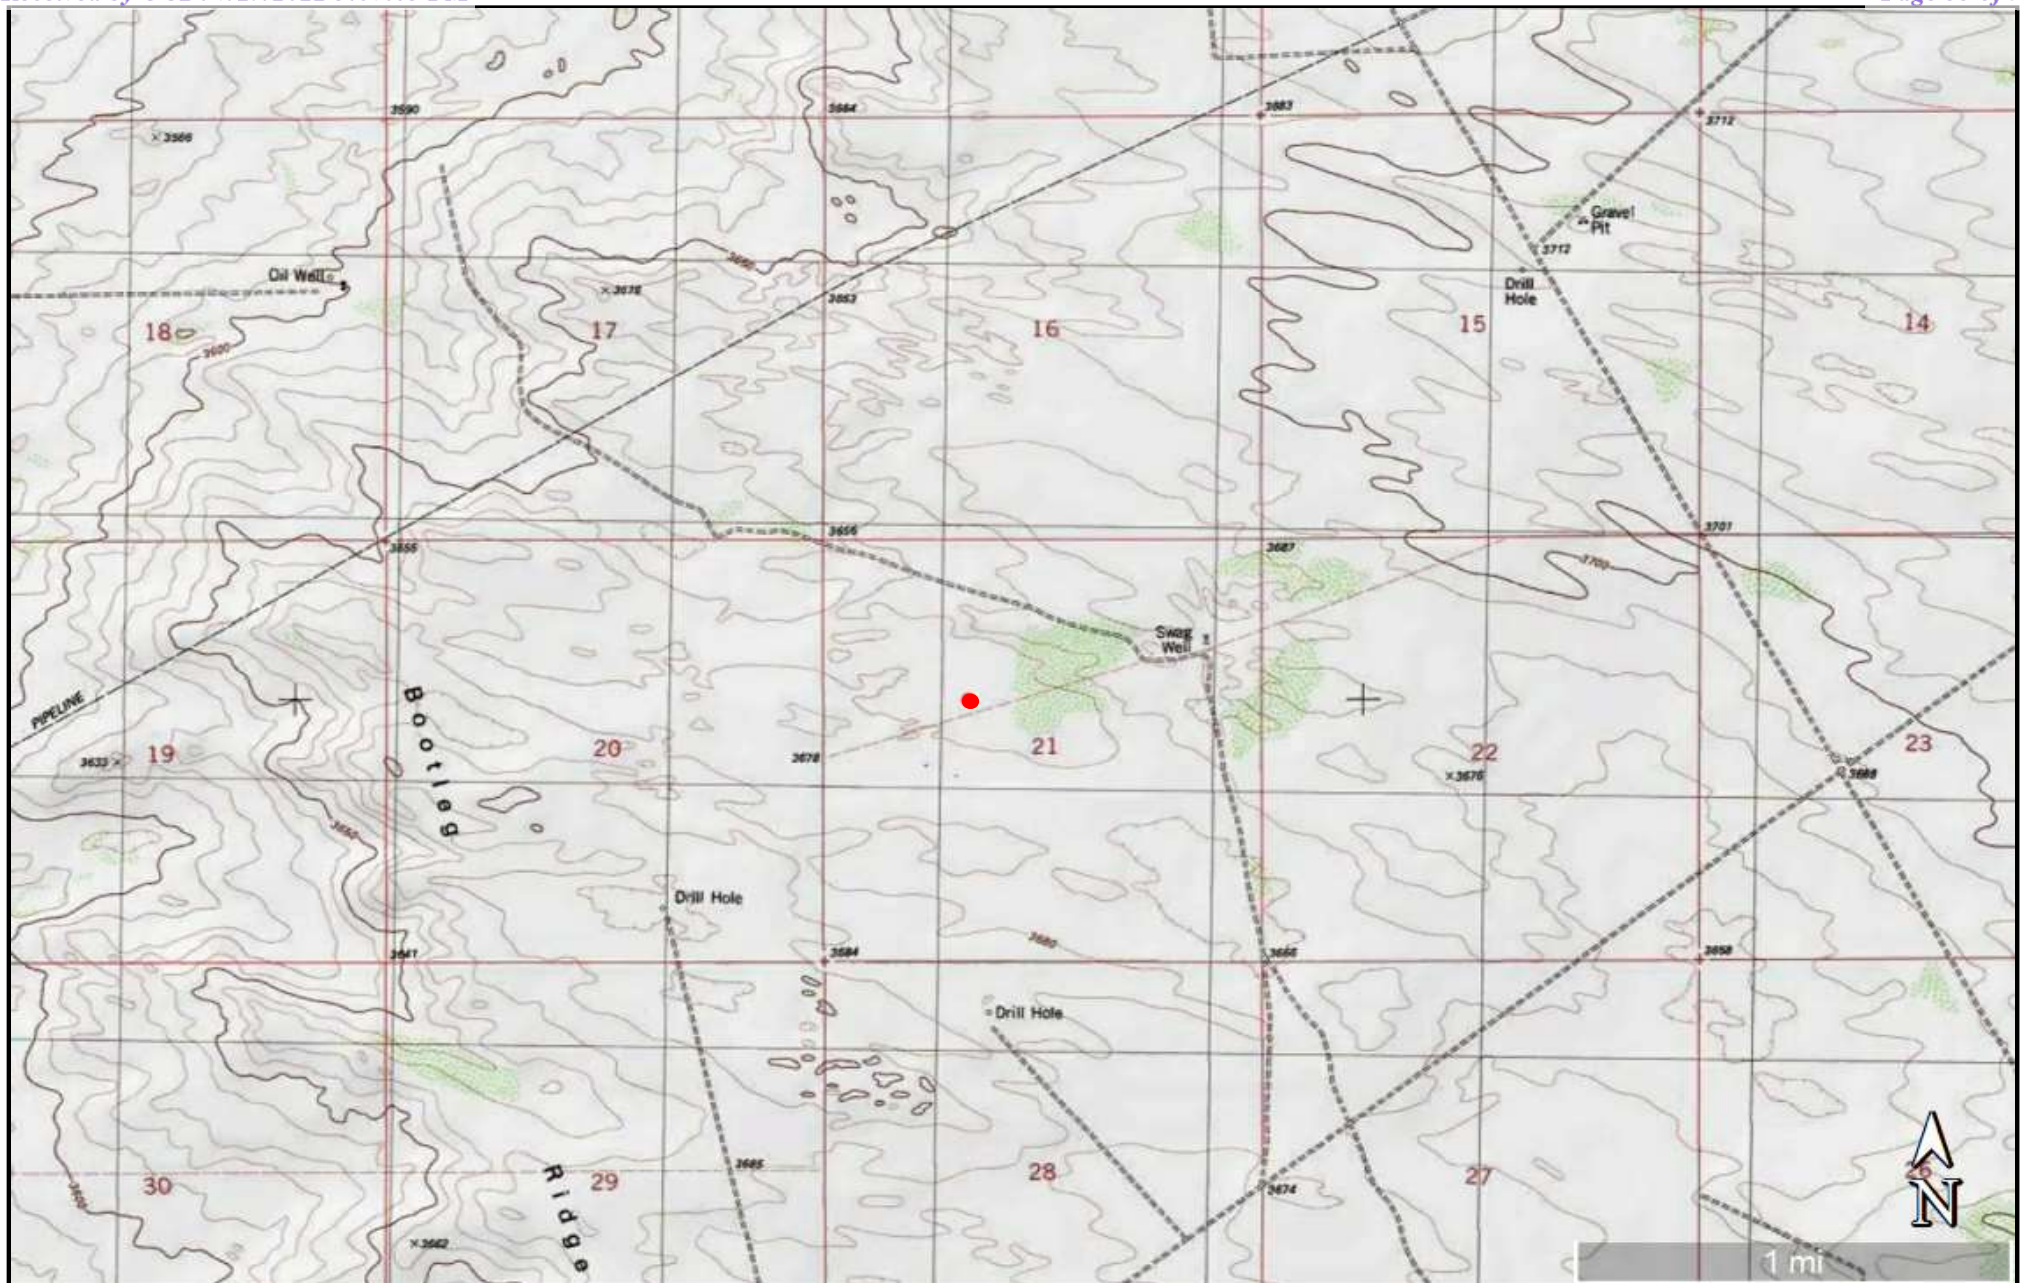
**Figure 1**

Topographic Map
 Devon Energy Corporation
 Tomcat Federal 21 Com #1
 GPS: 32.291682, -103.682428
 Lea County

The site is located in Unit Letter F (SE/NW), Section 21, Township 23 South, Range 32 East, approximately 32 miles Southwest of Eunice, in Lea County, New Mexico. The property is on Federal land. Topographic Map, OSE POD Locations Map, and USGS Well Locations Map are included as Figure 1, Figure 2, and Figure 3, respectively.

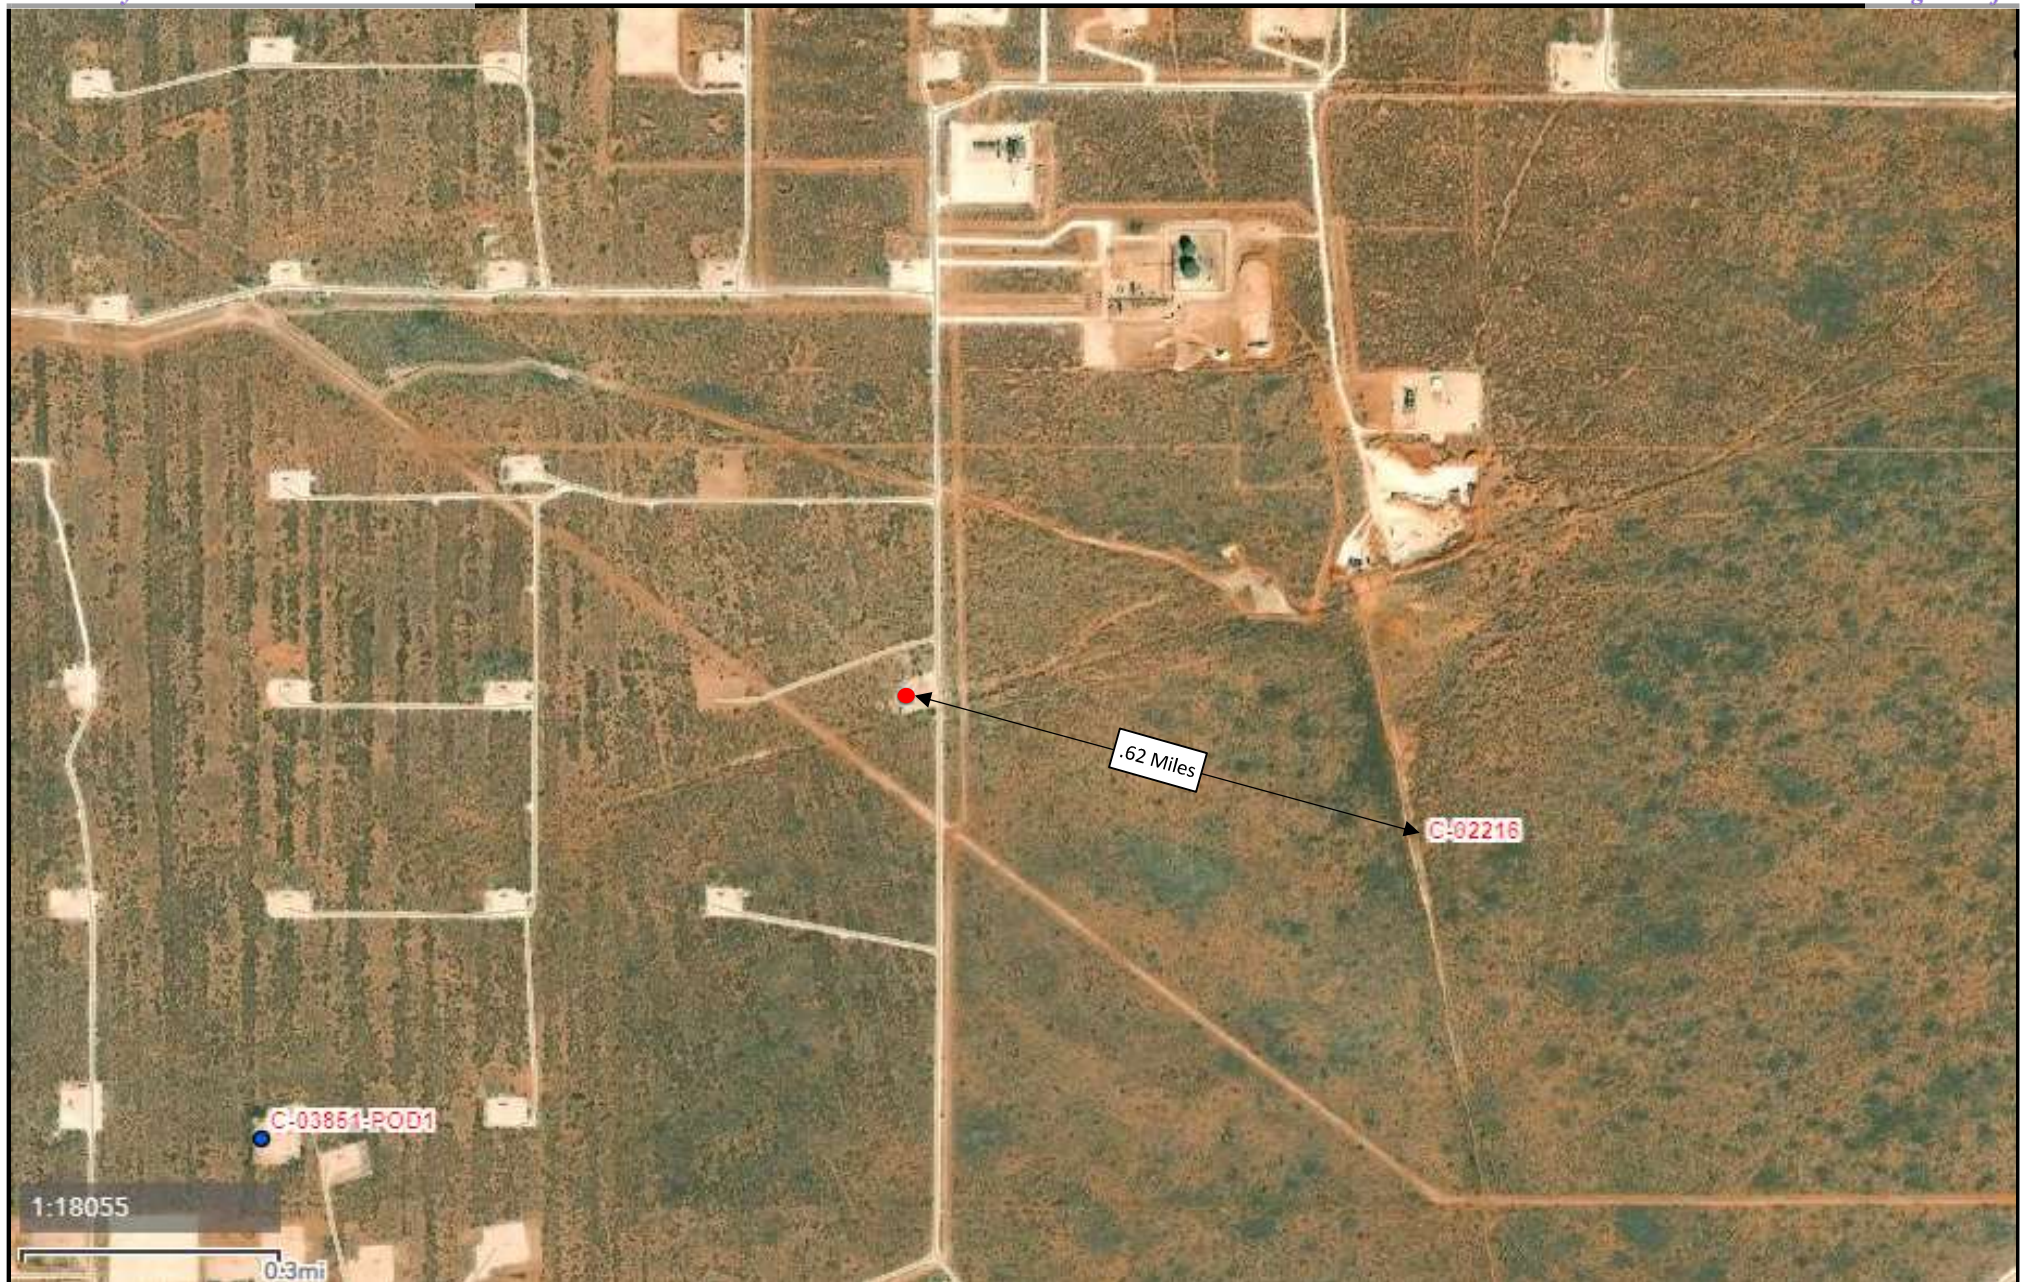
**Figure 2**

OSE POD Locations Map
Devon Energy Corporation
Tomcat Federal 21 Com #1
GPS: 32.291682, -103.682428
Lea County

A search of the New Mexico Office of the State Engineer (NMOSE) and United States Geological Survey (USGS) groundwater databases was completed in an effort to determine the horizontal distance to known water sources within a half mile radius of the release site. Approximate depth to groundwater was determined using maintained and published water well data. Karst mapping indicates the site is not located in a Karst designated area. Depth to groundwater information is provided as Attachment III and the results are depicted on Figures 2 & 3.

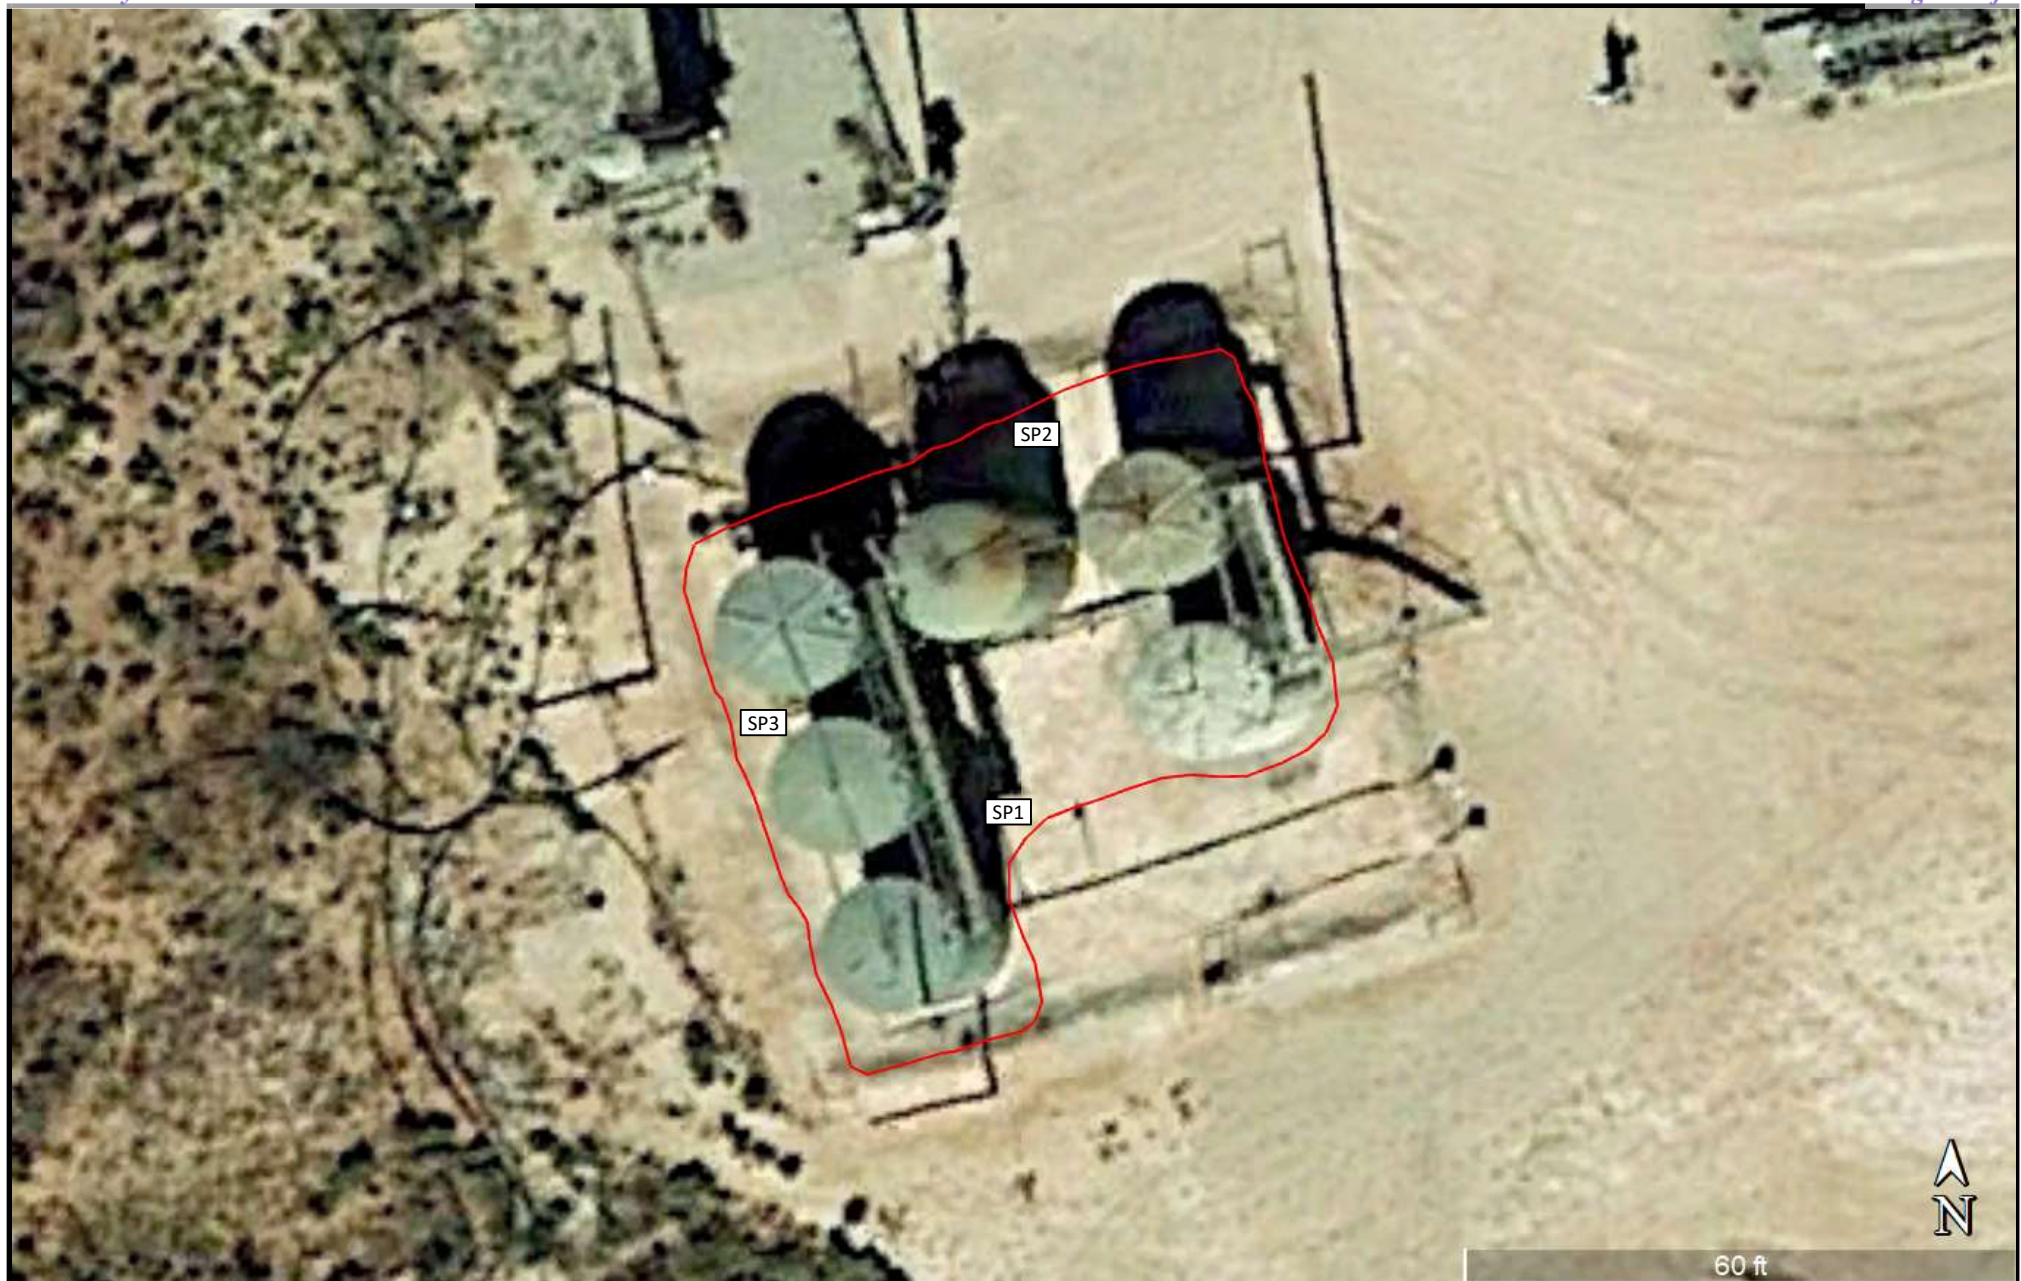
**Figure 4**

Sample Location Map
Devon Energy Corporation
Tomcat Federal 21 Com #1
GPS: 32.291682, -103.682428
Lea County
