Remediation Summary & Soil Closure Request

ConocoPhillips Company Little Bear Federal 33M CTB

Lea County, New Mexico
Unit Letter "M", Section 33, Township 20 South, Range 34 East
Latitude 32.52499 North, Longitude 103.57015 West
NMOCD Reference No. nAPP2202537169

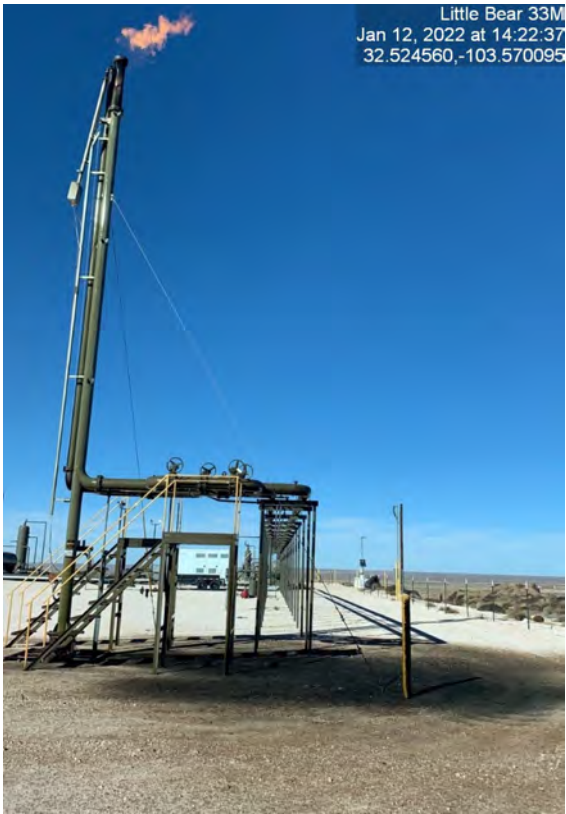
Photo Number: 1

Photo Direction: North	
Photo Description: View of the affected area.

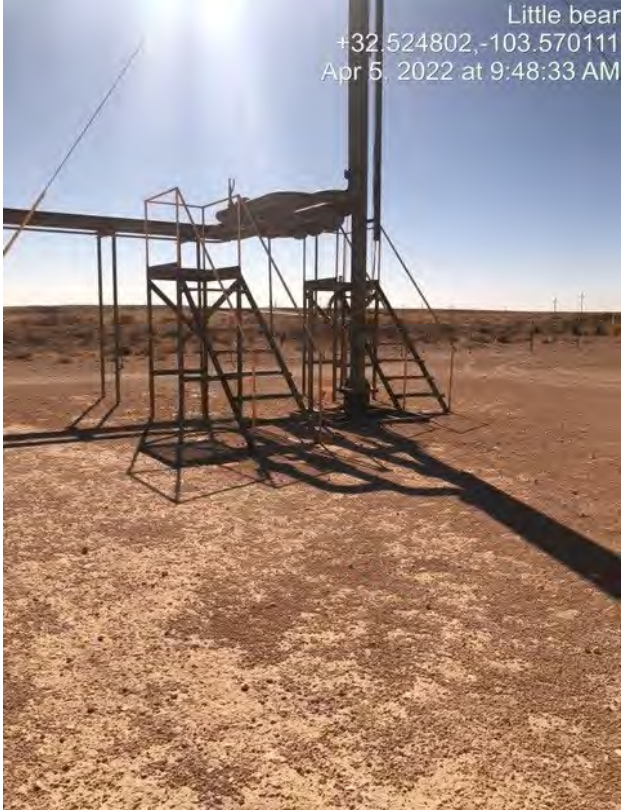
Photo Number: 3

<p>Little bear +32.524802,-103.570111 Apr 5, 2022 at 9:48:33 AM</p>
Photo Direction: Southeast	
Photo Description: View of the scraped area.

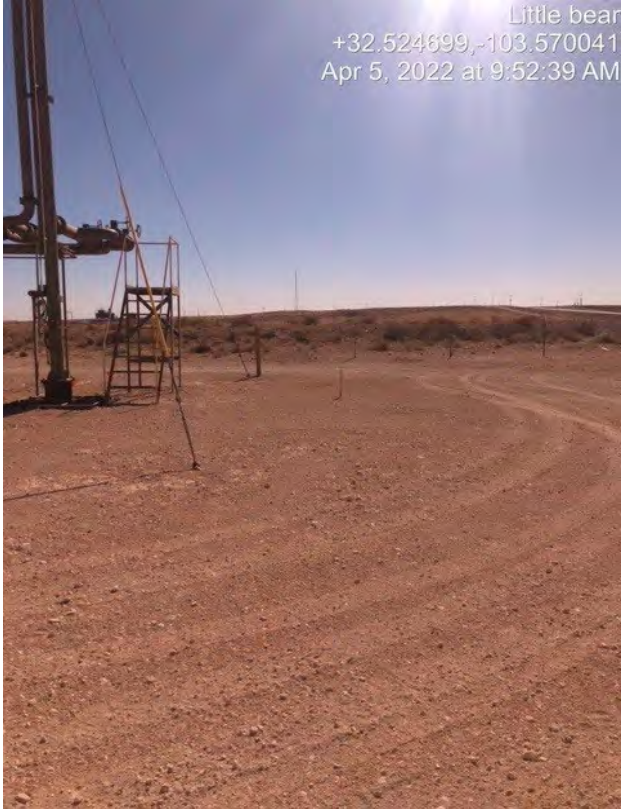
Photo Number: 4

<p>Little bear +32.524699,-103.570041 Apr 5, 2022 at 9:52:39 AM</p>
Photo Direction: East	
Photo Description: View of the scraped area.

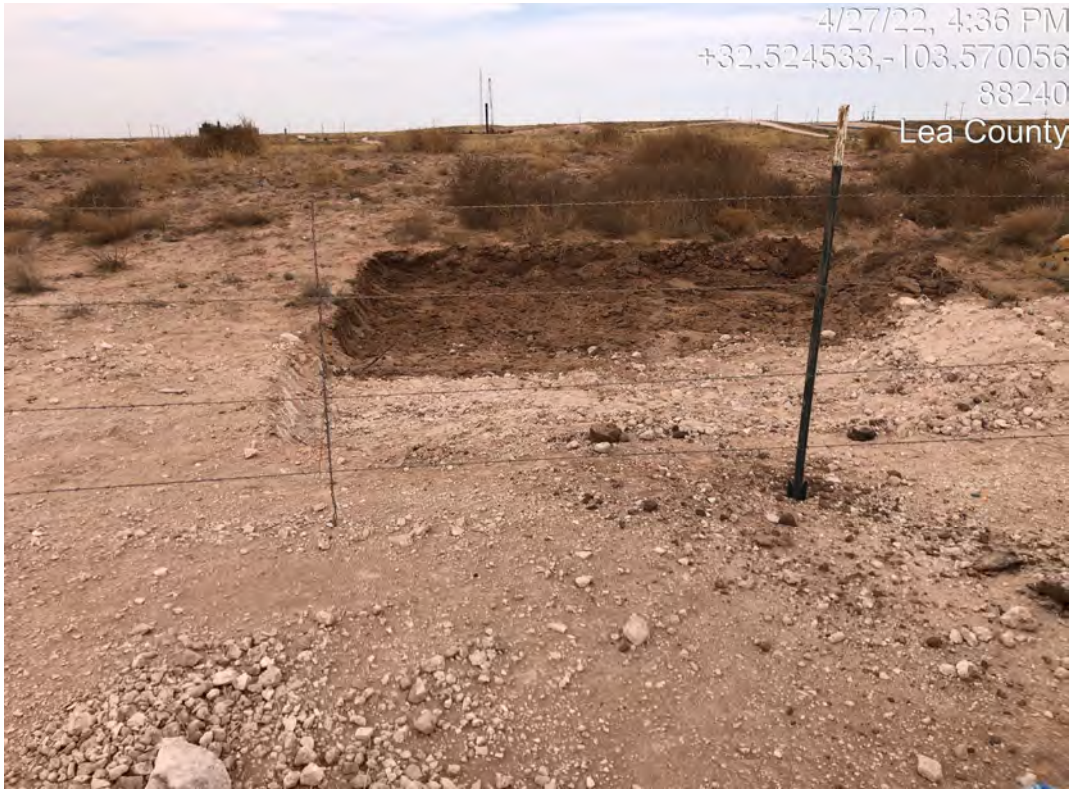
Photo Number: 5

<p>4/27/22, 4:36 PM +32.524533,-103.570056 88240 Lea County</p>
Photo Direction: East	
Photo Description: View of the excavated area.

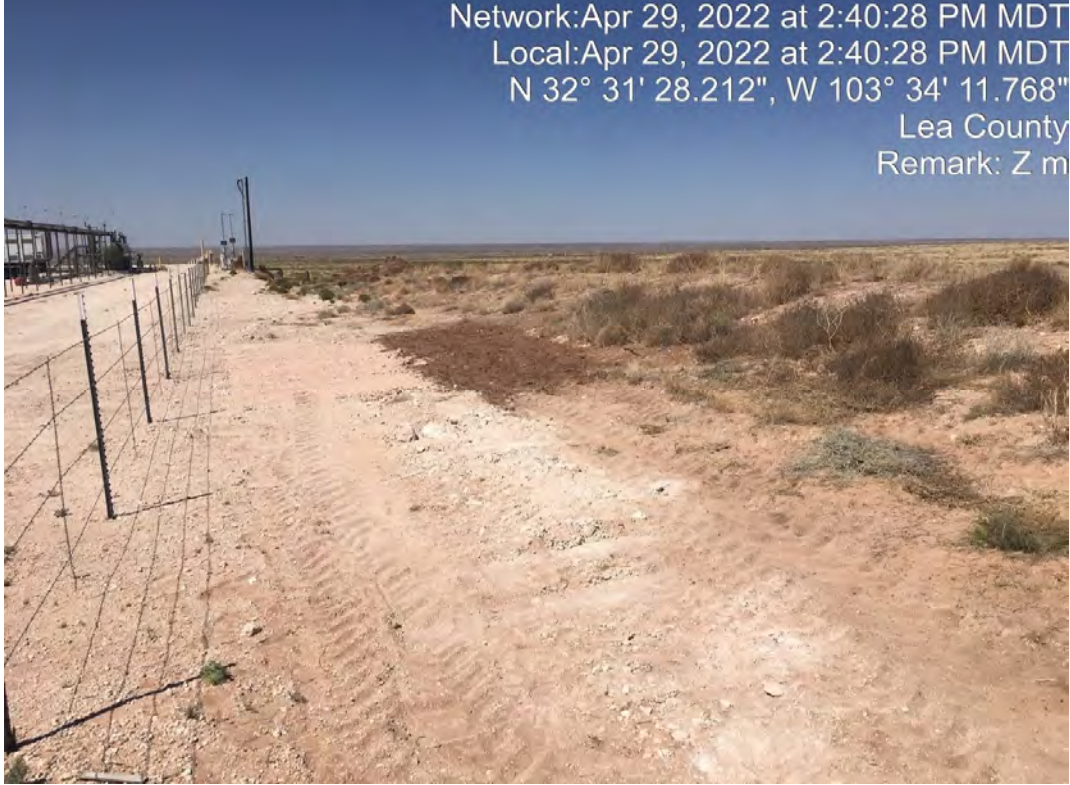
Photo Number: 7	<div>Network: Apr 29, 2022 at 2:40:28 PM MDT Local: Apr 29, 2022 at 2:40:28 PM MDT N 32° 31' 28.212", W 103° 34' 11.768" Lea County Remark: Z m</div>

Photo Direction: North	
Photo Description: View of the remediated area after backfilling and regrading.

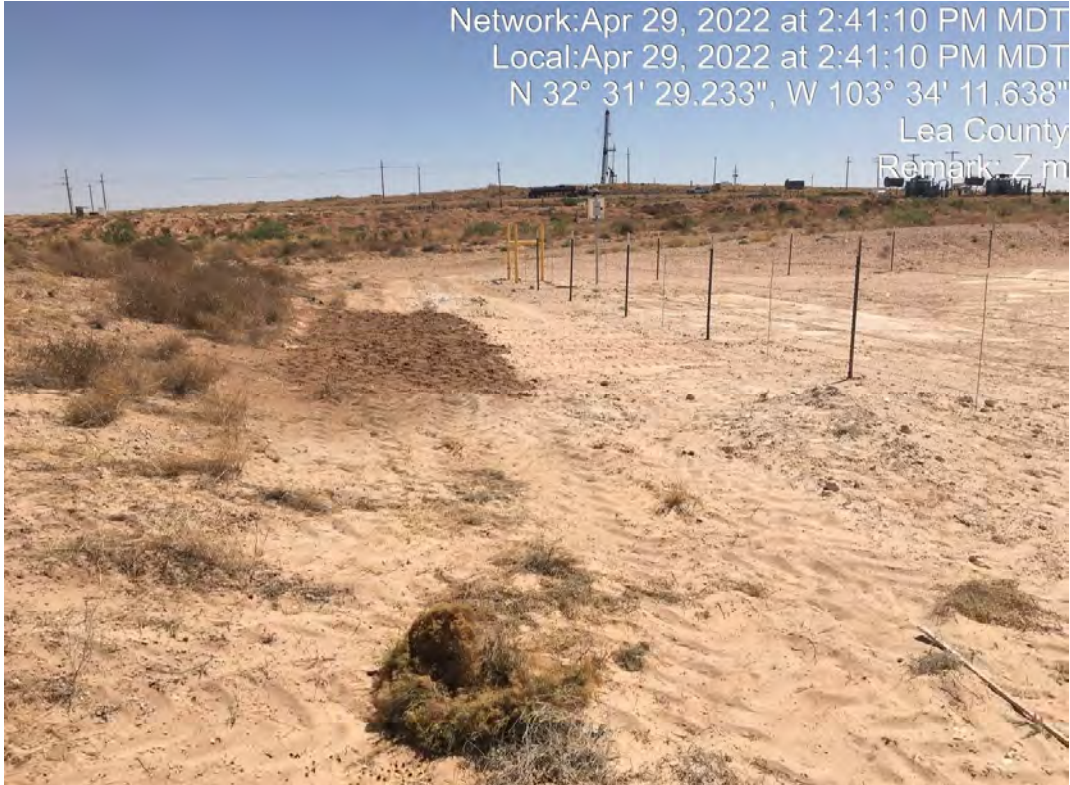
Photo Number: 8	<div>Network: Apr 29, 2022 at 2:41:10 PM MDT Local: Apr 29, 2022 at 2:41:10 PM MDT N 32° 31' 29.233", W 103° 34' 11.638" Lea County Remark: Z m</div>

Photo Direction: South-Southwest	
Photo Description: View of the remediated area after backfilling and regrading.
