Closure Report

Marauder 13 Federal Com 003H (03.09.22)

Eddy County, New Mexico

Crude Oil Release

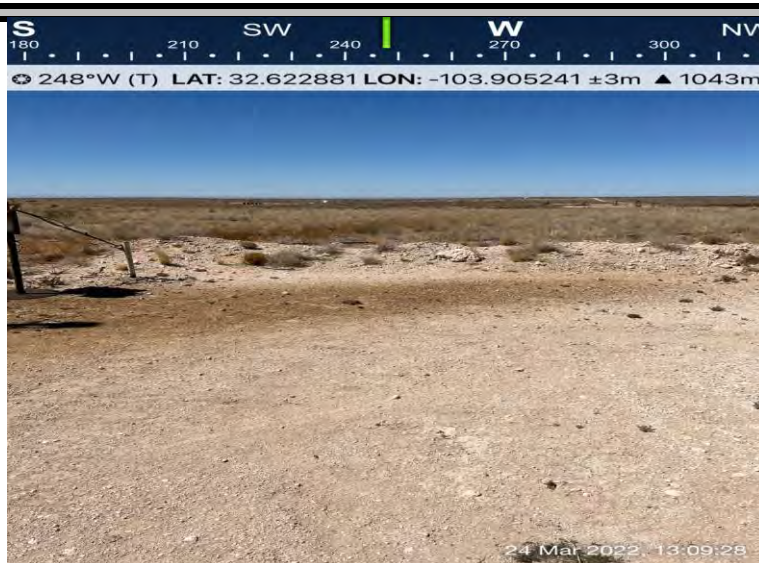
PHOTOGRAPHIC LOG**Concho Operating, LLC****Photograph No. 1****Facility:** Marauder 13 Federal Com
003H(03.09.22)**County:** Eddy County, New Mexico**Description:**
View Southwest of S-1

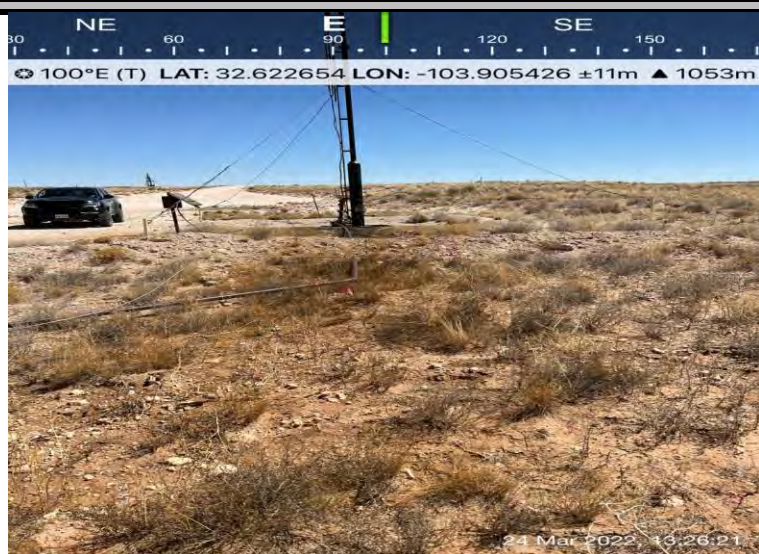
**Photograph No. 2****Facility:** Marauder 13 Federal Com
003H(03.09.22)**County:** Eddy County, New Mexico**Description:**
View East of S-2.

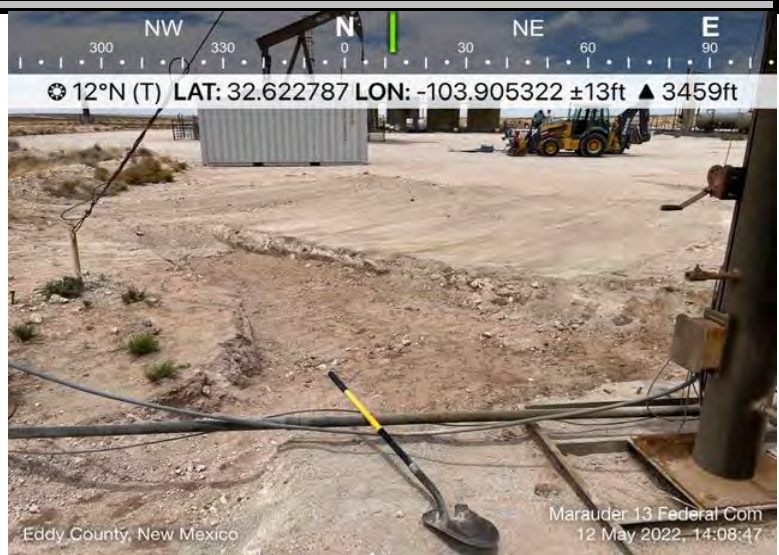
PHOTOGRAPHIC LOG**Concho Operating, LLC****Photograph No. 3****Facility:** Marauder 13 Federal Com
003H(03.09.22)**County:** Eddy County, New Mexico**Description:**

View North of remediation activities.

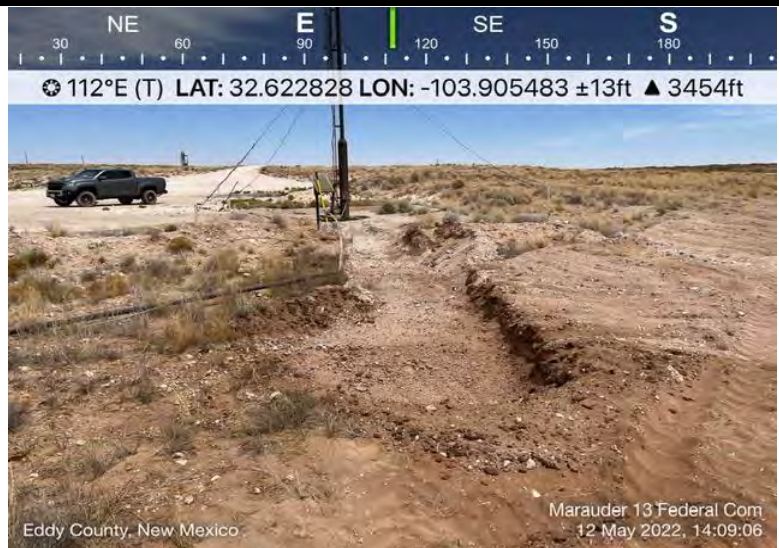
**Photograph No. 4****Facility:** Marauder 13 Federal Com
003H(03.09.22)**County:** Eddy County, New Mexico**Description:**

View East of remediation activities.
