SITE REMEDIATION AND CLOSURE REPORT

Spur Energy Partners

Ivar The Boneless Fed #11H

Incident ID: nAPP2212771896

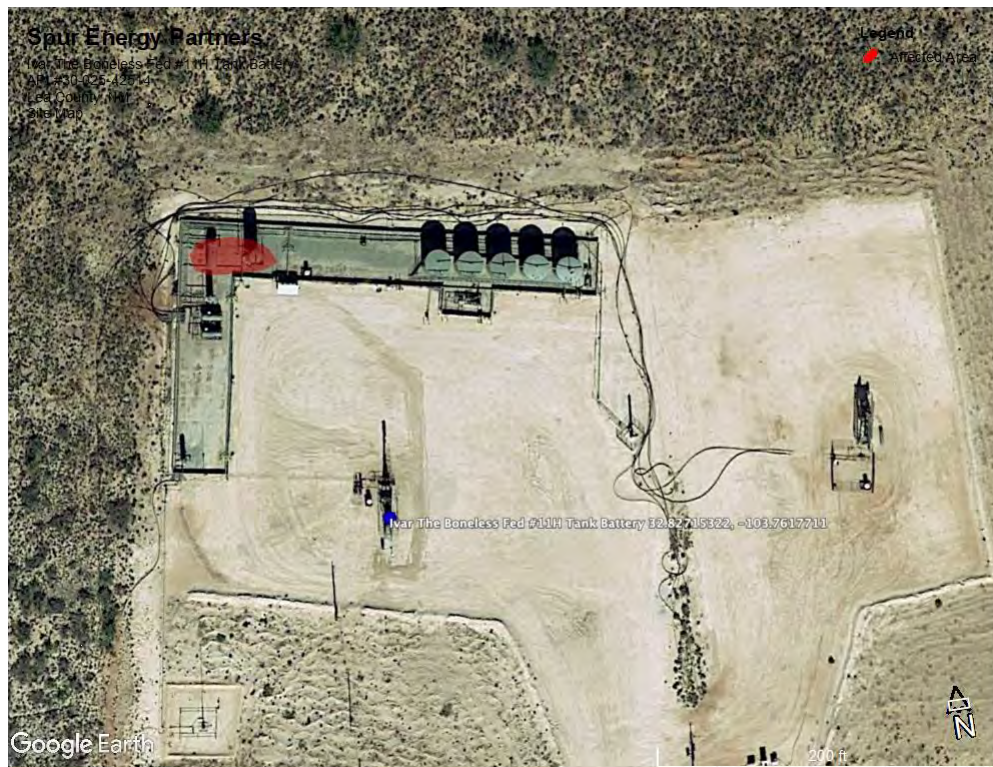
On May 16, 2022, Paragon went to the Ivar for an initial assessment. There were noticeable salt stains on the liner from the spill. There were no signs outside the containment that the liner had been breached. Therefore, no samples were taken. See the site map below showing the affected area.

On May 19, 2022, Paragon returned to the site with equipment and personnel to conduct cleanup activities. We initially sprayed the affected area with surface cleaner. We then power washed and squeegeed the runoff into the sump, which was pumped back into the production system.
