**Re: Site Assessment, Remediation, and Closure Report**  
**Maljamar Transfer Line**  
**API No. N/A**  
**GPS: Latitude 32.7969343 Longitude -103.763427**  
**ULSTR -- A, 33, T17S, R32E**  
**Lea County, NM**  
**NMOCD Ref. No. NAPP2220135929**

Pima Environmental Services, LLC. (Pima) has been contracted by Spur Energy Partners, LLC. (Spur) to perform a spill assessment, remediation, and submit this closure report for a produced water release that occurred at the Maljamar Transfer Line (Maljamar). The initial C-141 was submitted on July 20, 2022 (Appendix C). This incident was assigned Incident ID NAPP2220135929 by the New Mexico Oil Conservation Division (NMOCD).

# Maljamar Transfer Line

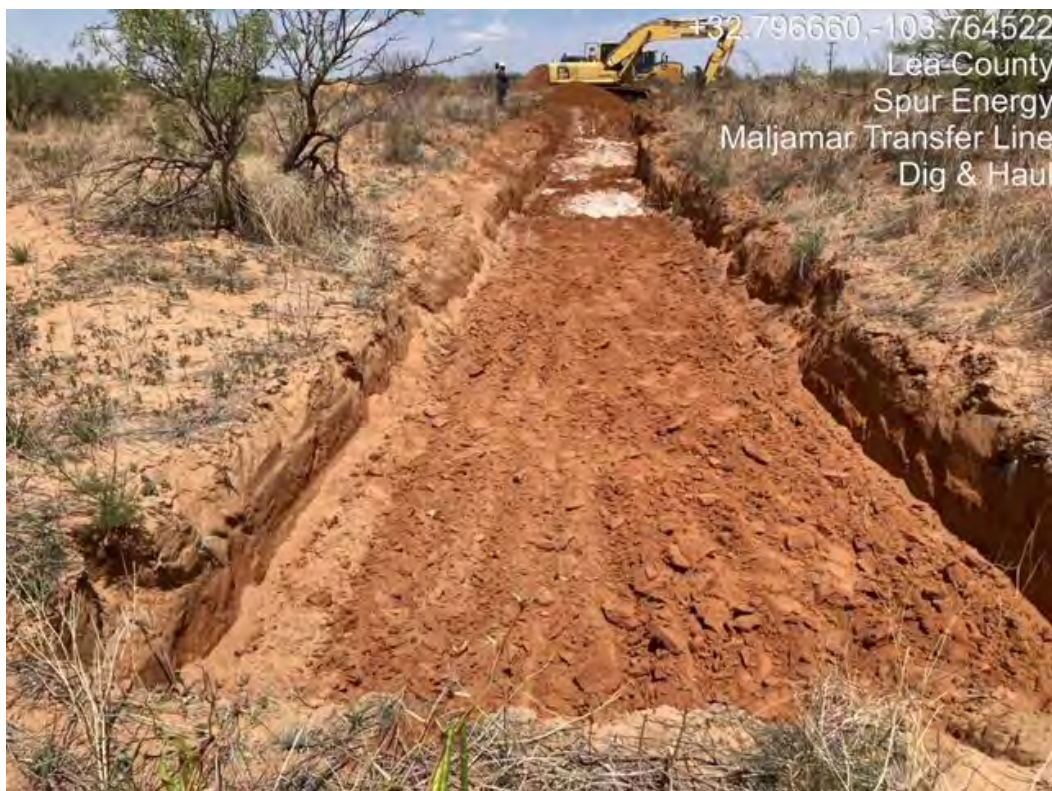
+32.796660, -103.764522  
Lea County  
Spur Energy  
Maljamar Transfer Line  
Dig & Haul

Based on the sample results, the bottom and sidewalls were below NMOCD Closure Criteria 19.15.29 NMAC. The contaminated material was transported to Lea Land, an NMOCD approved disposal site. The excavation was then backfilled with clean like material, machine compacted and contoured to match the surrounding terrain. See Appendix D for Photographic Documentation.

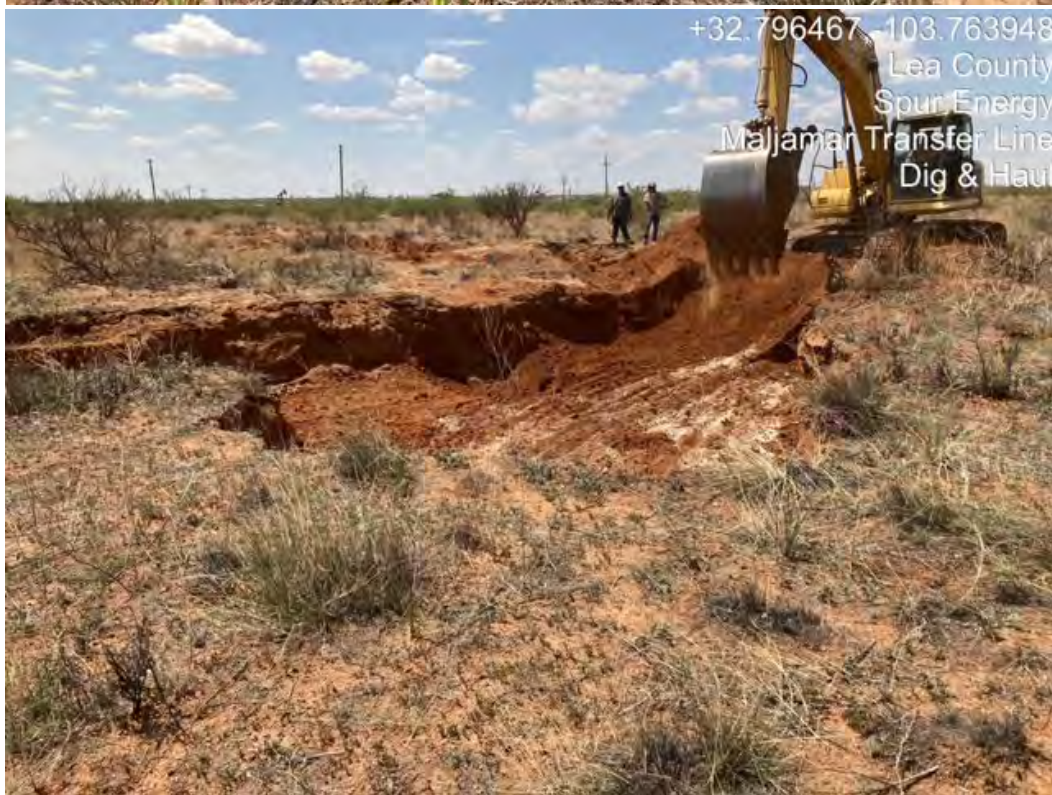
+32.796467, -103.763948  
Lea County  
Spur Energy  
Maljamar Transfer Line  
Dig & Haul

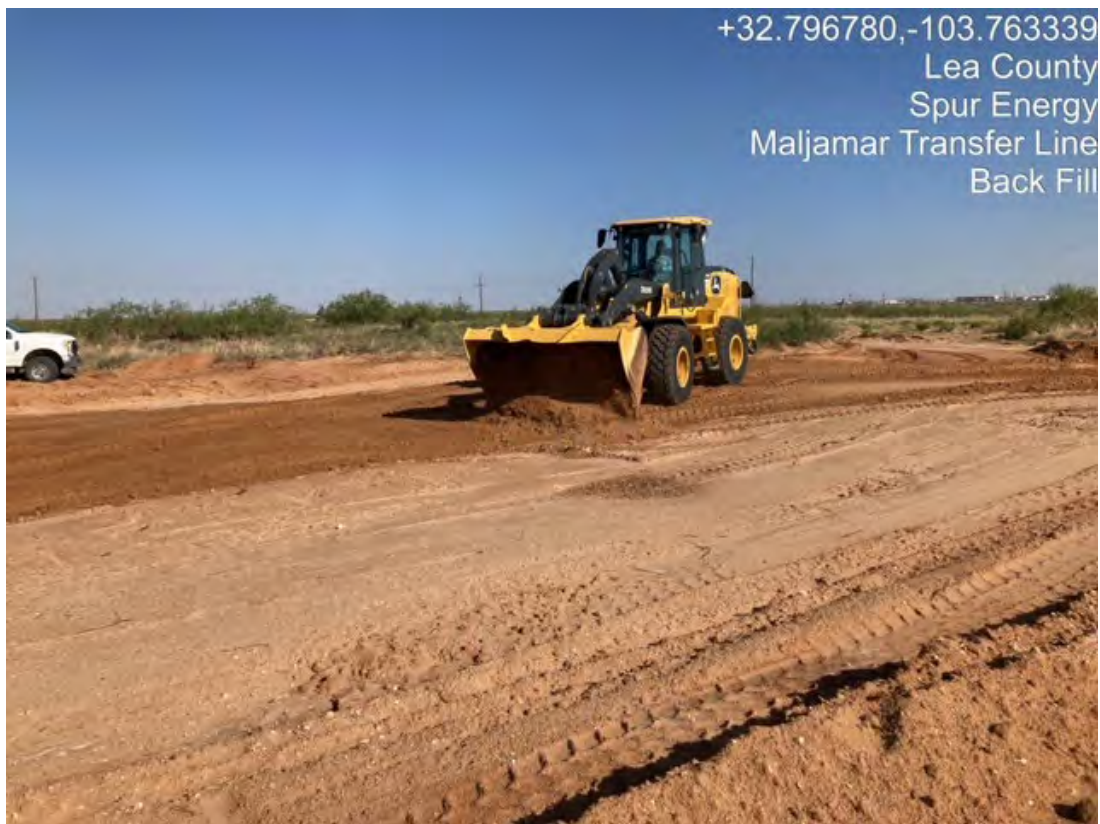
+32.796780,-103.763339  
Lea County  
Spur Energy  
Maljamar Transfer Line  
Back Fill

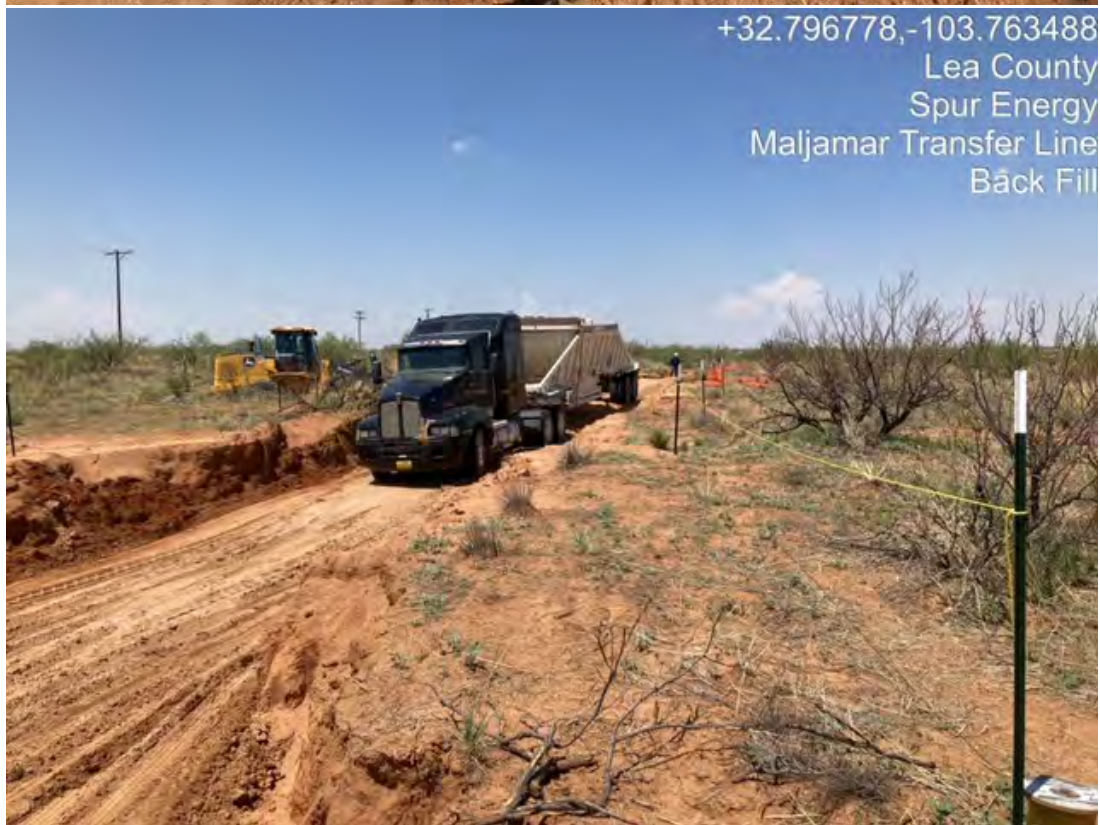
+32.796778,-103.763488  
Lea County  
Spur Energy  
Maljamar Transfer Line  
Back Fill

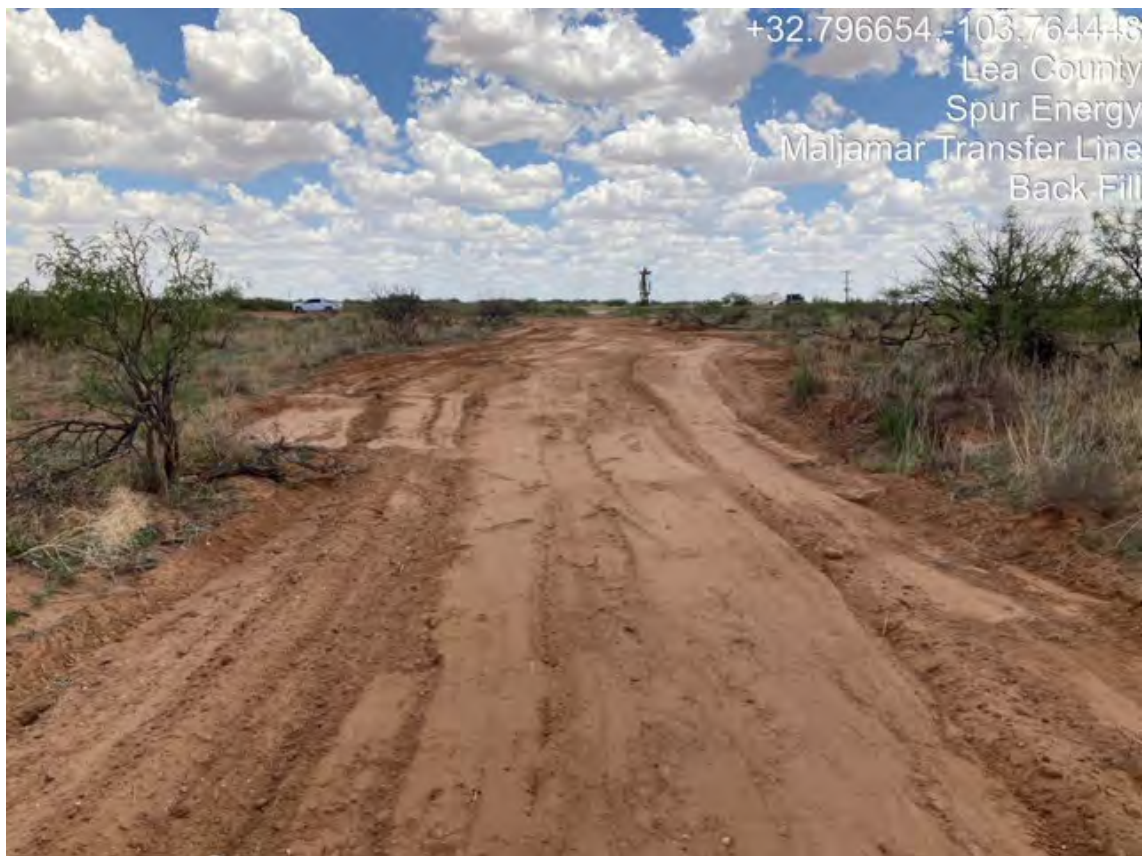
+32.796654,-103.764448  
Lea County  
Spur Energy  
Maljamar Transfer Line  
Back Fill

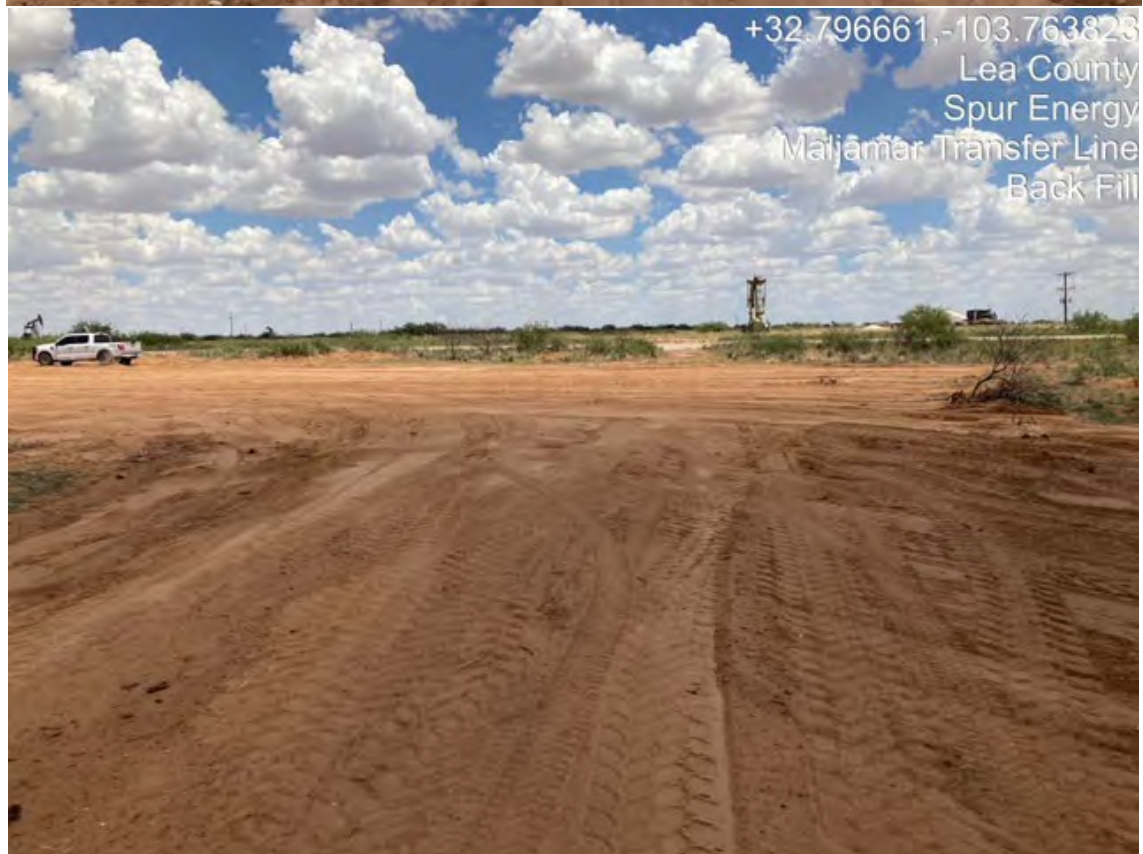
+32.796661,-103.763828  
Lea County  
Spur Energy  
Maljamar Transfer Line  
Back Fill
