## **Remediation and Closure Report**

Cascade 28 Federal 85,86H ROW  
Incident# nAPP2213134490  
Lea County, New Mexico

Subject: **Remediation and Closure Report**  
Cascade 28 Federal 85,86H ROW  
Lea County, NM

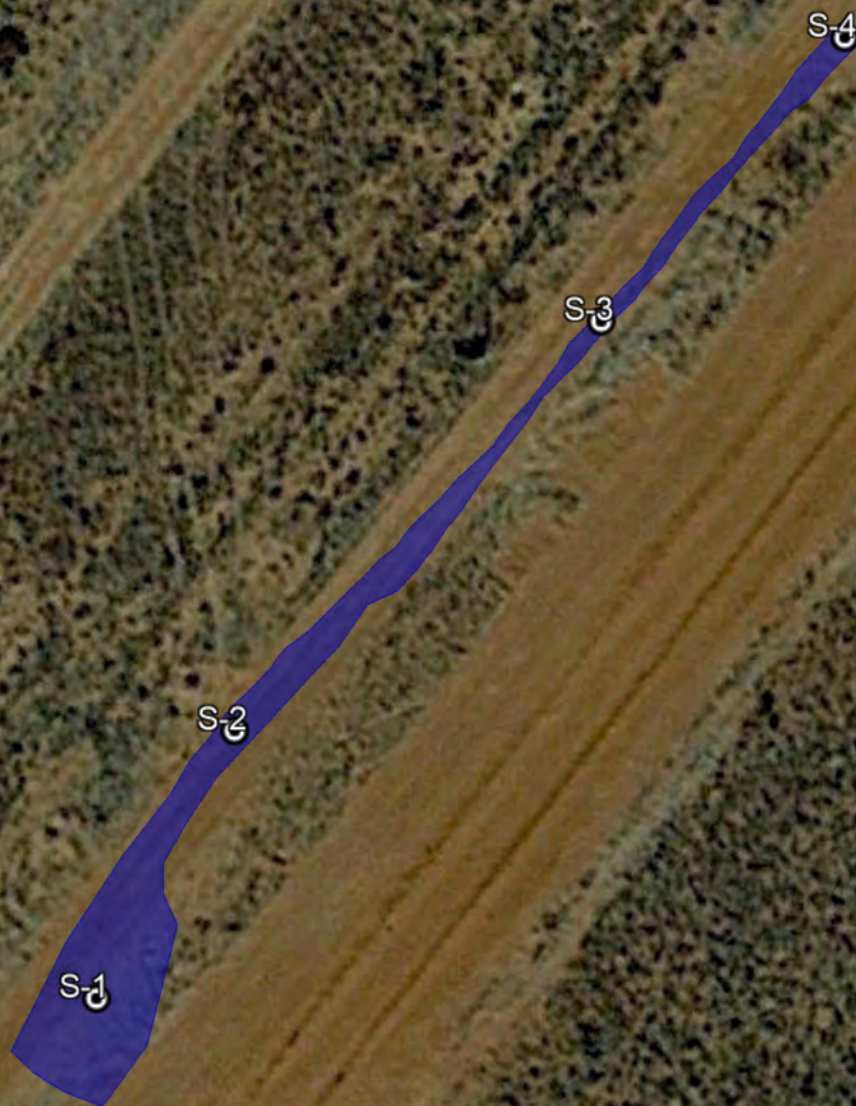
# Cascade 28 Federal 85,86H ROW

- Assessment Sample
- Release Area

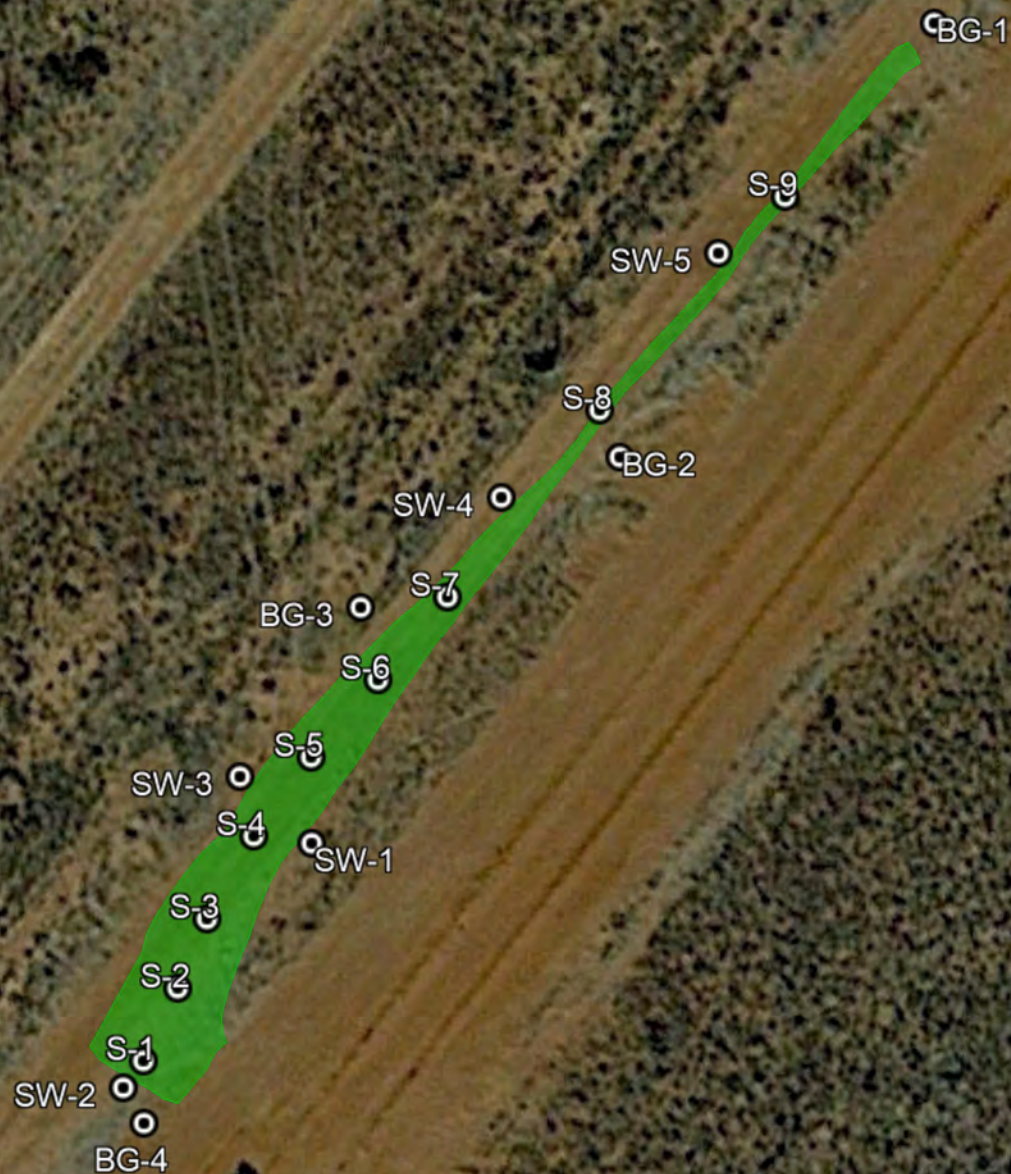
# Cascade 28 Federal 85,86H ROW

- 2-3ft. Excavation
- Composite Confirmation Sample/Background sample

- The impacted areas in the vicinity of confirmation sample points S-2 and S-4 through S-7 were excavated to a depth of 2-feet BGS.
- The impacted areas near sample points S-1, S-3, S-8, and S-9 were excavated to 3-feet BGS.
- Composite confirmation samples were obtained from the bottoms and sidewalls of the excavated areas to verify that all contaminants above closure criteria had been removed. The results are shown on Table 2 and the corresponding lab reports may be found in [Appendix VI](#).
- All the excavated material (208yds) was hauled to Lea Land, a NMOCD approved solid waste disposal facility.
- The excavated area was backfilled with new topsoil at depth and brought to grade, machine compacted and contoured to match the surrounding area.
- The Final C-141 formally documenting the remedial actions is attached in [Appendix III](#).
