Remediation Excavation Closure Report

Lucky Wolf 31 Federal Com #2H

API #30-015-37448

nAAP2128557106

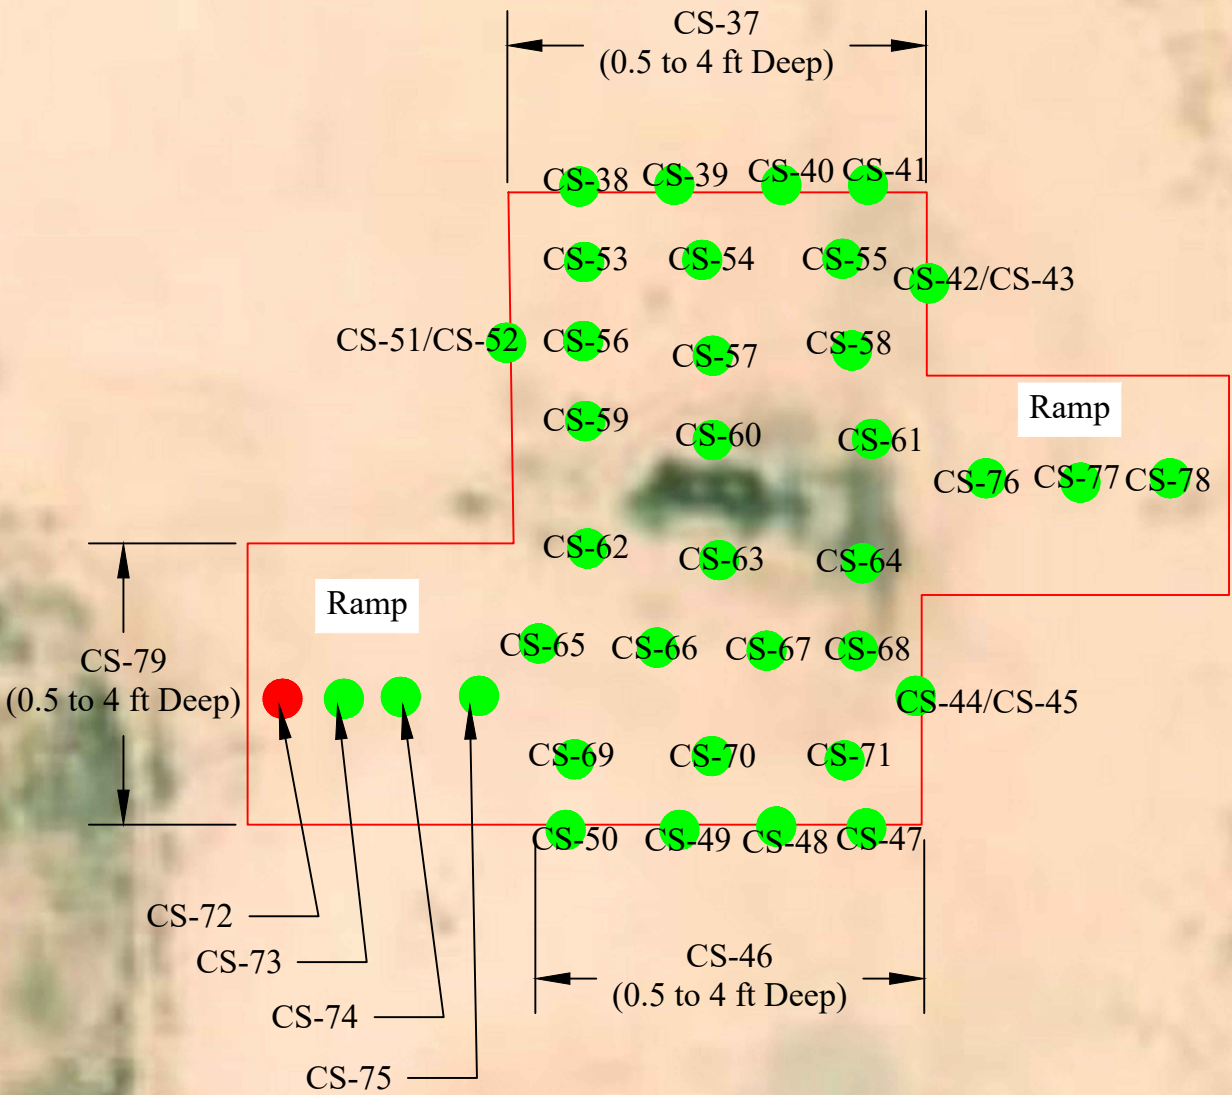
Figure 2, Site Map

- Excavation
- 5-point Composite Sample
- Over reclamation standard
(Used as backfill in base)
- CS-42/CS-43- 0.5 ft to 4 ft/ 4 ft to 22 ft deep
- SB-1

Overall Excavation Dimensions: 75 ft x 50 ft x 22 ft deep

Utilizing a trackhoe, the area of concern was excavated, and the contaminated soil was loaded into dump trucks to be transported to NMOCD permitted disposal facility. The final extents of the excavation measured approximately 75 feet by 50 feet by 22 feet bgs.

The soil samples were placed into individual laboratory provided 4-ounce jars, capped head space free, and transported on ice to Envirotech Analytical Laboratory under strict chain of custody. The NMOCD notification is included in **Appendix D, Regulatory Correspondence** and soil sample locations are illustrated in **Figure 2** and **Appendix C**.

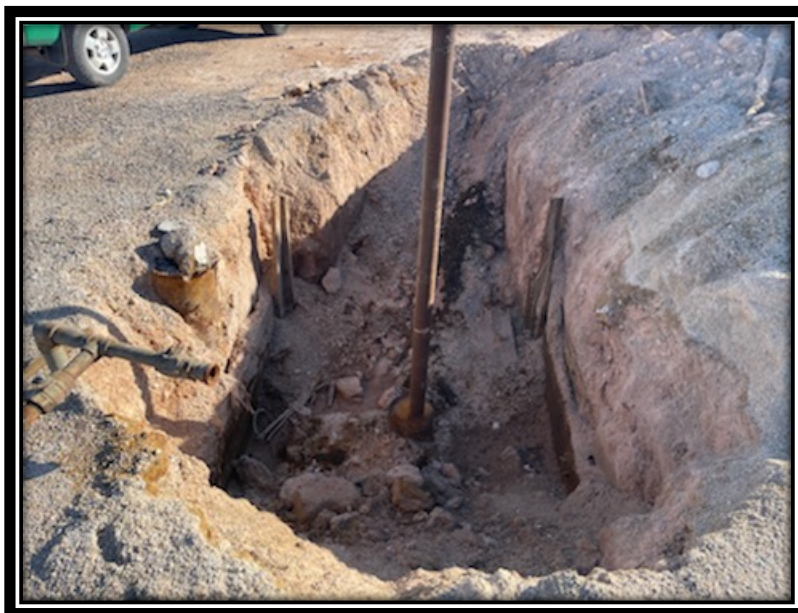
Picture 1: Excavation (View 1)

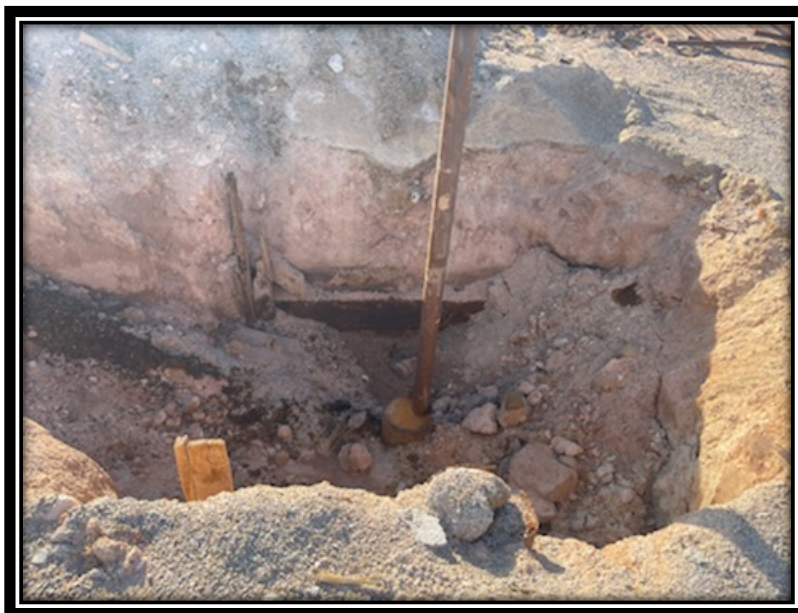
Picture 2: Excavation West Wall

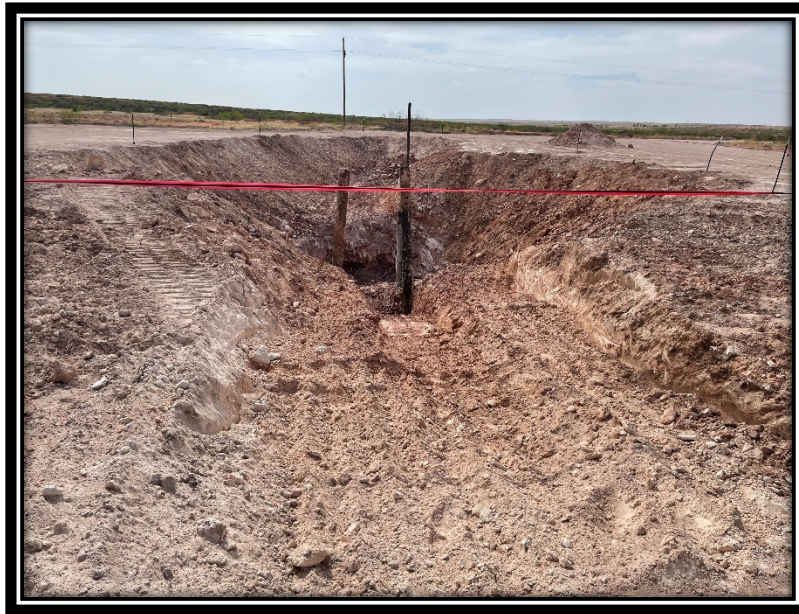
Picture 3: Northeast Ramp

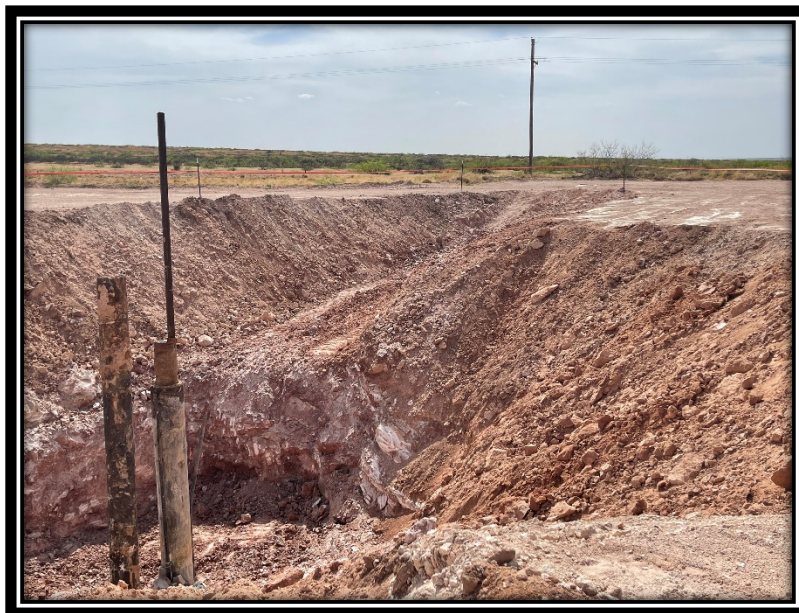
Picture 4: Southwest Ramp

On April 27, 2022, EOG's earth work contractor returned to the site to backfill the excavation. The southwest ramp (CS-72) was used as backfill in the base of the excavation and clean fill material was transported in for the remaining void to 4 feet bgs.

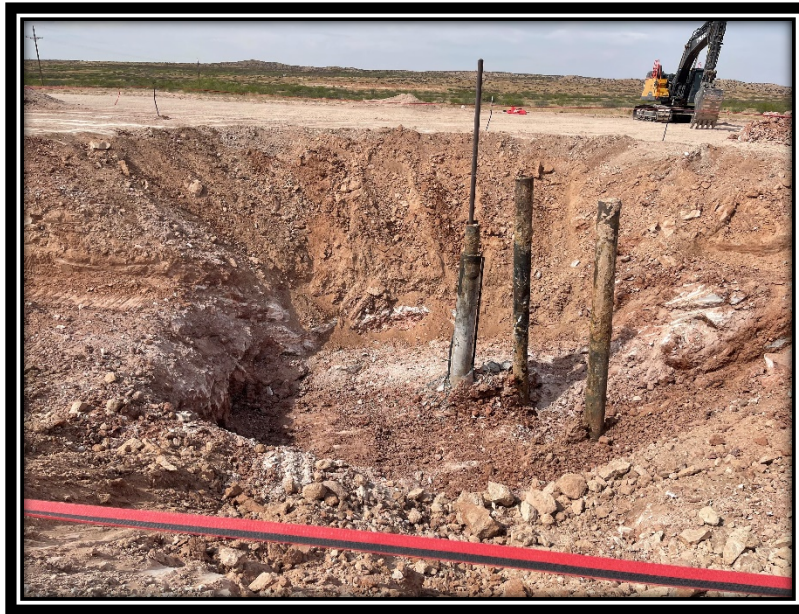
Picture 5: Final Excavation (View 1)

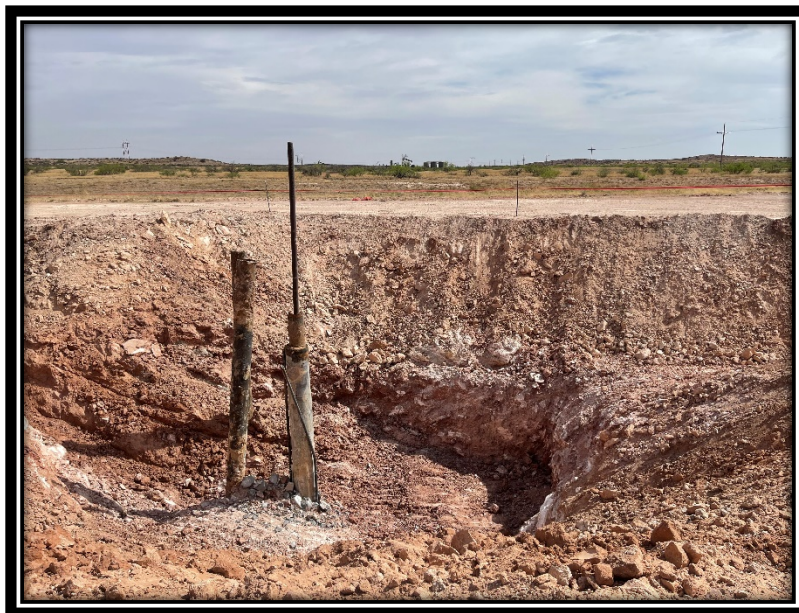
Picture 6: Final Excavation (View 2)

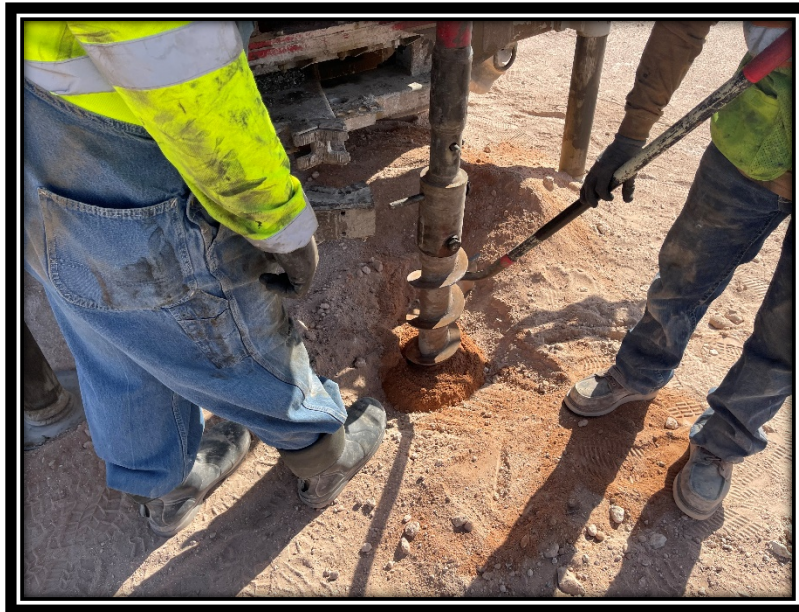
Picture 7: Soil Boring Drilling Activities

Since depth to groundwater records within 0.5 mile of the well site were not available, one (1) soil boring was advanced on April 26, 2022. Prior to installing soil boring, an *Application for Permit to Drill a Well with No Water Right* was submitted to New Mexico Office of the State Engineer (NMOSE) and was approved on April 13, 2022. The soil boring was installed utilizing a track mounted drill rig equipped with a hollow stem auger and was located on the north side of the well pad; see **Figure 2, Site Map**.

The soil boring was completed to a depth of 50 feet below ground surface (bgs). Once total depth had been reached, the augers were removed, and 2-inch polyvinyl chloride (PVC) screened-casing was placed into the boring to total depth. The casing was left in place over 72 hours. On May 3, 2022, using a water level meter, the boring was confirmed to be dry, and the casing was removed. The boring was then backfilled with a bentonite slurry and the drill cuttings. Soil boring activities are illustrated in **Appendix A, Site Photography** and **Appendix B, Field Notes**.

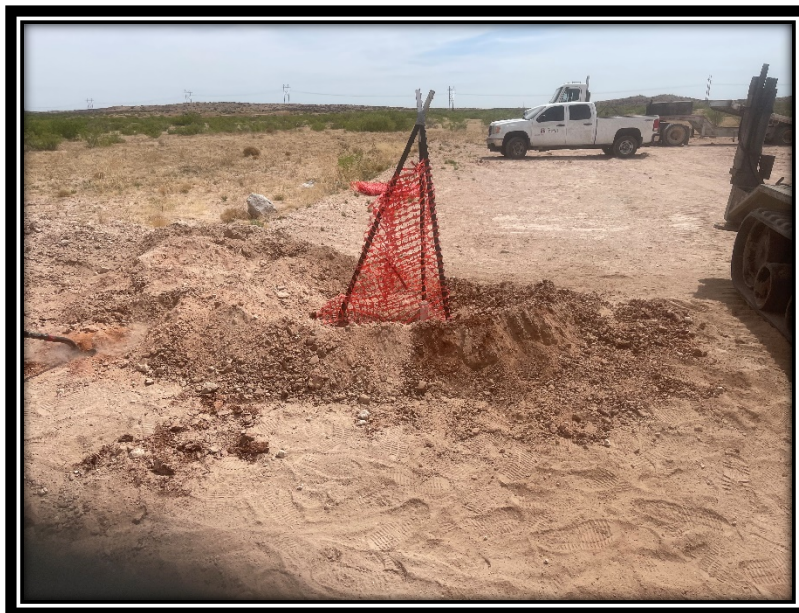
Picture 8: Completed SB-1

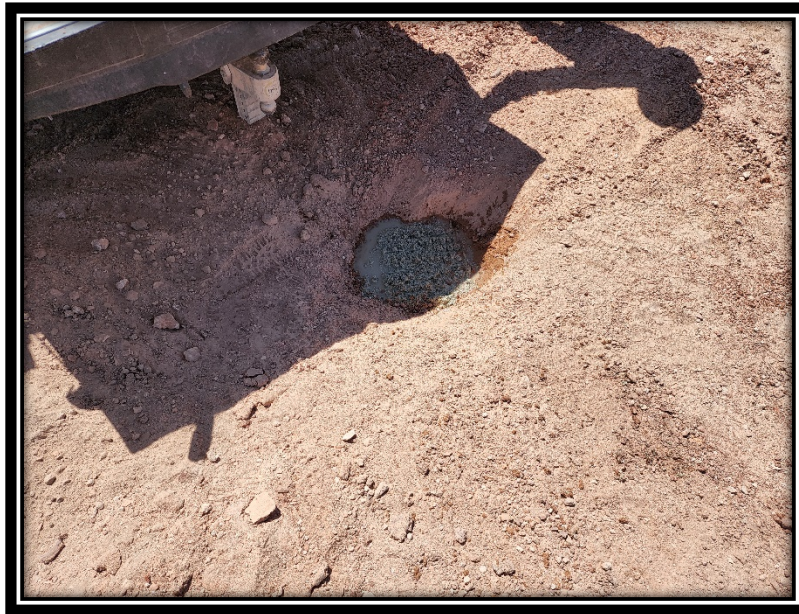
Picture 9: SB-1 P&A

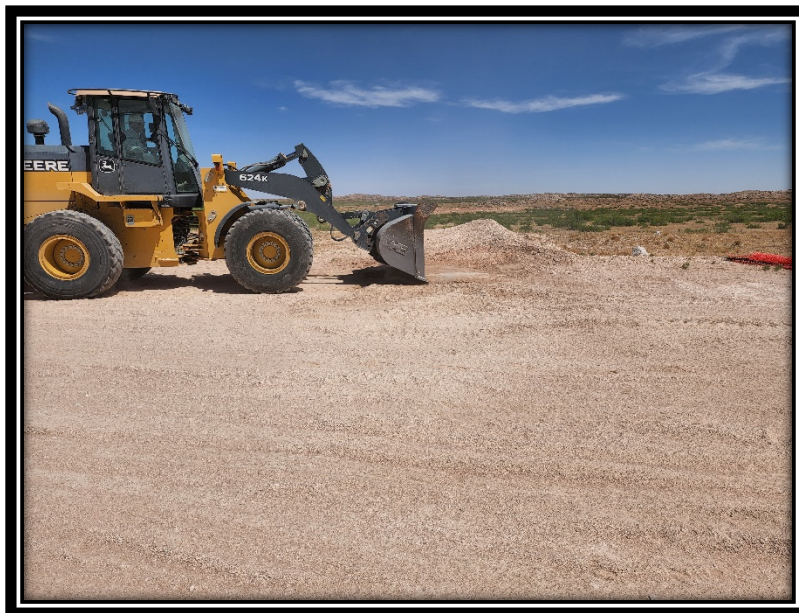
Picture 10: Backfilling Activities of SB-1

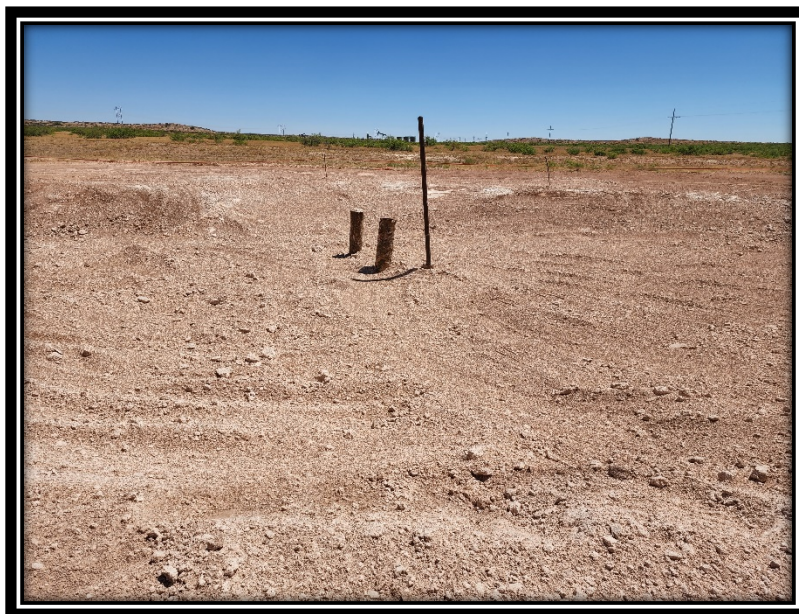
Picture 11: Backfilling Activities

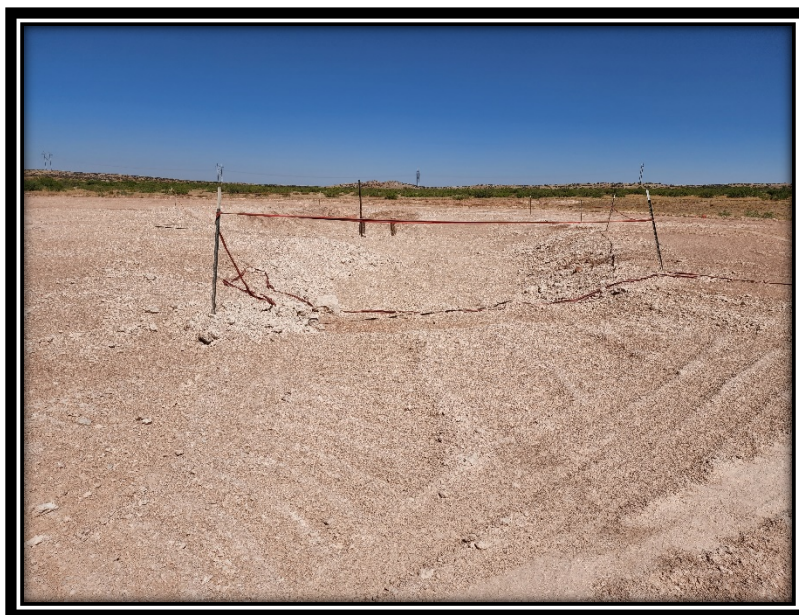
Picture 12: Backfilling Activities

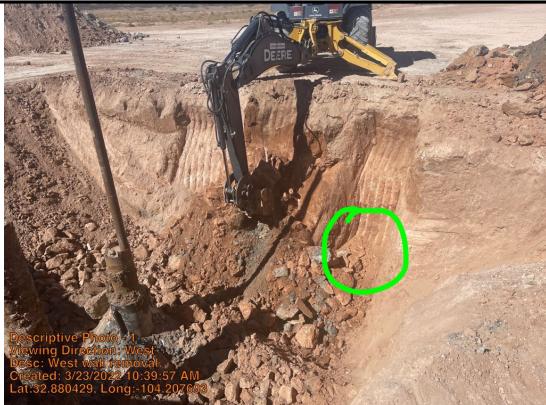
Descriptive Photo - 1
Viewing Direction: West
Desc: West wall removal
Created: 3/23/2022 10:39:57 AM
Lat:32.880429, Long:-104.207659

West wall removal. Green area is clear.

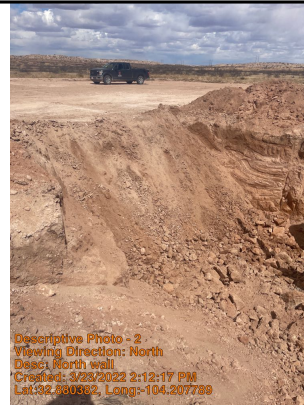
Descriptive Photo - 2
Viewing Direction: North
Desc: North wall
Created: 3/23/2022 2:12:17 PM
Lat:32.880429, Long:-104.207659

North wall. All of wall is visibly free of staining

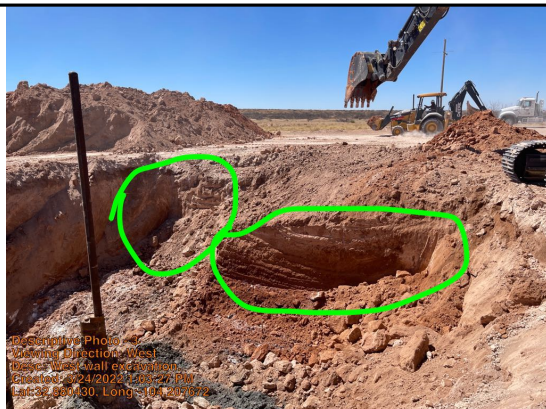
Descriptive Photo - 1
Viewing Direction: West
Desc: West wall excavation
Created: 3/24/2022 2:55:45 PM
Lat:32.680426, Long:-104.207785

West wall excavation. All of wall excavated to visibility and odor clearance

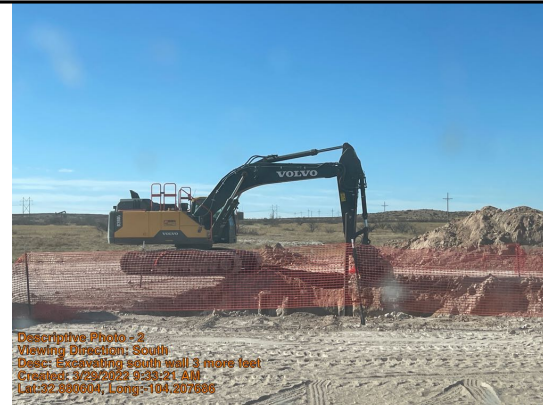
Excavating south wall 3 more feet

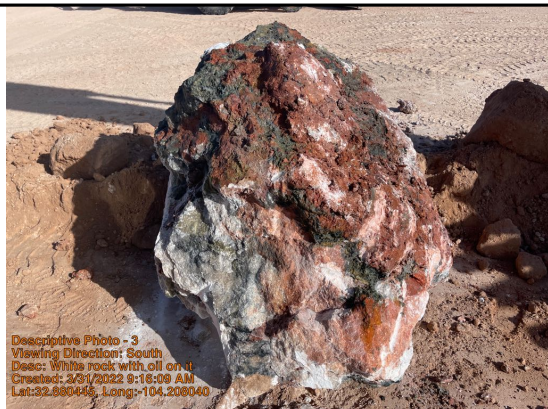
White rock with oil on it. Still wet

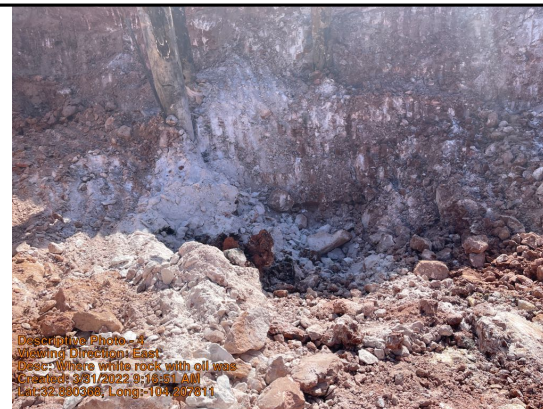
Where white rock with oil was

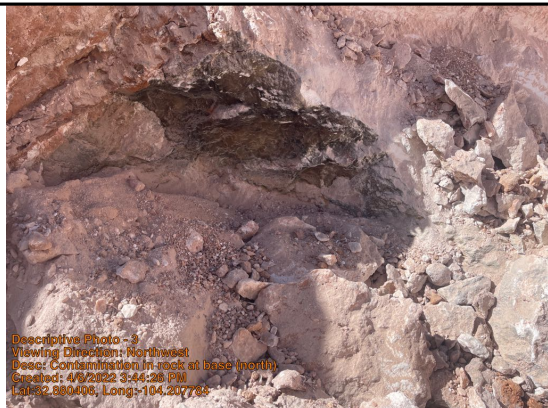
Contamination in rock at base (north)
