## Remediation Summary and Closure Request

**Frontier Field Services, LLC  
MAL 10-33 Siete 6" Steel Line  
Lea County, New Mexico**

**Unit Letter "I", Section 18, Township 18 South, Range 32 East  
Latitude 32.747034 North, Longitude 103.801475 West  
NMOCD Incident # nAPP2213335346**

**August 2022**

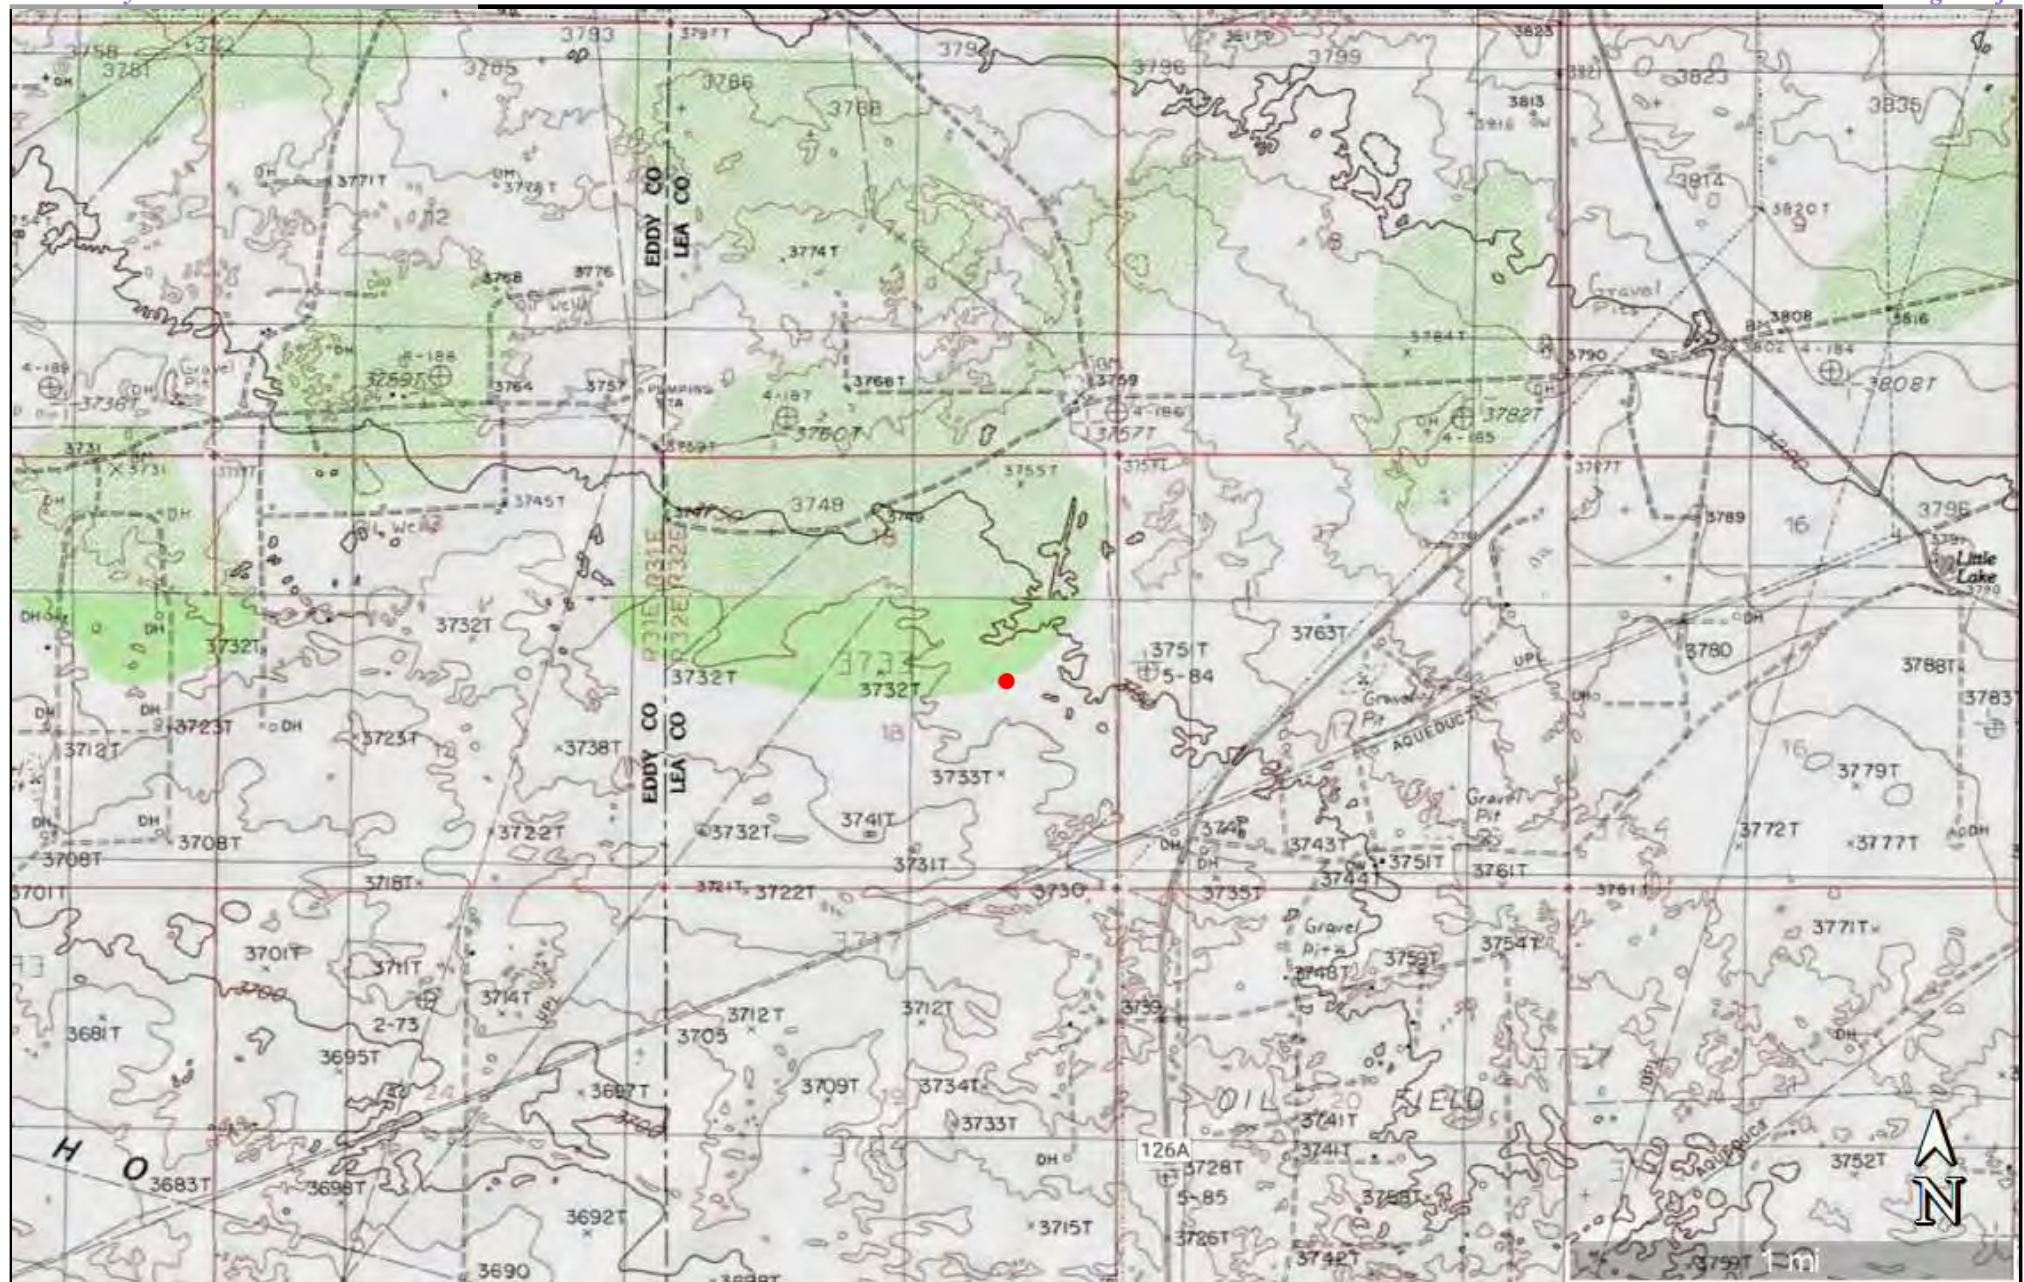
**Figure 1**

Topographic Map  
 Frontier Field Services, LLC  
 MAL 10-33 Siete 6" Steel Line  
 GPS: 32.747034, -103.801475  
 Lea County

The site is located in Unit Letter I (NE/SE), Section 18, Township 18 South, Range 32 East, approximately 8 miles Southwest of Maljamar, in Lea County, New Mexico. The property is Federally owned. Topographic Map, OSE POD Locations Map, and USGS Well Locations Map are included as Figure 1, Figure 2, and Figure 3, respectively.

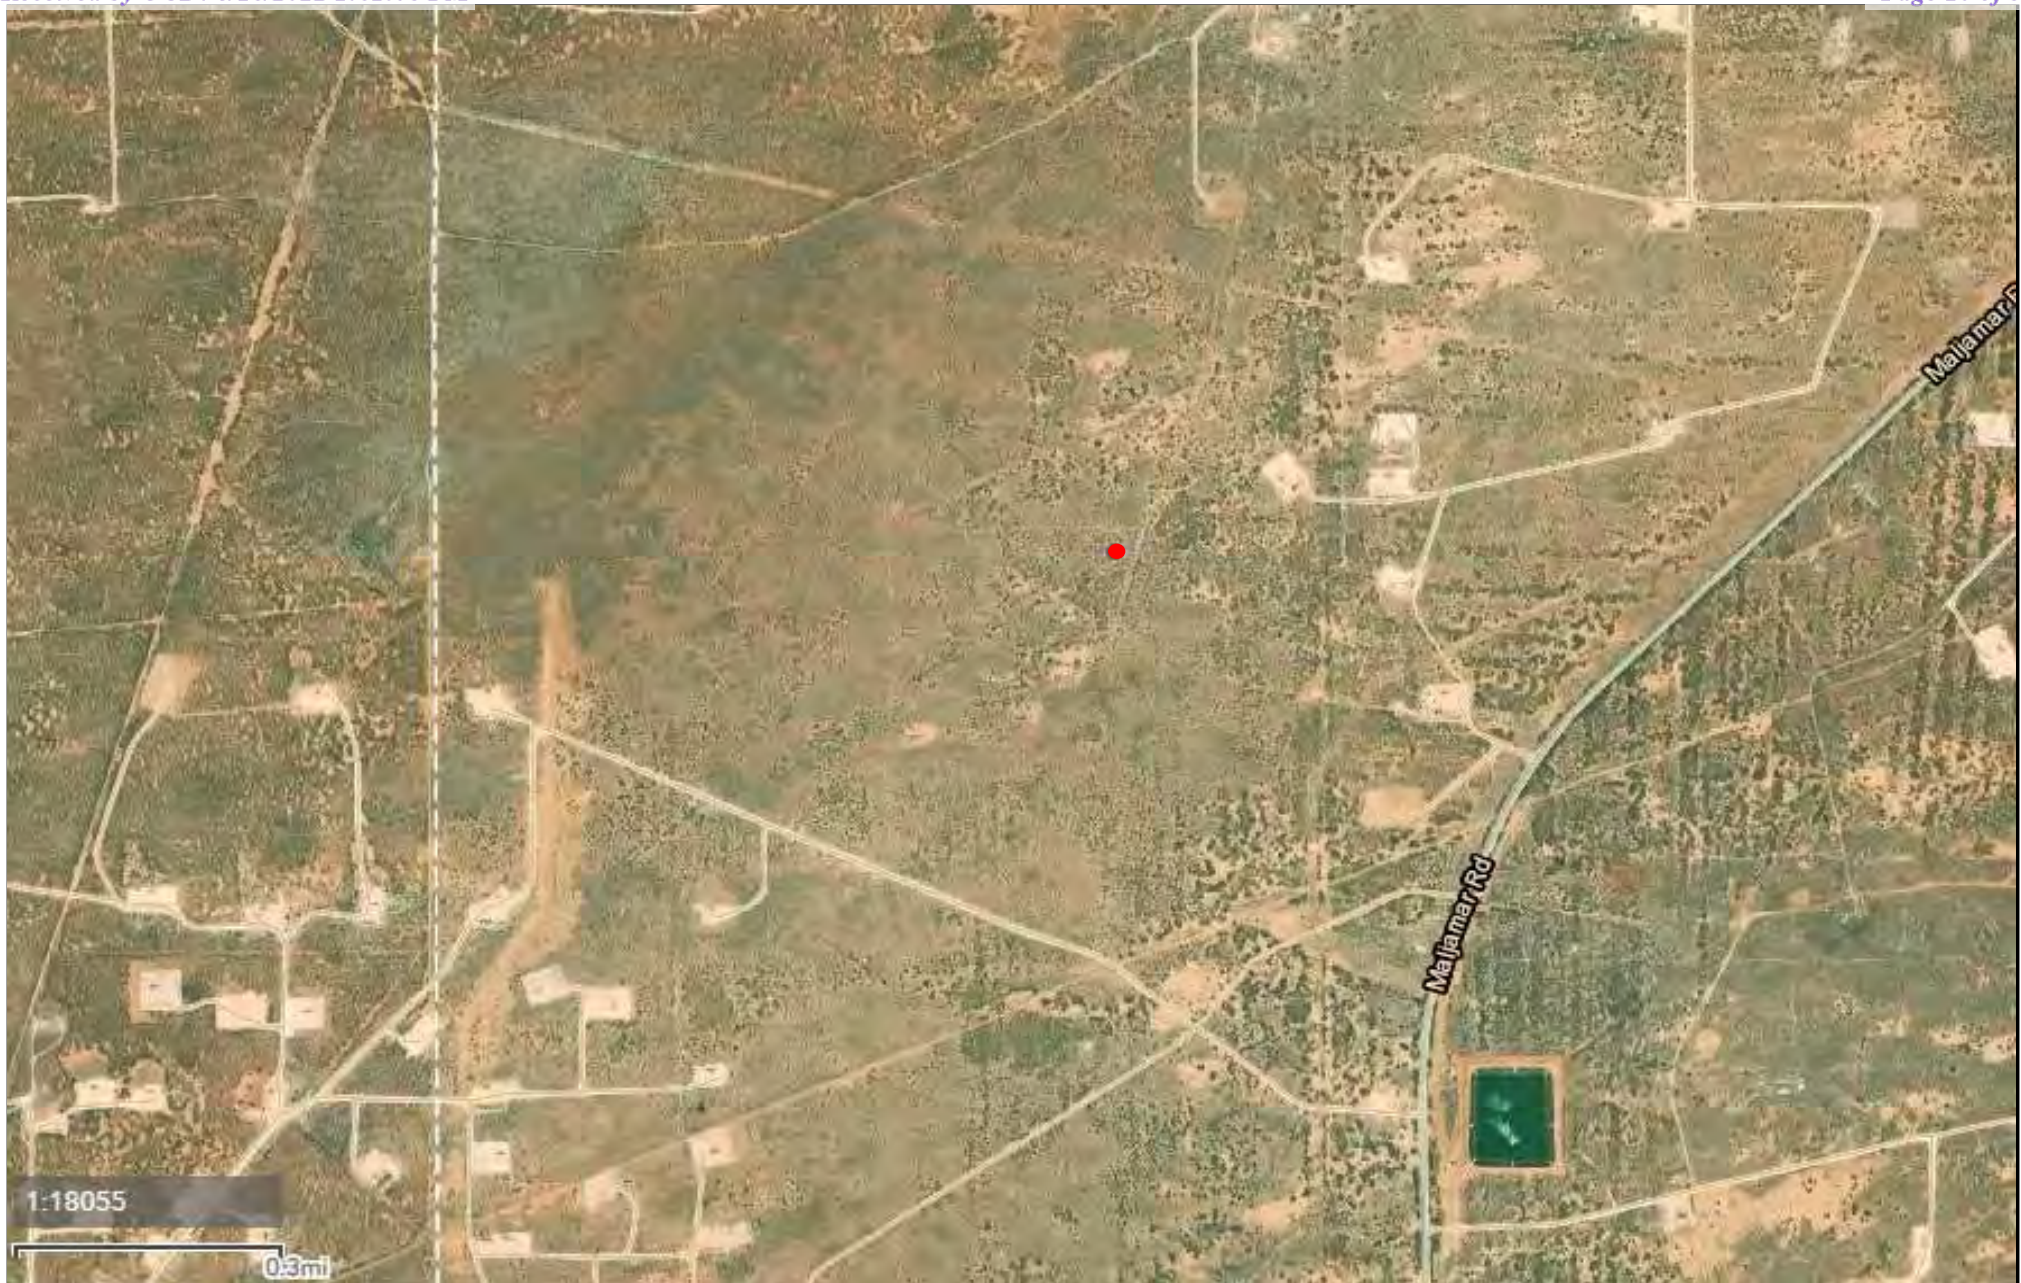
**Figure 2**

A search of the New Mexico Office of the State Engineer (NMOSE) and United States Geological Survey (USGS) groundwater databases was completed in an effort to determine the horizontal distance to known water sources within a half mile radius of the Release Site. Approximate depth to groundwater was determined using maintained and published water well data. Karst mapping indicates the site is not located in a Karst designated area. Karst and Wetland Maps are provided as Attachment I. Depth to groundwater information is provided as Attachment IV and the results are depicted on Figures 2 & 3.

OSE POD Locations Map  
Frontier Field Services, LLC  
MAL 10-33 Siete 6" Steel Line  
GPS: 32.747034, -103.801475  
Lea County

No water wells were located within a half mile of the release area, therefore depth to groundwater could not be determined. Consequently, the site was delineated and further remediated according to the strictest NMOCD Closure Criteria. Utilizing this information, the NMOCD Closure Criteria for the Site were determined as follows:

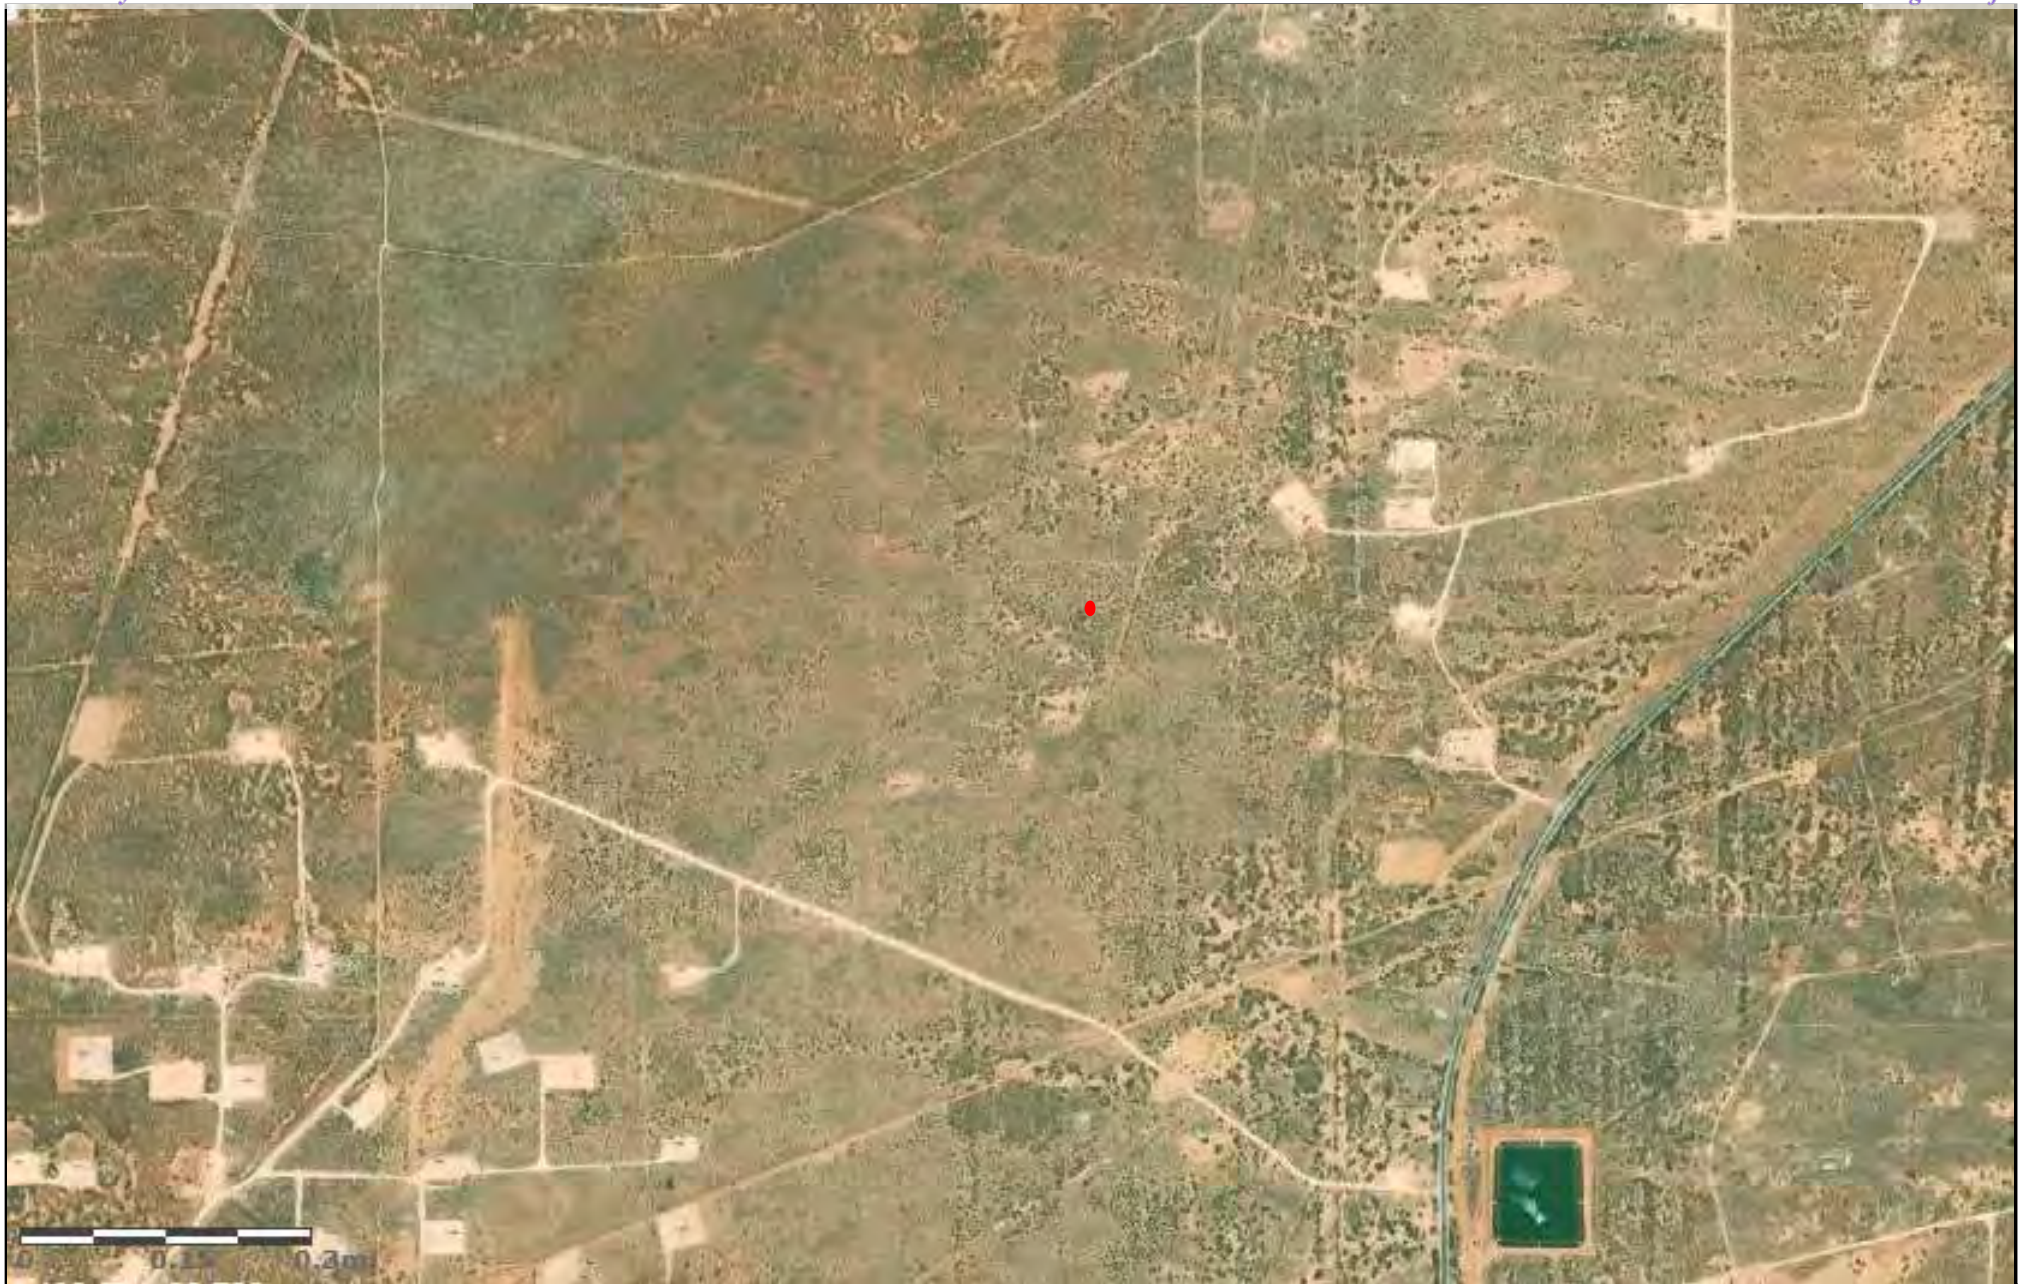
**Figure 3**

USGS Well Locations Map  
Frontier Field Services, LLC  
MAL 10-33 Siete 6" Steel Line  
GPS: 32.747034, -103.801475  
Lea County

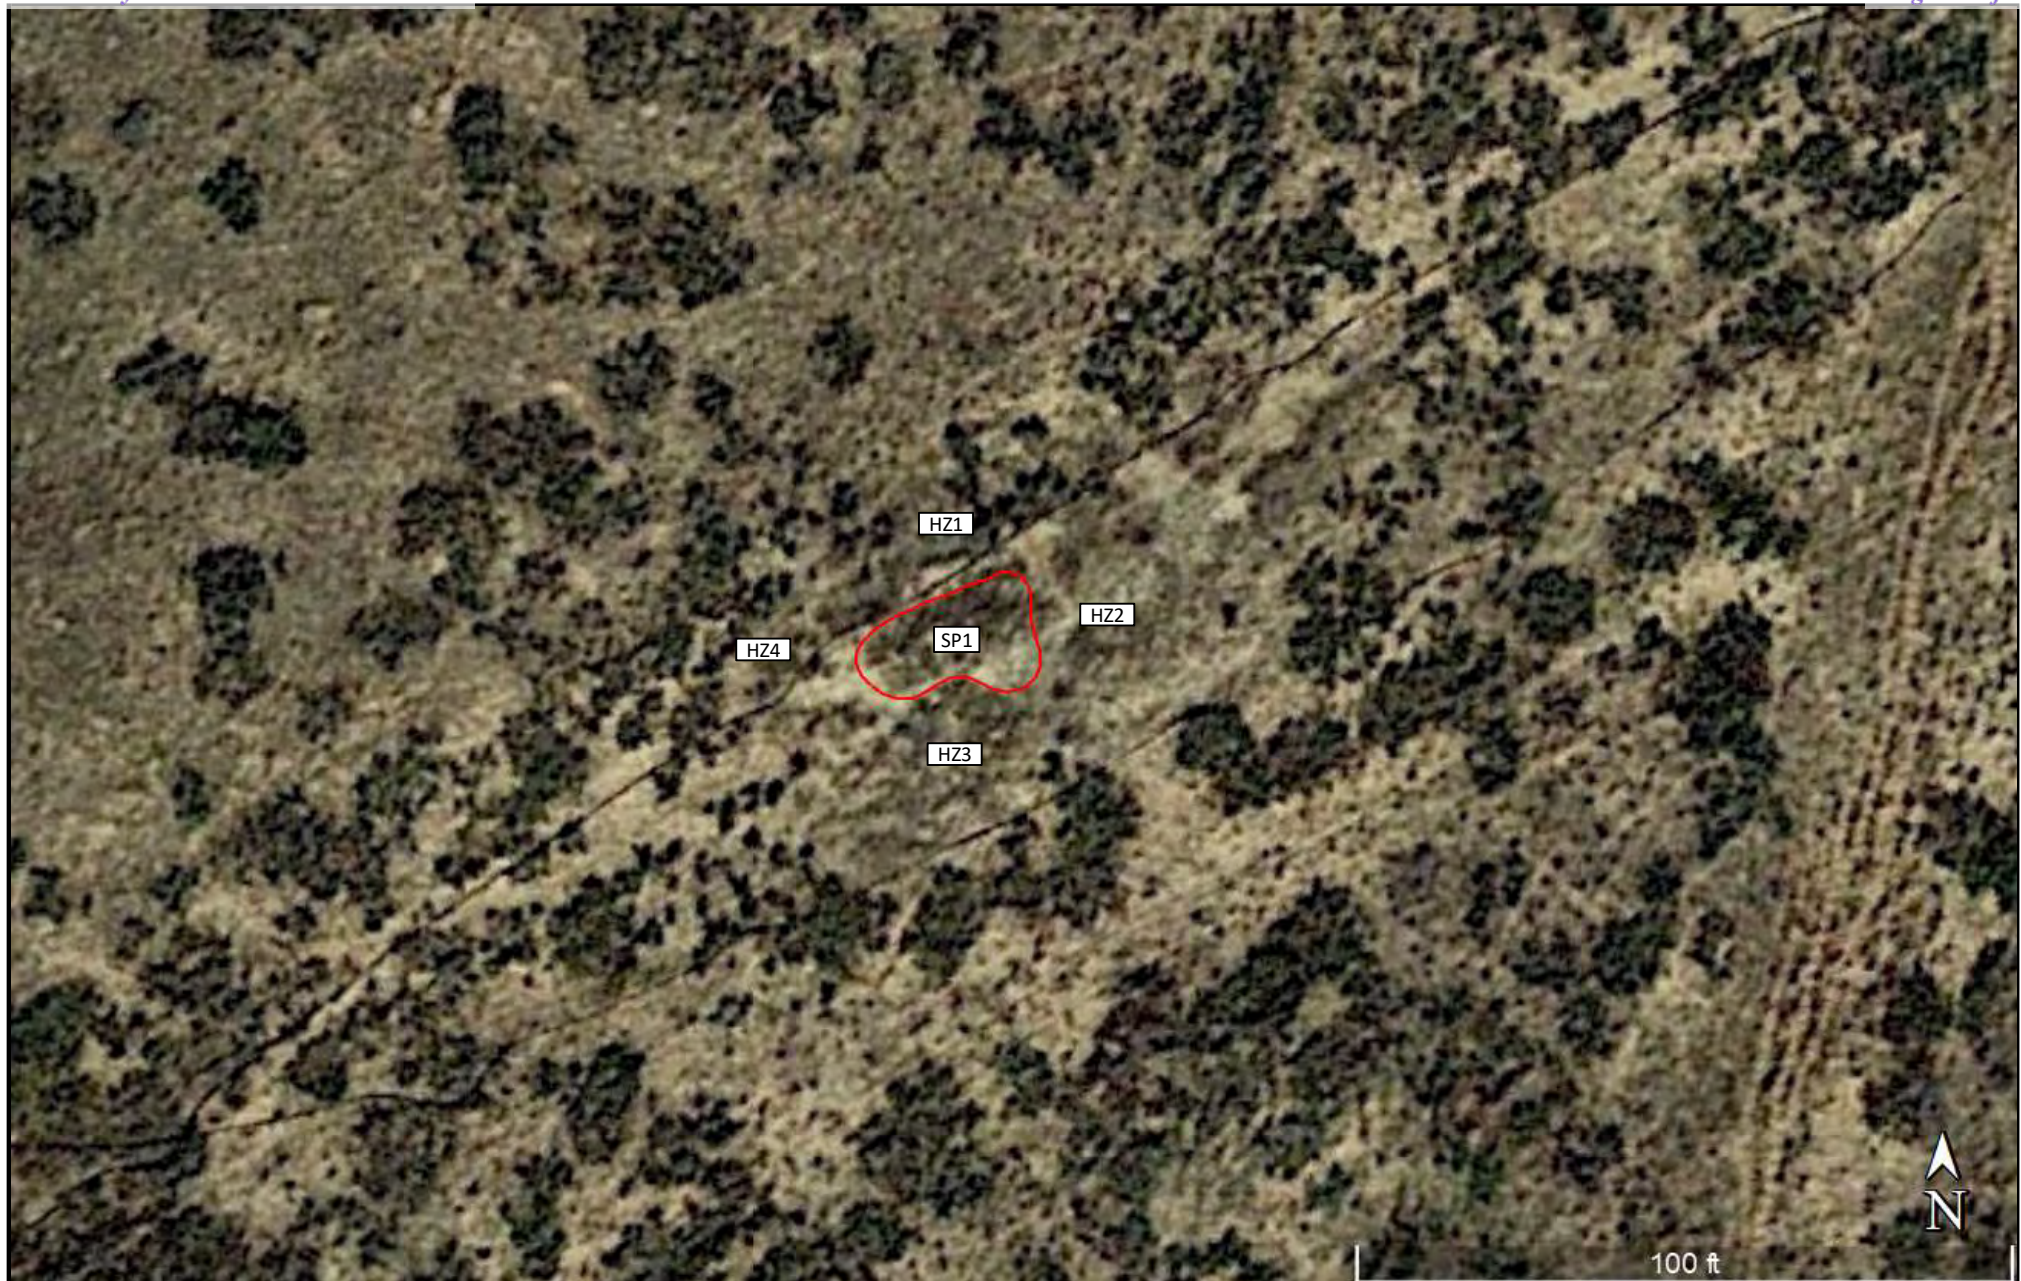
**Figure 4**

On July 8 and 18, 2022, Hungry Horse conducted an initial site assessment and a series of sampling events. During the sampling events, a test trench was advanced in the floor of the excavated area in an effort to determine the vertical extent of contamination. This sample location is identified by SP designation. In addition, test trenches were advanced along the outside edges of the excavated area in an effort to determine the horizontal extent of contamination. These sample locations are identified by HZ designation. During the advancement of the test trenches, soil samples were collected and field screened for the presence of chloride concentrations utilizing a Hach Quantab® chloride test kit.

Based on field observations and field test data noted above and provided in Attachment IV, ten representative soil samples were selected for laboratory analysis. Delineation soil samples, SP1 and HZ1 through HZ4, were submitted to the laboratory for analysis of BTEX, TPH, and chloride. Laboratory analytical results indicated contaminant concentrations were below the NMOCD Closure Criteria in each of the submitted samples with the exception of SP1 at Surface which exhibited TPH concentrations in excess of NMOCD Closure Criteria.

Delineation Sample Map  
Frontier Field Services, LLC  
MAL 10-33 Siete 6" Steel Line  
GPS: 32.747034, -103.801475  
Lea County

A Delineation Sample Map and Excavation Sample Map are provided as Figure 4 and Figure 5, respectively. A Summary of Soil Sample Laboratory Analytical Results is provided as Table 1 and Laboratory Analytical Reports are provided as Attachment VI.

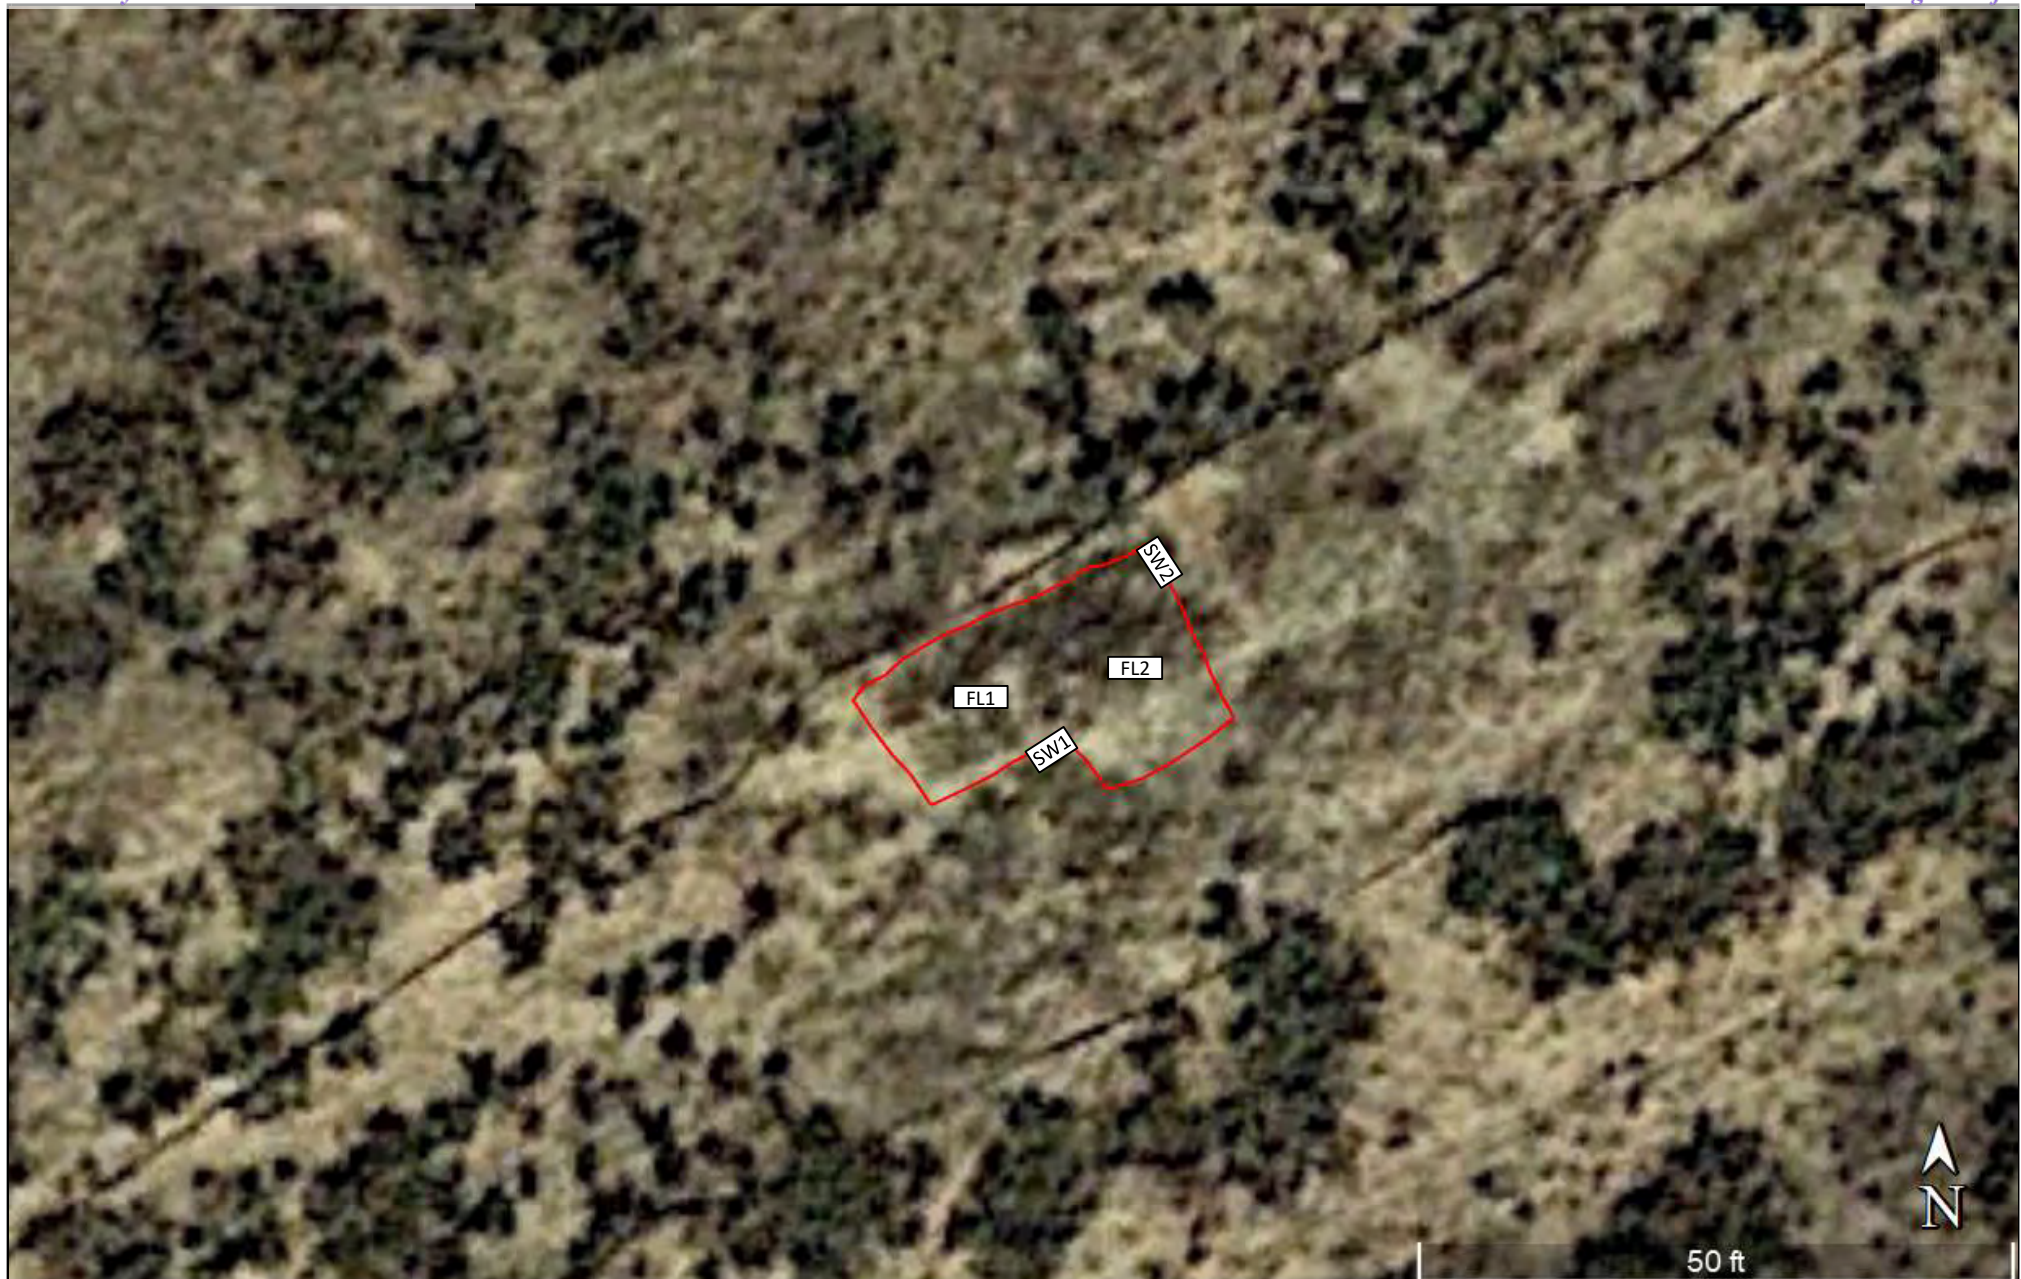
**Figure 5**

The excavated area measured approximately twenty-seven feet in length, eighteen feet in width, and six feet in depth. During remediation activities approximately 252 cubic yards of impacted soil were excavated and hauled to an NMOCD approved disposal facility. Manifests can be provided upon request.

On July 28, 2022, four composite confirmation soil samples were collected from the excavation floor and sidewalls, every 200 square feet and every 50 linear feet, respectively. Soil samples FL1, FL2, SW1, and SW2, were submitted to the laboratory for analysis of BTEX, TPH, and chloride. Laboratory analytical results indicated contaminant concentrations were below the NMOCD Closure Criteria in each of the submitted samples.

Excavation Sample Map  
Frontier Field Services, LLC  
MAL 10-33 Siete 6" Steel Line  
GPS: 32.747034, -103.801475  
Lea County

Based upon laboratory analytical results from confirmation soil samples, the excavated area was backfilled with locally sourced, clean, non-impacted material. The area was contoured to achieve erosion control and preserve surface water flow. The affected area will be reseeded
