**Re: Closure Report
West Shugart 29 Federal #003H
Devon Energy Production Company
Site Location: Unit M, S29, T18S, R31E
(Lat 32.7139549°, Long -103.8970413°)
Eddy County, New Mexico
Incident ID: NAPP2201436236**

On behalf of Devon Energy Production Company (Devon), New Tech Global Environmental, LLC (NTGE) has prepared this letter to document site assessment and remedial action activities at the West Shugart 29 Federal #003h (Site). The Site is located approximately 9 miles Southeast of Loco Hills, New Mexico in Eddy County (Figures 1 and 2).

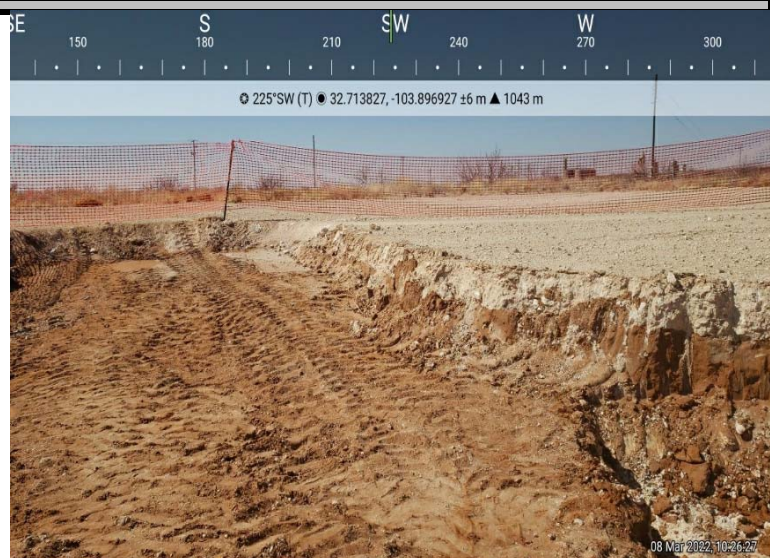
**Photograph No. 8**

Description:
View of Excavtion

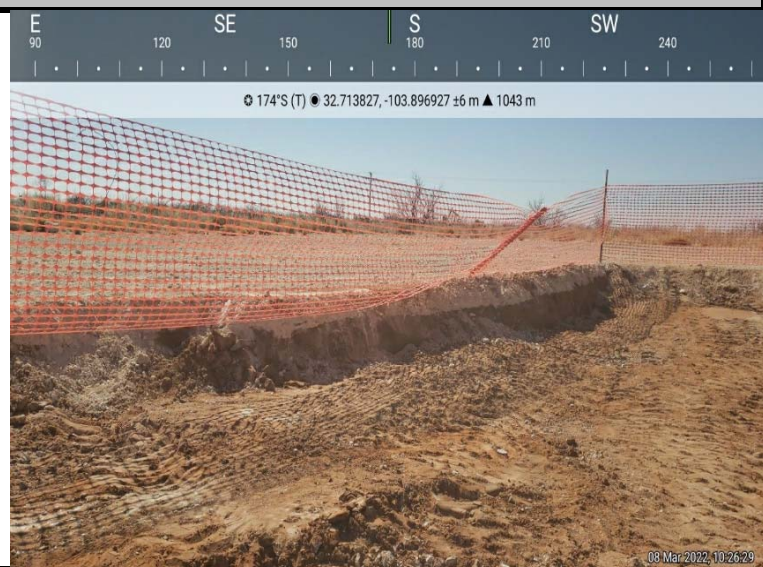
**Photograph No. 9**

Description:
View of Excavtion
