**Re: Closure Report
West Shugart 29 Federal #003H
Devon Energy Production Company
Site Location: Unit M, S29, T18S, R31E
(Lat 32.7139549°, Long -103.8970413°)
Eddy County, New Mexico
Incident ID: NAPP2201364627**

On behalf of Devon Energy Production Company (Devon), New Tech Global Environmental, LLC (NTGE) has prepared this letter to document site assessment and remedial action activities at the West Shugart 29 Federal #003h (Site). The Site is located approximately 9 miles Southeast of Loco Hills, New Mexico in Eddy County (Figures 1 and 2).

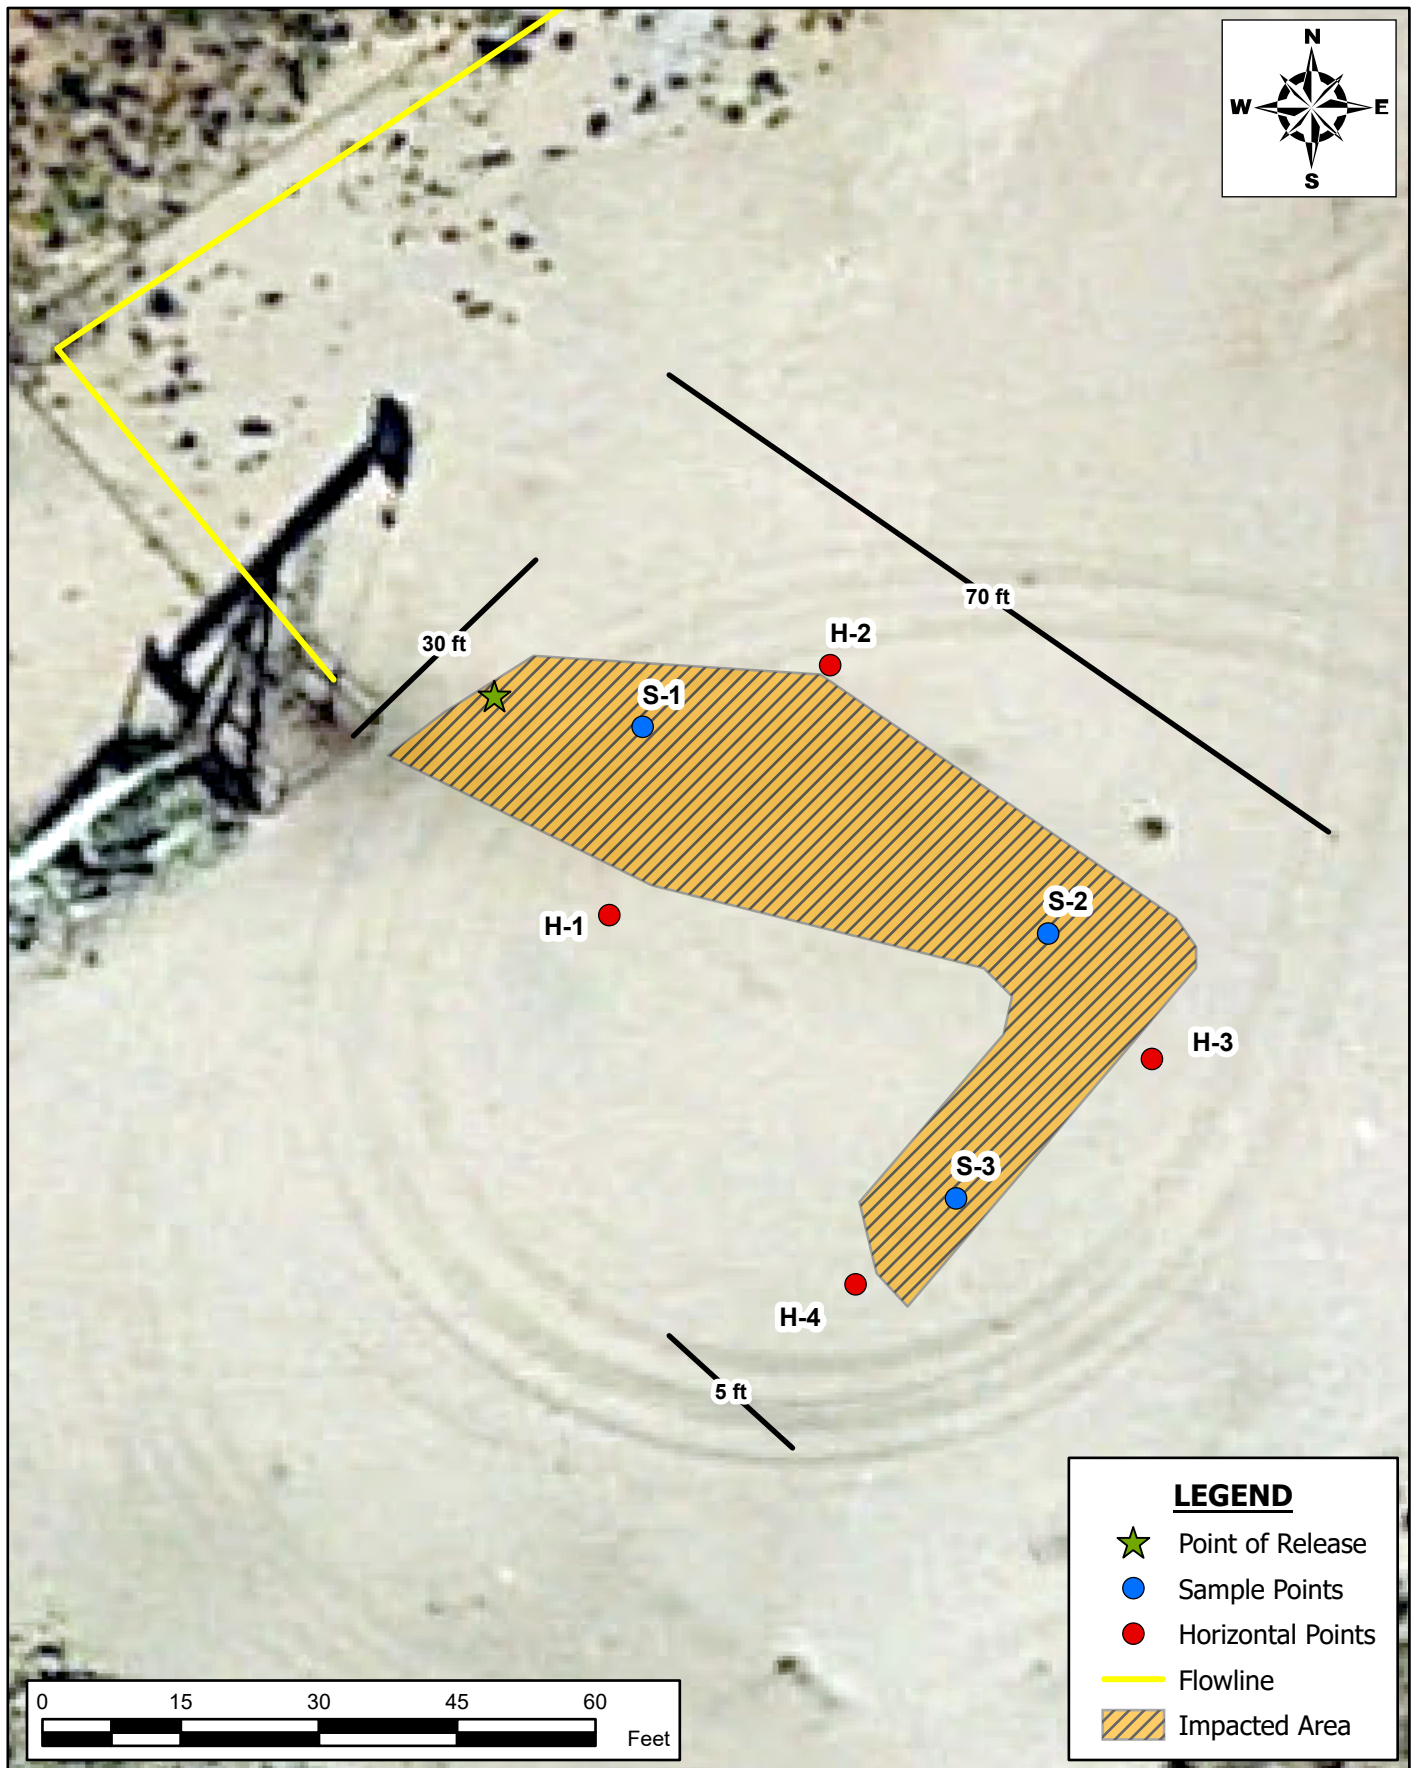
SAMPLE LOCATION MAP
DEVON ENERGY
 WEST SHUGART 29 FEDERAL #003H
 EDDY COUNTY, NEW MEXICO
 32.7139549, -103.8970413

On January 27, 2022, NTGE conducted site assessment activities to assess the horizontal and vertical extent of impacts at the Site. A total of 3 sample points (S-1 through S-3) were installed within the release area to characterize the impacts. Additionally, 4 horizontal delineation sample points (H-1 through H-4) were installed to define the extent of impacts. Soil samples were in 0.5 to 1 ft depth intervals and collected from depths ranging from 0 – 3.5 ft bgs with a geotechnical handauger. The handauger was decontaminated with Alconox and deionized water between soil borings to prevent cross-contamination. Sample locations are shown on Figure 3.

Based on the initial C-141 obtained from the New Mexico Oil Conservation Division (NMOCD), the release was discovered on December 31, 2021. The release was a result of a tubing failure. The failure resulted in the release of approximately 3 barrels (bbls) of crude oil of which 2 bbls were recovered also resulting in approximately 4 (bbls) of produced water being released of which 1 bbl was recovered. Upon discovery, the well was shut-in and area was secured. The release is shown on Figure 3. The initial C-141 form is attached.

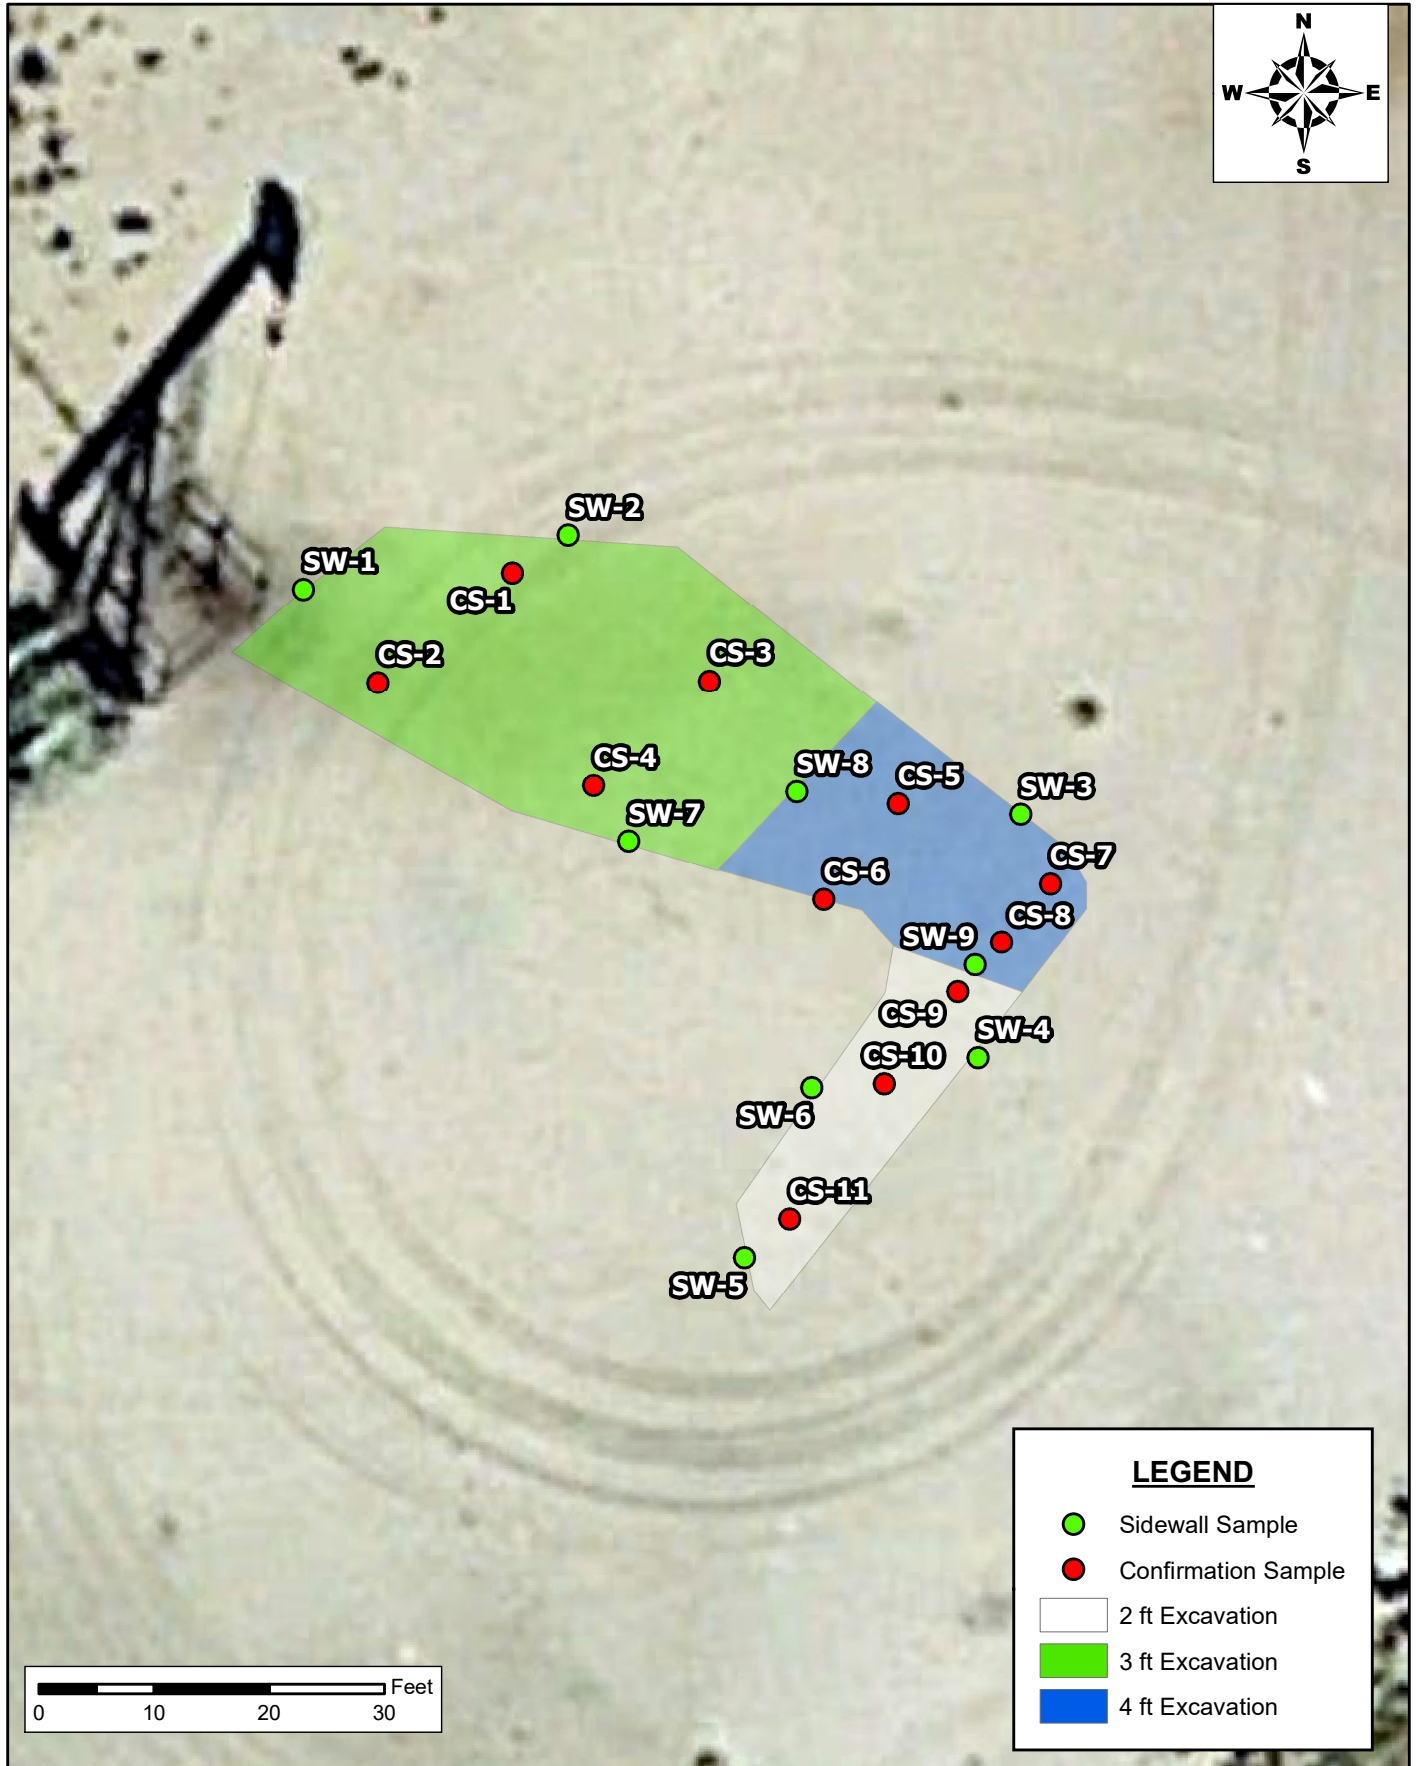
Based on the analytical results, Devon proceeded with the remedial actions at the Site to include the excavation and disposal of impacted soils above the regulatory limits. The release area was excavated to the depths detailed below and illustrated on Figure 4.

- The area of S-1 was excavated to a depth of 3 ft bgs
- The area of S-2 was excavated to a depth of 4 ft bgs
- The area of S-3 was excavated to a depth of 2 ft bgs

The soils were field screened during excavation activities to aide in determining final excavation depths, primarily in the areas of S-2, where the vertical delineation of impacts was not achieved during site assessment activities. A total of 20 confirmation samples were collected from the excavation base (CS-1 - CS-11) and 9 confirmation samples were collected from the excavation sidewalls (SW-1 - SW-9) were collected from the excavation sidewalls to ensure impacted soil was removed.

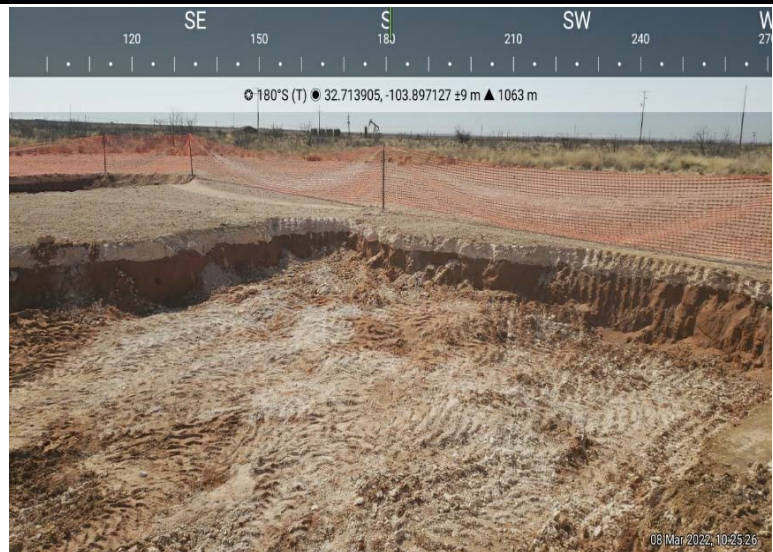
Description:
View of Excavtion

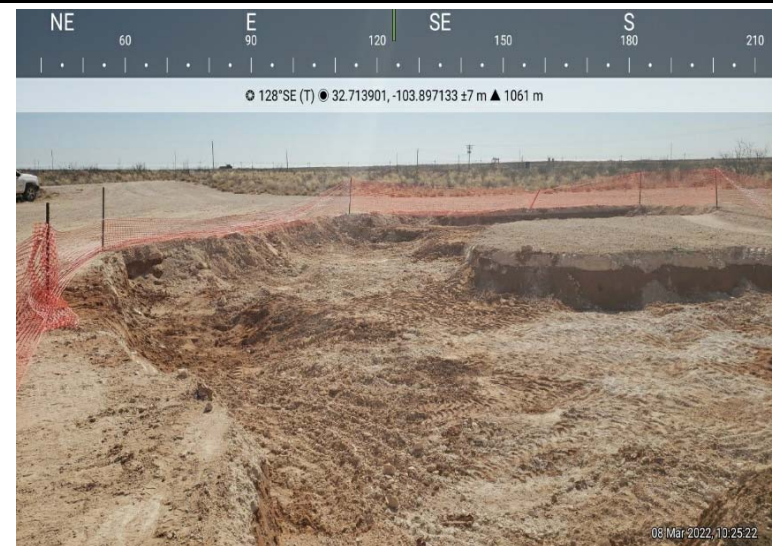
**Photograph No. 2**

Description:
View of Excavtion

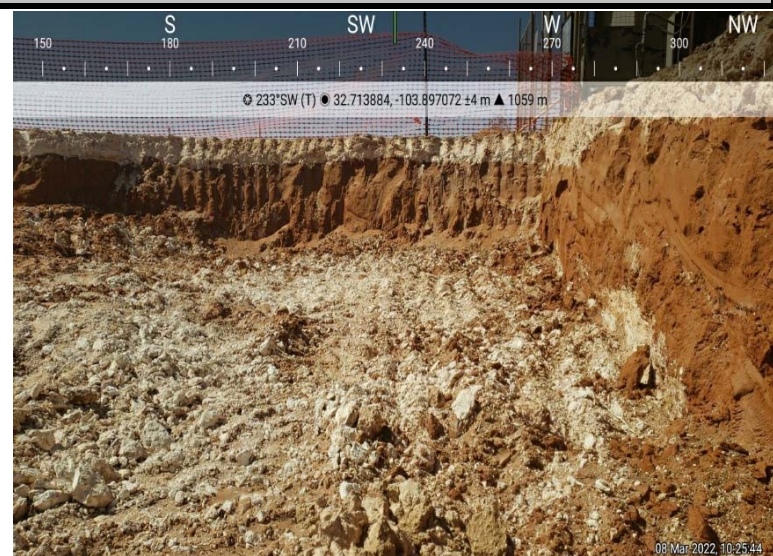
**Photograph No. 3**

Description:
View of Excavtion

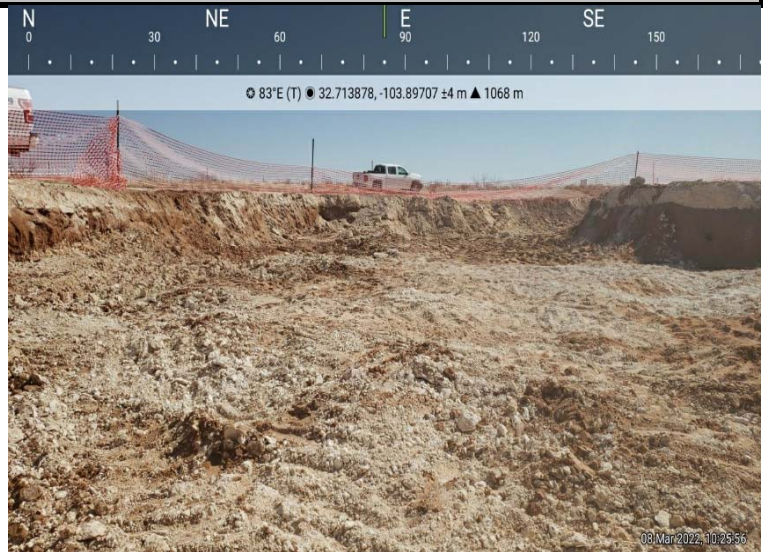
Description:
View of Excavtion

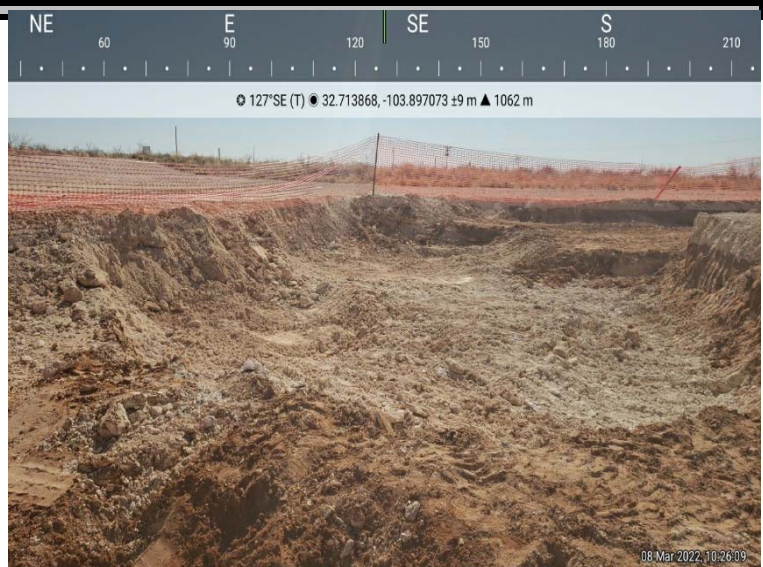
**Photograph No. 5**

Description:
View of Excavtion

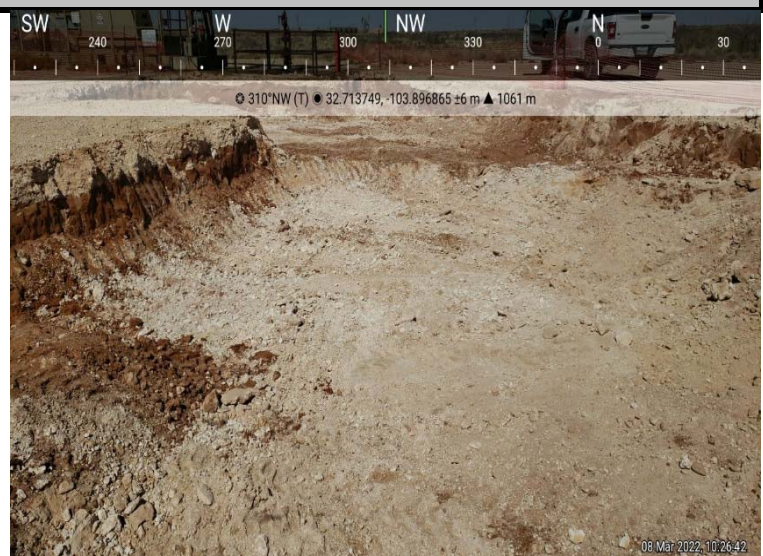
**Photograph No. 6**

Description:
View of Excavtion

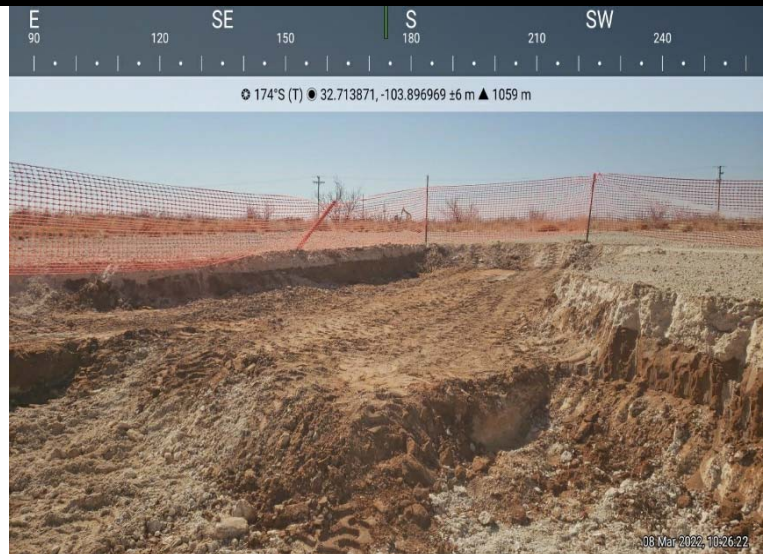
Description:
View of Excavtion
