## **Remediation and Closure Report**

Bonnie 35 Federal Com 1H  
Incident# nAPP2213973514  
Eddy County, New Mexico

Subject: **Remediation and Closure Report**  
Bonnie 35 Federal Com 1H  
Incident# nAPP2213973514  
Eddy County, NM

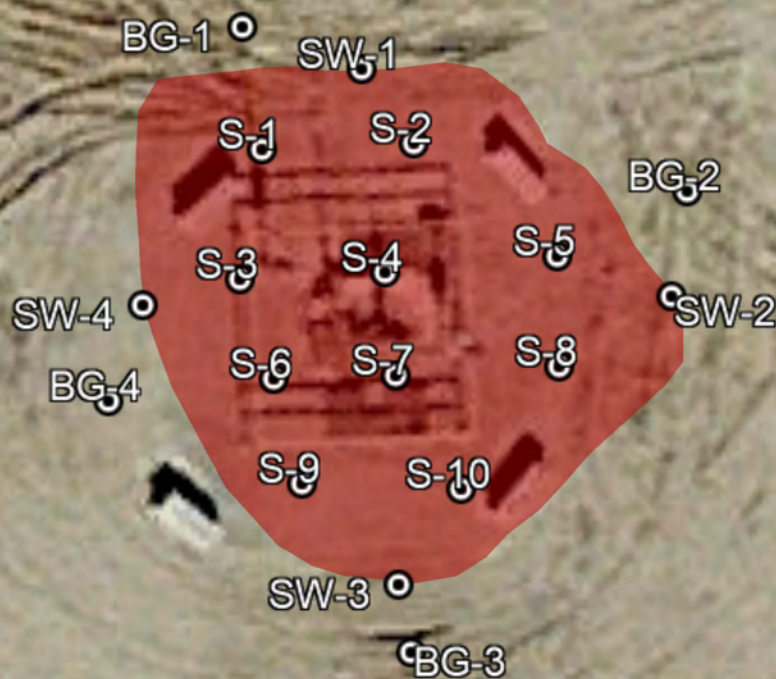
Cimarex Energy Co.  
Incident# nAPP2213973514  
Eddy County, NM  
Confirmation Sample Map

3ft. Excavation
-

Composite Confirmation Sample

On August 02, 2022, H&R mobilized personnel to begin excavation of the release area on location. A hydrovac truck was utilized to exposed the flow lines coming off of the wellhead as well as remove any contaminants from the inside of the concrete bottomed and metal sided cellar. The hydrovac also pressure washed the wellhead. Field chloride titrations were performed to help determine the depth and horizontal extents of the release. Once excavation was complete composite confirmation samples were collected from the bottom and sidewalls of the excavation. Confirmation samples were taken to Cardinal Laboratories for analysis to ensure all contaminants above closure criteria were removed. Results from the confirmation sampling are contained in the following table. Excavation dimensions and confirmation sample locations can be found on Confirmation Sample Map, [Appendix I](#). Before, during, and, after photographs of the location are attached in [Appendix IV](#). Complete laboratory reports can be found in [Appendix VI](#).

- The entire impacted area around the wellhead was excavated to a total depth of 3-feet BGS.
- The cellar was cleaned out and pressure washed.
- Composite confirmation samples were obtained from the sidewalls and bottoms of the excavated area every 200 square feet to verify that all contaminants above closure criteria had been removed.
- All the excavated material (268yds) was hauled to Lea Land, a NMOCD approved solid waste disposal facility.
- The excavated areas on the well pad were backfilled with new caliche at depth and brought to grade, machine compacted and contoured to match the surrounding location.
- The Final C-141 formally documenting the remedial actions is attached in [Appendix III](#).
