SITE CHARACTERIZATION AND PROPOSED REMEDIATION PLAN

**JUDSON AUU STATE COM #2
UNIT O, SECTION 26, TOWNSHIP 10S, RANGE 34E
LEA COUNTY, NEW MEXICO
33.412582, -103.432854
RANGER REFERENCE NO. 5375**

**EOG RESOURCES, INC.
ARTESIA DIVISION
105 S 4TH STREET
ARTESIA, NEW MEXICO 88210**

AUGUST 8, 2022

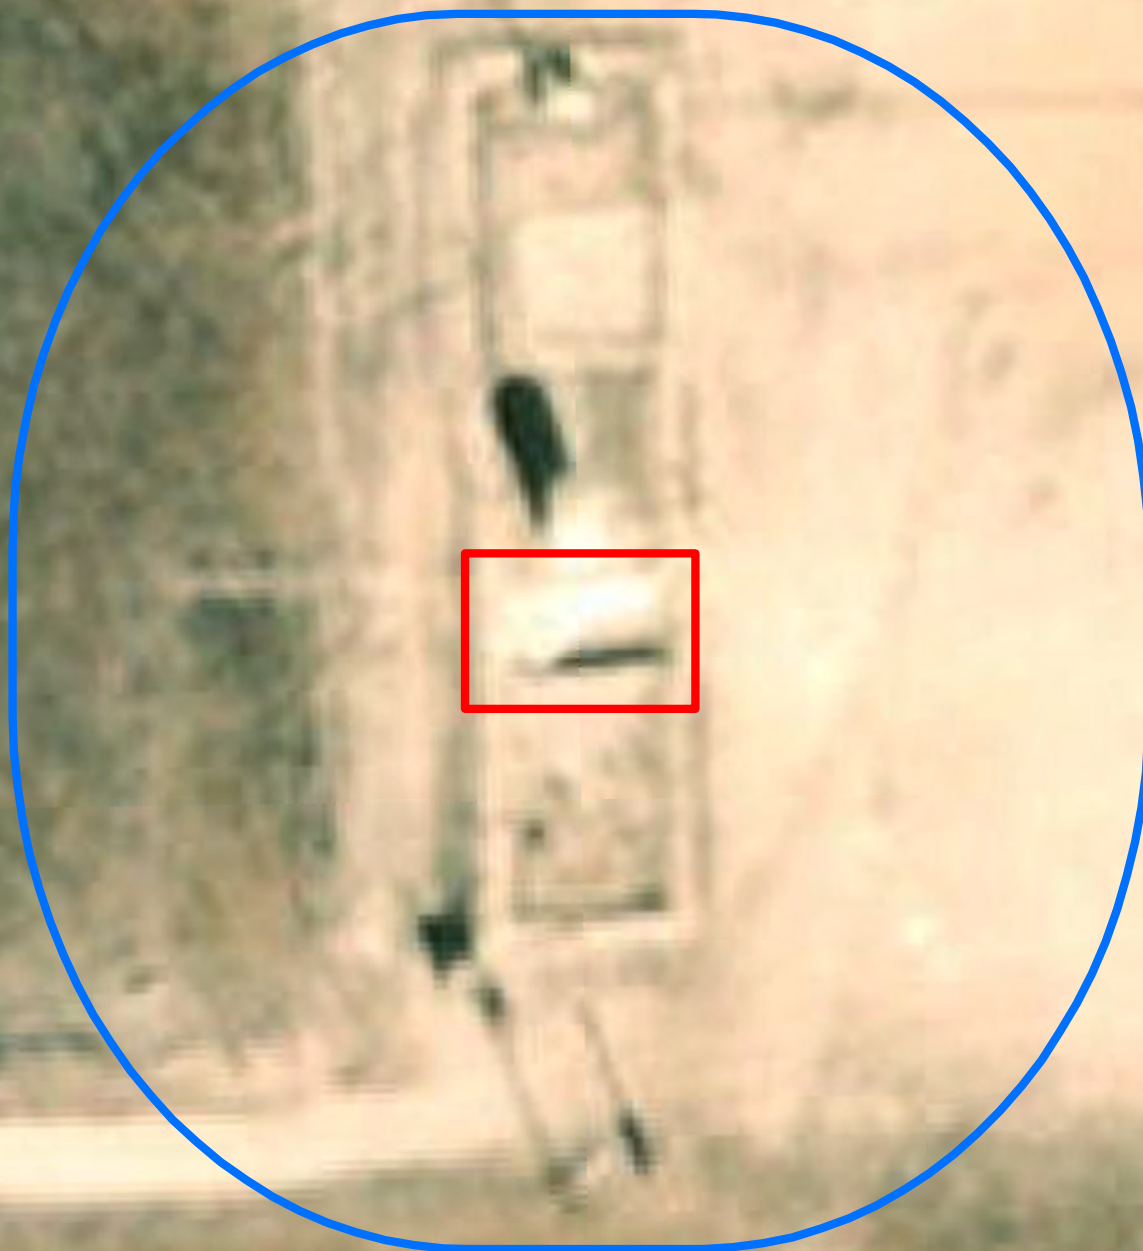
Anticipated Limit of Benching and Shoring Requirements*

Based on the observed conditions at the Site, it is anticipated that the impact area has dimensions of approximately 40 feet long and 27 feet wide and will require excavation to depths of approximately 26 to 30 feet bgs. Based on previously completed engineered plans for similar remediation projects, it is anticipated that an area approximately 215 feet by 198 feet will be necessary to allow for proper benching and shoring requirements. The extent of the anticipated

A *Proposed Excavation Area Map* depicting the anticipated excavation boundaries is attached. It should be noted that the depicted boundaries are pending the P.E. approved excavation plan. A *Proposed Confirmation Sample Location Map* depicting the proposed excavation base grab sample locations is attached.

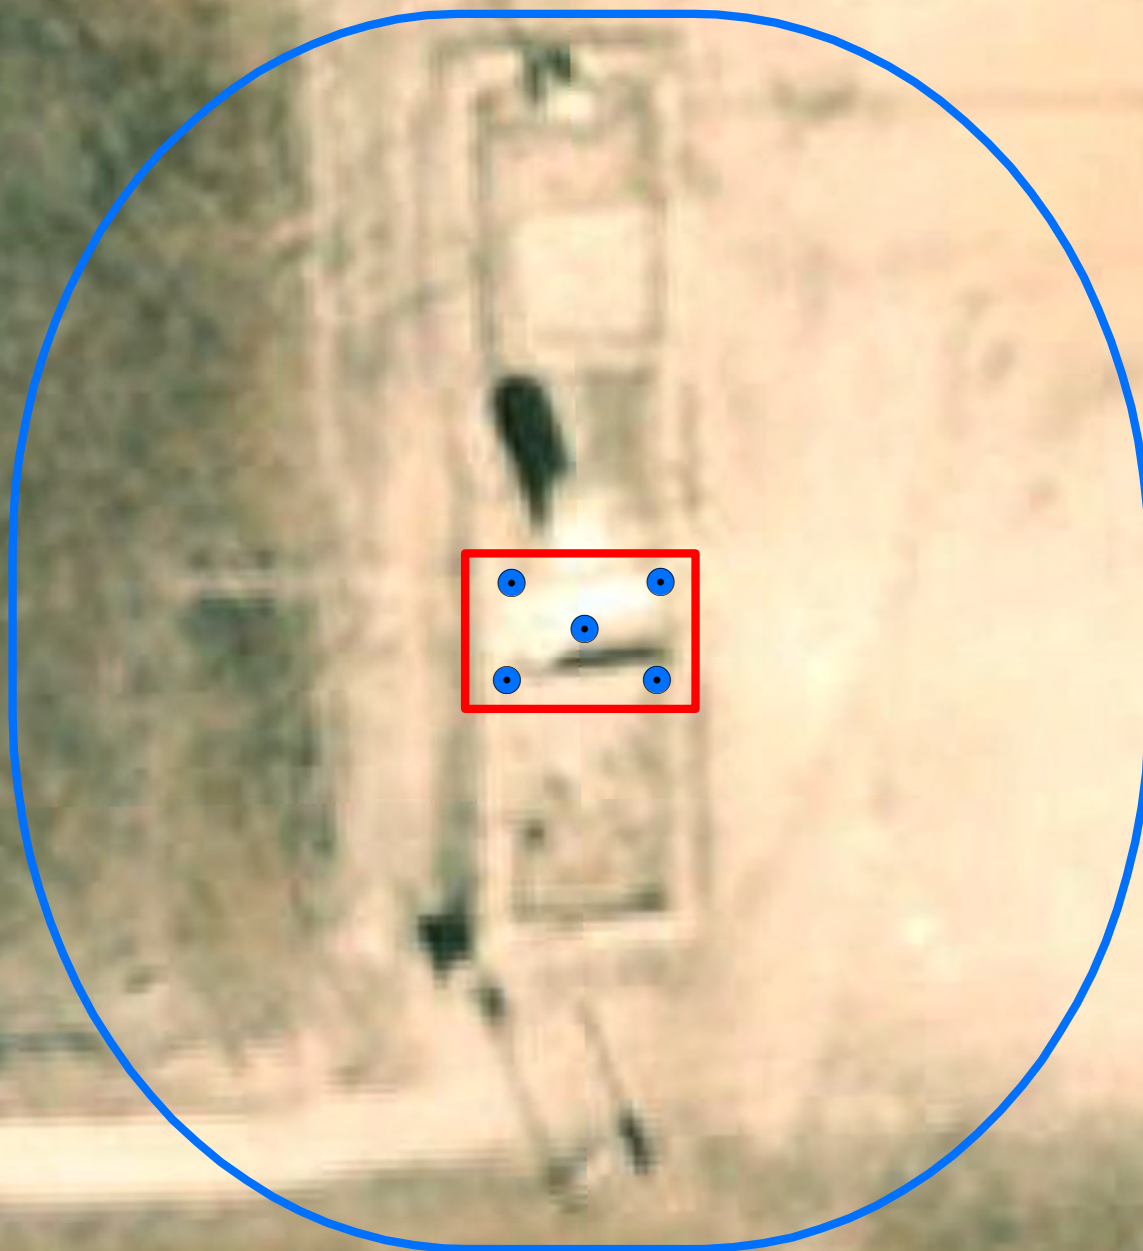
Proposed Grab Sample Location

*Confirmation soil samples from the Anticipated Benching and shoring area are proposed to be collected as five-part composite samples at a frequency of one composite sample per 1,000 square feet.

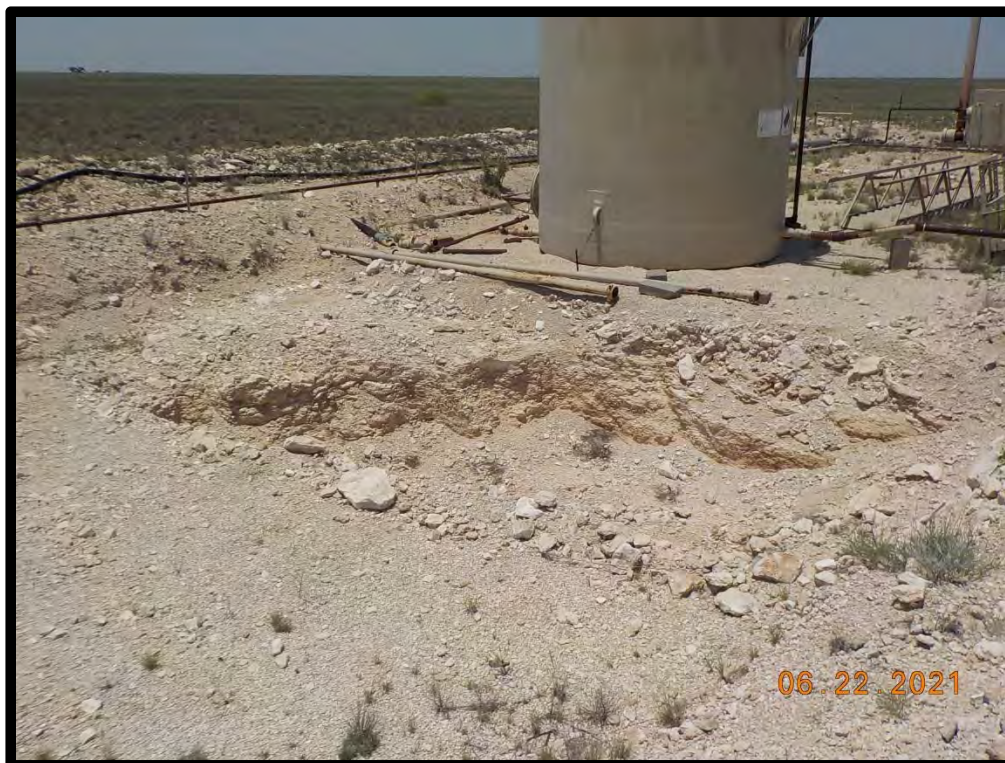
PHOTOGRAPH NO. 1 – A general view of the excavation area at the Site on June 22, 2021. The view is towards the northwest.

(Approximate GPS: 33.412585, -103.432814)

On June 22, 2021, Ranger personnel mobilized to the Site to conduct a precursory review of the impact/excavation area at the Site. Upon arrival at the Site, Ranger reviewed and documented the extent of the completed excavation. Upon inspection, the Site excavation was noted to have dimensions of approximately 27 feet by 12 feet and was completed to depths varying from one to four and one-half feet bgs. The excavated material generated during these initial response efforts was noted to be removed from the Site. During the inspection process, Ranger personnel field screened soils from various locations in the excavated area using an organic vapor monitor (OVM) and a field chloride titration kit to assist in evaluating the soil conditions and/or levels of impacts in the area. Field OVM readings at the Site indicated that hydrocarbon impacts were still present

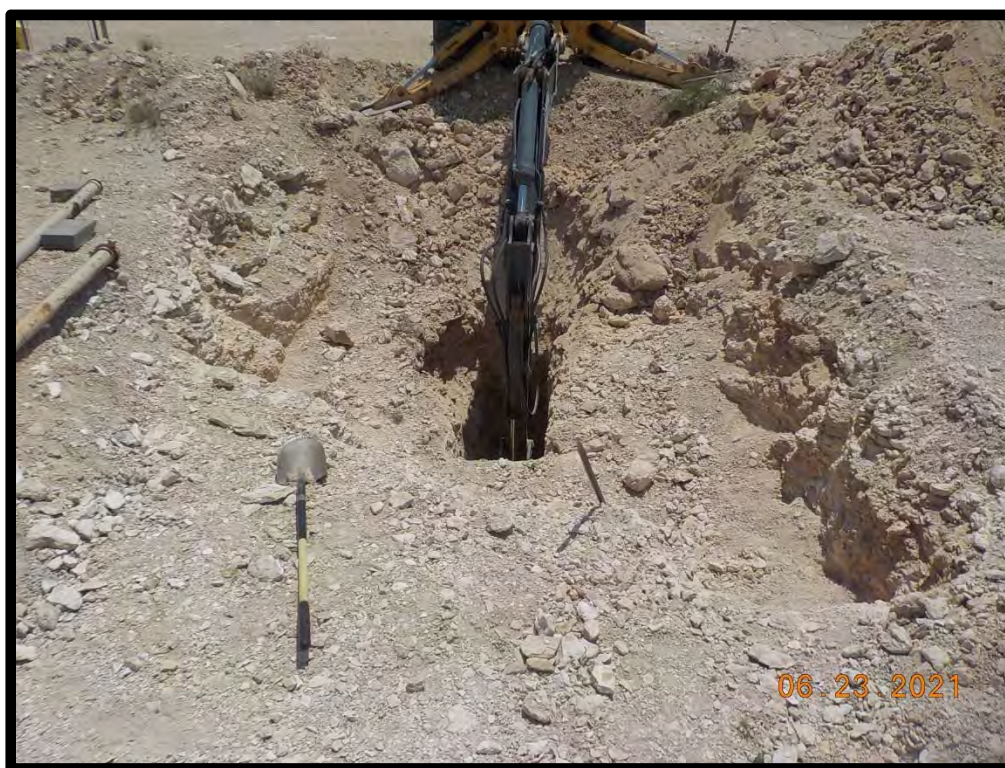
PHOTOGRAPH NO. 2 – A view of the assessment test excavation being completed in the base of the excavation area on June 23, 2021. The view is towards the east.

(Approximate GPS: 33.412613, -103.432865)

Based on the conditions documented at the Site, it was determined that additional assessment and delineation efforts were warranted. On June 23, 2021, Ranger personnel and representatives of EOG returned to the Site to conduct additional assessment activities. Utilizing earth moving equipment (backhoe), an initial test excavation was completed in the base of the excavation area in an attempt to vertically delineate the observed impacts in the area. Additionally, test excavation trenches were completed into the excavation sidewalls in each cardinal direction to assist in the horizontal delineation of impacts in the area. During the assessment process Ranger personnel once again collected field OVM and chloride readings to assist in evaluating the level of impacts and to identify appropriate sample locations. Due to the lithology at the Site, further assessment of multiple locations was limited. Within the excavation, the depth of investigation was limited to approximately 12 feet bgs, where field OVM readings indicated that elevated soil concentrations were still present. Along the northern wall of the excavation, elevated soil concentrations were observed and documented; however, due to the presence of production equipment in the area, additional trenching assessment could not safely be completed. During the assessment process, soil samples for laboratory analysis were collected from the test excavation locations. It should be noted, due to field readings collected along the north wall of the excavation and Site constraints limiting the ability to complete additional assessment further north, no additional samples were collected from the area.

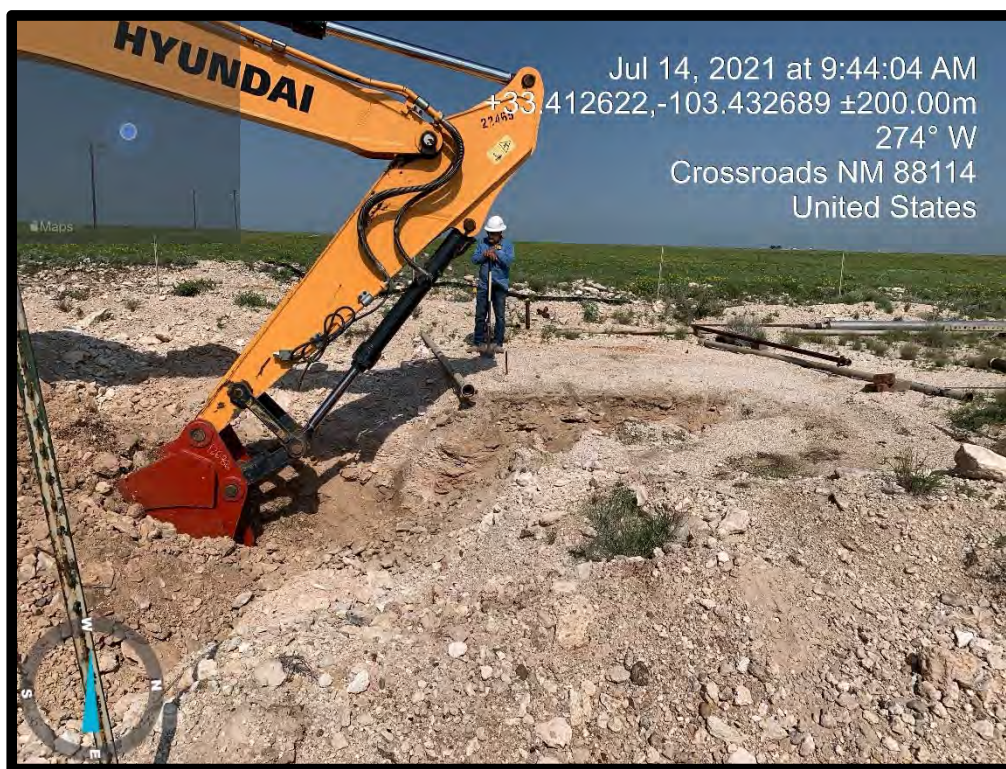
PHOTOGRAPH NO. 3 – A general view of the assessment activities along the northern wall of the excavated area on July 14, 2021. The view is towards the west.

At the time of the July 14, 2022 assessment activities, the production equipment located immediately north of the excavated area, that limited assessment activities during the July 2021 activities had been removed making the area available for assessment. Thus, an excavation test trench was completed at the location.

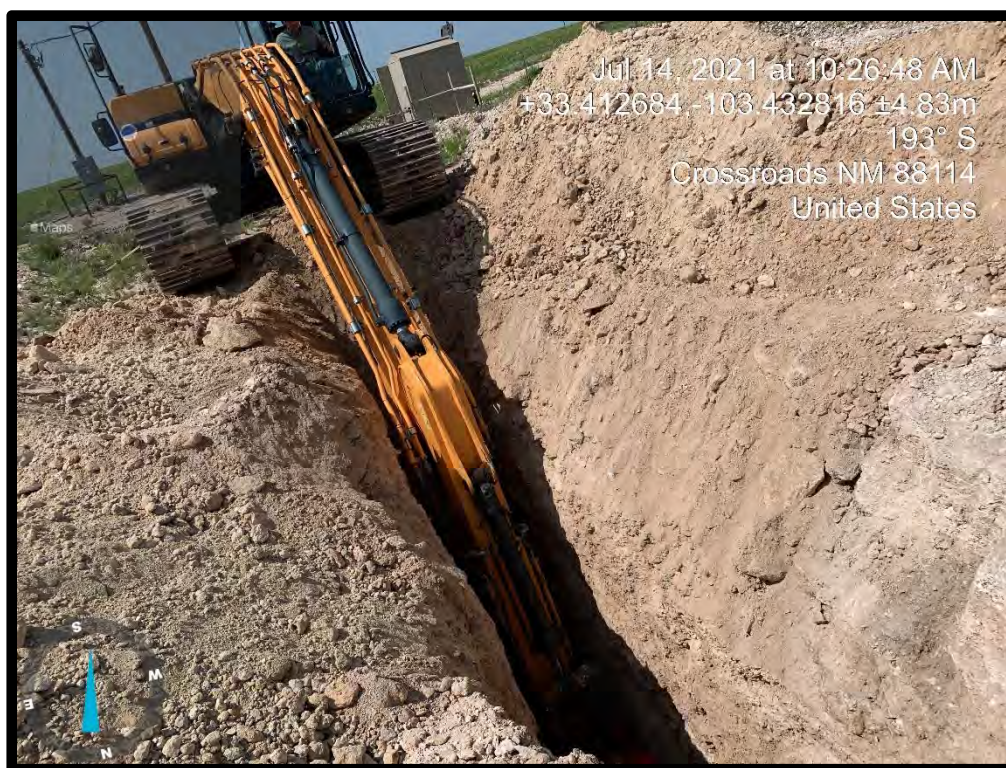
PHOTOGRAPH NO. 4 – A view of the additional assessment activities in the base of the excavation area on July 14, 2021. The view is towards the south.

Based on the results of the samples collected from the test excavation completed in the base of the excavated area, an additional test excavation was completed to a depth of approximately 22 feet bgs, which was the maximum extent of the on-site equipment.
