Re: Site Assessment, Remediation, and Closure Report
Jones D #5
API No. 30-015-20421
GPS: Latitude 32.7468376 Longitude -104.3258286
ULSTR - L-18-T18S-R27E
Eddy County, NM
NMOCD Ref. No. NAB1811557328

Spur Energy Partners (Spur) has contracted Pima Environmental Services, LLC (Pima) to perform a spill assessment, remediation, and submit this closure report for a produced water release that occurred at the Jones D #5 (Jones). The initial C-141 was submitted on April 24, 2018 (Appendix C). This incident was assigned Incident ID NAB1811557328, by the New Mexico Oil Conservation Division (NMOCD).

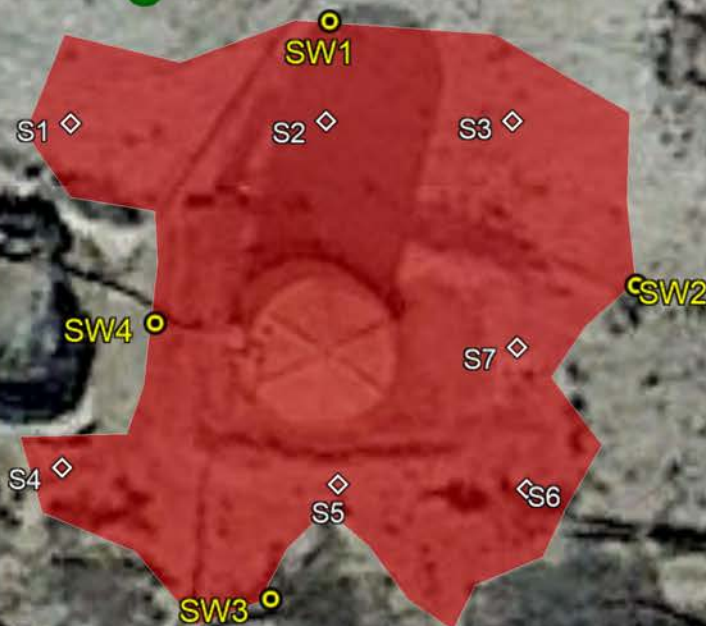
Spur Energy
API #30-015-20421
Eddy County, NM
Site Map

On January 19, 2022, Pima mobilized personnel to the site to assess the area. We sampled the impacted area. Laboratory results of this sampling event can be found in the following data table. A Site Map can be found in Figure 4.

Estimated Spill Area
-

Samples
-

Sidewalls

On May 24, 2022, after all equipment and plumbing had been decommissioned and removed from the site, Pima returned to remediate the area by excavating the contaminated soil. An area measuring approximately 200 square feet surrounding sample point S-4 was excavated to a depth of 3' bgs. This was a total of approximately 22 cubic yards of contaminated soil. See Appendix D for Photographic Documentation.

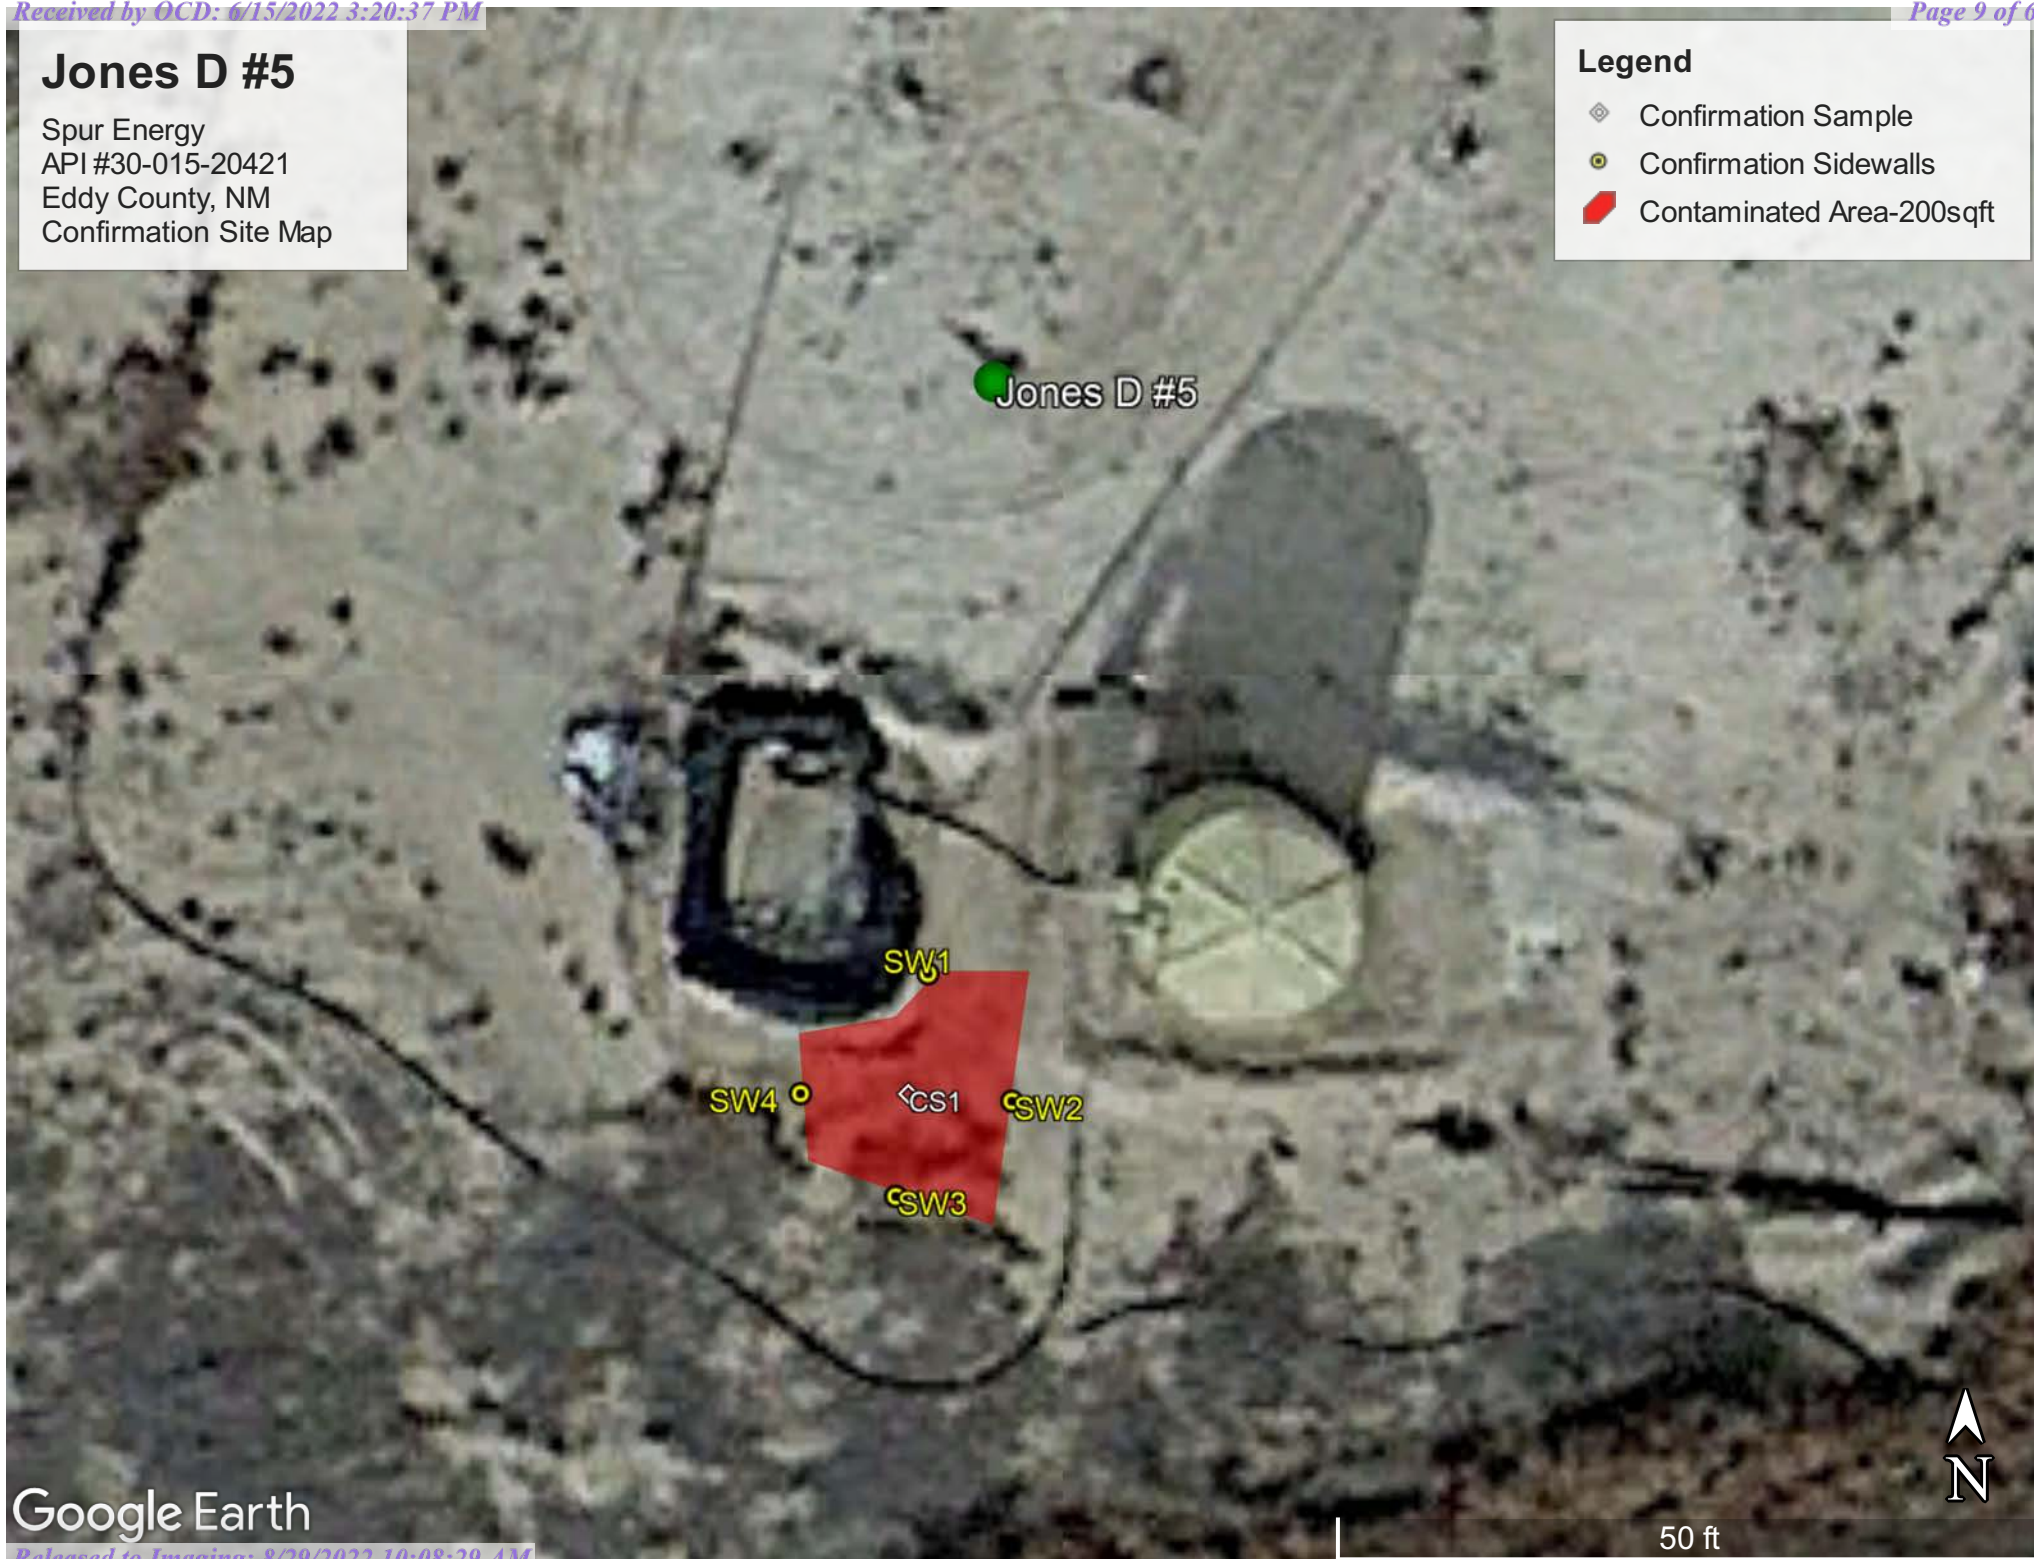
Spur Energy
API #30-015-20421
Eddy County, NM
Confirmation Site Map

On June 3, 2022, after sending a 48-hour notification, Pima returned to collect confirmation samples of the excavated area. 5-point composite samples were taken from the bottom and each sidewall of the excavation. The laboratory results of this sampling event can be found in the following table. A Confirmation Sample Map can be found in Figure 5.

- Confirmation Sample
- Confirmation Sidewalls
- Contaminated Area-200sqft

Based on the sample results, the bottom and sidewalls were below NMOCD Closure Criteria 19.15.29 NMAC. The contaminated material was transported to Lea Land, a NMOCD approved disposal site. The excavation was not backfilled due to the pad site being reclaimed. When the reclaim was finished, the pad surface was machine compacted and contoured to match the surrounding terrain.
