Closure Report Federal 26 A No. 1 Incident ID NAPP2123935327 Lea County, New Mexico Unit N Sec 26 T18S R33E 32.713021°, -103.635650°

Produced Water Release Point of Release: Lightning strike hit battery Release Date: 08/09/2021 Volume Released: 1.0 barrels of Produced Water Volume Recovered: 0 barrels of Produced Water

Re: Closure Report Federal 26 A No. 1 Fasken Oil and Ranch, Ltd Incident ID NAPP2123935327 Site Location: Unit N, S26, T18S, R33E (Lat 32.713021°, Long -103.635650°) Lea County, New Mexico

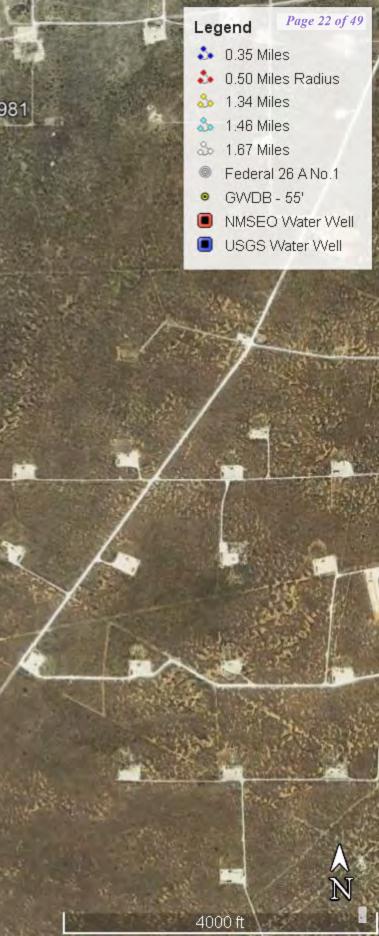
Boring terminated at 55' with no presence of groundwater or moisture. Boring was left open for over 72 hours and measured with a Heron Water Meter on August 3, 2020. No presence of groundwater was detected. Received by OCD: 8/30/2022 1:17:08 PM LOW KARSI FASKEN OIL AND RANCH
