Release Notification

Site Name Sandrock North Water Line (located approx. 1,090 ft northwest of the Payne 3E wellsite)	Site Type 4-inch Produced Water Line
Date Release Discovered 12/21/2021 @ 15:30 pm (MT)	API# 30-045-25953 (nearby Payne 3E wellsite)

Subject: Closure Report - Sandrock North Water Line – Incident No. nAPP2200560379

Hilcorp Energy Company (Hilcorp) has prepared this Closure Report for the Sandrock North Water Line (Site) located on United States Bureau of Land Management (BLM) surface in San Juan County, New Mexico. A release of produced water was discovered by Hilcorp personnel on December 21, 2021 originating from a 4-inch produced water line. Based on initial assessments conducted by Hilcorp, the pipeline froze and ruptured due to cold weather in the area, which allowed the released fluids to migrate outside of the pipeline ROW horizontally to the west. Immediately upon discovery, Hilcorp operators isolated nearby wells and removed all possible pooled fluids from the ground surface. The unrecovered fluids soaked into the surface soils. Because the release impacted a nearby ephemeral wash, Hilcorp submitted immediate notice to the New Mexico Oil Conservation Di

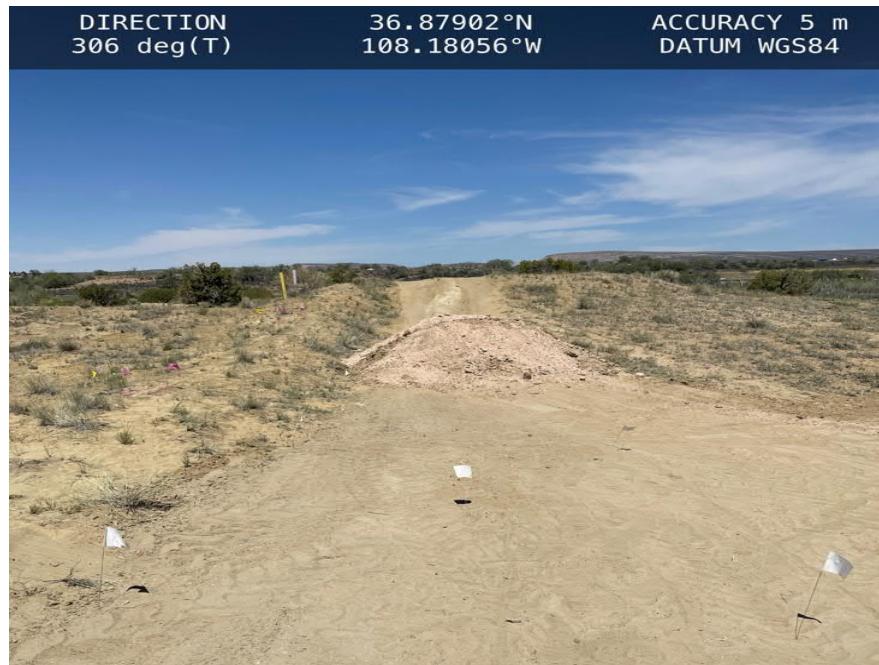
Photograph 2 (dated 5/17/22) – View of Soil Sample Identification S-2 3".

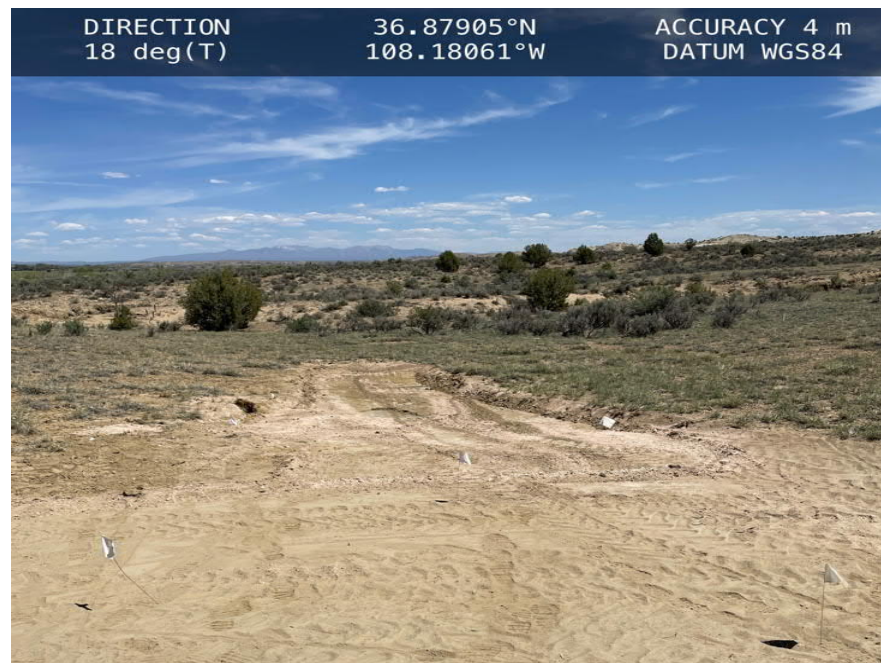
Photograph 3 (dated 5/17/22) – View of Soil Sample Identification S-3 3".

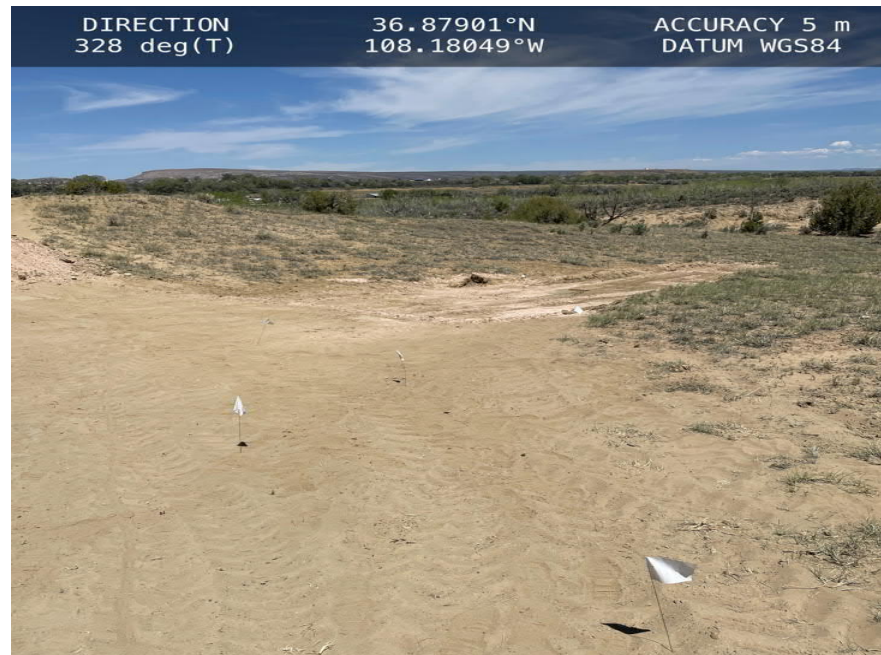
Photograph 4 (dated 5/17/22) – View of Soil Sample Identification S-4 3".

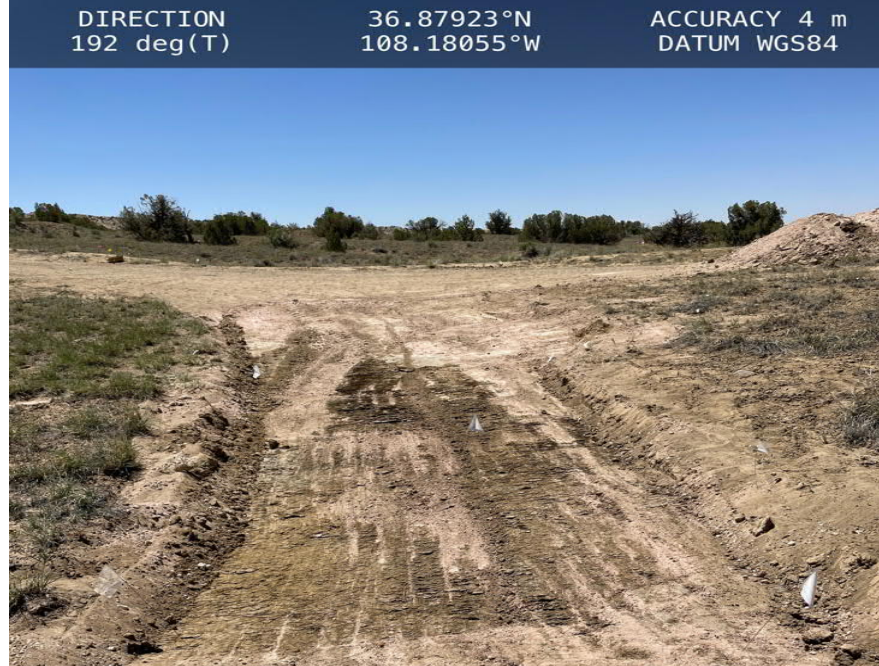
Photograph 6 (dated 5/17/22) – View of Soil Sample Identification S-6 6".

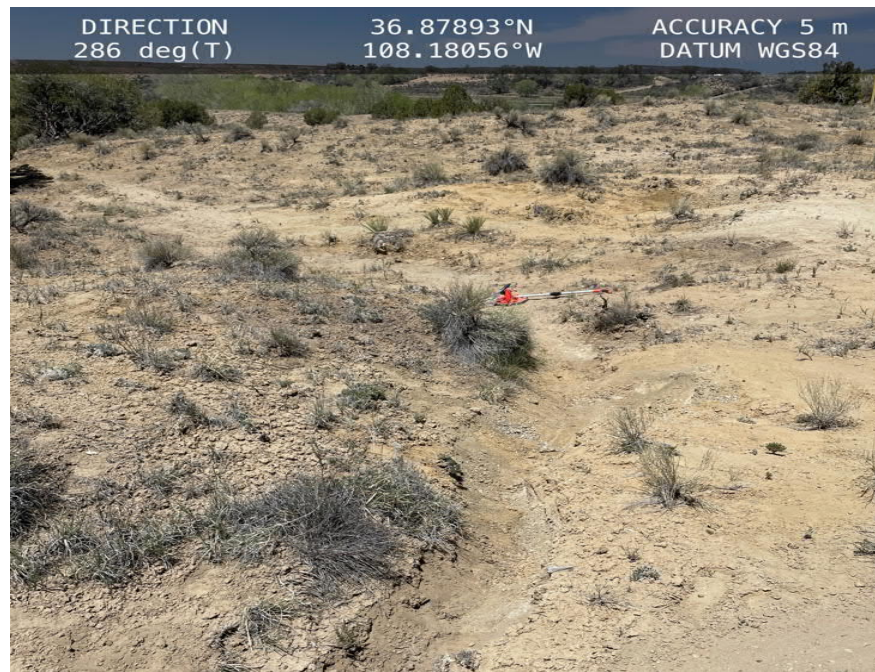
Photograph 7 (dated 5/17/22) – View of Soil Sample Identification S-7 3" taken along the ephemeral wash.

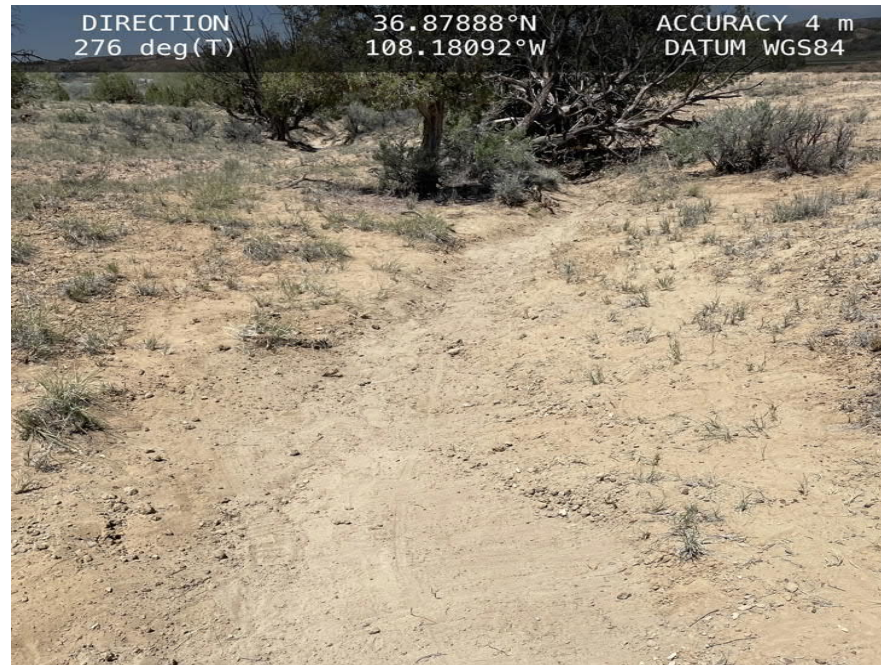
Photograph 8 (dated 5/17/22) – View of Soil Sample Identification S-8 3" taken along the ephemeral wash.

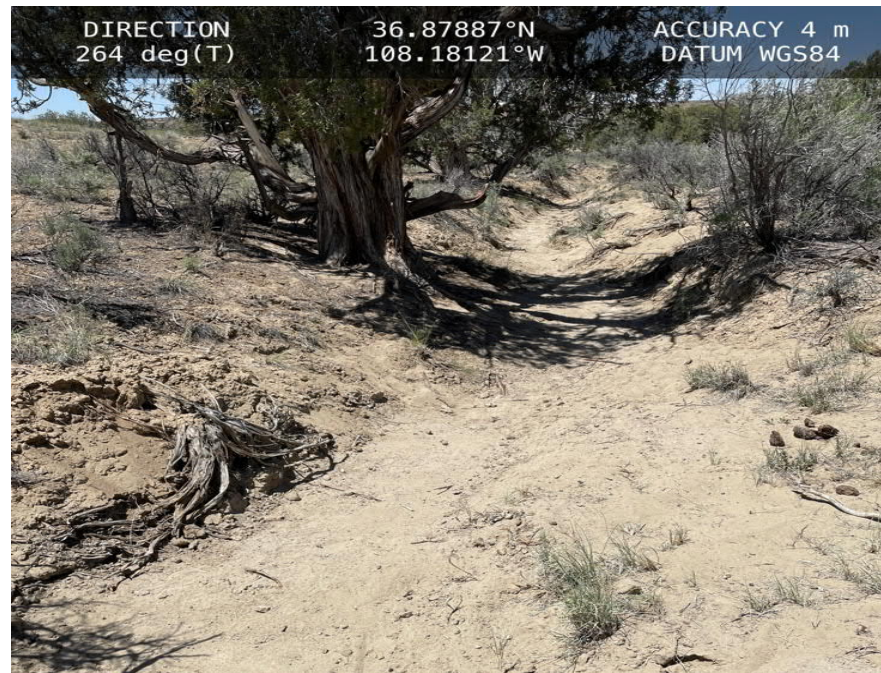
Photograph 9 (dated 5/17/22) – View of Soil Sample Identification S-9 3" taken along the ephemeral wash.

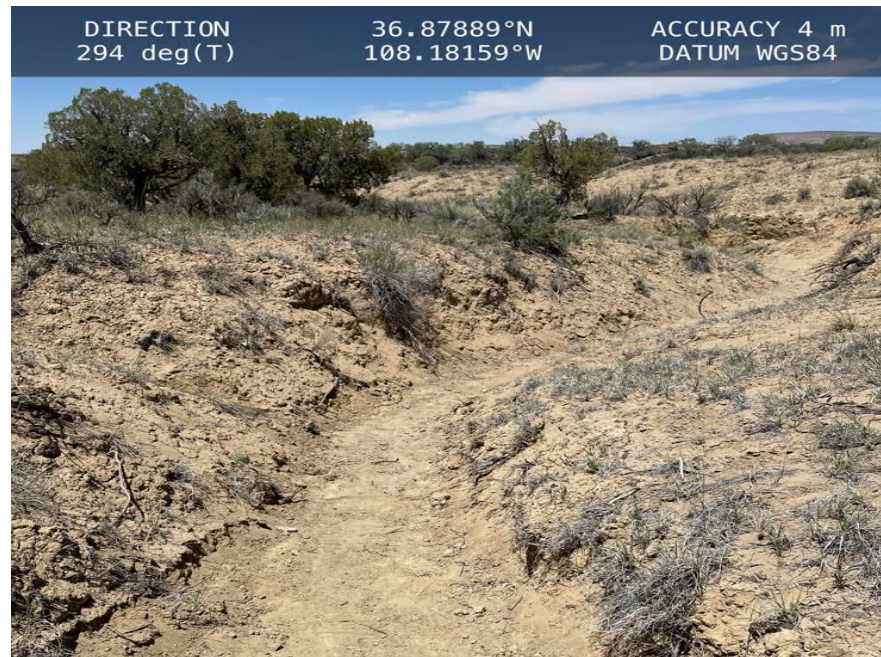
Photograph 10 (dated 5/17/22) – View of Soil Sample Identification S-10 3" taken along the ephemeral wash.

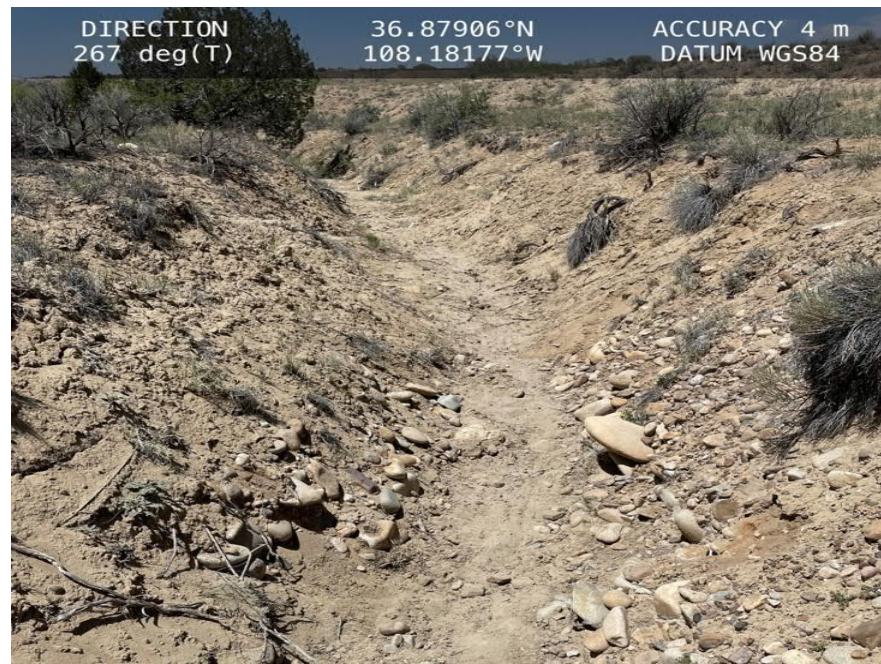
Photograph 11 (dated 5/17/22) – View of Soil Sample Identification S-11 3" taken along the ephemeral wash.

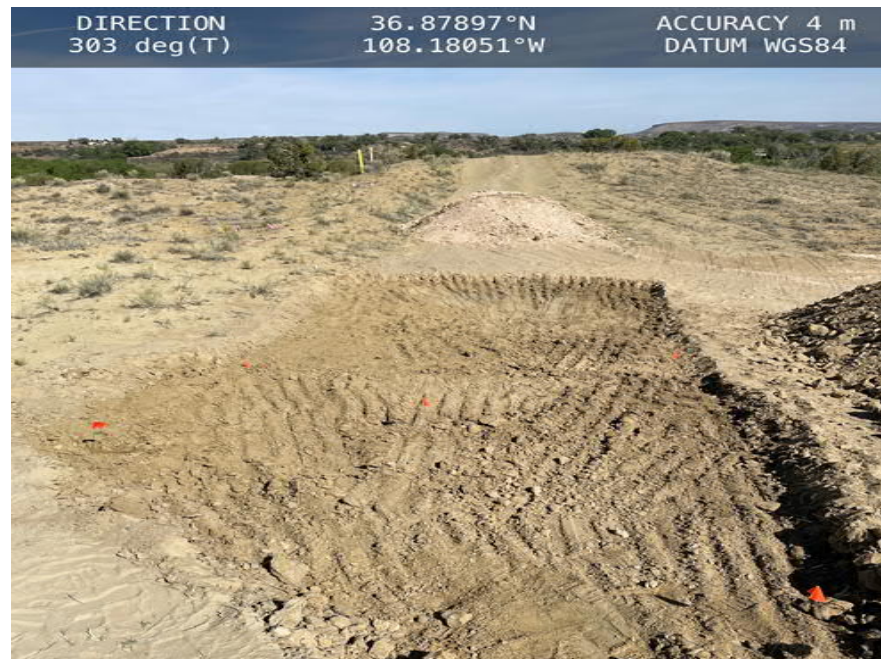
Photograph 12 (dated 6/3/22) – View of Soil Sample Identification S-1 9".

Following agency approval, Hilcorp remediated the Site via dig/haul on May 13, 2022 and a final event on June 3, 2022. During the initial event, this involved using a backhoe to remove the upper 3-6 inches of soil in the ponding area and a roustabout crew to manually remove (i.e. use of shovels) the upper 3 inches of soil along the ephemeral wash. On the final event, a backhoe was used to remove an additional 6 inches of soil at sample points S-1 and S-2 only.

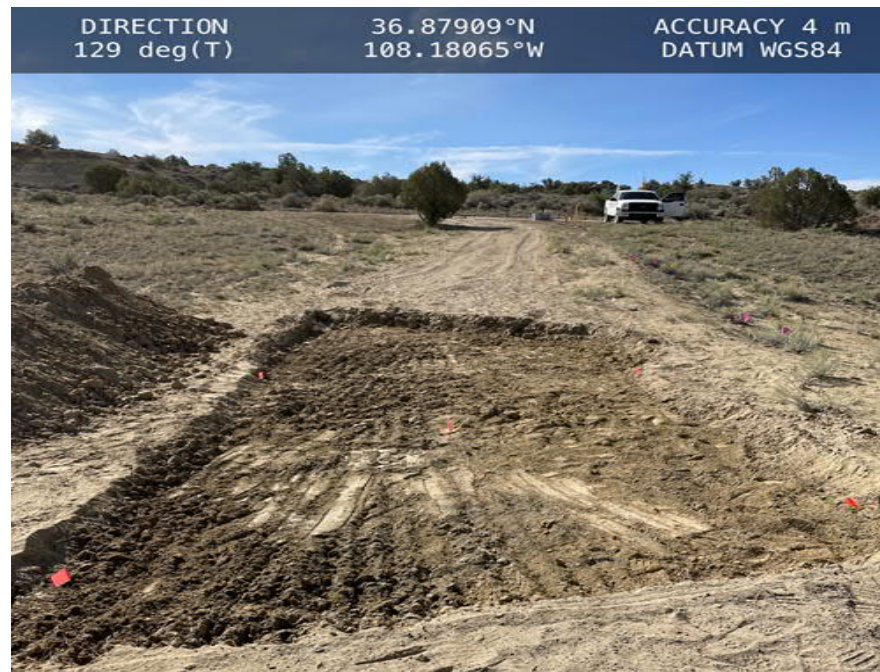
Photograph 13 (dated 6/3/22) – View of Soil Sample Identification S-2 9".

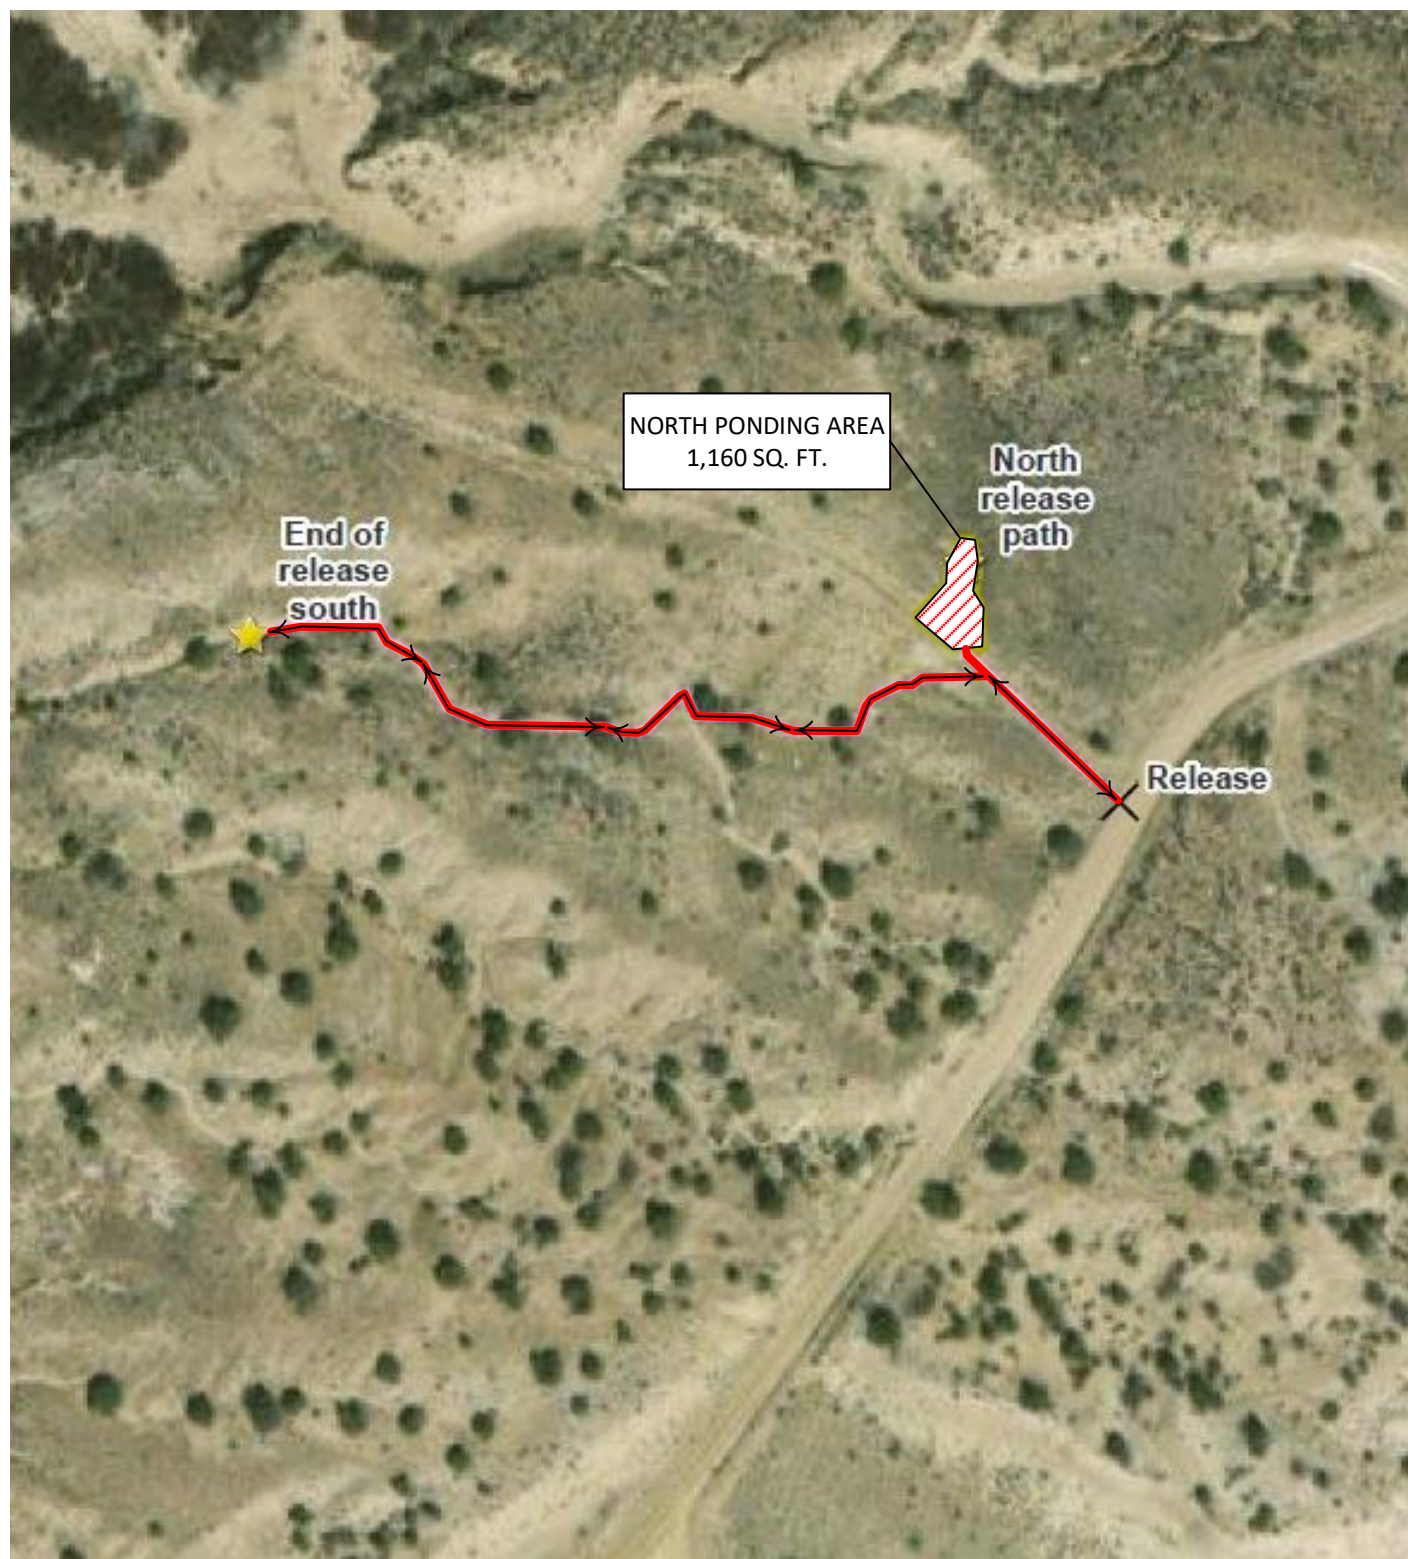
Figure: Proposed Confirmation Sampling

- RELEASE PATH, APPROX. 450 LINEAR FEET
- ↔ CONFIRMATION SAMPLING AREAS, APPROX. 90 LINEAR FEET
