Release Notification

Re: Site Characterization Report and Remediation Work Plan

Sunray B 1B
San Juan County, New Mexico
Hilcorp Energy Company
NMOCD Incident Number: nAPP2212649502

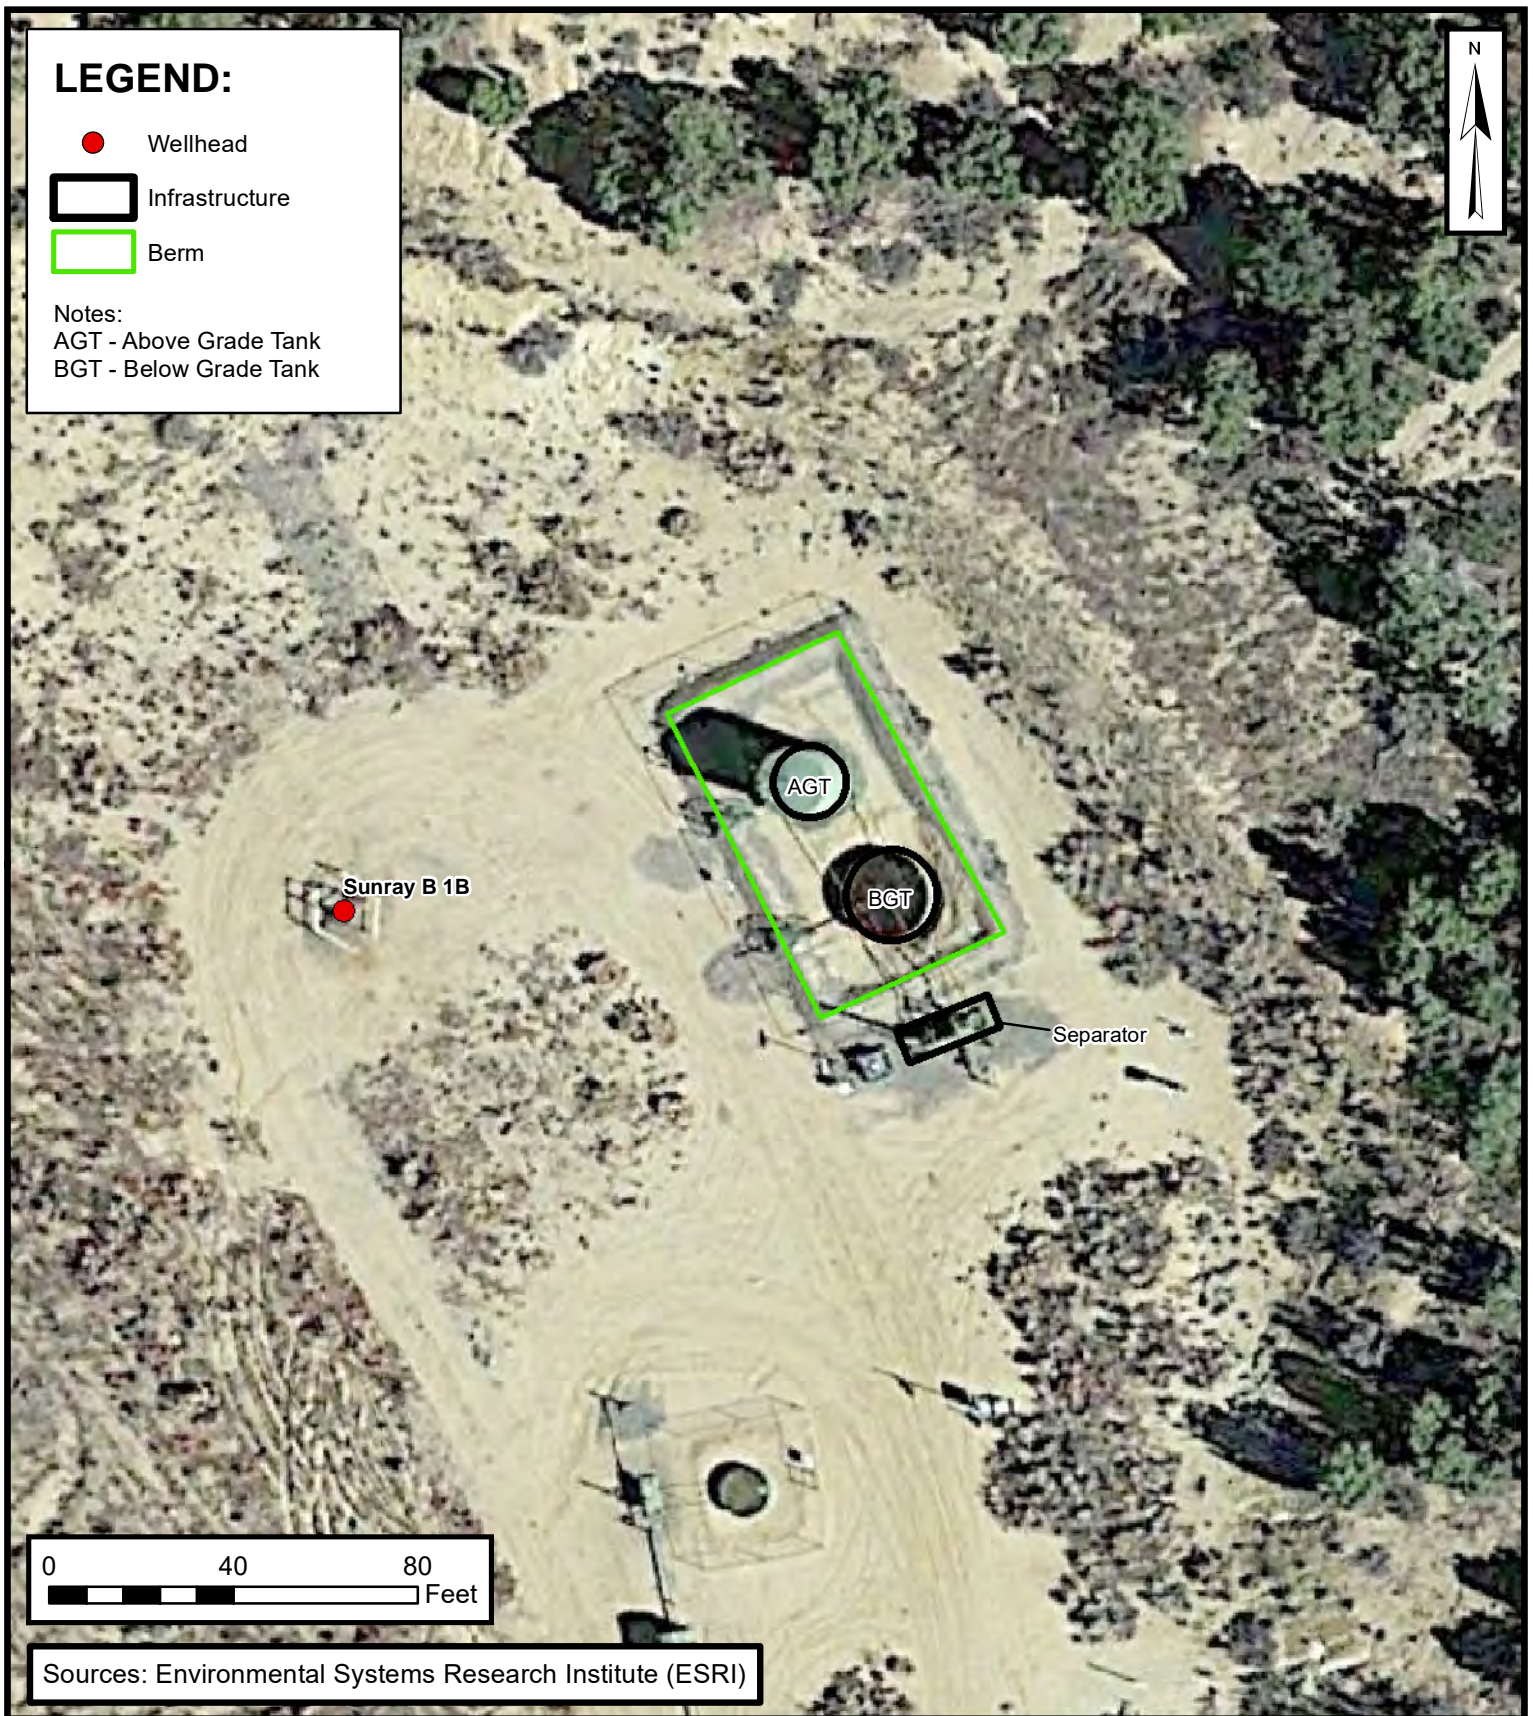
On April 26, 2022, Hilcorp discovered a release of produced water and condensate originating from a 1/8-inch hole in the 300-barrel (bbl) production storage tank at the Site (location shown on Figure 2). The hole appeared to be caused by corrosion of the steel tank. Based on the operator's tank-gauging data and the volume of fluid remaining in the tank, the release is estimated to consist of 7 bbls of produced water (no volume recovered) and 14 bbls of condensate, of which 5 barrels were recovered. All released fluids stayed within the bermed, unlined secondary containment on the production pad. Immediately upon discovery, the operator shut off the oil dump controller and removed the remaining fluids from the production storage tank. Additionally, Hilcorp moved the tank and excavated the top three feet of visually-impacted soil from the Site on April 27 to 29, 2022 in order to remove the petroleum-saturated soil and mitigate further migration of contaminants. Hilcorp submitted the initial Form C-141 to the New Mexico Oil Conservation Division (NMOCD) on May 6, 2022 and the Site was assigned NMOCD incident number nAPP2212649502. Hilcorp also submitted a *Report of Undesirable Event* to the BLM via sundry on May 9, 2022 (Appendix A).

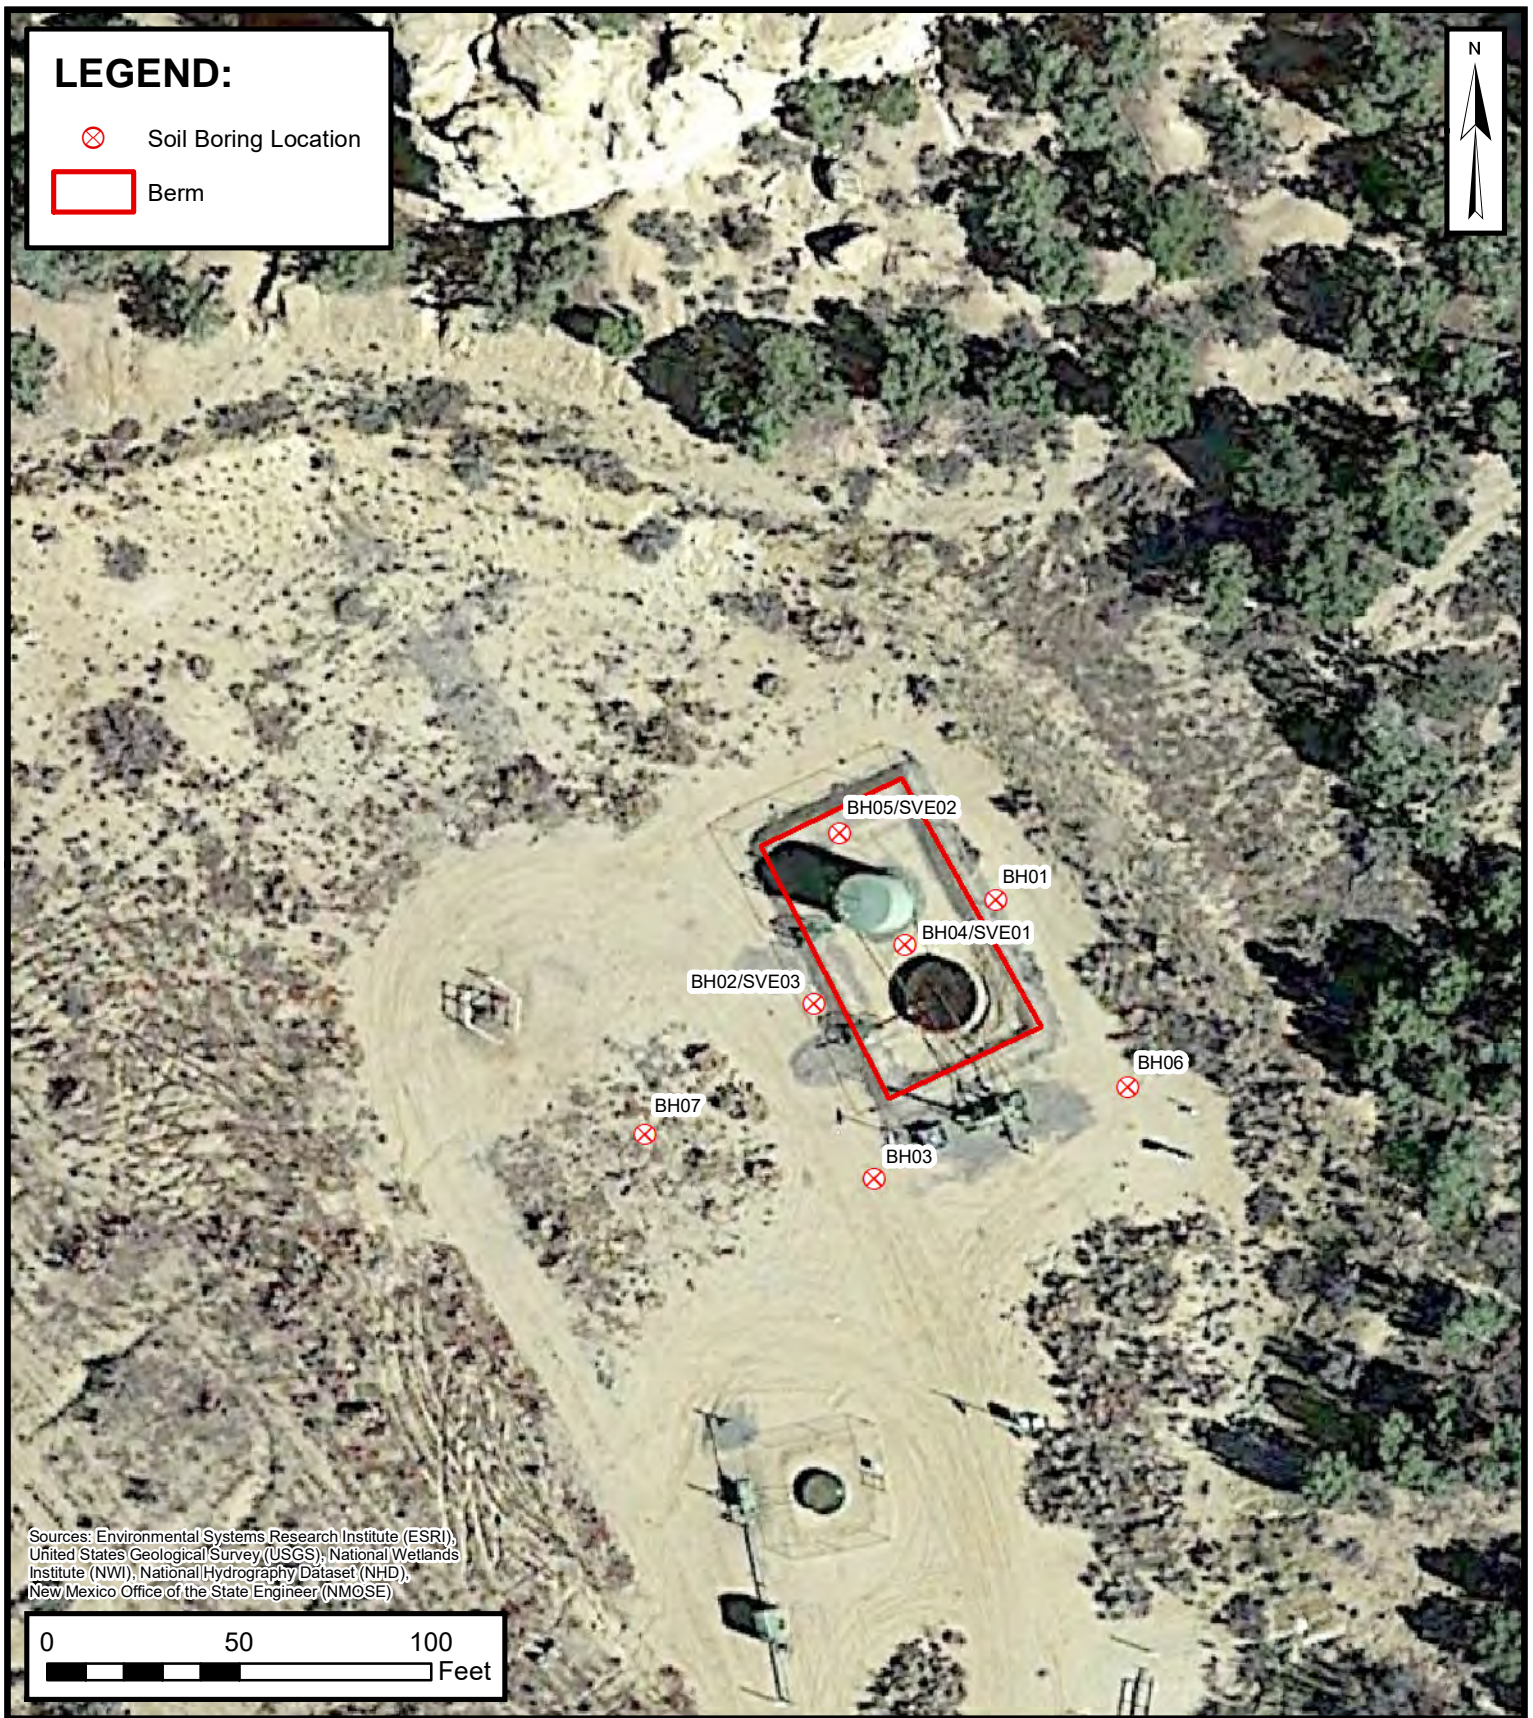
On June 27 and 28, 2022, Hilcorp retained Ensolum to perform delineation activities to identify the horizontal and vertical extent of impacts related to the Site release. Ensolum submitted notice of sampling to the NMOCD 48 hours in advance of the work (Appendix D). Drilling was performed by Enviro-Drill, Inc. using a Central Mining Equipment 75 hollow-stem auger drill rig. Seven borings, BH01 through BH07, were advanced to depths up to 30 feet bgs during this investigation in the locations presented on Figure 5.

Based on field screening during drilling, borings BH04 (SVE01), BH05 (SVE02), and BH02 (SVE03) were completed as SVE wells to be used for future remediation. Screened casing was installed across the subsurface interval with the highest petroleum hydrocarbon impacts based on PID readings in order to direct the applied vacuum to these depth intervals. Well construction details are included on the boring logs attached as Appendix E. SVE wells were constructed with 2-inch diameter Schedule 40 polyvinyl chloride (PVC) casing and 2-inch Schedule 40 PVC 0.010-inch slotted screen. Wells were completed with 10-20 silica sand pack to 3 feet above the screened interval, then hydrated bentonite seal to the ground surface. SVE well locations are indicated on Figure 5.

Ensolum recommends performing a SVE pilot test to evaluate the effectiveness of SVE for the Site and, if applicable, assess the Site-specific flow and vacuum rates required to volatilize and remove contaminants from the impacted subsurface. Data collected during the SVE pilot test will be used to estimate the system's radius-of-influence (ROI) and radius-of-effect (ROE) to determine well spacing and the need for additional SVE wells at the Site.

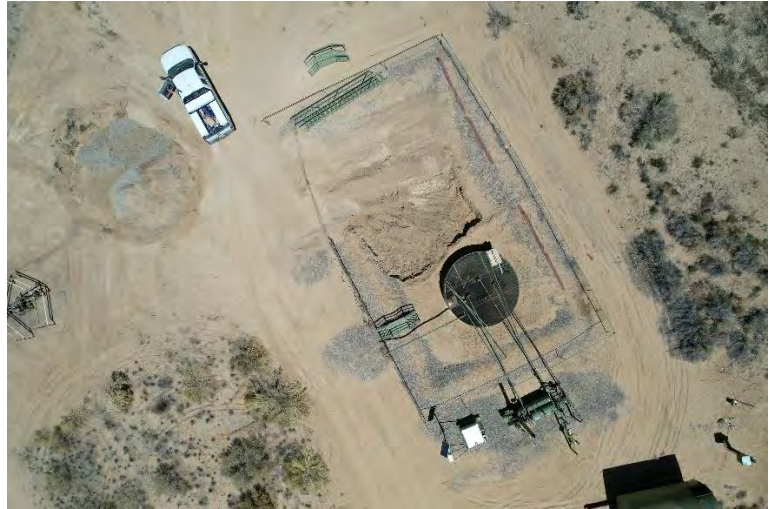
Photograph 3

Aerial view of the Site showing the initial excavation performed by Hilcorp immediately following discovery of the release
