Release Notification

Cooter 16 State 5H	Production Battery
Date Release Discovered 1/7/2017	API# (if applicable) 30-015-37875

Devon Energy Cooter 3&5H CTB Remediation PHOTO DOCUMENTATION

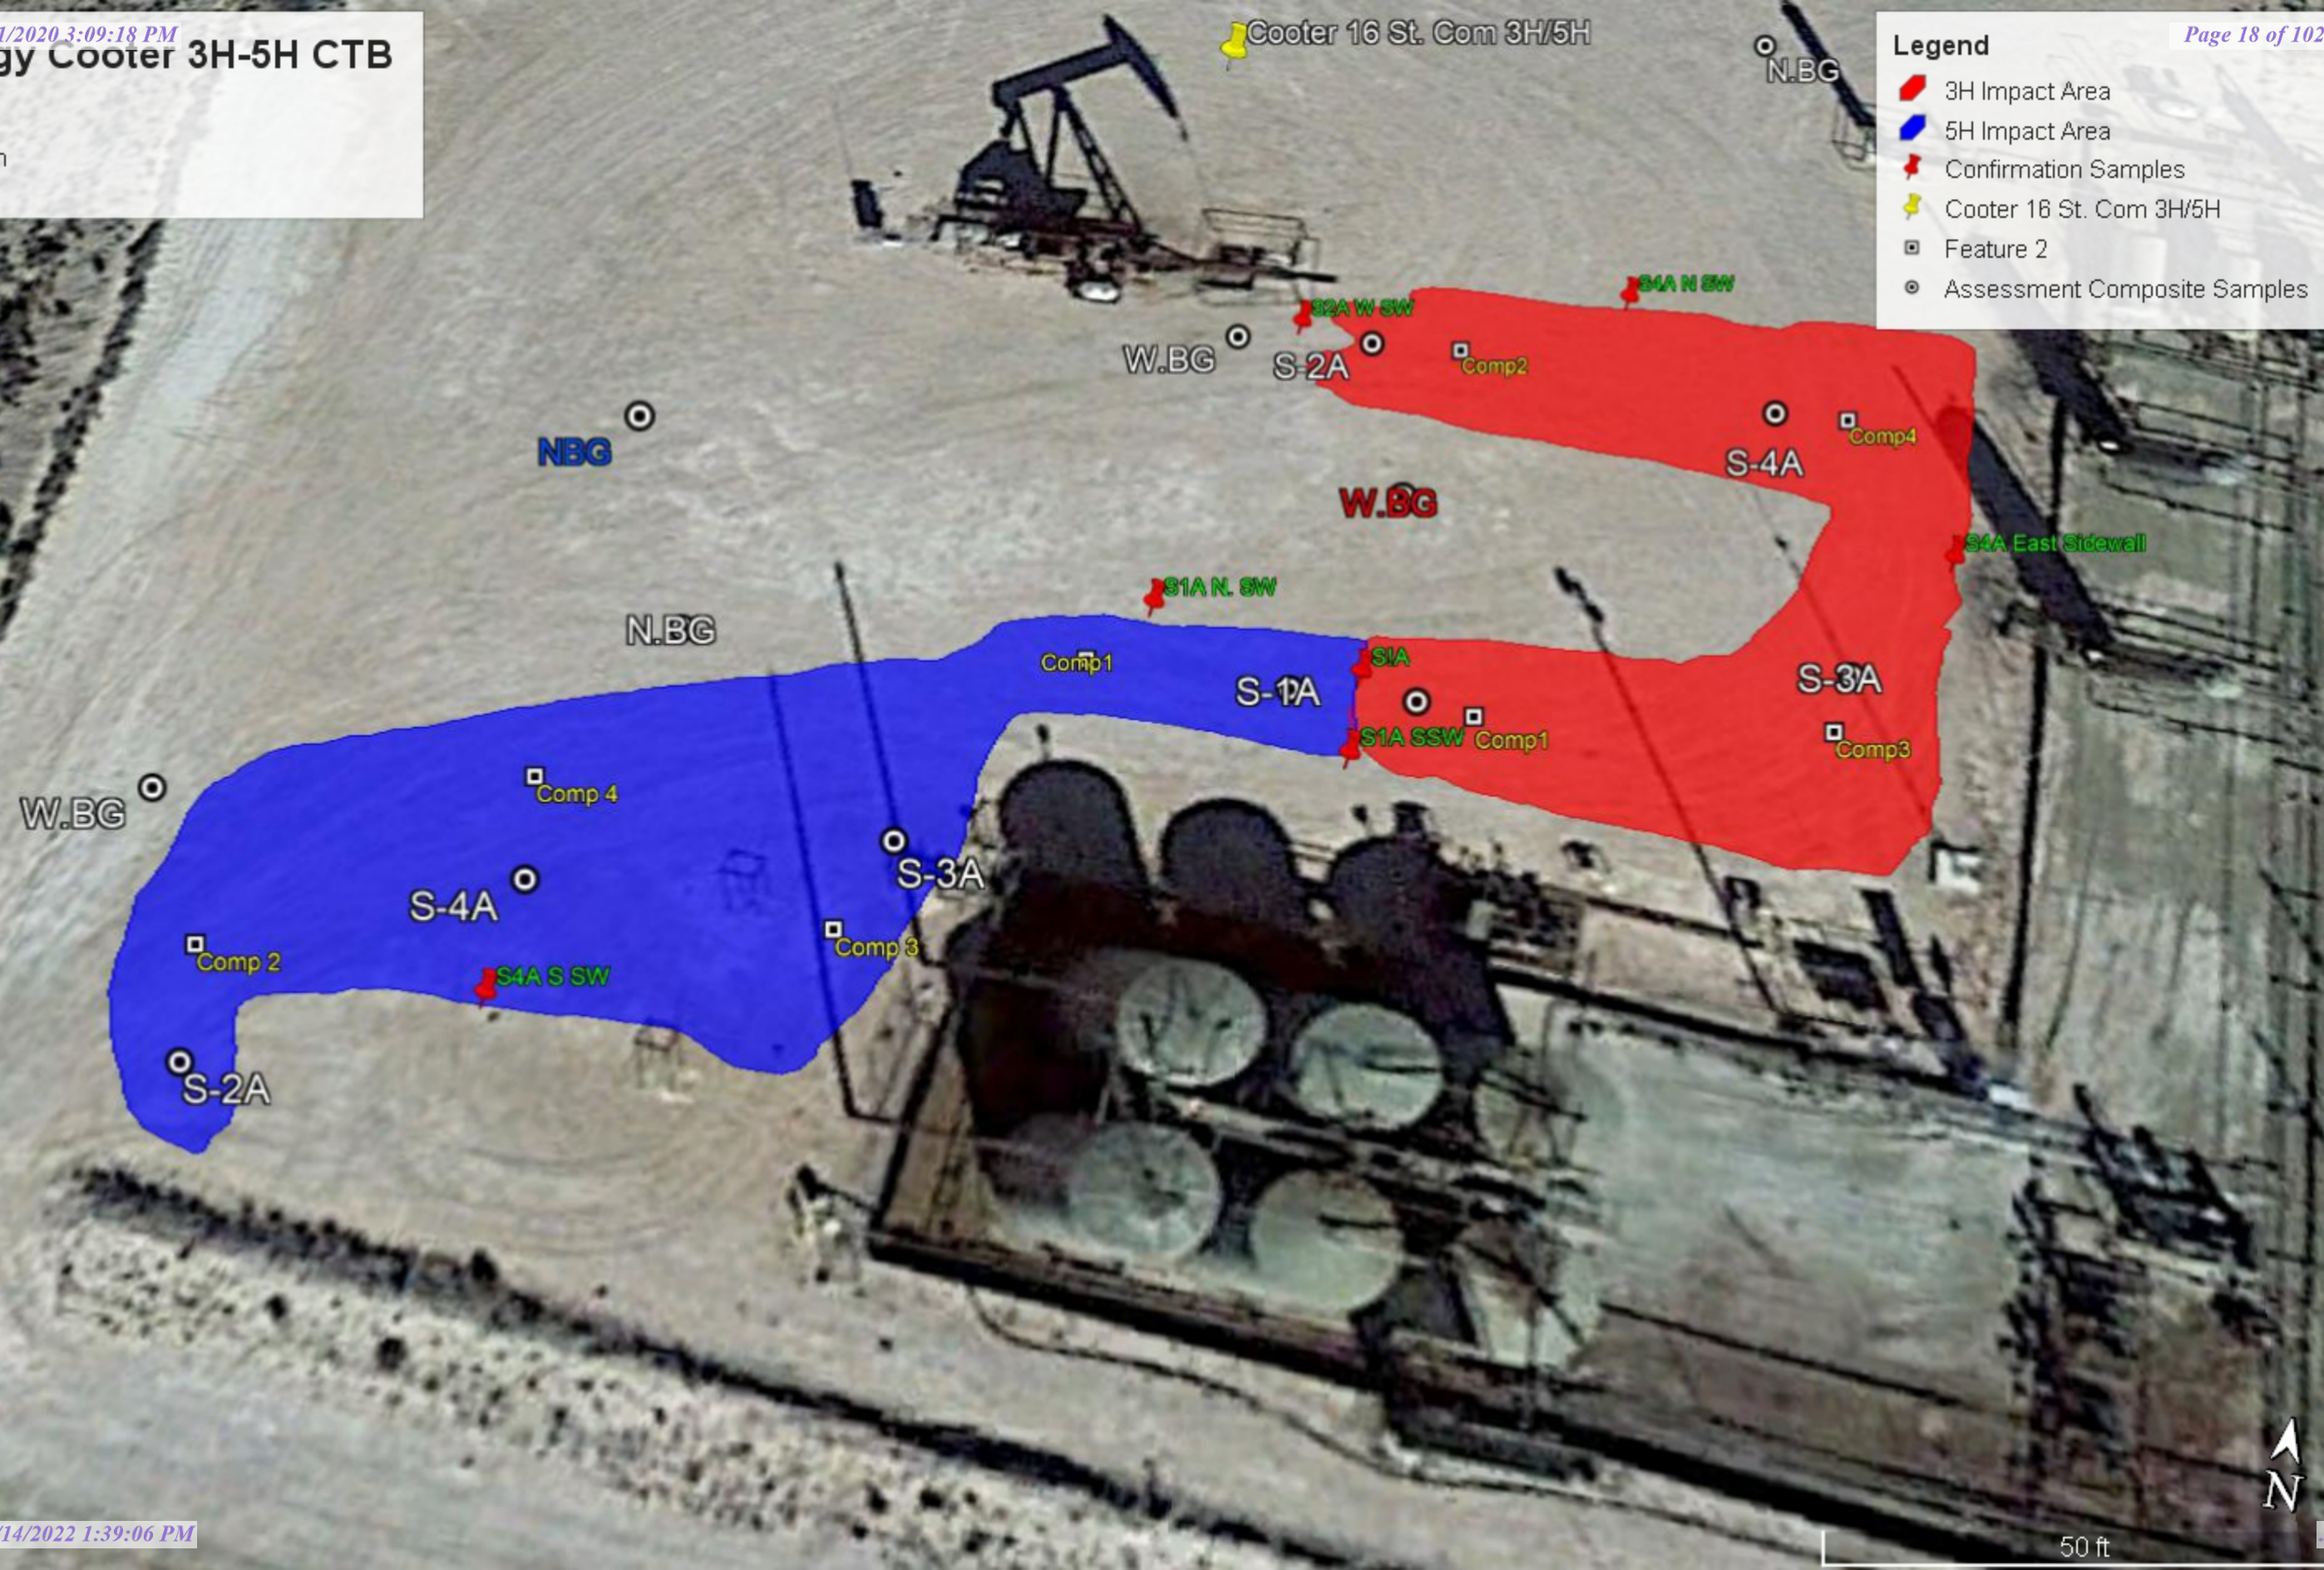
- 3H Impact Area
- 5H Impact Area
- Confirmation Samples
- Cooter 16 St. Com 3H/5H
- Feature 2
- Assessment Composite Samples

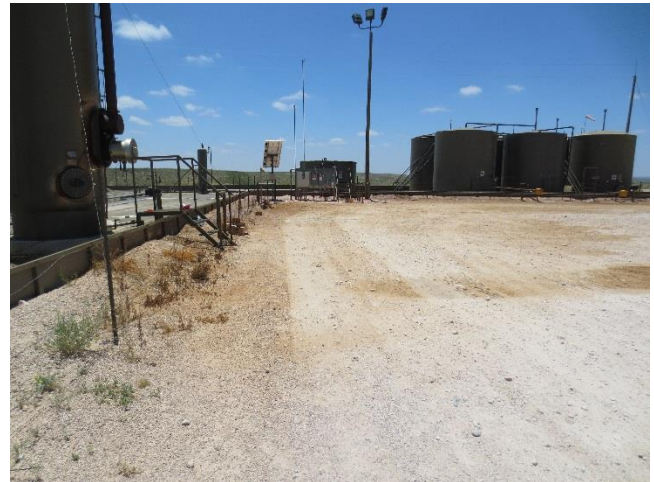
06-23-15 Spill area East side of pad

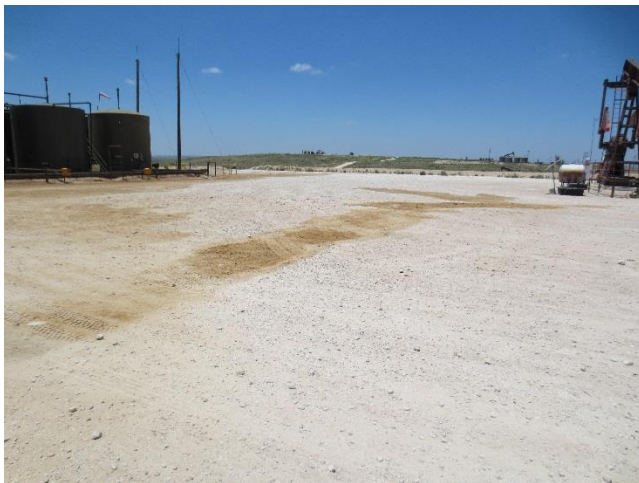
06-23-15 Spill run looking SW

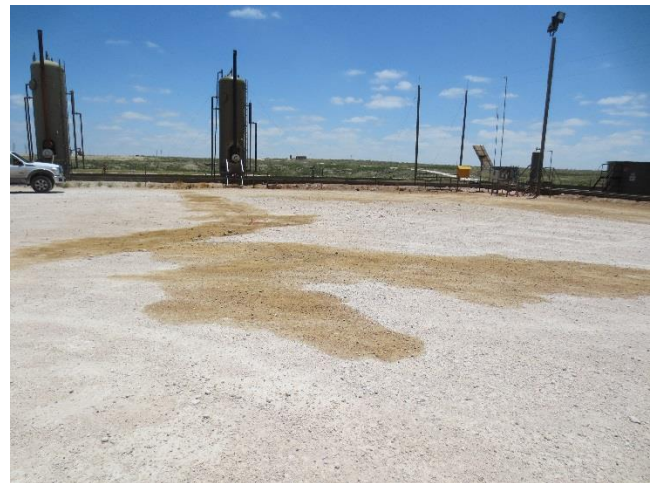
06-23-15 Spill Run Looking East

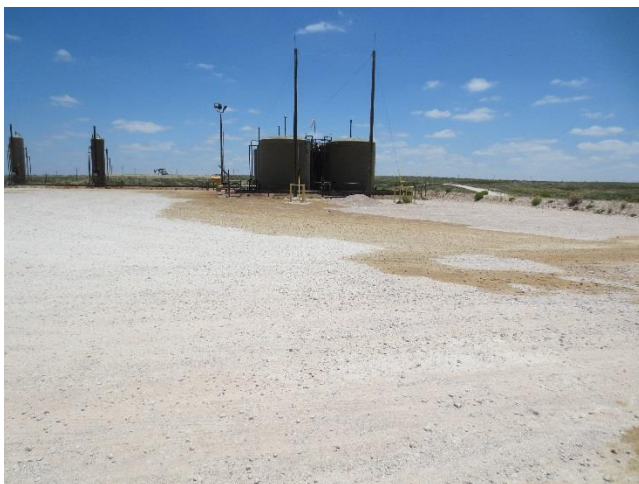
06-23-15 Western Extent of Spill Run

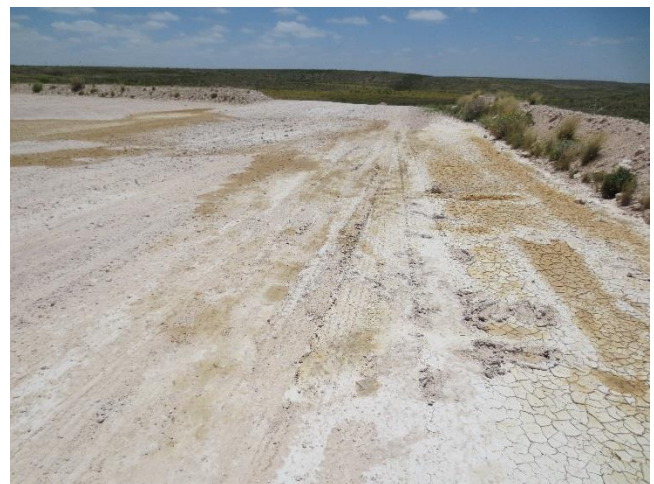
06-23-15 Spill Run West side of Battery

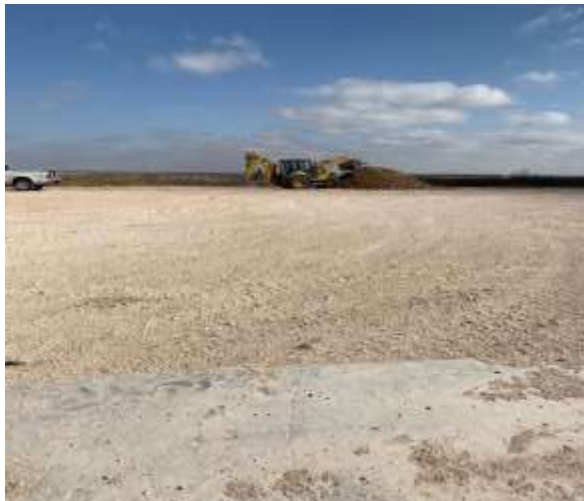
South Side 5H

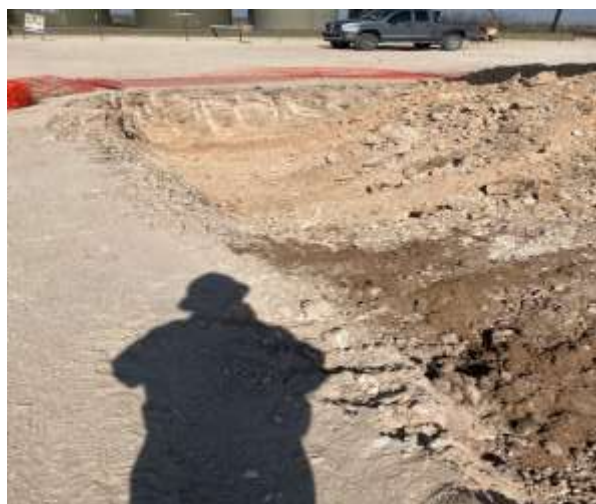
Near Well Head 3H

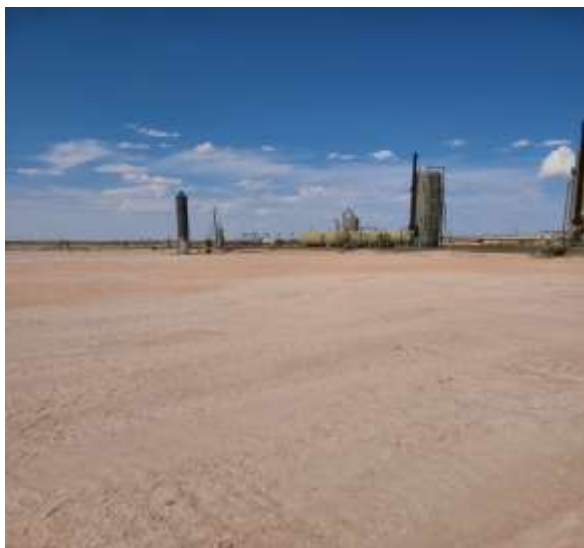
Backfilled to Grade
