# Closure Report

Site Name:	Oxy USA
Company:	Simpson CDM Com #1H CTB
Legal Description:	U/L A, Section 29, T21S, R27E
County:	Eddy County, NM
GPS Coordinates:	N 32.45662 W-104.20454

Date of Release:	04/23/2017
Type of Release:	Produced water
Source of Release:	3 inch steel water line
Volume of Release:	40 bbls
Volume Recovered:	35 bbls

Remediation Parameters:	Excavate the entire leak area to a depth of 2.5 feet. Backfill the site with clean soil.	
Remediation Activities:	04/26/2018 to 05/07/2018	
Plan Sent to OCD:	09/11/2017	Email from Cliff Brunson to Mike Bratcher
OCD Approval of Plan:	09/20/2017	Email from Mike Bratcher to Cliff Brunson
Plan Sent to BLM:	n/a	n/a
BLM Approval of Plan:	n/a	n/a

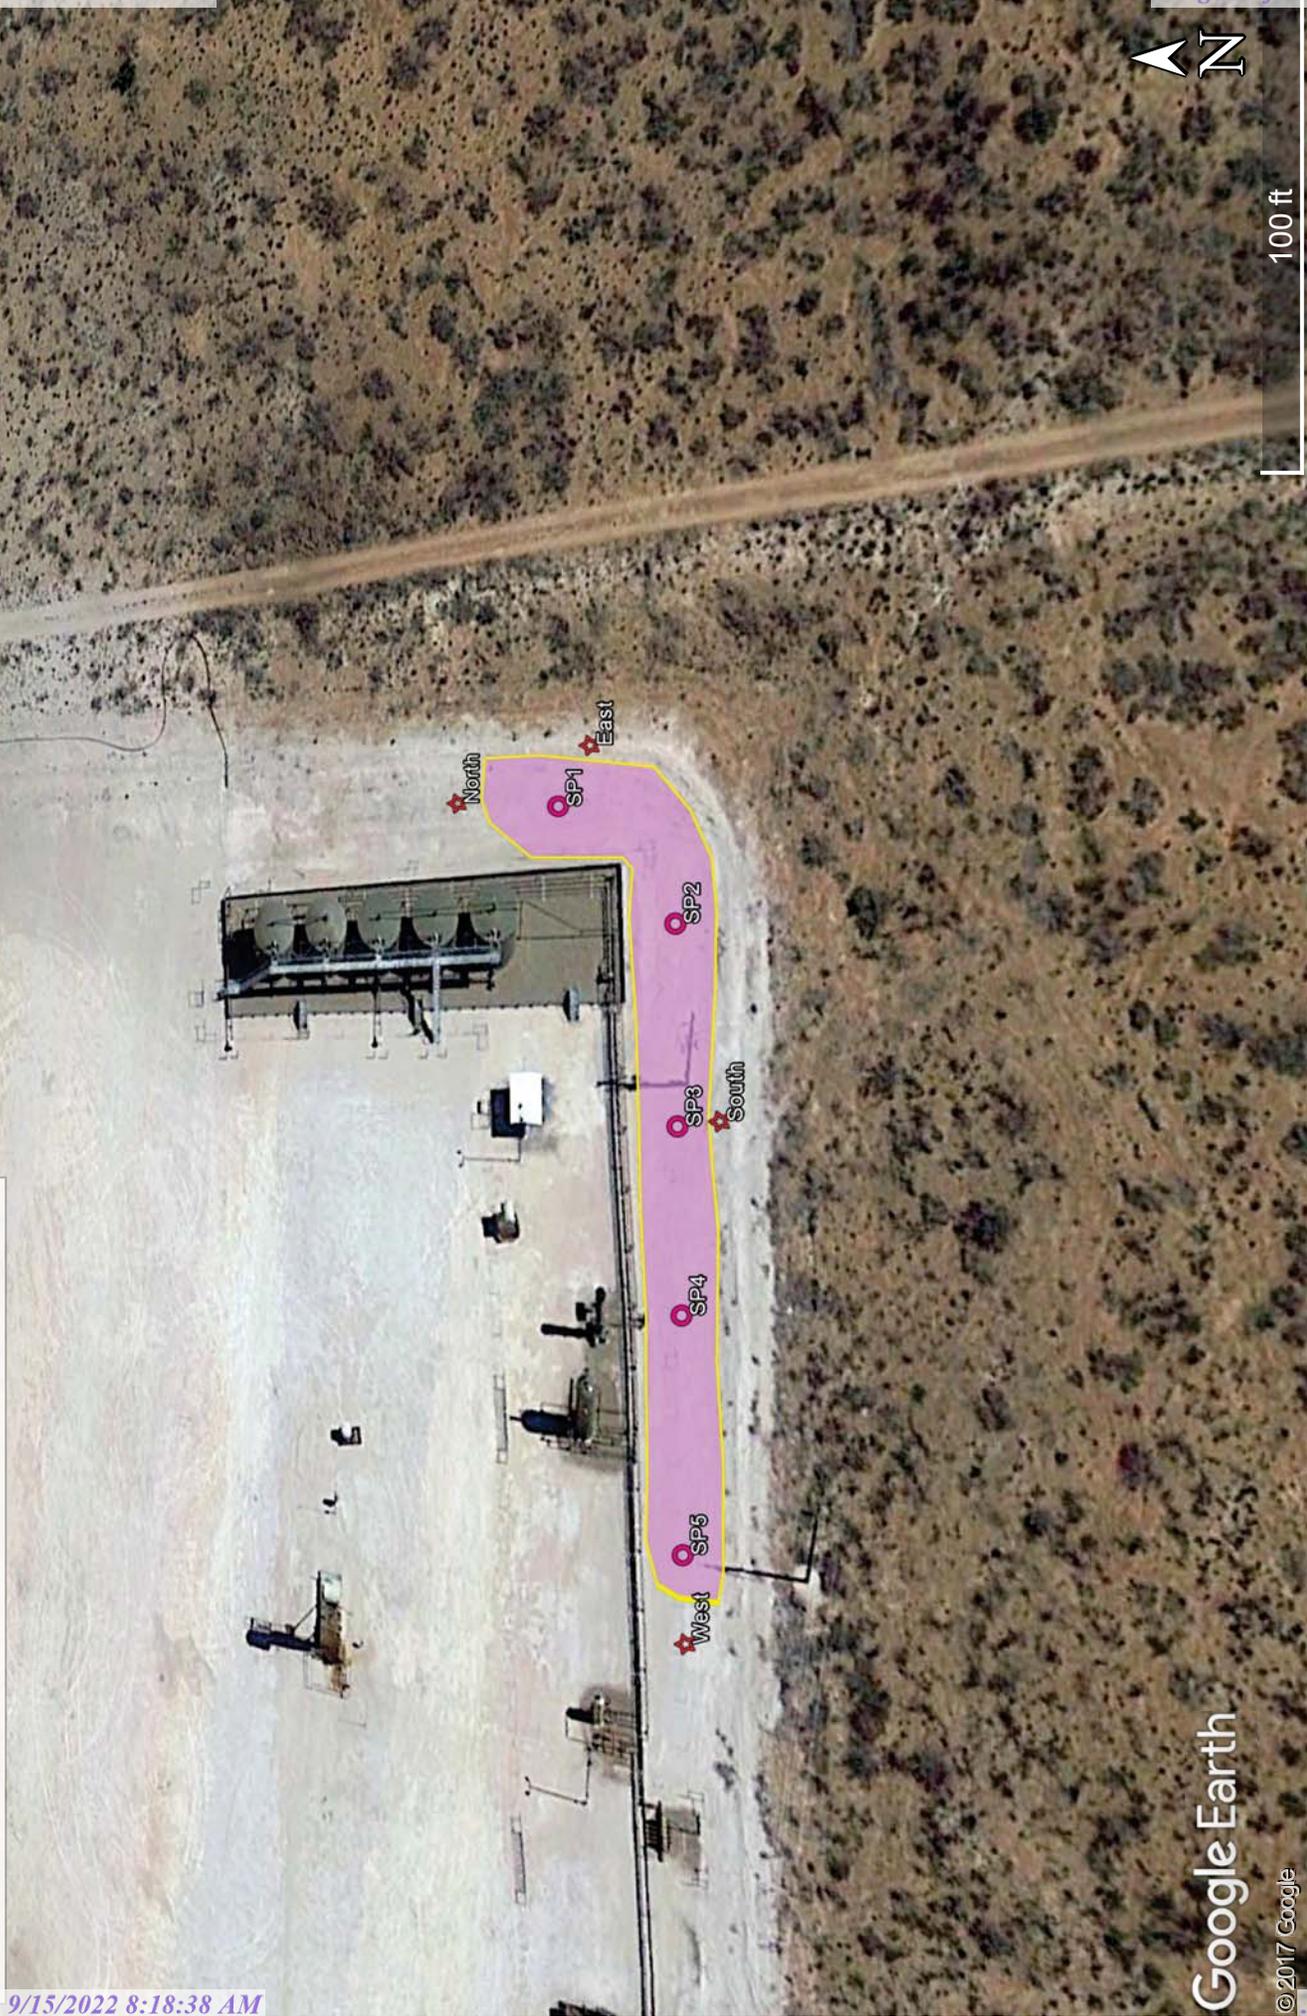
# Oxy, Simpson CDM Com #1H CTB

Leak date: 04/23/2017  
Eddy County, NM  
API# 30-015-42012  
2RP-4188

- ☆ Cardinal sample points, hand auger
- ◻ Leak Area, 2.5' Excavation
- Sample points, hand auger

Oxy, Simpson CDM Com #1H CTB

Sample points, hand auger

SP1, N 32.45667 W-104.20382

SP2, N 32.45658 W-104.20392

SP3, N 32.45658 W-104.20408

SP4, N 32.45658 W-104.20423

SP5, N 32.45658 W-104.20442

NORTH, N 32.45676 W-104.20381

SOUTH, N 32.45654 W-104.20407

EAST, N 32.45665 W-104.20377

WEST, N 32.45657 W-104.20449
