SITE REMEDIATION AND CLOSURE REPORT

Strata Production Company

Paloma St. #1

Incident ID No. NAPP2127345557

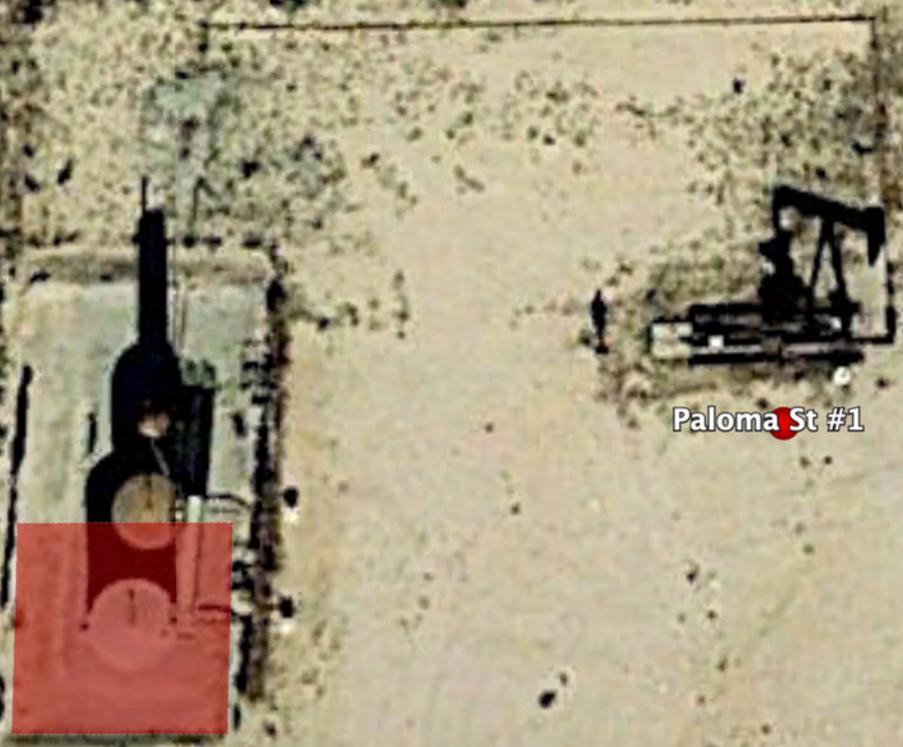
Paloma St #1
API 30-025-31153
Lea County, NM
Site Map

The produced water tank had an equipment failure from a connection, resulting in the release of 58 bbls of produced water. The release was contained in the earthen bermed with poly-lined containment. A vacuum truck was dispatched to aid in the recovery of the fluids.

Spill Area

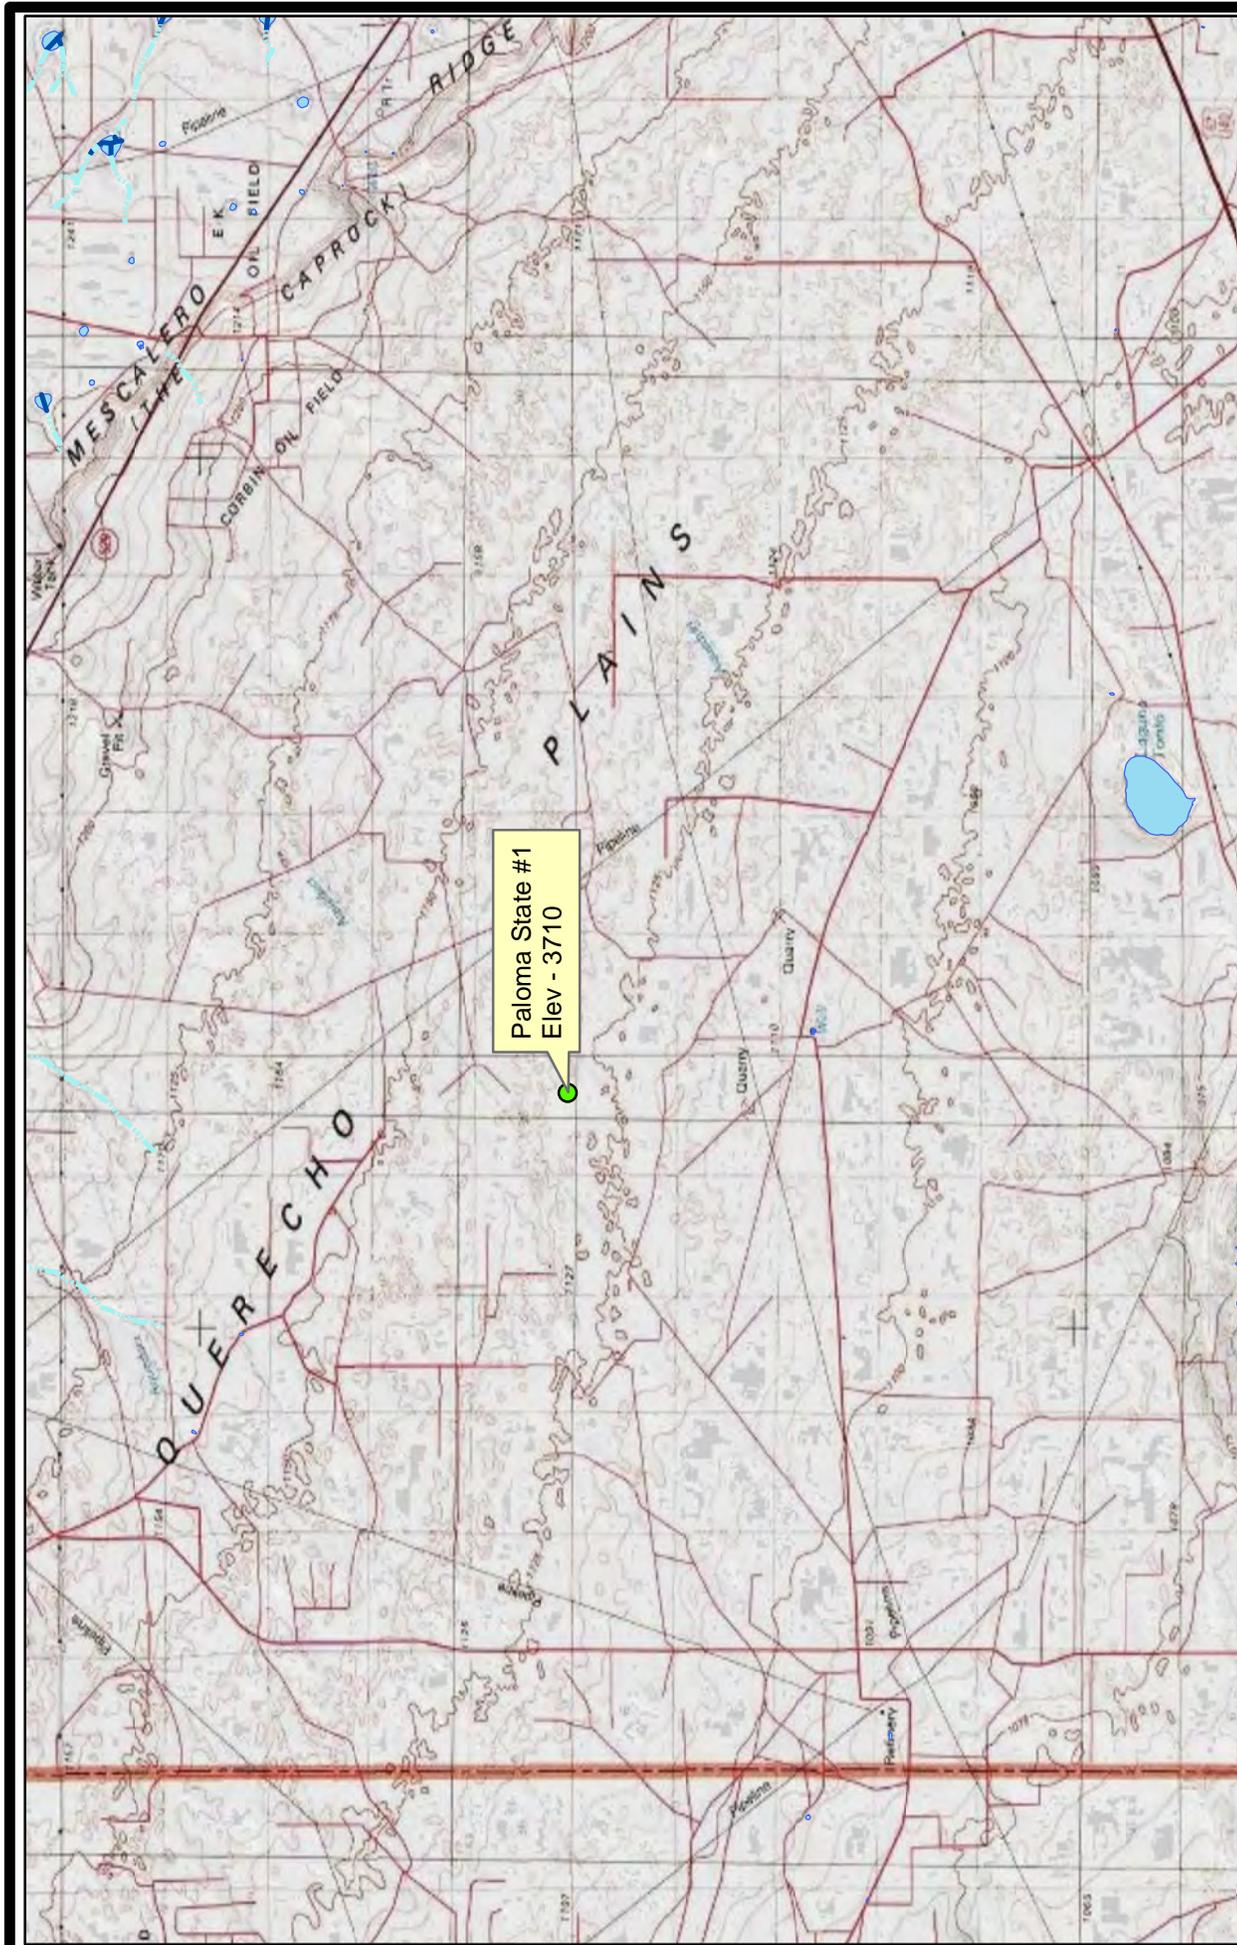
Plate 2

Groundwater Elevation Map

Paloma State #1
Elev - 3710

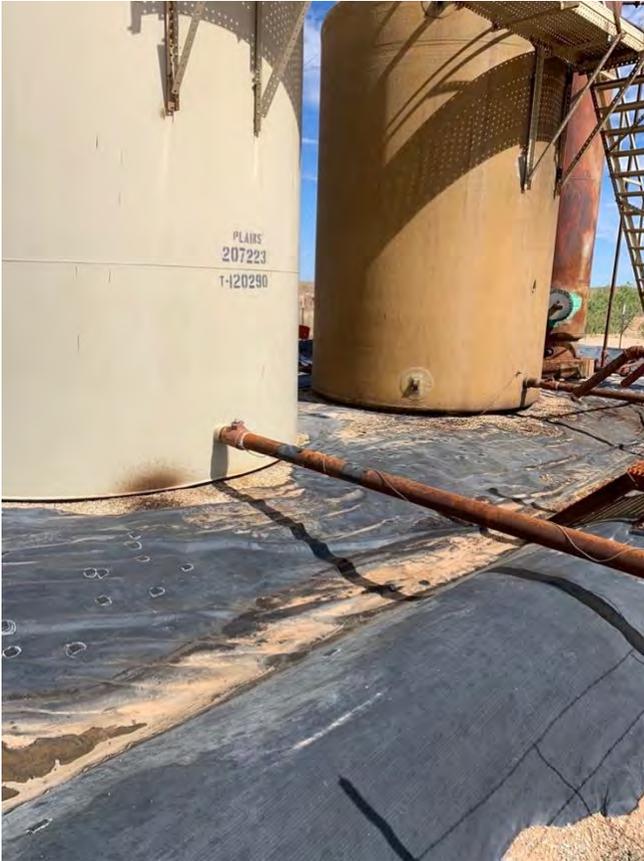
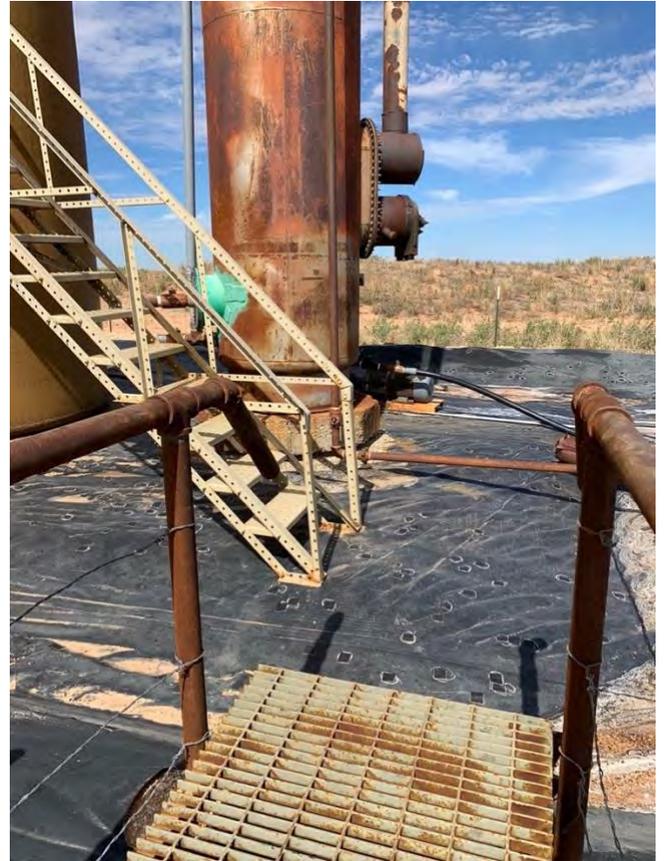
Photographic Documentation

Visualization	Yes	No	Comments
Is there a tear in the liner?		x	
Are there holes in the liner?		x	
Is the liner retaining any fluids?		x	
Does the liner have integrity to contain a leak?	x

Paragon was brought in later to complete this project. On 6/16/22, Paragon notified the NMOCD that we would be conducting a liner inspection on 6/20/22 (Appendix D). There were no rips or tears that needed to be repaired prior to this event. Nothing major was found other than the usual wear from the pea gravel. The liner is in good condition and does not require any repairs (Appendix E). We also hauled off the excavated material and left the liner exposed for easy cleanup and access for any future incident.

Based on the liner inspection results, it was determined that the unaccounted fluid loss was absorbed within the caliche and pea gravel that had been removed.
