**Re: Site Remediation and Closure Report
Beetlejuice 19 Federal #003H
API No. 30-015-39321
GPS: Latitude 32.65251 Longitude -103.91257
UL "C", Sec. 19, T19S, R31E
Eddy County, NM
NMOCD Ref. No. NAB1734038480 (2RP-4511)**

Pima Environmental Services, LLC (Pima) has been contracted by Devon Energy Production Company (Devon) to perform a spill assessment and remediation activities for a fire/produced water release that occurred at the Beetlejuice 19 Fed #3H (Beetlejuice). The initial C-141 was submitted on December 1st, 2017 (Appendix C). This incident was assigned Incident ID NAB1734038480 (2RP-4511), by the New Mexico Oil Conservation Division (NMOCD).

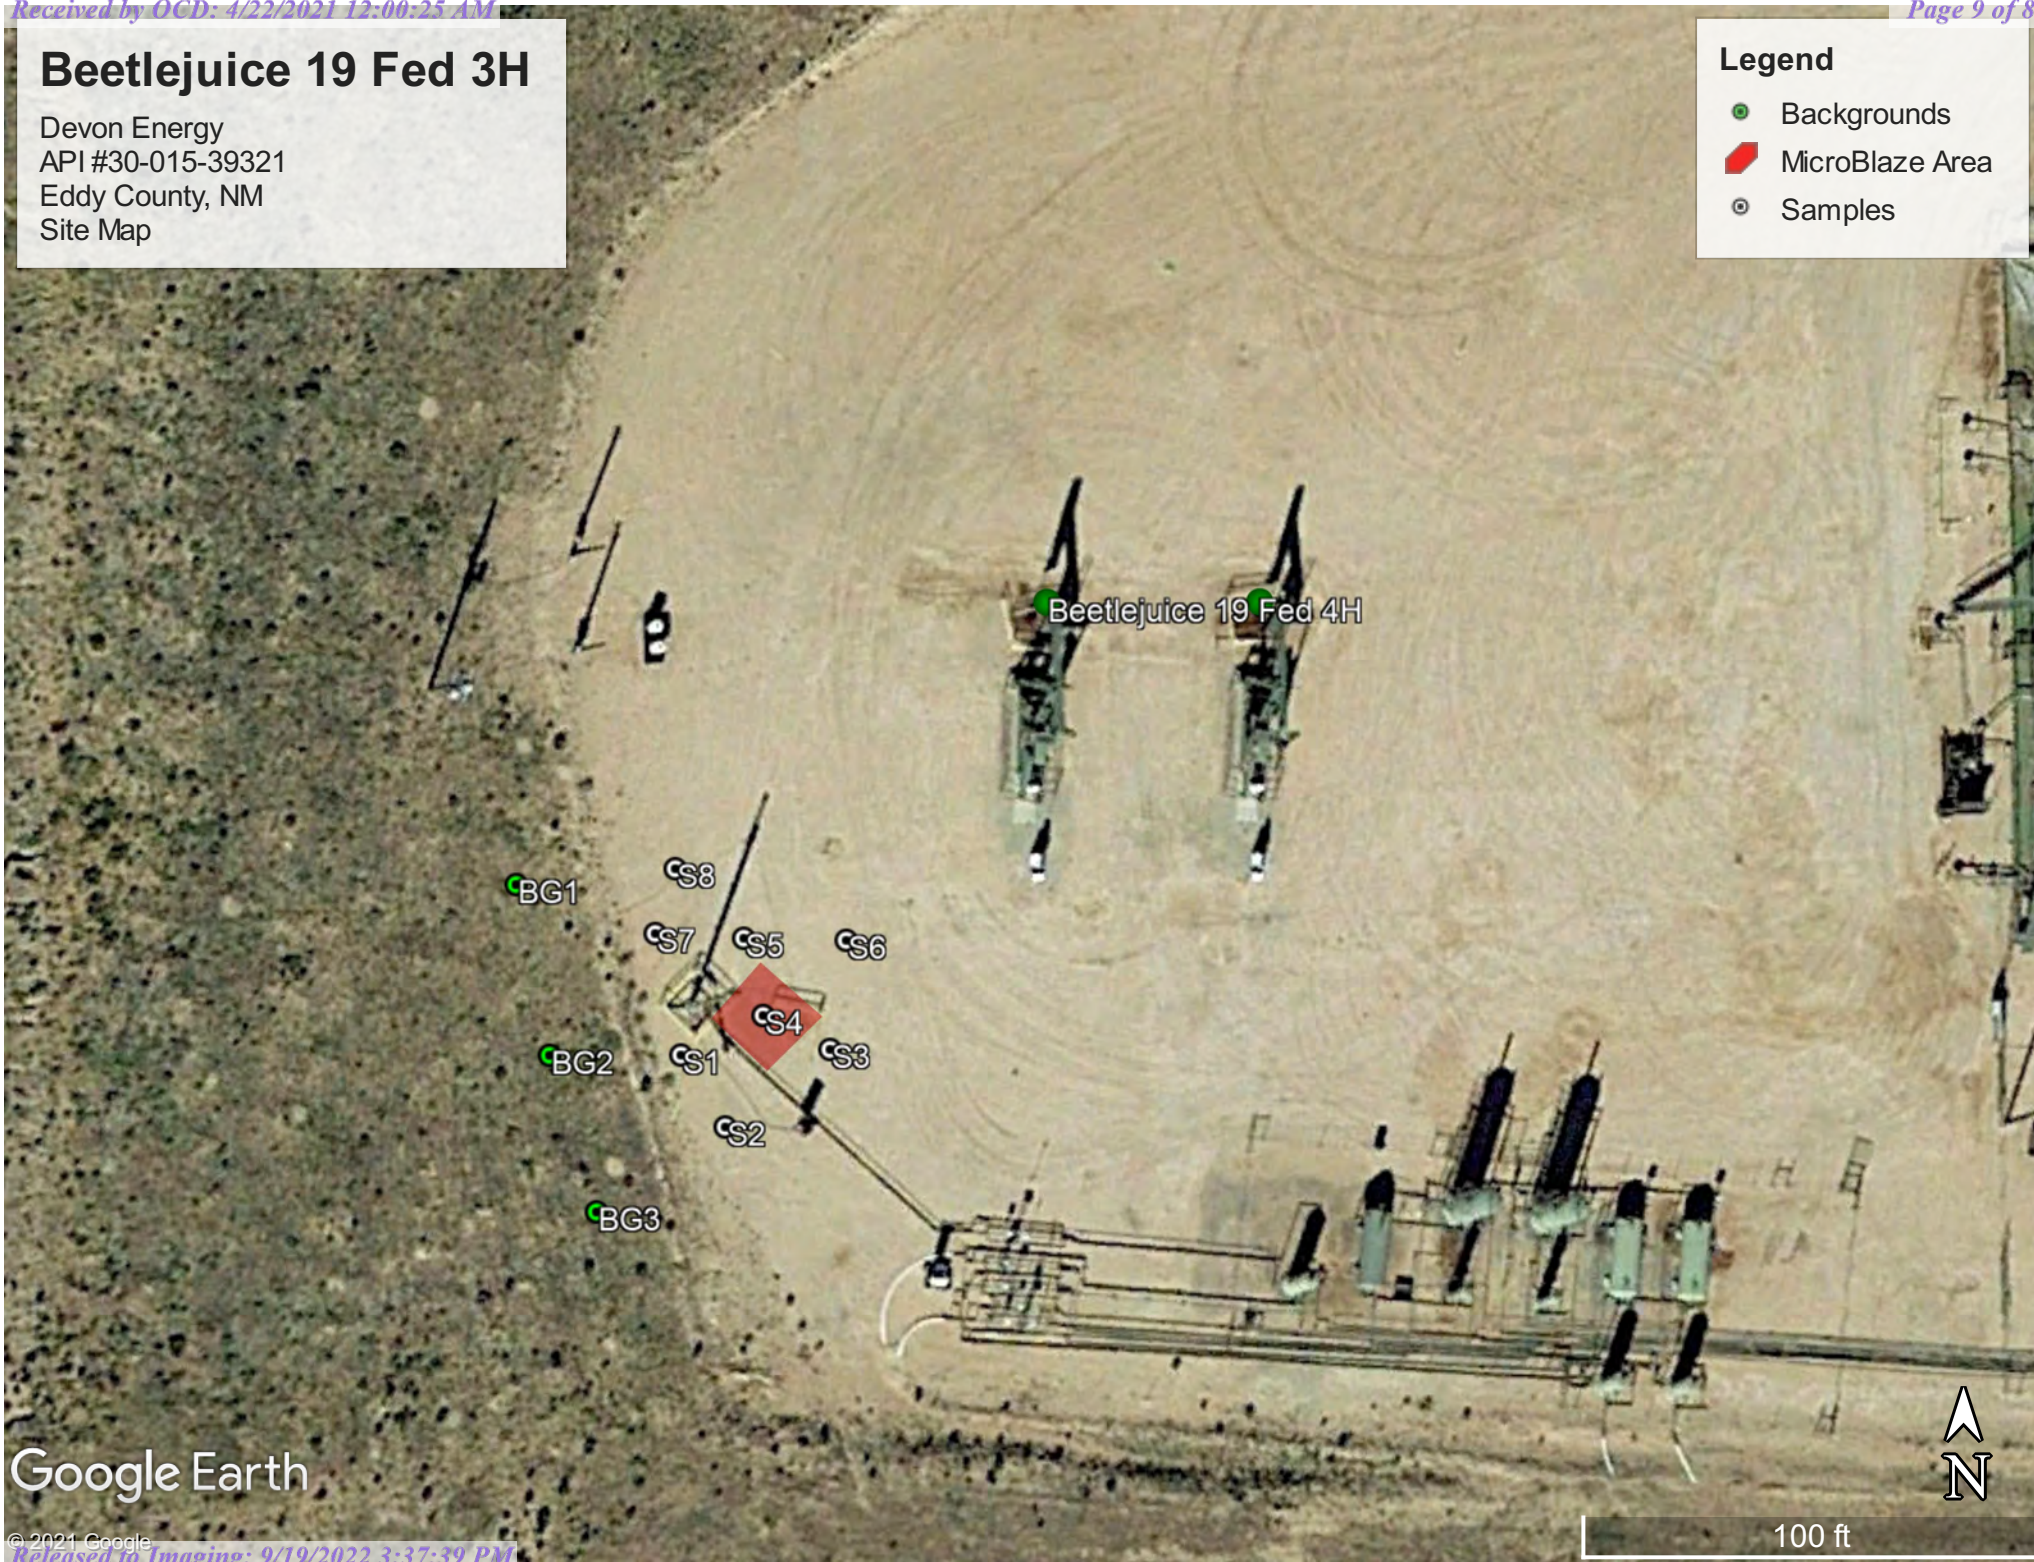
Devon Energy
API #30-015-39321
Eddy County, NM
Site Map

On August 19th, 2020, Pima mobilized personnel and equipment to conduct remedial activities. We treated the area in the vicinity of S-4, just east of the flare, with a bioremediation chemical solution. Photographic documentation can be found in Appendix D.

- Backgrounds
- MicroBlaze Area
- ⊙ Samples
