Release Notification and Corrective Action

Name of Company: BOPCO, L.P. 260737	Contact: Tony Savoie
Address: 522 W. Mermod, Suite 704 Carlsbad, N.M. 88220	Telephone No. 575-887-7329
Facility Name: JRU-29 SWD Tank Battery	Facility Type: SWD

FIGURE 2
EXCAVATION SOIL SAMPLE LOCATIONS
JAMES RANCH UNIT 29 SWD
UNIT K SEC 36 T22S R30E
EDDY COUNTY, NEW MEXICO
XTO ENERGY, INC.

JRU 29 SWD Tank Battery
Eddy County, New Mexico
Photographs Taken: July 2018 through March 2020

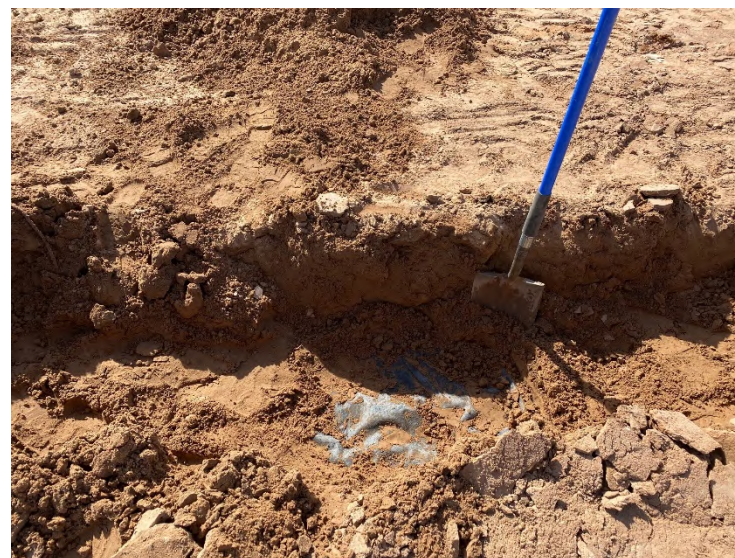
Photograph 4: Previously installed liner near SP-4 exposed.

- Replaced the liner in the area around test trench SP-4.
- Excavated pasture soils to a depth of 4 feet bgs.
- Collected confirmation soil samples from the sidewalls of the excavation from a depth of 2 feet bgs.

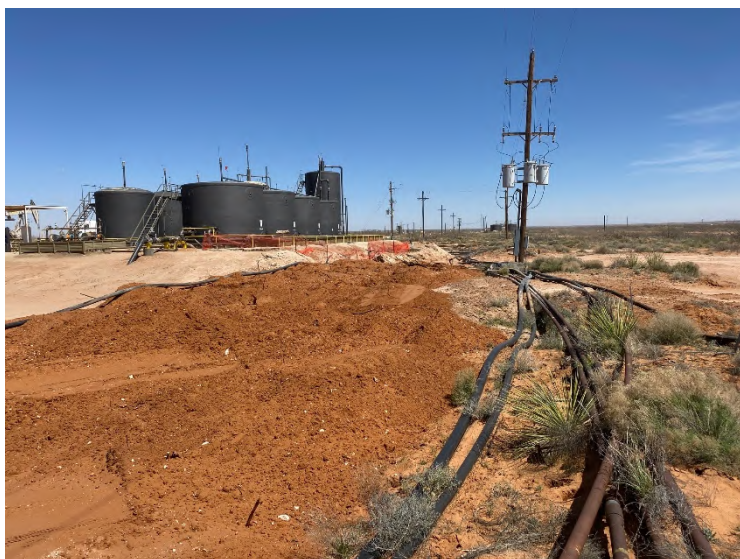
Photograph 7: East facing view during backfilling activities.
