## Release Notification and Corrective Action

## XTO JRU 29 SWD

2RP-2766, 2RP-3082, 2RP-3302,  
2RP-3726 & 2RP-4040

JRU 29 SWD Tank Battery  
Eddy County, New Mexico  
Photographs Taken: July 2018 through March 2020

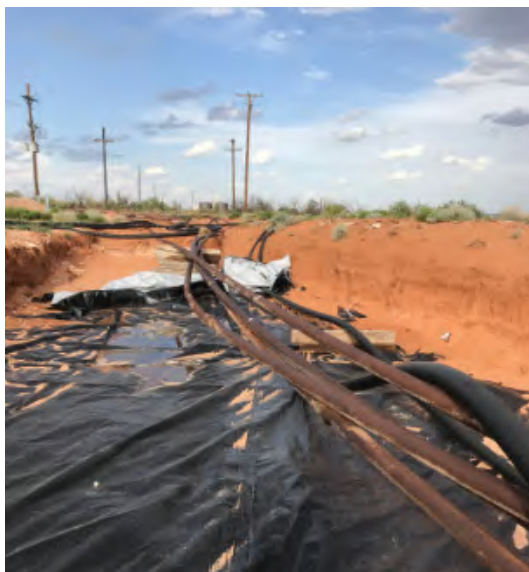
**Photograph 1:** East facing view of open excavation.

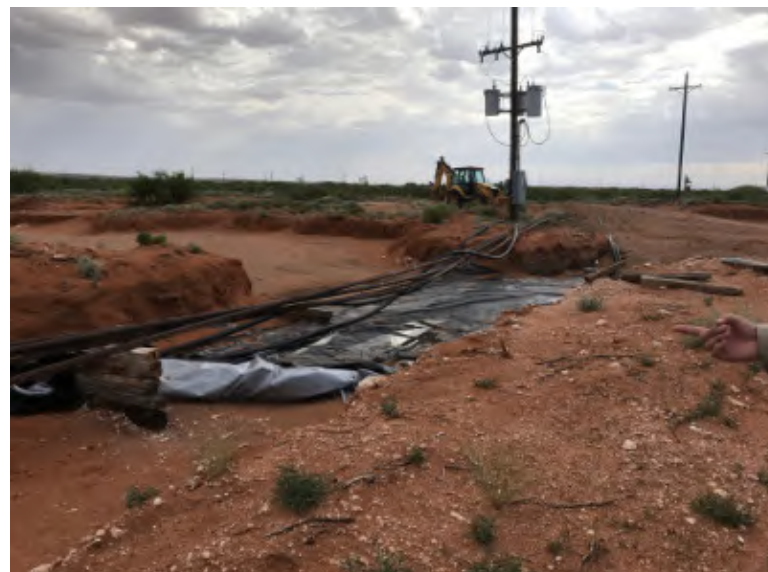
**Photograph 2:** West facing view of open excavation.

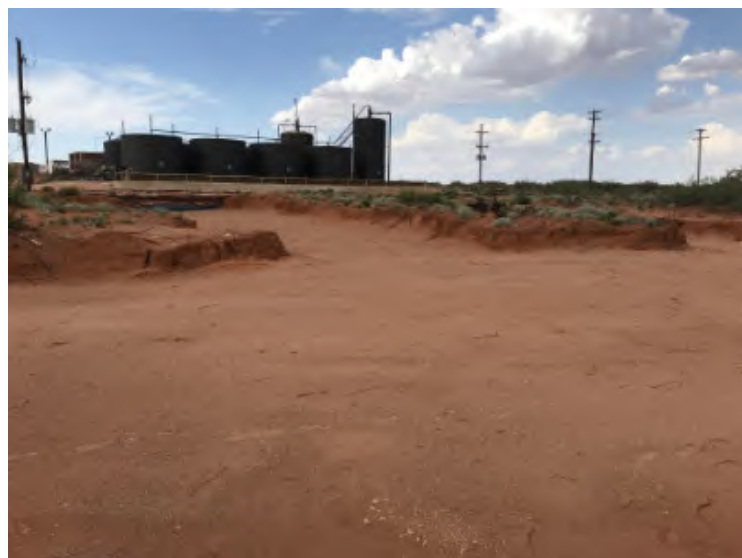
**Photograph 3:** North facing view of open excavation

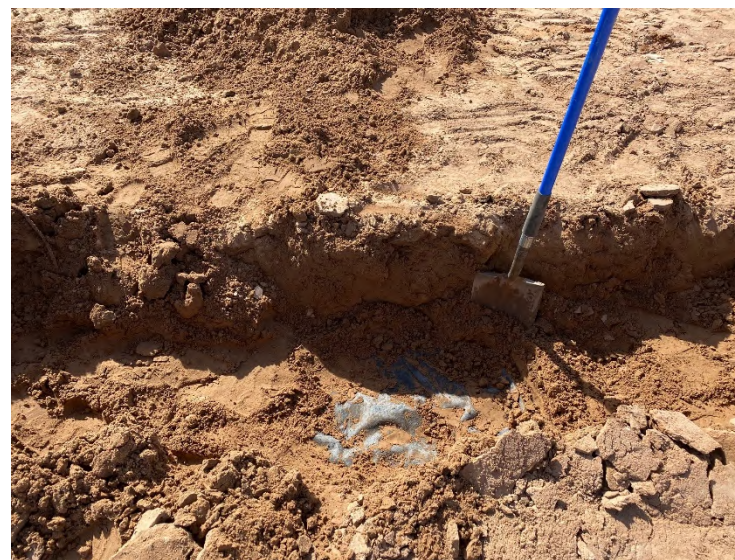
**Photograph 4:** Previously installed liner near SP-4 exposed.

- Replaced the liner in the area around test trench SP-4.
- Excavated pasture soils to a depth of 4 feet bgs.
- Collected confirmation soil samples from the sidewalls of the excavation from a depth of 2 feet bgs.

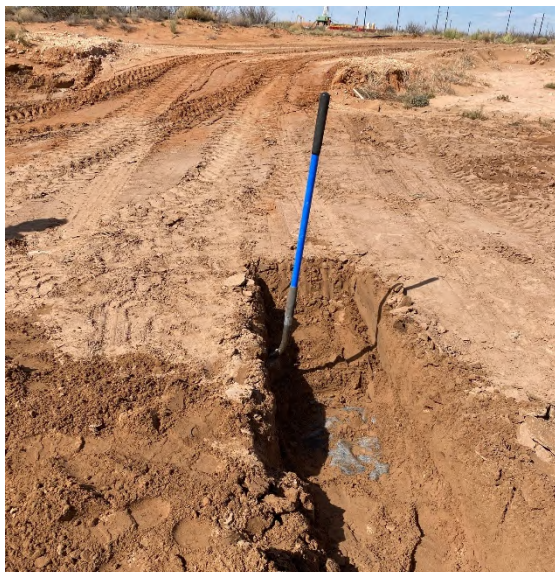
**Photograph 5:** North facing view of previously installed liner exposed.

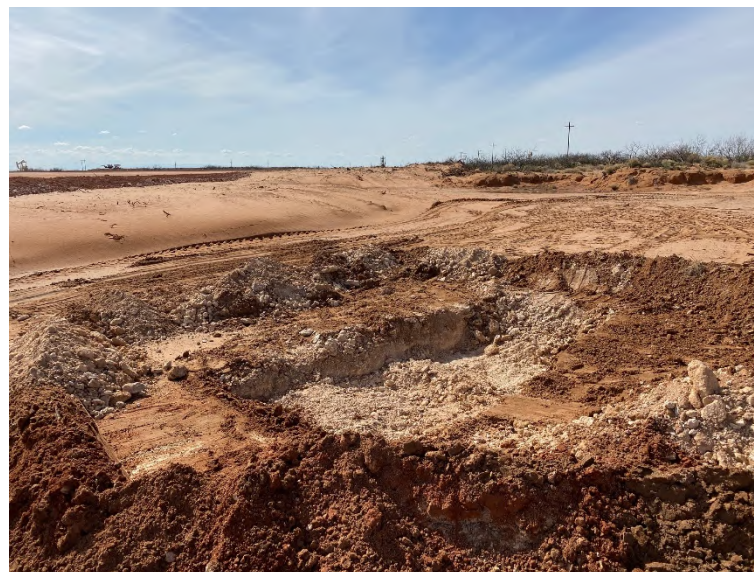
**Photograph 6:** West facing view of excavation area at SP-7.

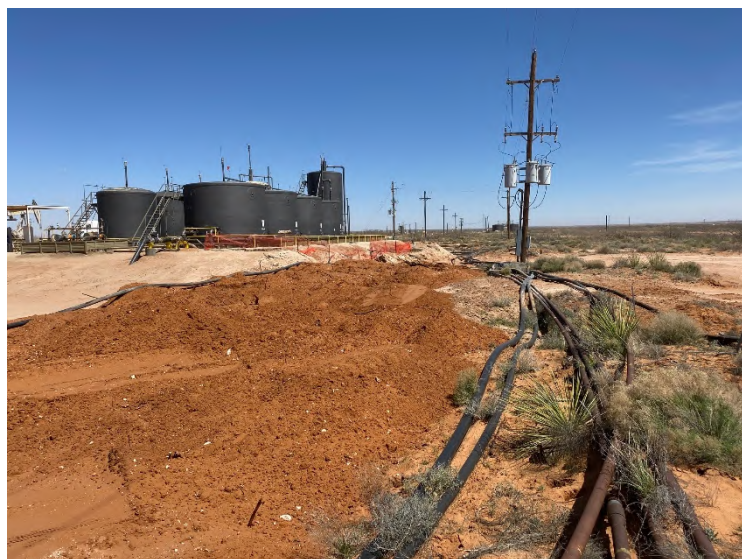
**Photograph 7:** East facing view during backfilling activities.

Initial response efforts, natural attenuation, and excavation of impacted soil have mitigated impacts at this Site. XTO requests no further action for RP Numbers 2RP-3082, 2RP-3302, 2RP-3726, and 2RP-4040. XTO backfilled the excavation with material purchased locally and recontoured the Site to match pre-existing site conditions. An updated NMOCD Form C-141 for each release event is included in Attachment 1.

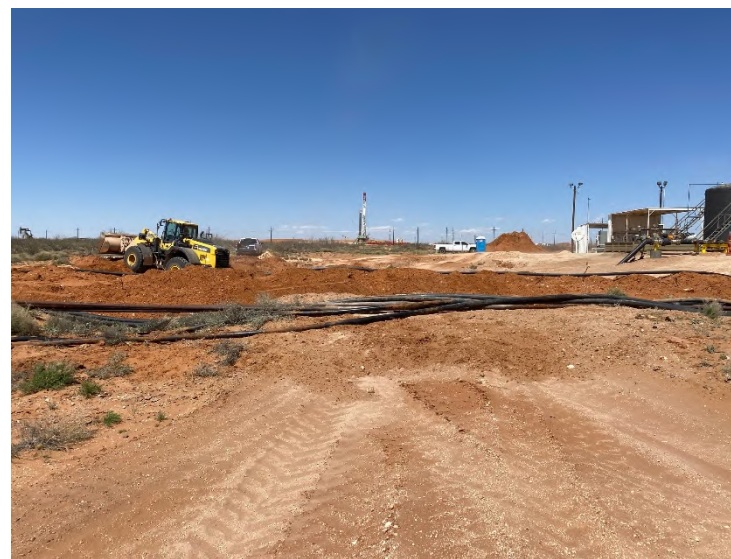
**Photograph 8:** North facing view during backfilling activities
