Re: Status Report – 1st Quarter 2021
Kaufman No. 1
San Juan County, New Mexico
OCD No.: AP-0138

On behalf of Hilcorp Energy Company (Hilcorp), Timberwolf Environmental, LLC (Timberwolf) prepared this letter to document the 1st Quarter 2021 (1Q21) groundwater monitoring activities at the Kaufman No. 1 (Site). The Site is located approximately 9.1 miles north of Farmington in San Juan County, New Mexico (Figure 1).

Timberwolf Project No. HEC-180061

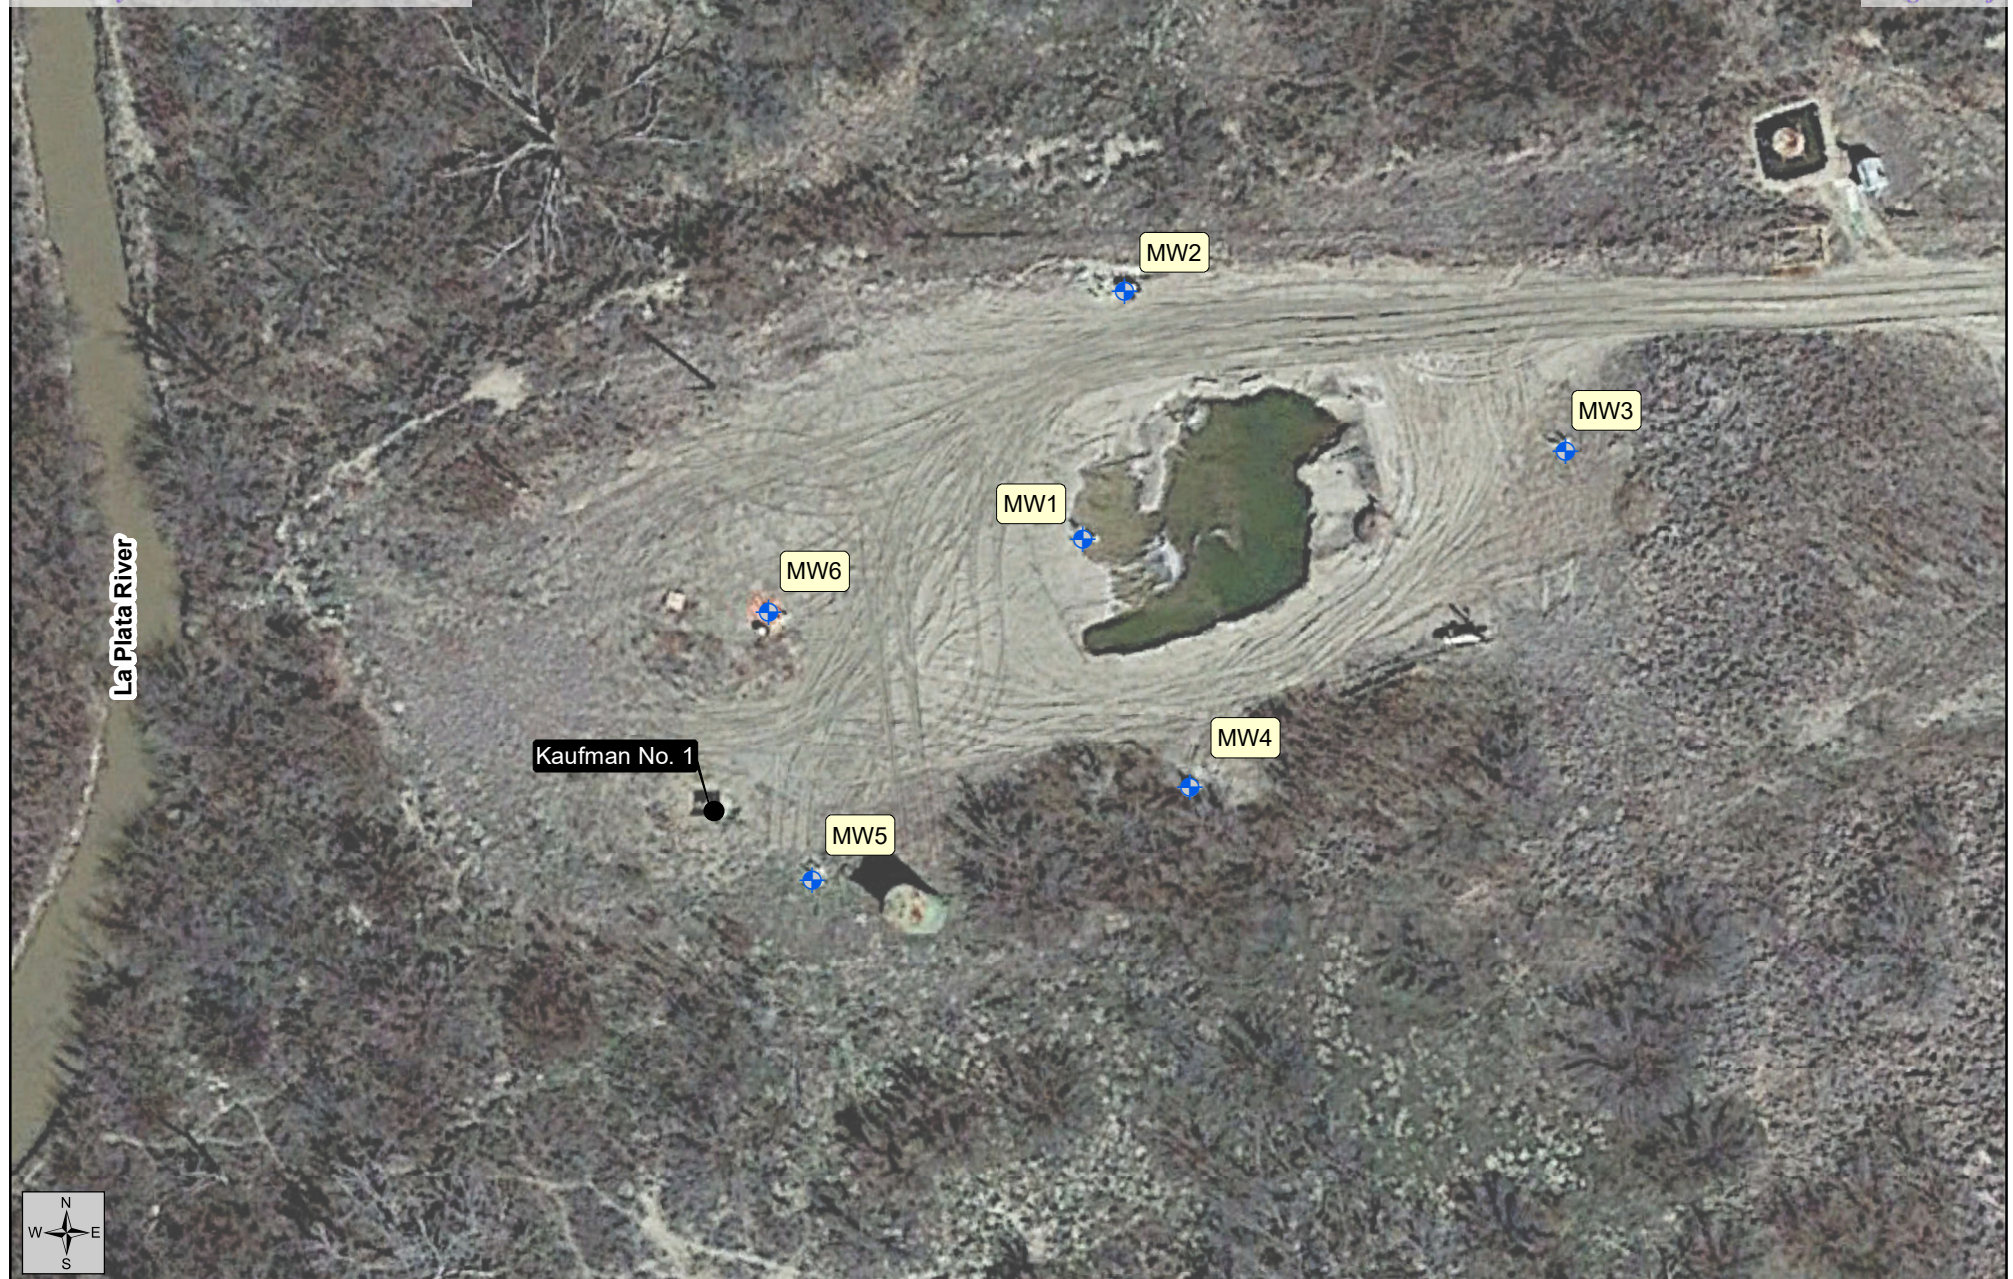
Figure 4
Monitor Well Location Map

On 1/11/21, Timberwolf conducted the 1Q21 groundwater monitoring event at the Site. Groundwater and surface water gauging, groundwater sample collection, and analytical results are documented below. Monitor well locations are shown in the attached Figure 4.

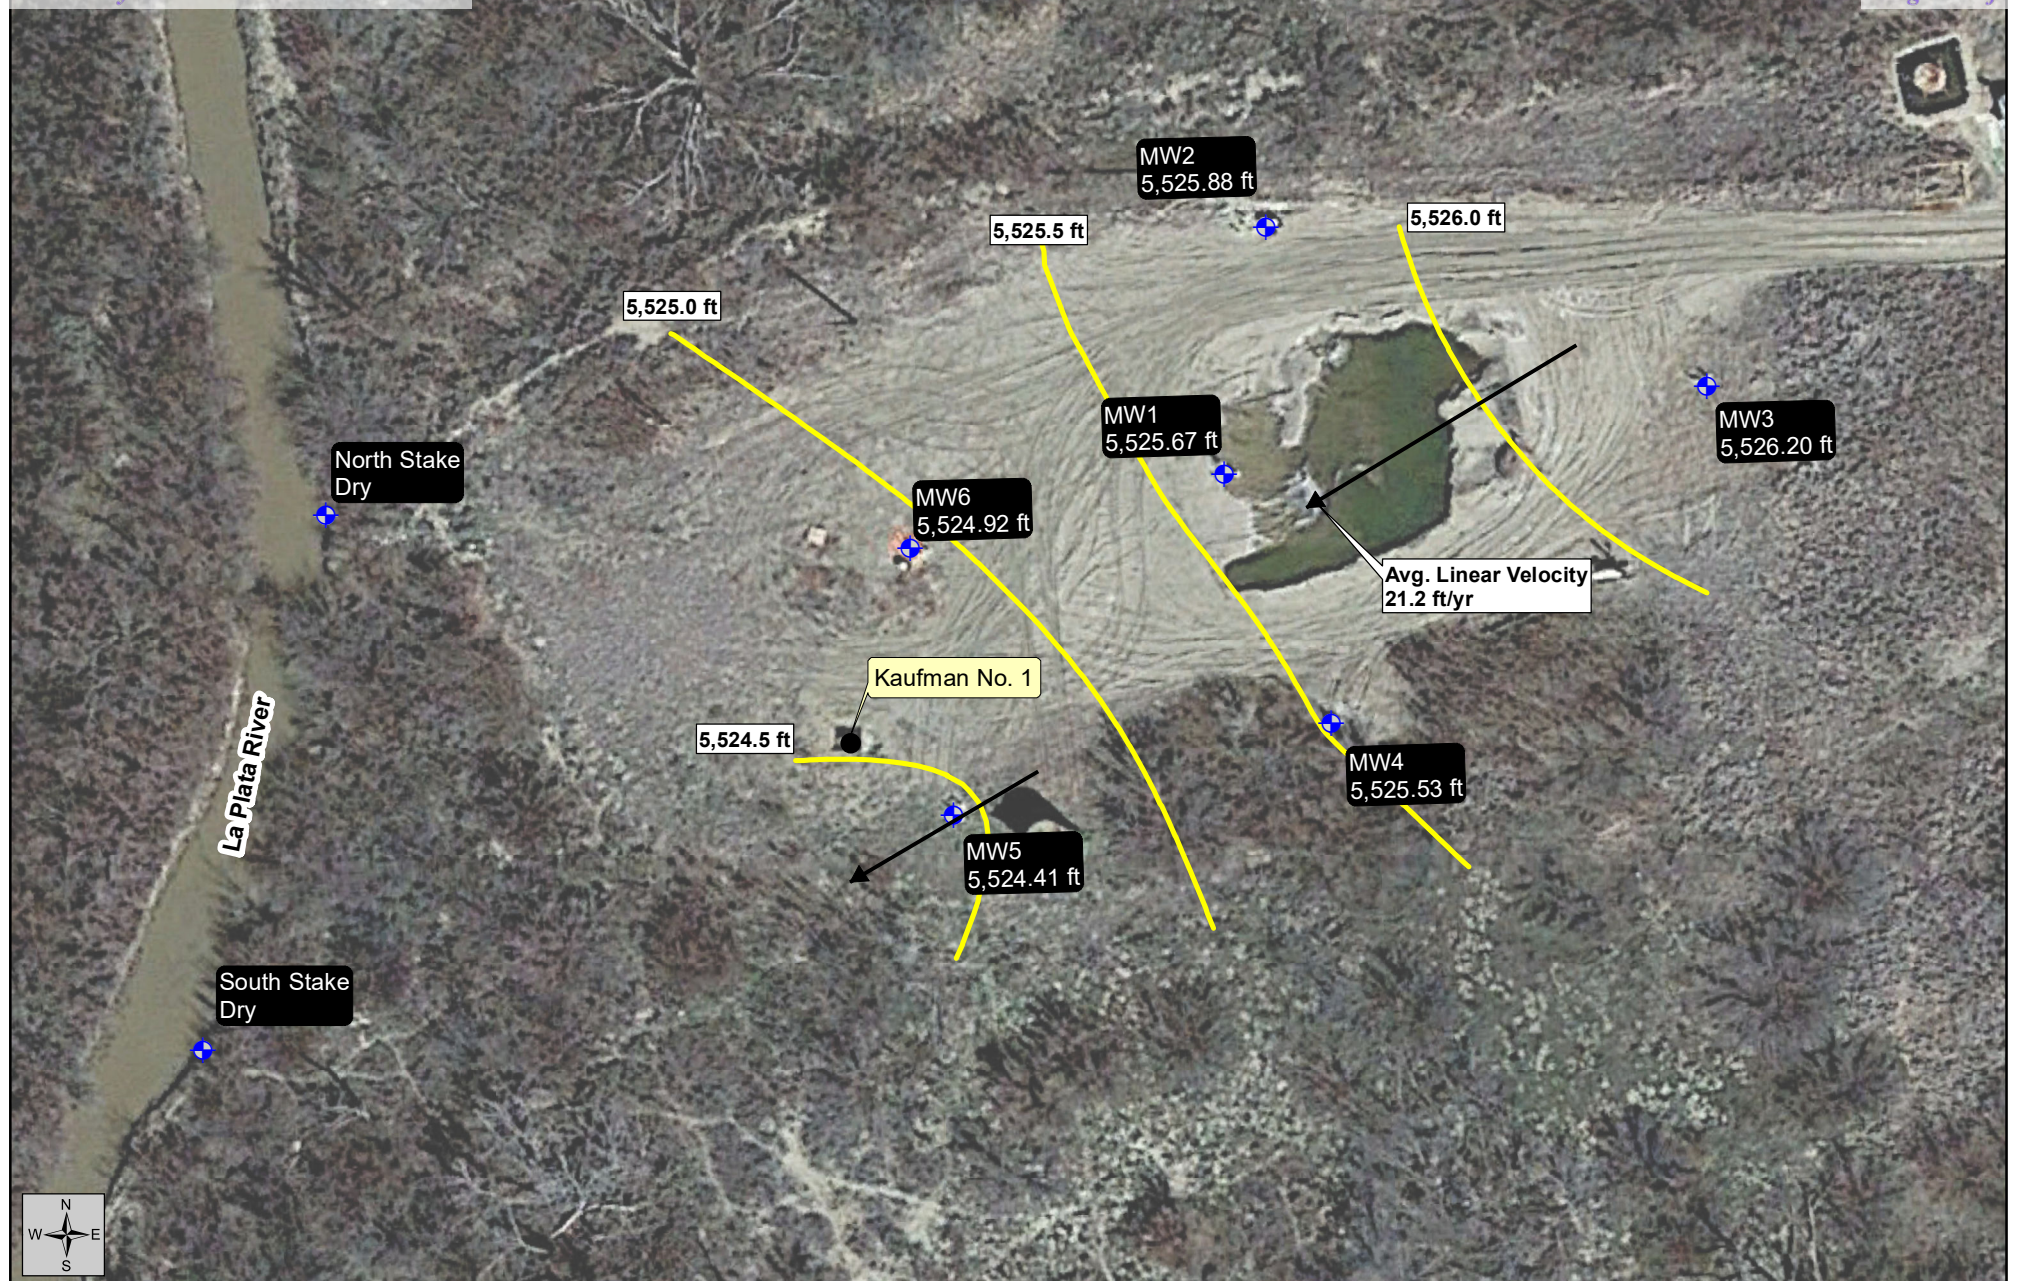
Figure 5
Potentiometric Surface
Elevation Map

Timberwolf prepared a potentiometric surface elevation (PSE) map as shown in Figure 5. The 1Q21 PSE map revealed that groundwater flow across the Site was west-southwest towards the La Plata River with an average linear velocity of 21.2 feet per year (ft/yr).

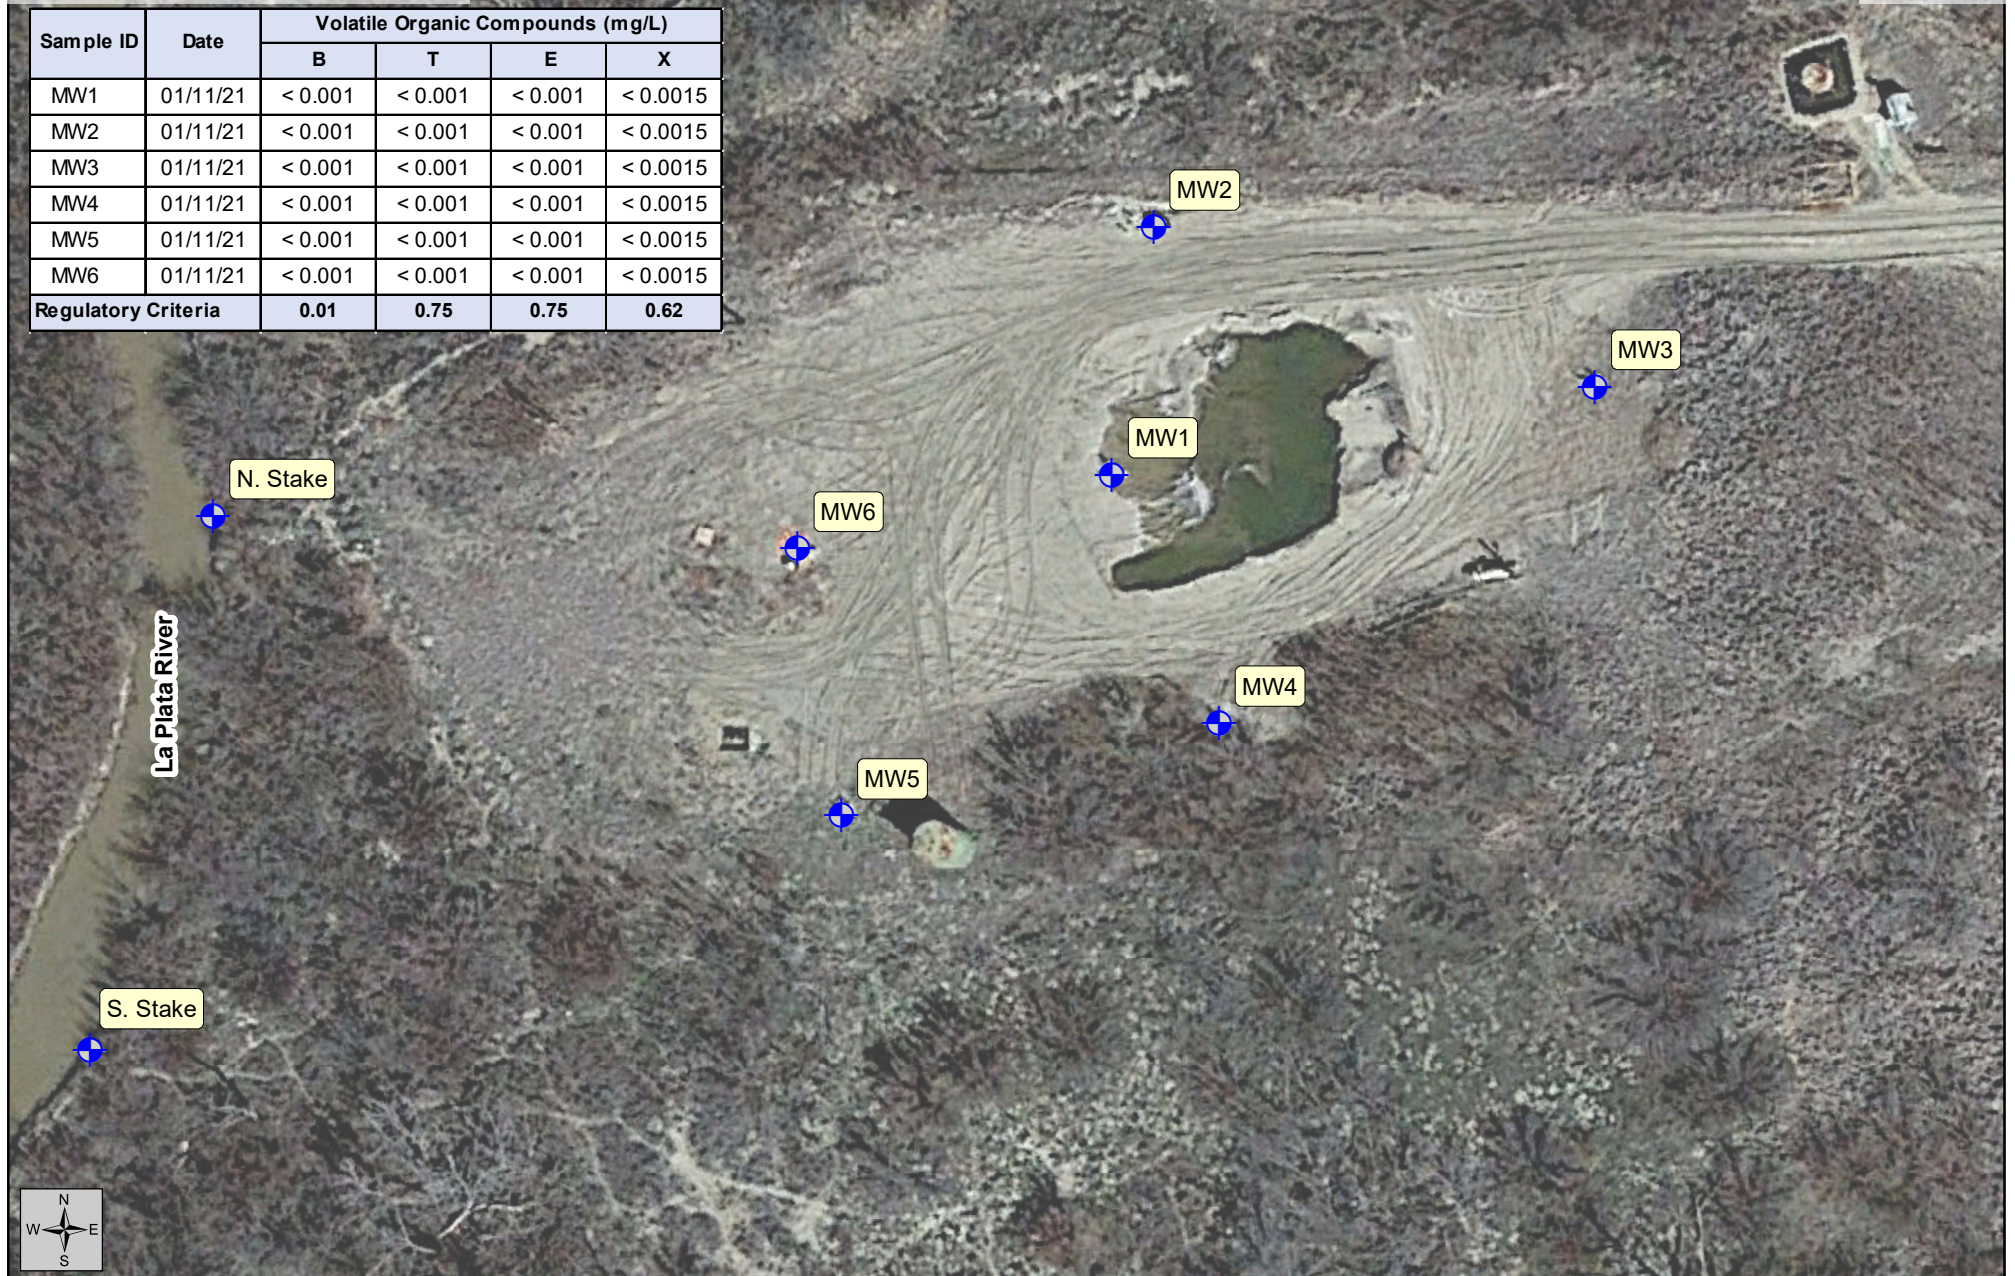
Figure 6
BTEX Results - 1Q21

Groundwater samples were analyzed for the following constituents: BTEX by EPA Method 8260. Cumulative analytical results from each groundwater sampling station is documented in Table A-3 (attached). Analytical results for the 1Q21 groundwater monitoring event are summarized in Table 2 below and shown in Figure 6.
