State of New Mexico
Oil Conservation Division

Incident ID	NAPP2205655153
District RP	
Facility ID	
Application ID

Based on laboratory analytical results, field activities conducted to date and conditions at the site, Caprock Services LLC, recommends Devon Energy provides a copy of this remediation summary and closure report to the NMOCD and request closure to be granted to the Mesquite Booster @ 33 connection.

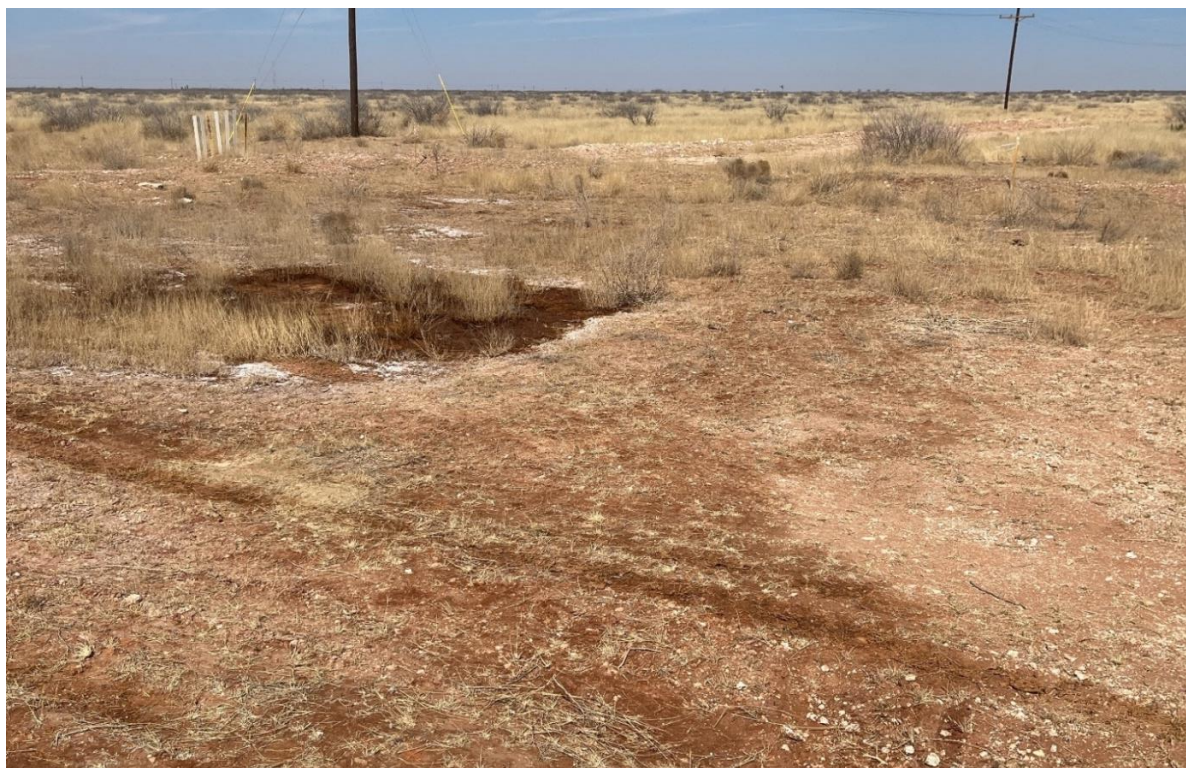
Figure 1 View of east side of release looking north west.

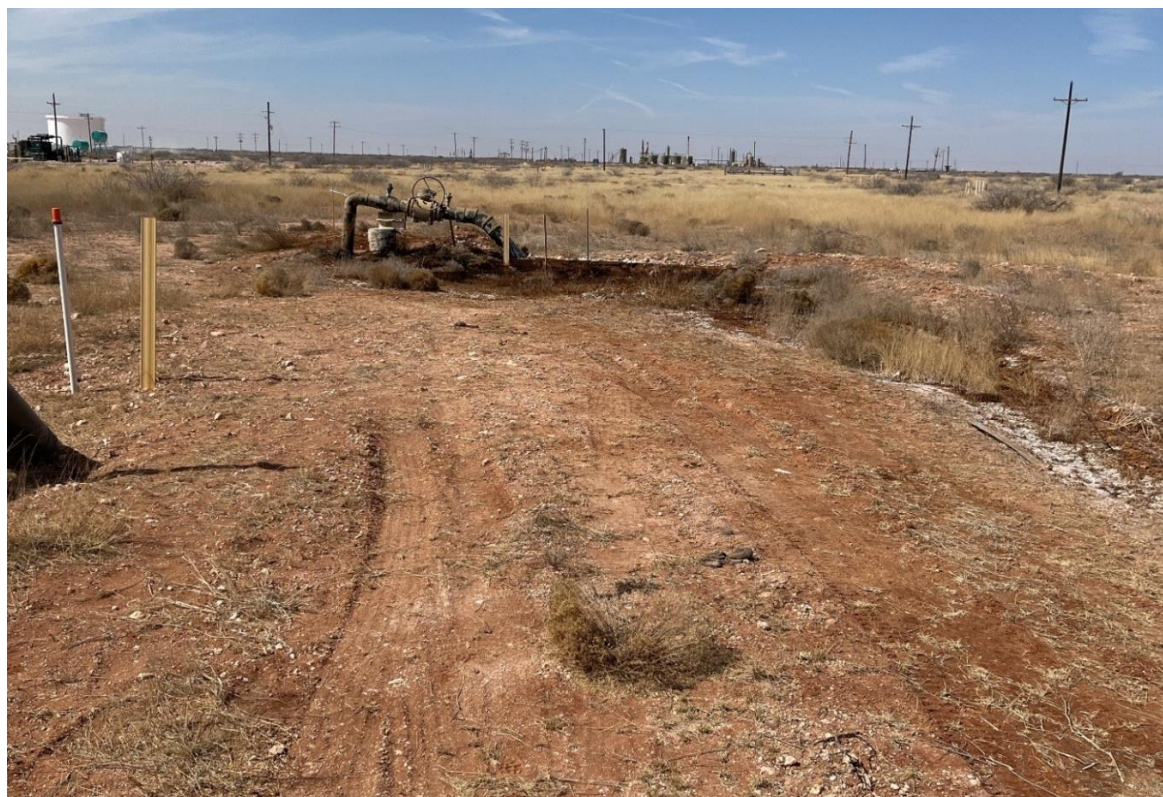
Figure 2 View looking west towards release point.

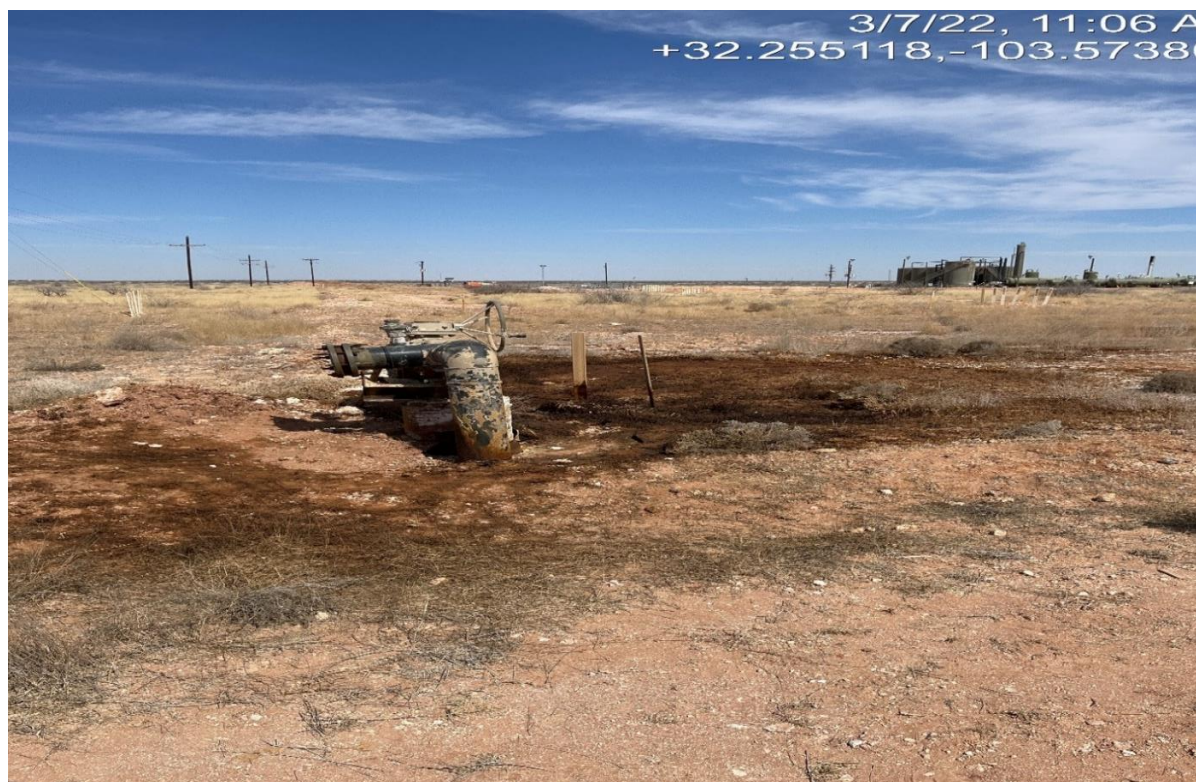
Figure 3 View of release point looking north.
