Release Notification

Re: Remediation Report and Closure Request

Linda 31 #27 – Trunk Q Pipeline Release
San Juan County, New Mexico
Harvest Four Corners, LLC
NMOCD Incident No: nAPP2217930240

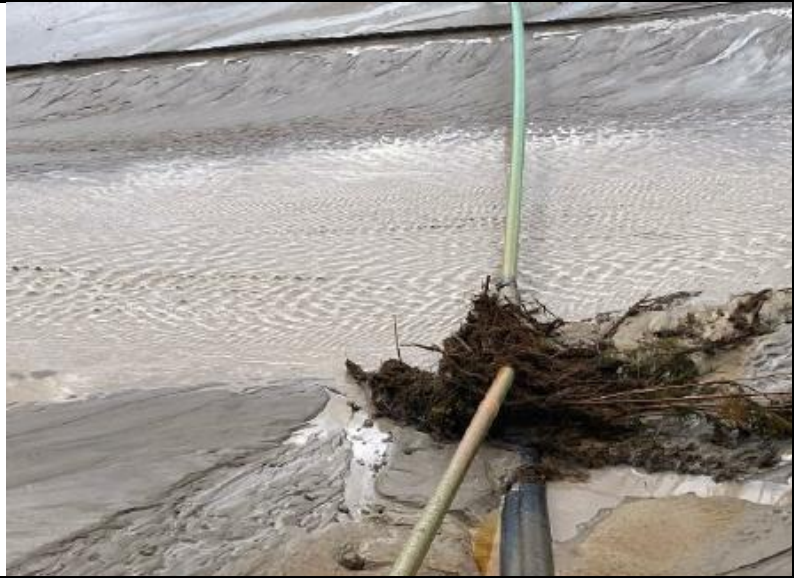
Photograph 1

Debris from rapid flow in wash accumulating on stinger to pipeline. Photo taken by Harvest on June 27, 2022. View to the west.

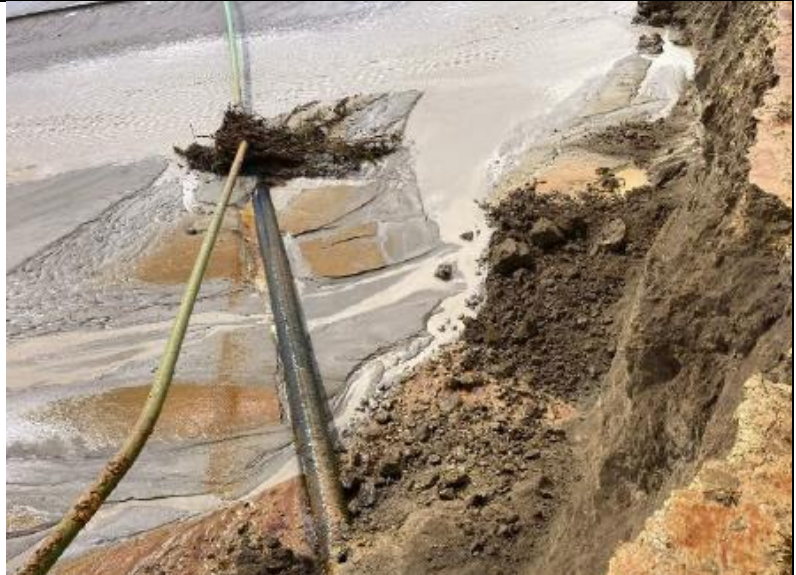
**Photograph 2**

Following a heavy precipitation event, a release was discovered on June 27, 2022, at a drip tank and stinger connection. Rapid erosion of the bank due to surface run off during a precipitation event washed out the tank support and pulled the stinger from the field tank.

Bank erosion and exposed pipeline and stinger. Photo taken by Harvest on June 27, 2022. View to the northwest.

Once the wash dried and the access roads were repaired Harvest was able to retrieve the drip tank from the wash and begin excavation near the wash bank. The tank will not be replaced, and the aboveground piping will be repaired and moved further away from the bank to prevent future

incidents. The repaired pipeline is planned to be lowered into a 5-foot-deep trench and backfilled beneath Blanco Canyon wash. The BLM, NMED, USACE, Navajo EPA, Region 9 USEPA have all been involved in the permitting for the construction in the wash.

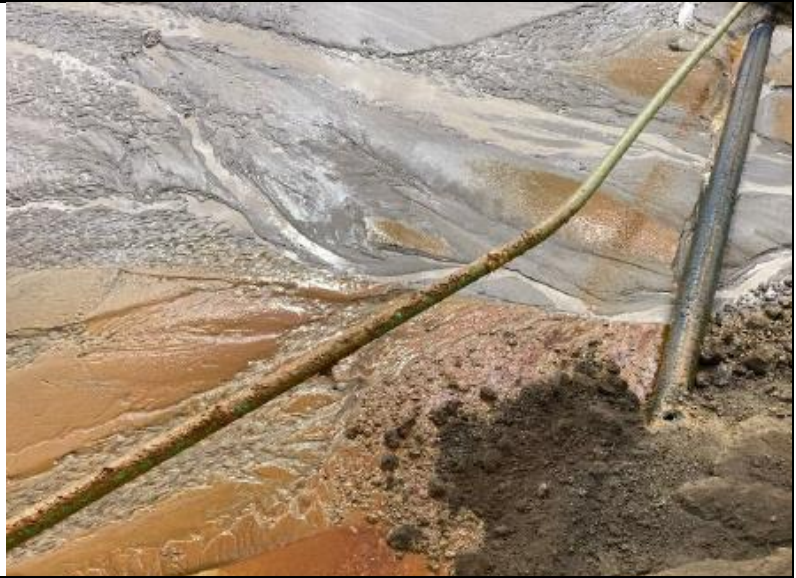
Photograph 3

Condensate on wash bank.
Photo taken by Harvest on June 27,
2022. View to the west.

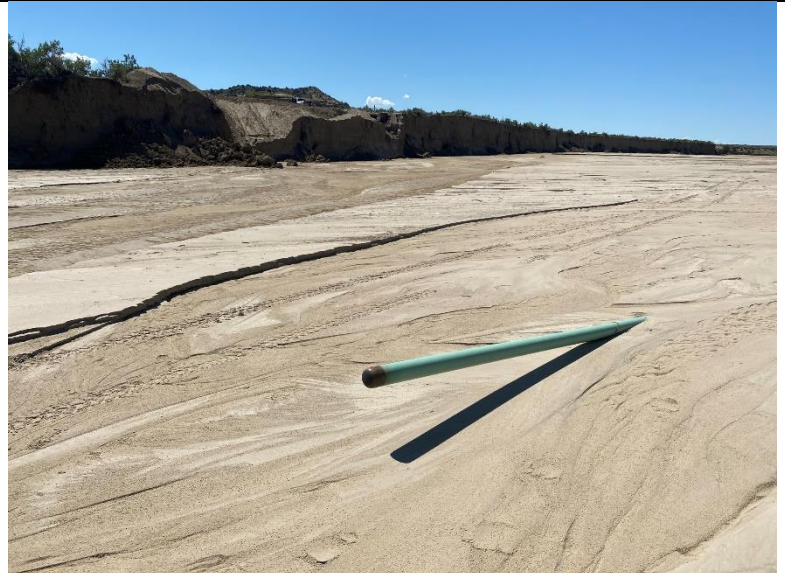
**Photograph 4**

Capped end of Trunk Q Pipeline in
Blanco Canyon Wash. Photo taken
July 14, 2022. View southeast.

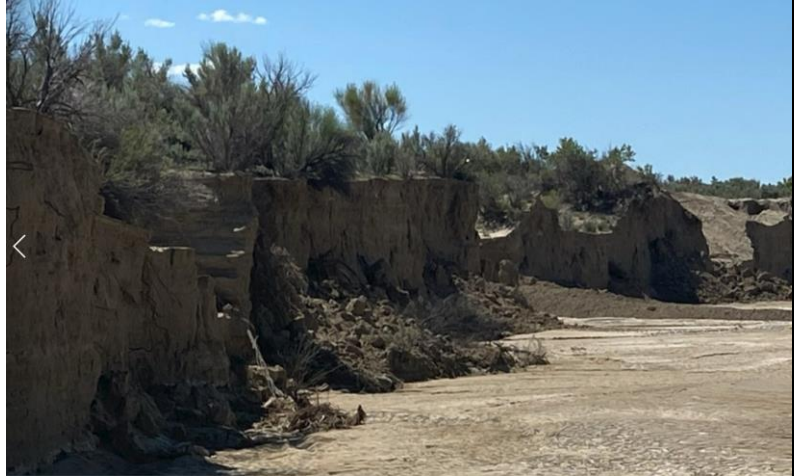
Photograph 5

Soil piles from natural erosion of the wash bank in the Site vicinity. Photo taken on July 14, 2022. View to the South.

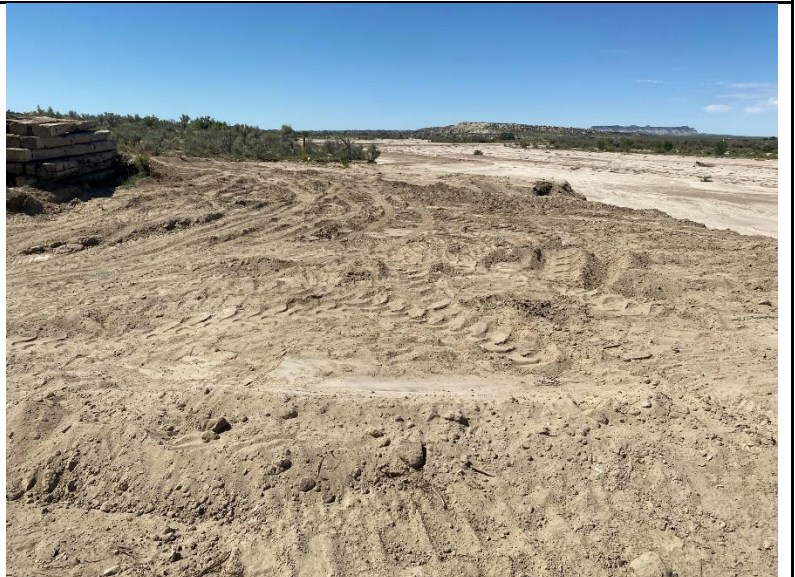
**Photograph 6**

Surface Excavation. Photo taken on July 14, 2022. View to the South.

Following the discovery of the release, Harvest initiated emergency repair and remediation activities in June and July 2022. The pipeline was shut-in and Harvest excavated visually impacted soil from the release area. Due to the saturation of soil from the heavy rains, stabilization pads were used in conjunction with heavy equipment (trackhoe and backhoe) to complete the necessary work. Ensolum, was onsite July 14, 2022, to map the wash boundary and the extent of the excavation and collect preliminary soil samples. The excavation was approximately 170 feet by 60 feet in areal extent with depths varying from 6 inches to 1 foot bgs (Figure 3). Harvest built a ramp from the excavation to the wash which is approximately 17 feet elevation difference. The ramp was used for heavy equipment to enter the wash in order to retrieve the tank that had moved downstream during the original storm event. An estimated 350 cubic yards of impacted soil have been removed from the Site and disposed of at Envirotech, Inc.'s (Envirotech) landfarm in Bloomfield, New Mexico.

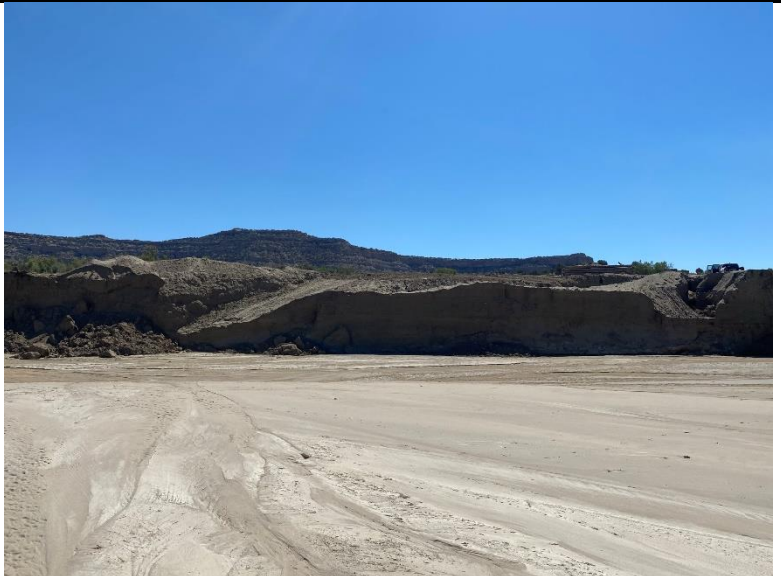
Photograph 7

Ramp and surface excavation.
Photo taken on July 14, 2022.
View to the east.

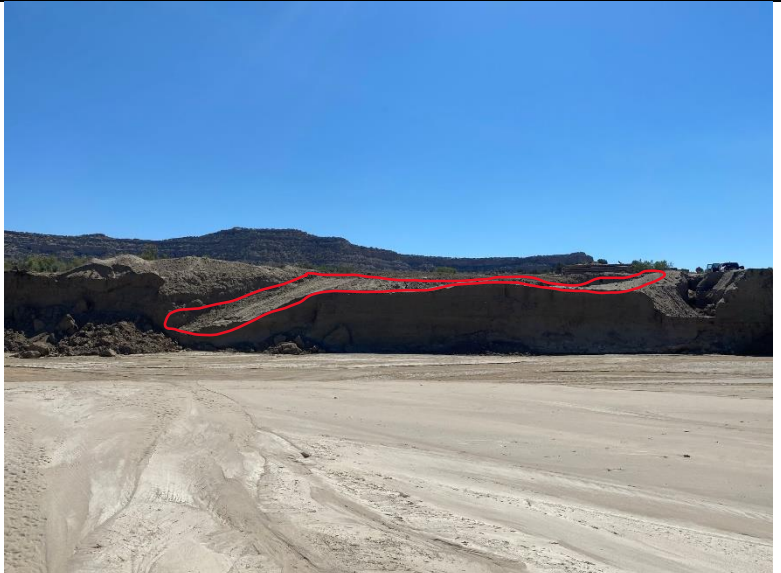
**Photograph 8**

Ramp and surface excavation area
highlighted in red.
Photo taken on July 14, 2022.
View to the east.

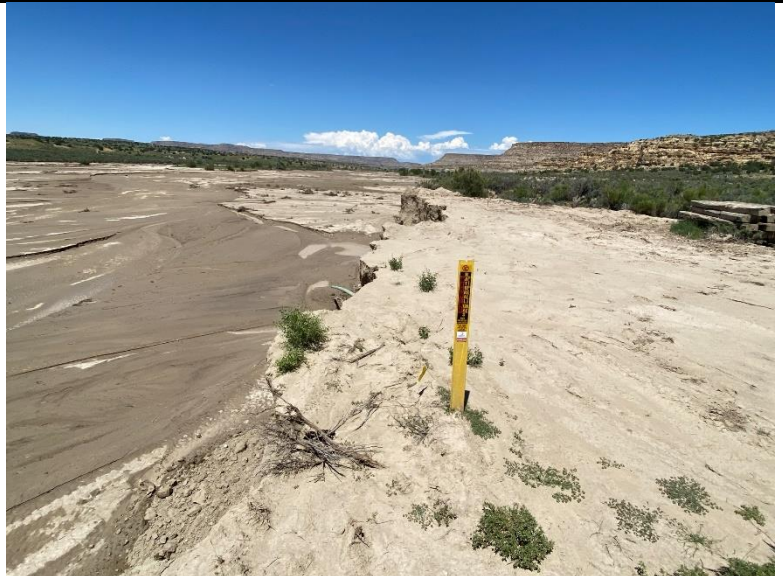
Photograph 9

Additional excavation was put on hold due to continued heavy rain and surface water flow within Blanco Canyon, which resulted in further erosion of the bank. After access roads were repaired, Ensolum was able to return to the Site on August 9, 2022, to assess Site conditions and re-map the wash boundary. The wash had eroded an additional 10 feet to 50 feet in the vicinity of the Site, including a portion of the excavated area. Large fissure cracks were observed at the top of the wash bank indicating the area was unstable.

Excavated area after additional erosion.
Photo taken on August 12, 2022.
View to the north.

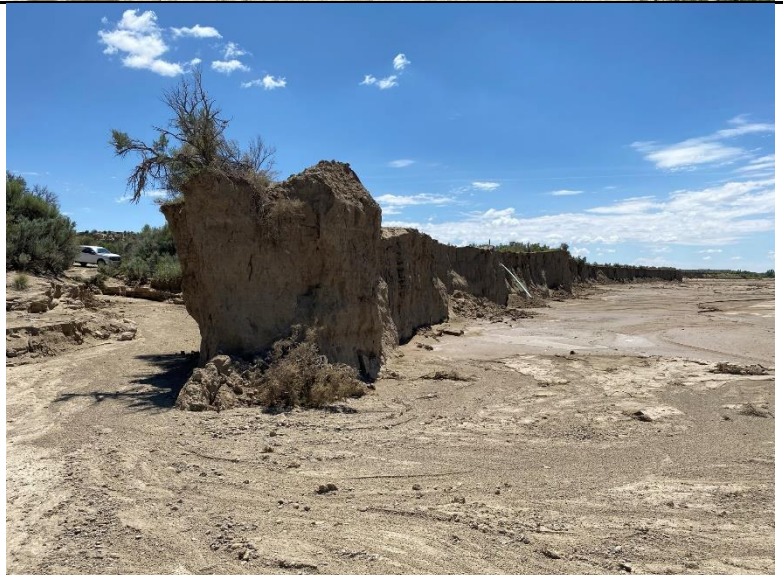
**Photograph 10**

View to the south of a tributary into Blanco Canyon north of the excavation area. The truck is on the access road that has been destroyed.
Photo taken on August 12, 2022.
View to the south.
