Closure Report
Azul State 13 Federal Com 1H
Incident ID: nAPP2225859009
Lea County, New Mexico
Unit D Sec 13 T23S R33E
32.31101°, -103.53347°

Produced Water Release
Point of Release: A water pump seal failed on the water transfer pump
Release Date: 09/04/2022
Volume Released: 12 Barrels of Produced Water
Volume Recovered: 10 Barrels of Produced Water

Re: Closure Report
Azul State 13 Federal Com 1H
Cimarex Energy Co.
Site Location: Unit D, S13, T23S, R33E
(Lat 32.31101°, Long -103.53347°)
Lea County, New Mexico

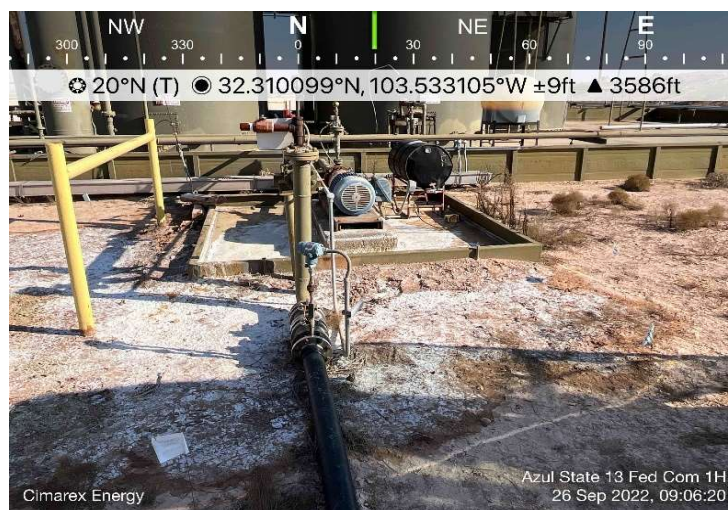
Photograph No. 2

View Northeast, area of impact.

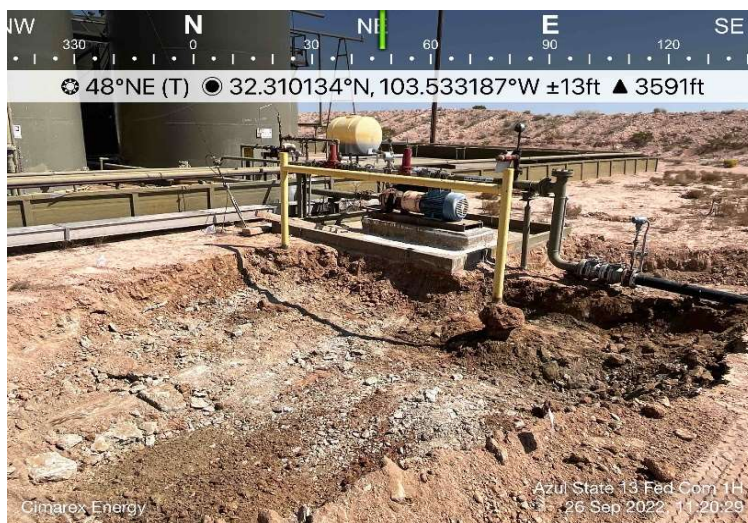
Photograph No. 4

View Northeast, area of Confirmation Sample (CS-2 and CS-3).

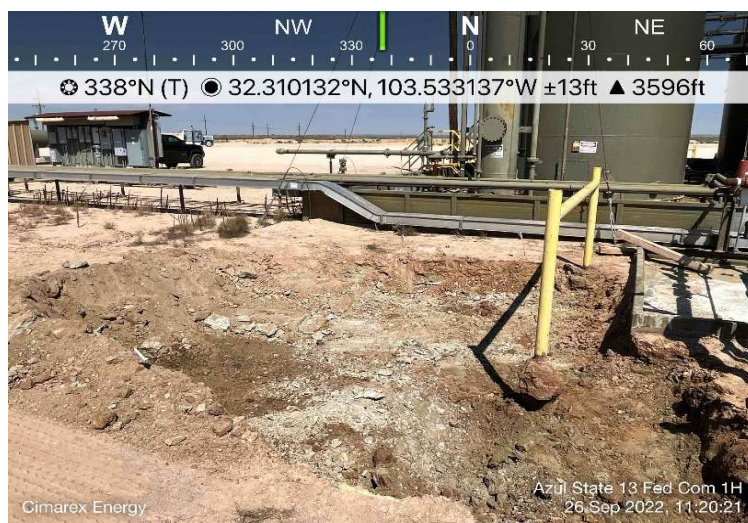
Photograph No. 5

View Northwest, area of Confirmation Sample (CS-2 and CS-3).

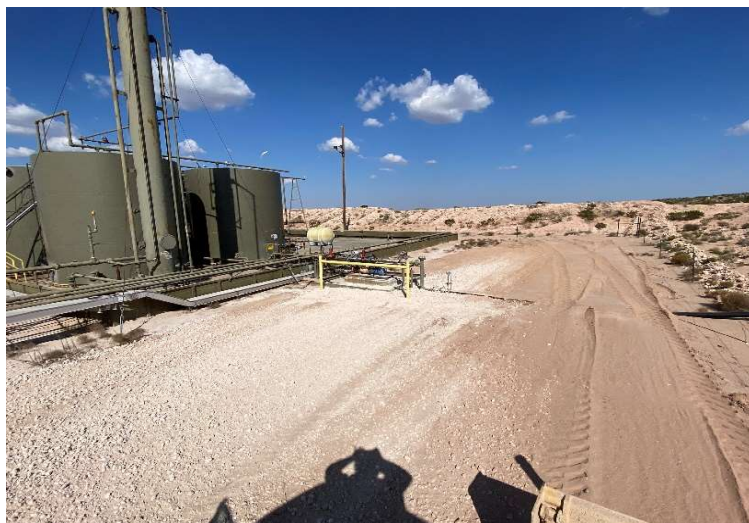
Photograph No. 6

View East, area of backfill.

Once the remediation activities were completed, the excavated areas were backfilled with clean material to surface grade. Approximately 40 cubic yards of material were excavated and transported offsite for proper disposal.

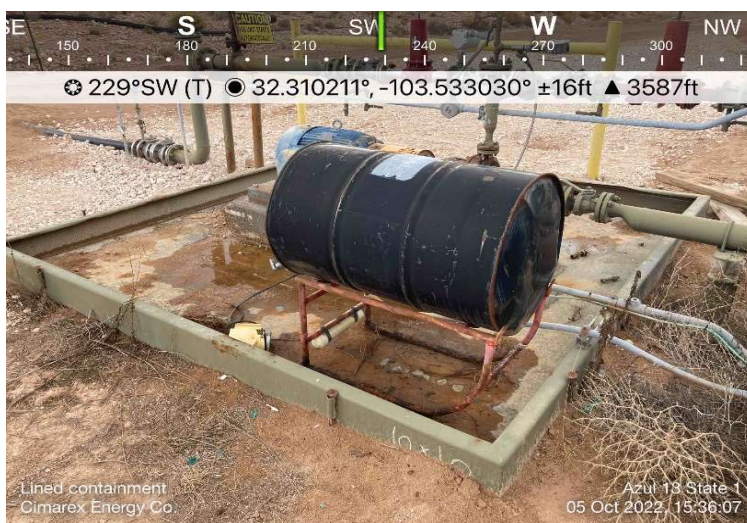
Photograph No. 9

View Southwest, area containment after recent rains.

The following serves to verify that the affected liner has been inspected and found to be in serviceable condition in accordance with 19.15.29.11 A.(5)(a)(i-ii) of the New Mexico Administrative Code.
