Release Notification

Site Name: GALLEGOS CANYON UNIT 189	Site Type: Natural Gas Production Wellpad
Date Release Discovered: 9/29/2019	API# (if applicable): 30-045-07678

Incident #: NCS2001742271 API #: 30-045-07678
 Unit E, Sec. 36, T29N, R13W Federal Lease #: Private
 BGT Closure & Remediation - Lab Results

GALLEGOS CANYON UNIT 189

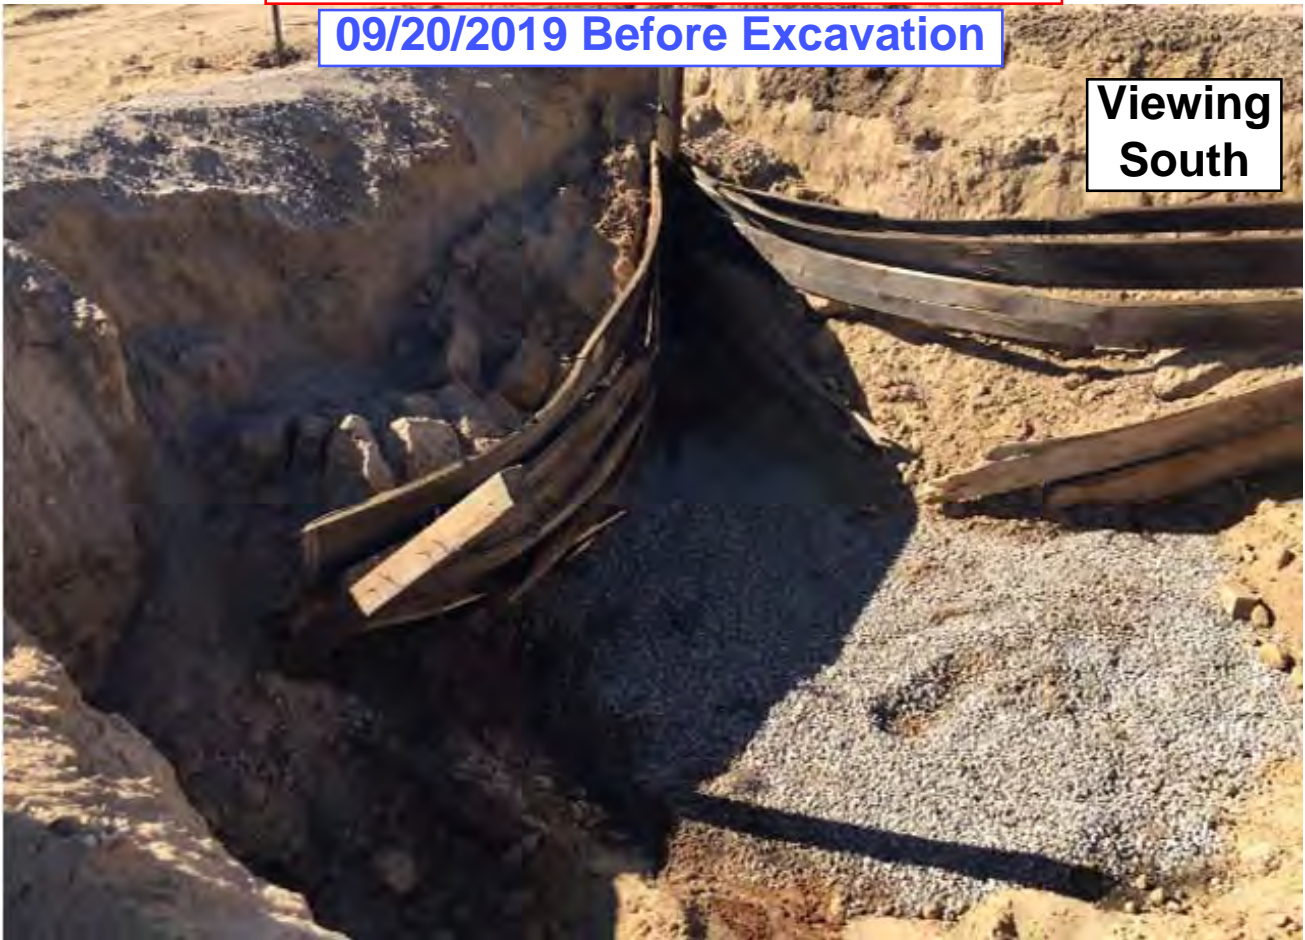
09/20/2019 Before Excavation

CONSISTENCY (NON COHESIVE SOILS): <input checked="" type="checkbox"/> LOOSE / <input type="checkbox"/> FIRM / <input type="checkbox"/> DENSE / <input type="checkbox"/> VERY DENSE	HC ODOR DETECTED: <input checked="" type="checkbox"/> YES / <input type="checkbox"/> NO EXPLANATION - SLIGHTLY WITHIN STAINED SOILS
MOISTURE: <input checked="" type="checkbox"/> DRY / <input type="checkbox"/> SLIGHTLY MOIST / <input type="checkbox"/> MOIST / <input type="checkbox"/> WET / <input type="checkbox"/> SATURATED / <input type="checkbox"/> SUPER SATURATED	ANY AREAS DISPLAYING WETNESS: <input type="checkbox"/> YES / <input checked="" type="checkbox"/> NO EXPLANATION -
SAMPLE TYPE: <input checked="" type="checkbox"/> GRAB / <input type="checkbox"/> COMPOSITE # OF PTS. 3 & 5	DISCOLORATION/STAINING OBSERVED: <input checked="" type="checkbox"/> YES / <input type="checkbox"/> NO EXPLANATION - GRAY TO BLACK STAINING AT EAST SIDE OF BGT FOOTPRINT PERIMETER

Viewing
South

The tank was removed on 9/20/2019 and closure sampling was conducted on 10/1/2019. Approximately 8- 10 yards of soil was removed from the site and placed in a permitted landfarm for treatment and disposal.

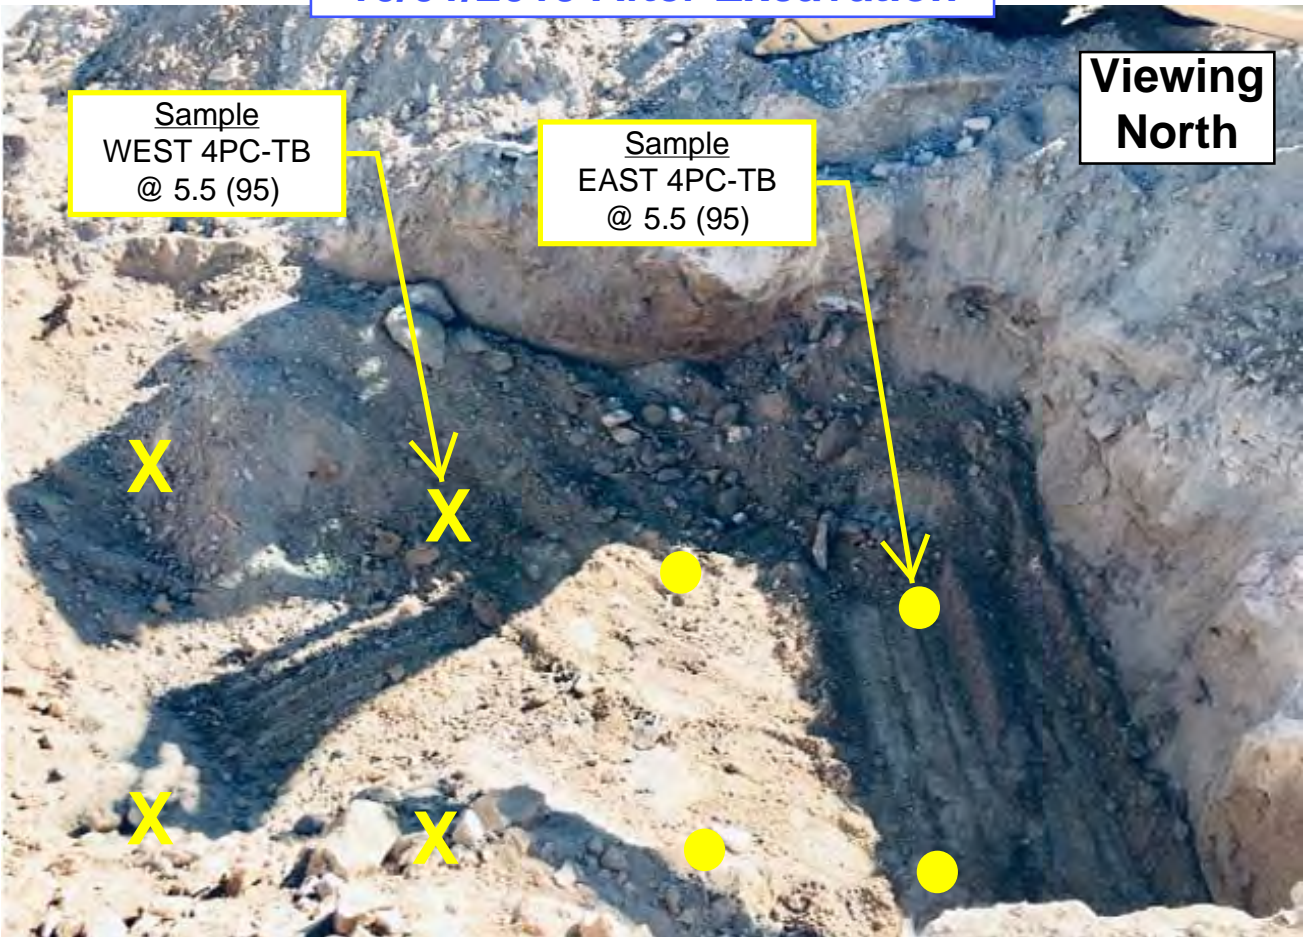
10/01/2019 After Excavation

Viewing
North

Sample
WEST 4PC-TB
@ 5.5 (95)

Sample
EAST 4PC-TB
@ 5.5 (95)

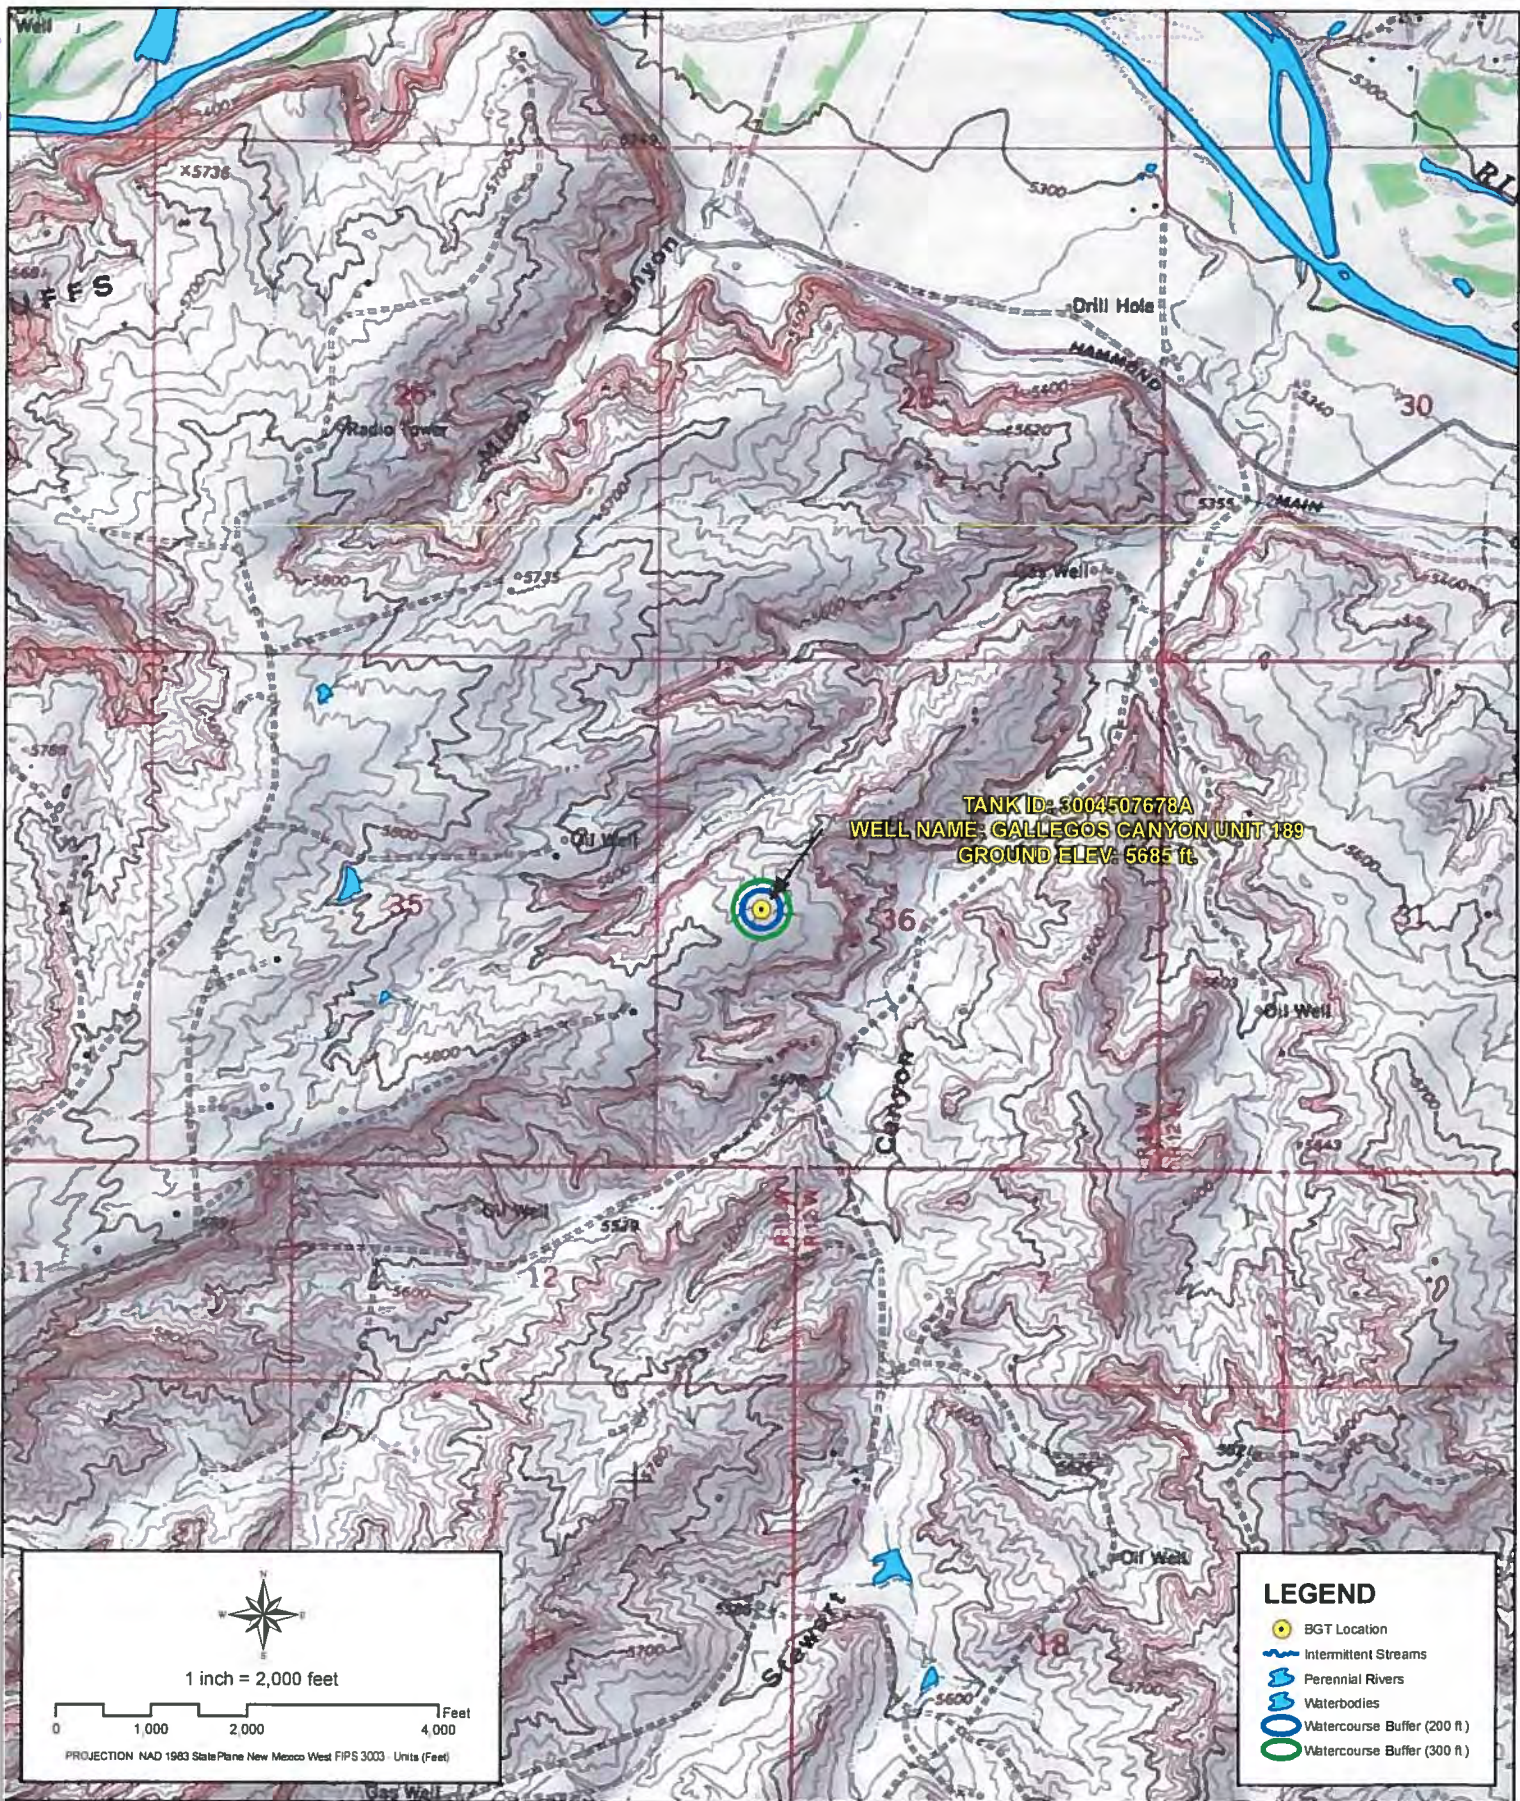
FIGURE
2

PROXIMITY TO WATERCOURSES

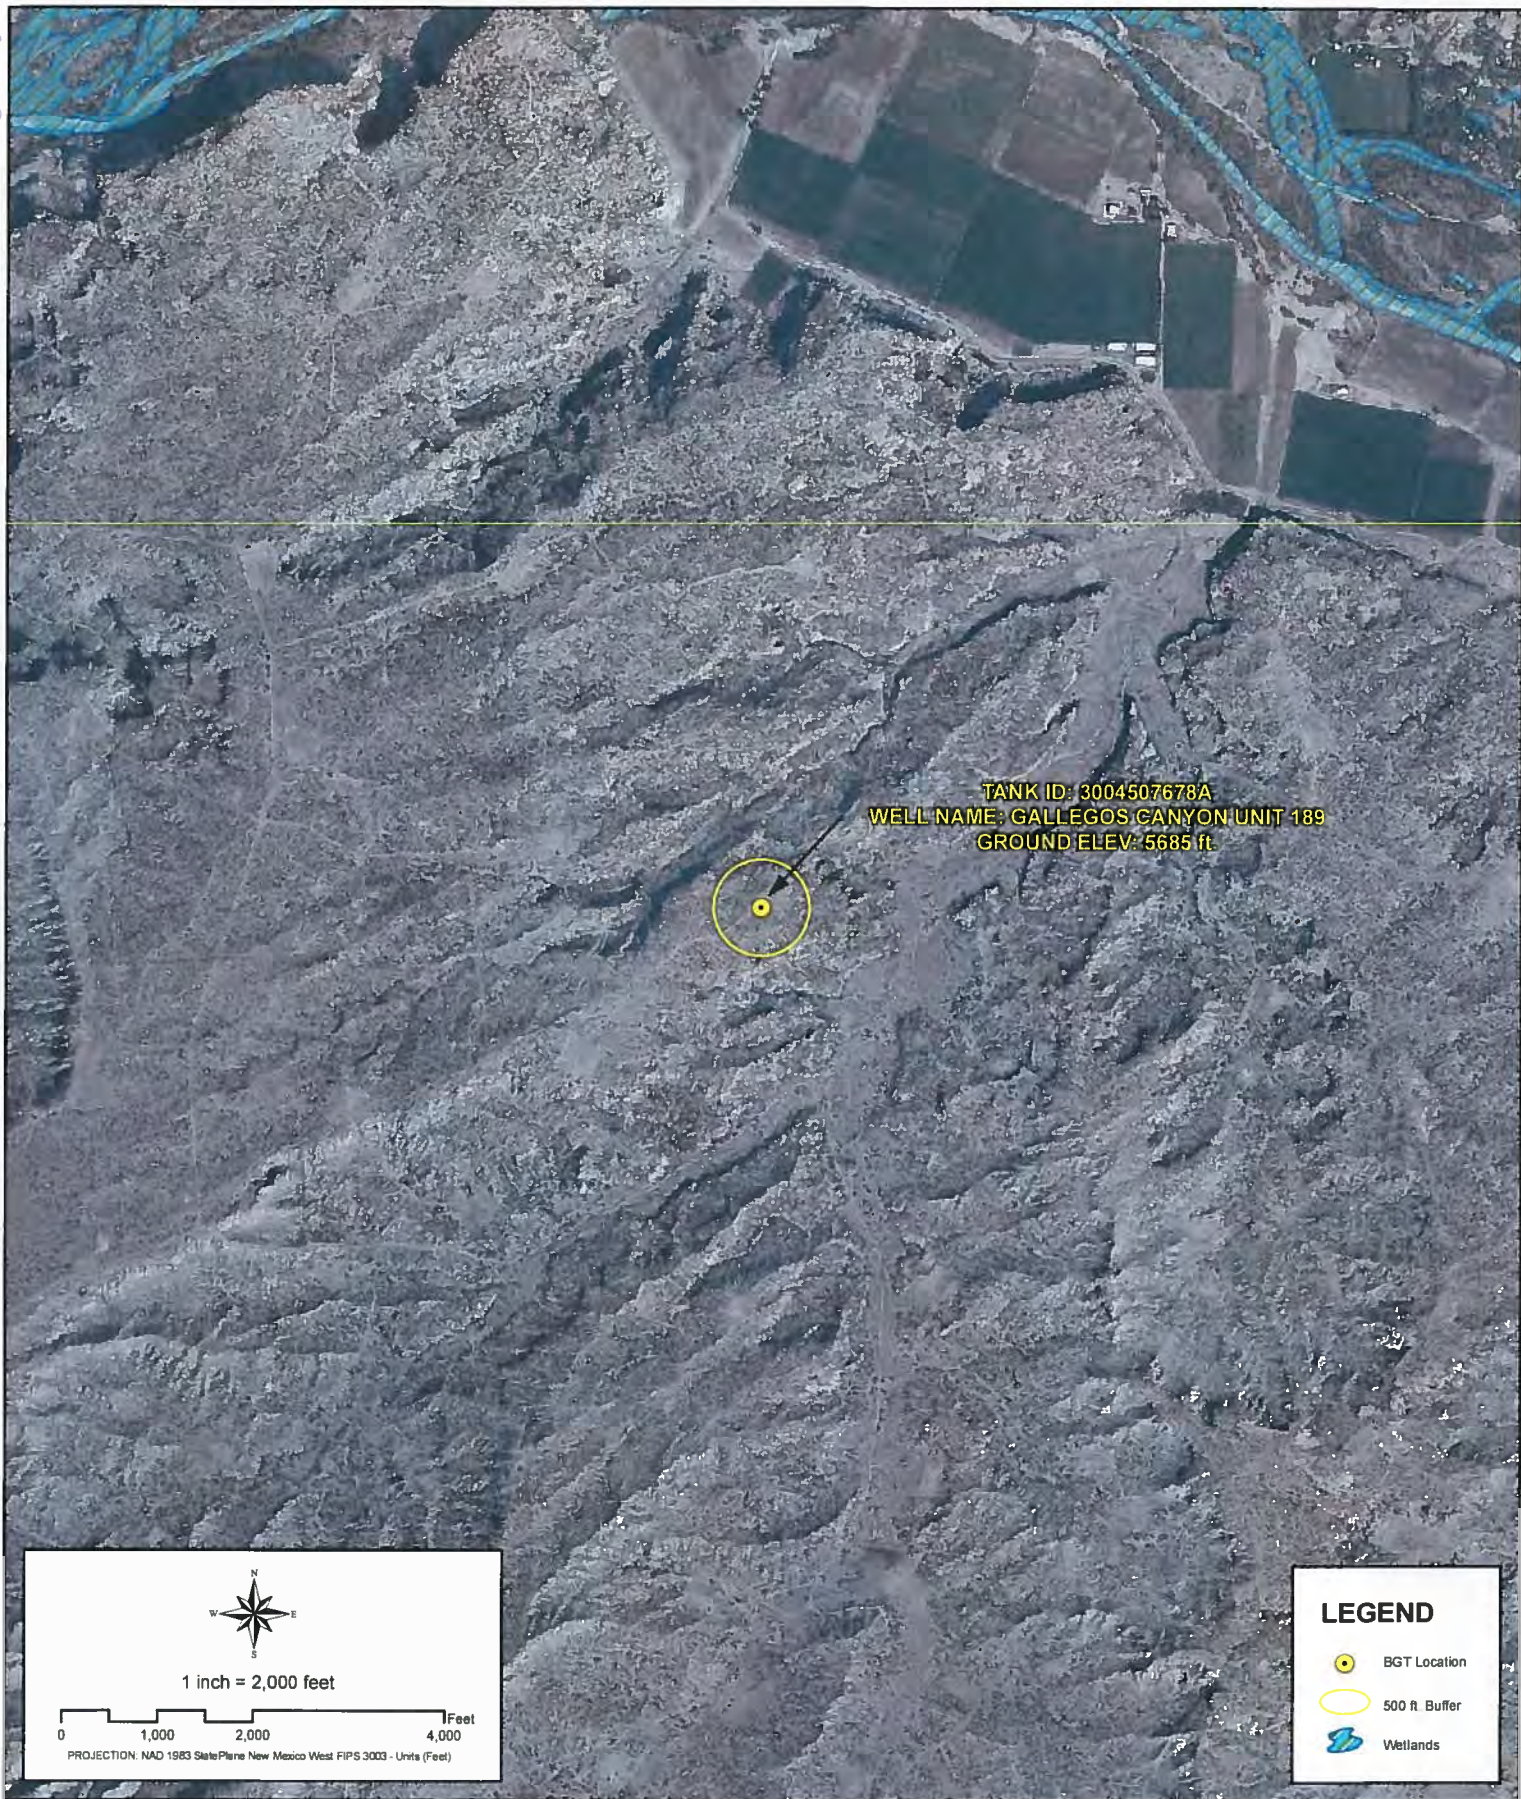
FIGURE
6

PROXIMITY TO WETLANDS
WELL NAME: GALLEGOS CANYON UNIT 189
API NUMBER: 3004507678 TANK ID: 3004507678A
SECTION 36, TOWNSHIP 29.0N, RANGE 13W, P.M. NM23
