Incident ID	NAPP2208253120
District RP	
Facility ID	
Application ID

**Figure 2**  
**Initial Delineation Map**  
**Mewbourne Oil Co.**  
**Delaware Ranch 13 B2DA Fed Com #1H**  
**Eddy County, New Mexico**  
**NMOCD Reference # NAPP2208253120**

# NAPP2208253120 | DELAWARE RANCH 13 B2DA FED COM #1H

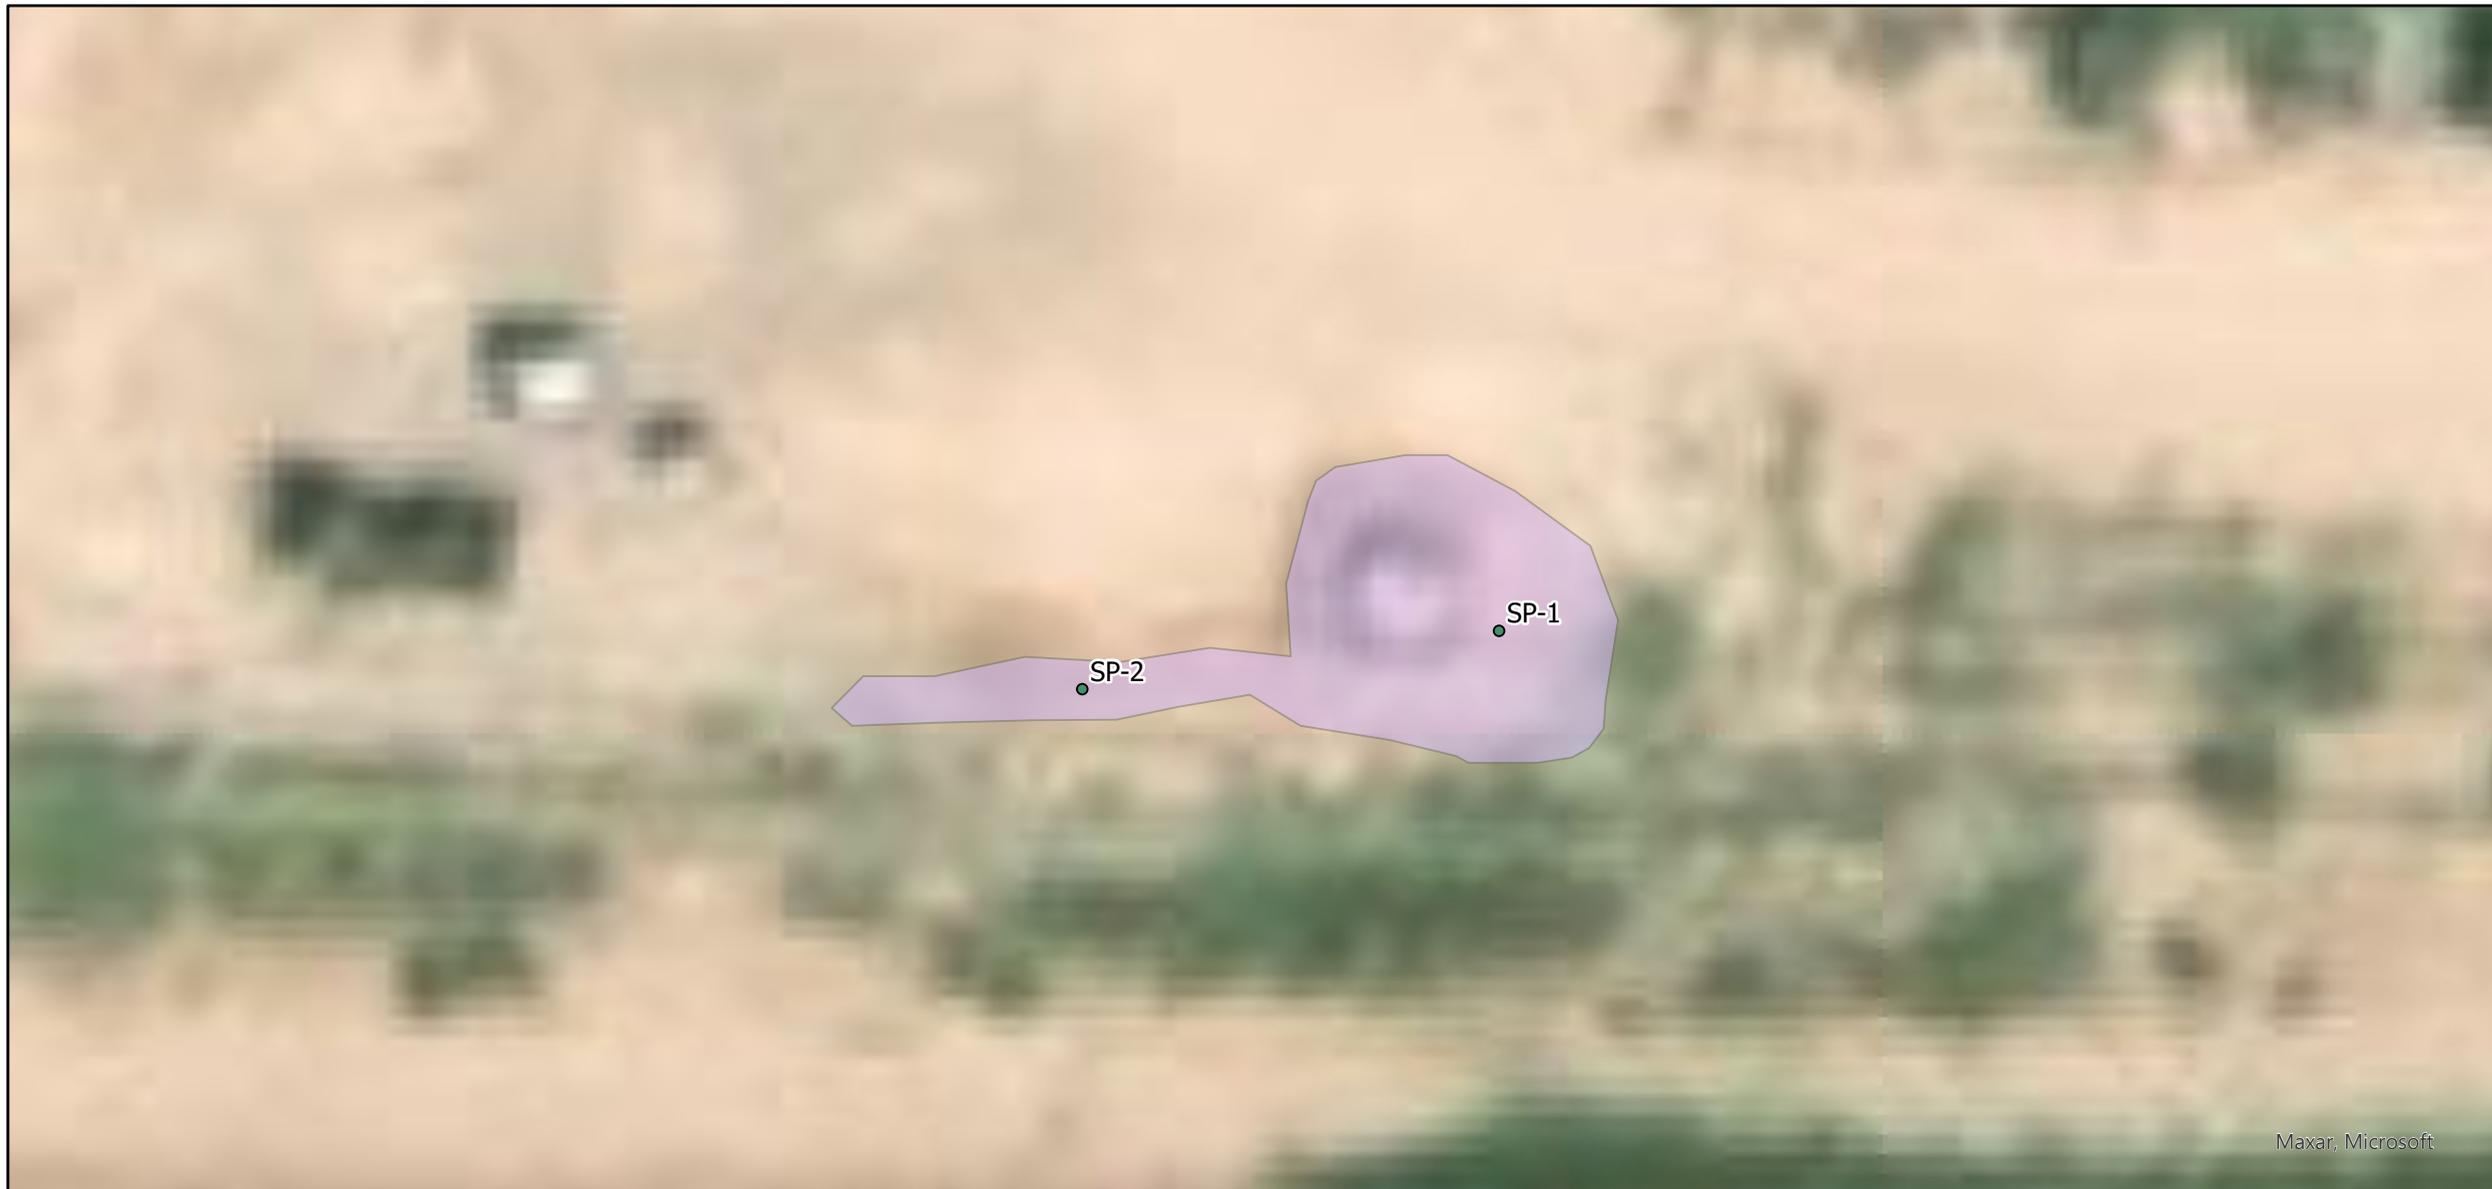
On 03/23/2022, Mewbourne reported a release at the referenced location. The release was caused when a dump on a compressor hung open and overflowed a tank set up to hold such releases. A berm around the tank contained the release. Approximately 1,000 ft<sup>2</sup> of the pad was found to be damp upon initial inspection
