Re: Site Assessment, Remediation, and Closure Report
Paloma State #1
API No. 30-025-31153
GPS: Latitude 32.6973678 Longitude -103.716568
UL "O", Sec. 36, T18S, R32E
Eddy County, NM
NMOCD Ref. No. NJXK1523953591

Paragon Environmental, LLC (Paragon) has been contracted by Strata Production Company (Strata) to perform a spill assessment and remediation activities for the Release Site known as the Paloma St #1 (Paloma). Details of the release are summarized below:

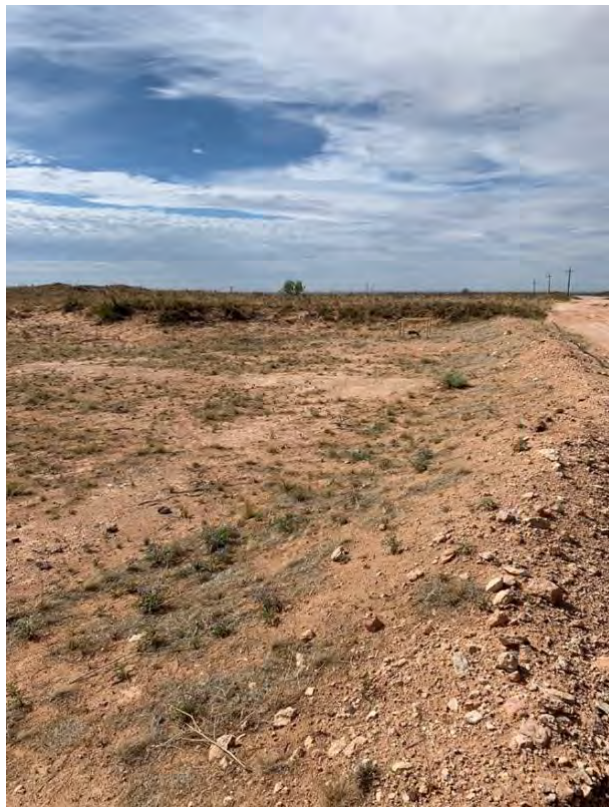
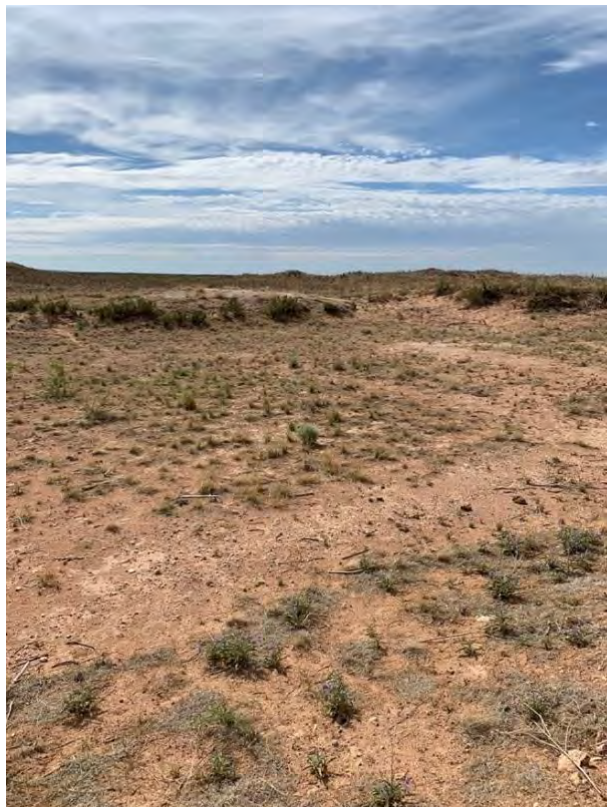
Before the Remediation
The Area Had Vegetation Growth

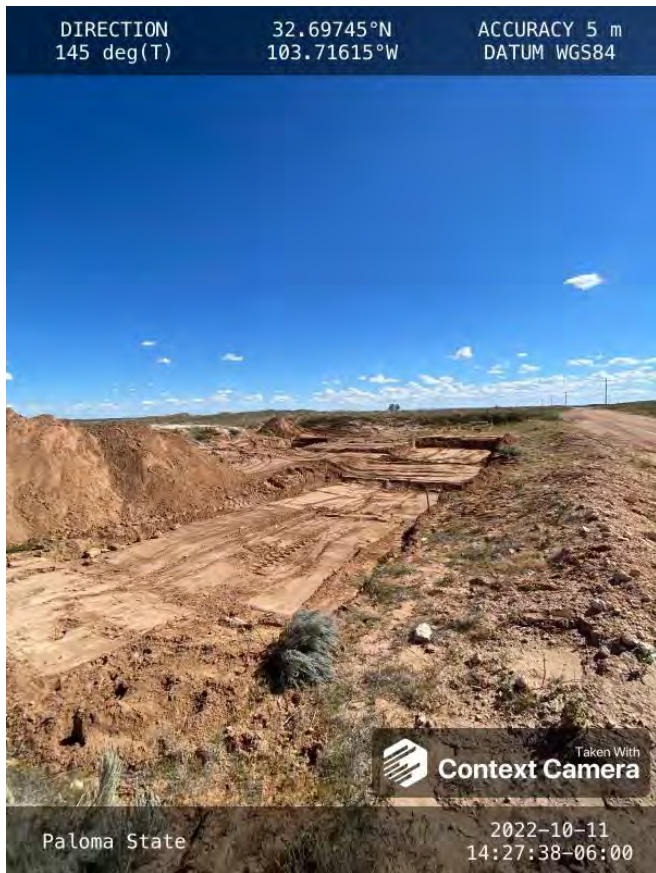
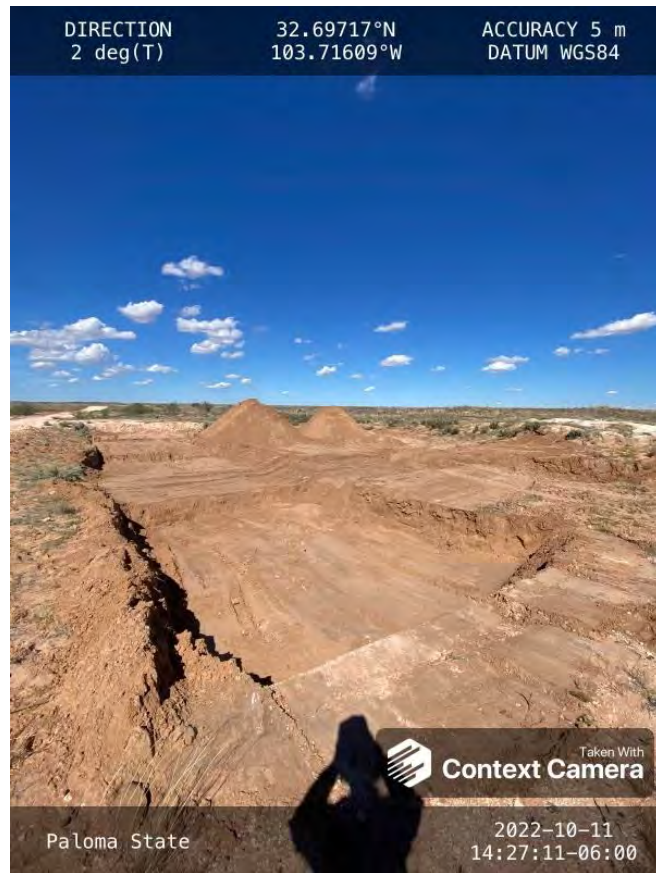
During Remediation

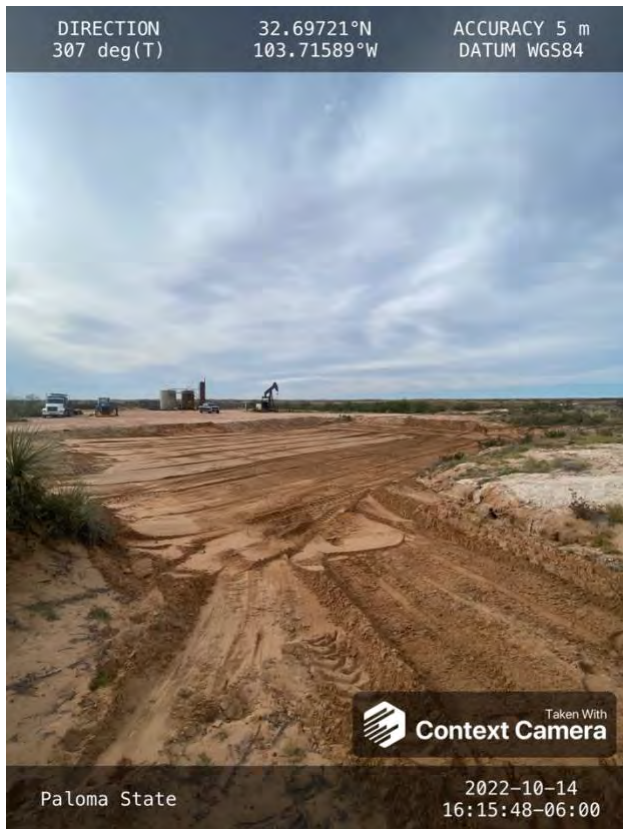
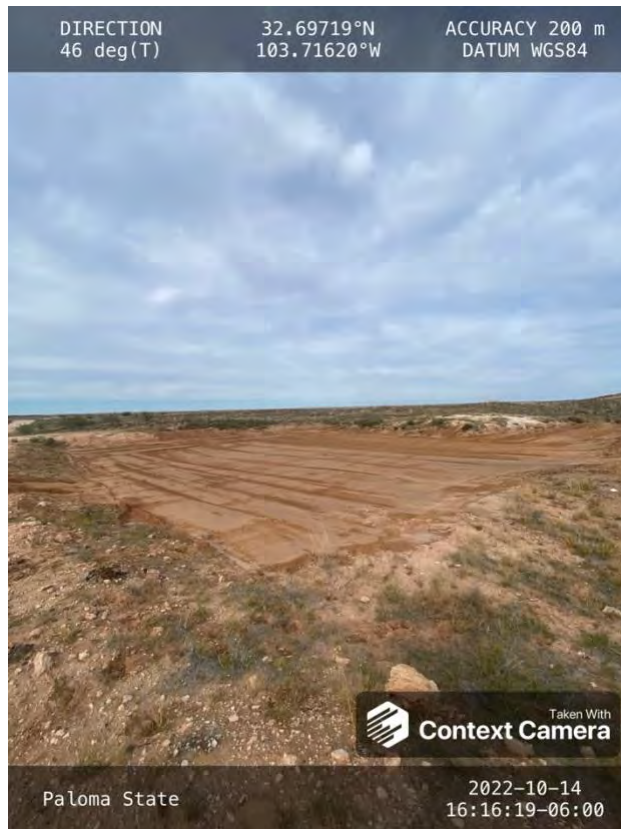
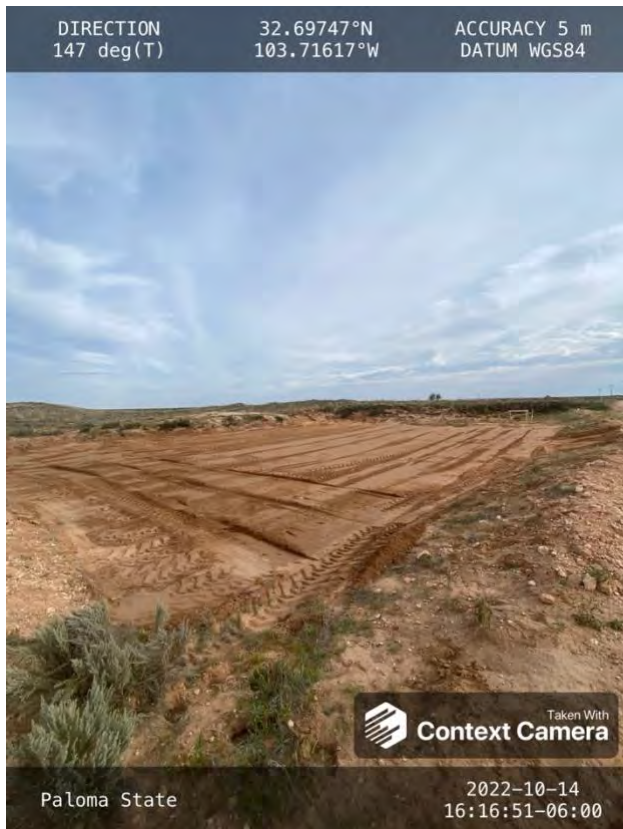
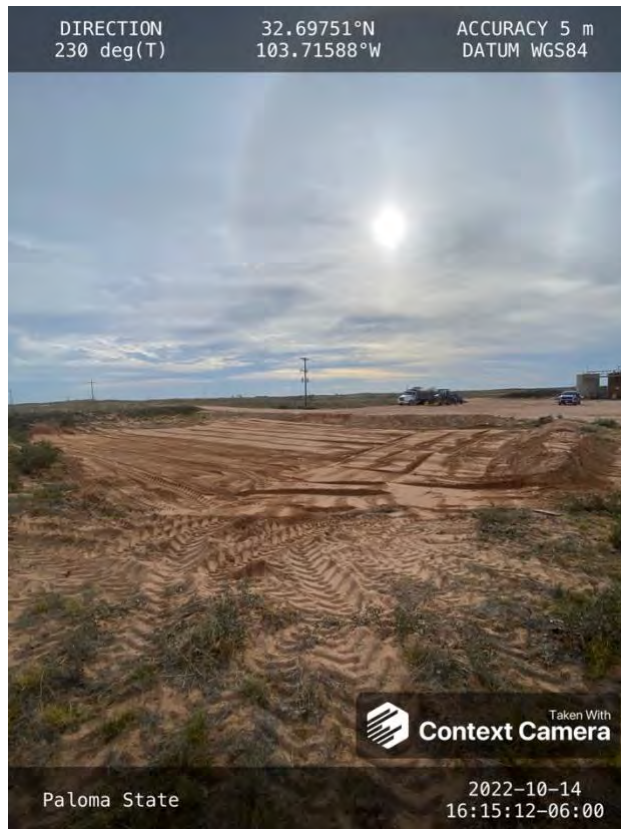
Completed
