Responsible Party: BP America Production Co	OGRID: 778	FINAL – Closure Request
Contact Name: Steve Moskal	Contact Telephone: (505) 330-9179	
Contact email: steven.moskal@bpx.com	Incident # (assigned by OCD) NRM2012166326	
Contact mailing address: 1199 Main St., Suite 101, Durango CO, 81301

Site Name: Northeast Blanco Unit 426A Waterline	Site Type: Water Transfer System
Date Release Discovered: April 14, 2020	API#: No API assigned to ROW

FIELD REPORT:	(circle one): BGT CONFIRMATION / RELEASE INVESTIGATION / <u>OTHER:</u> <u>RELEASE CLOSURE</u>	PAGE #: <u>1</u> of <u>1</u>
----------------------	--	------------------------------

NEBU 426A Waterline
Pipeline Release
4/13/2020

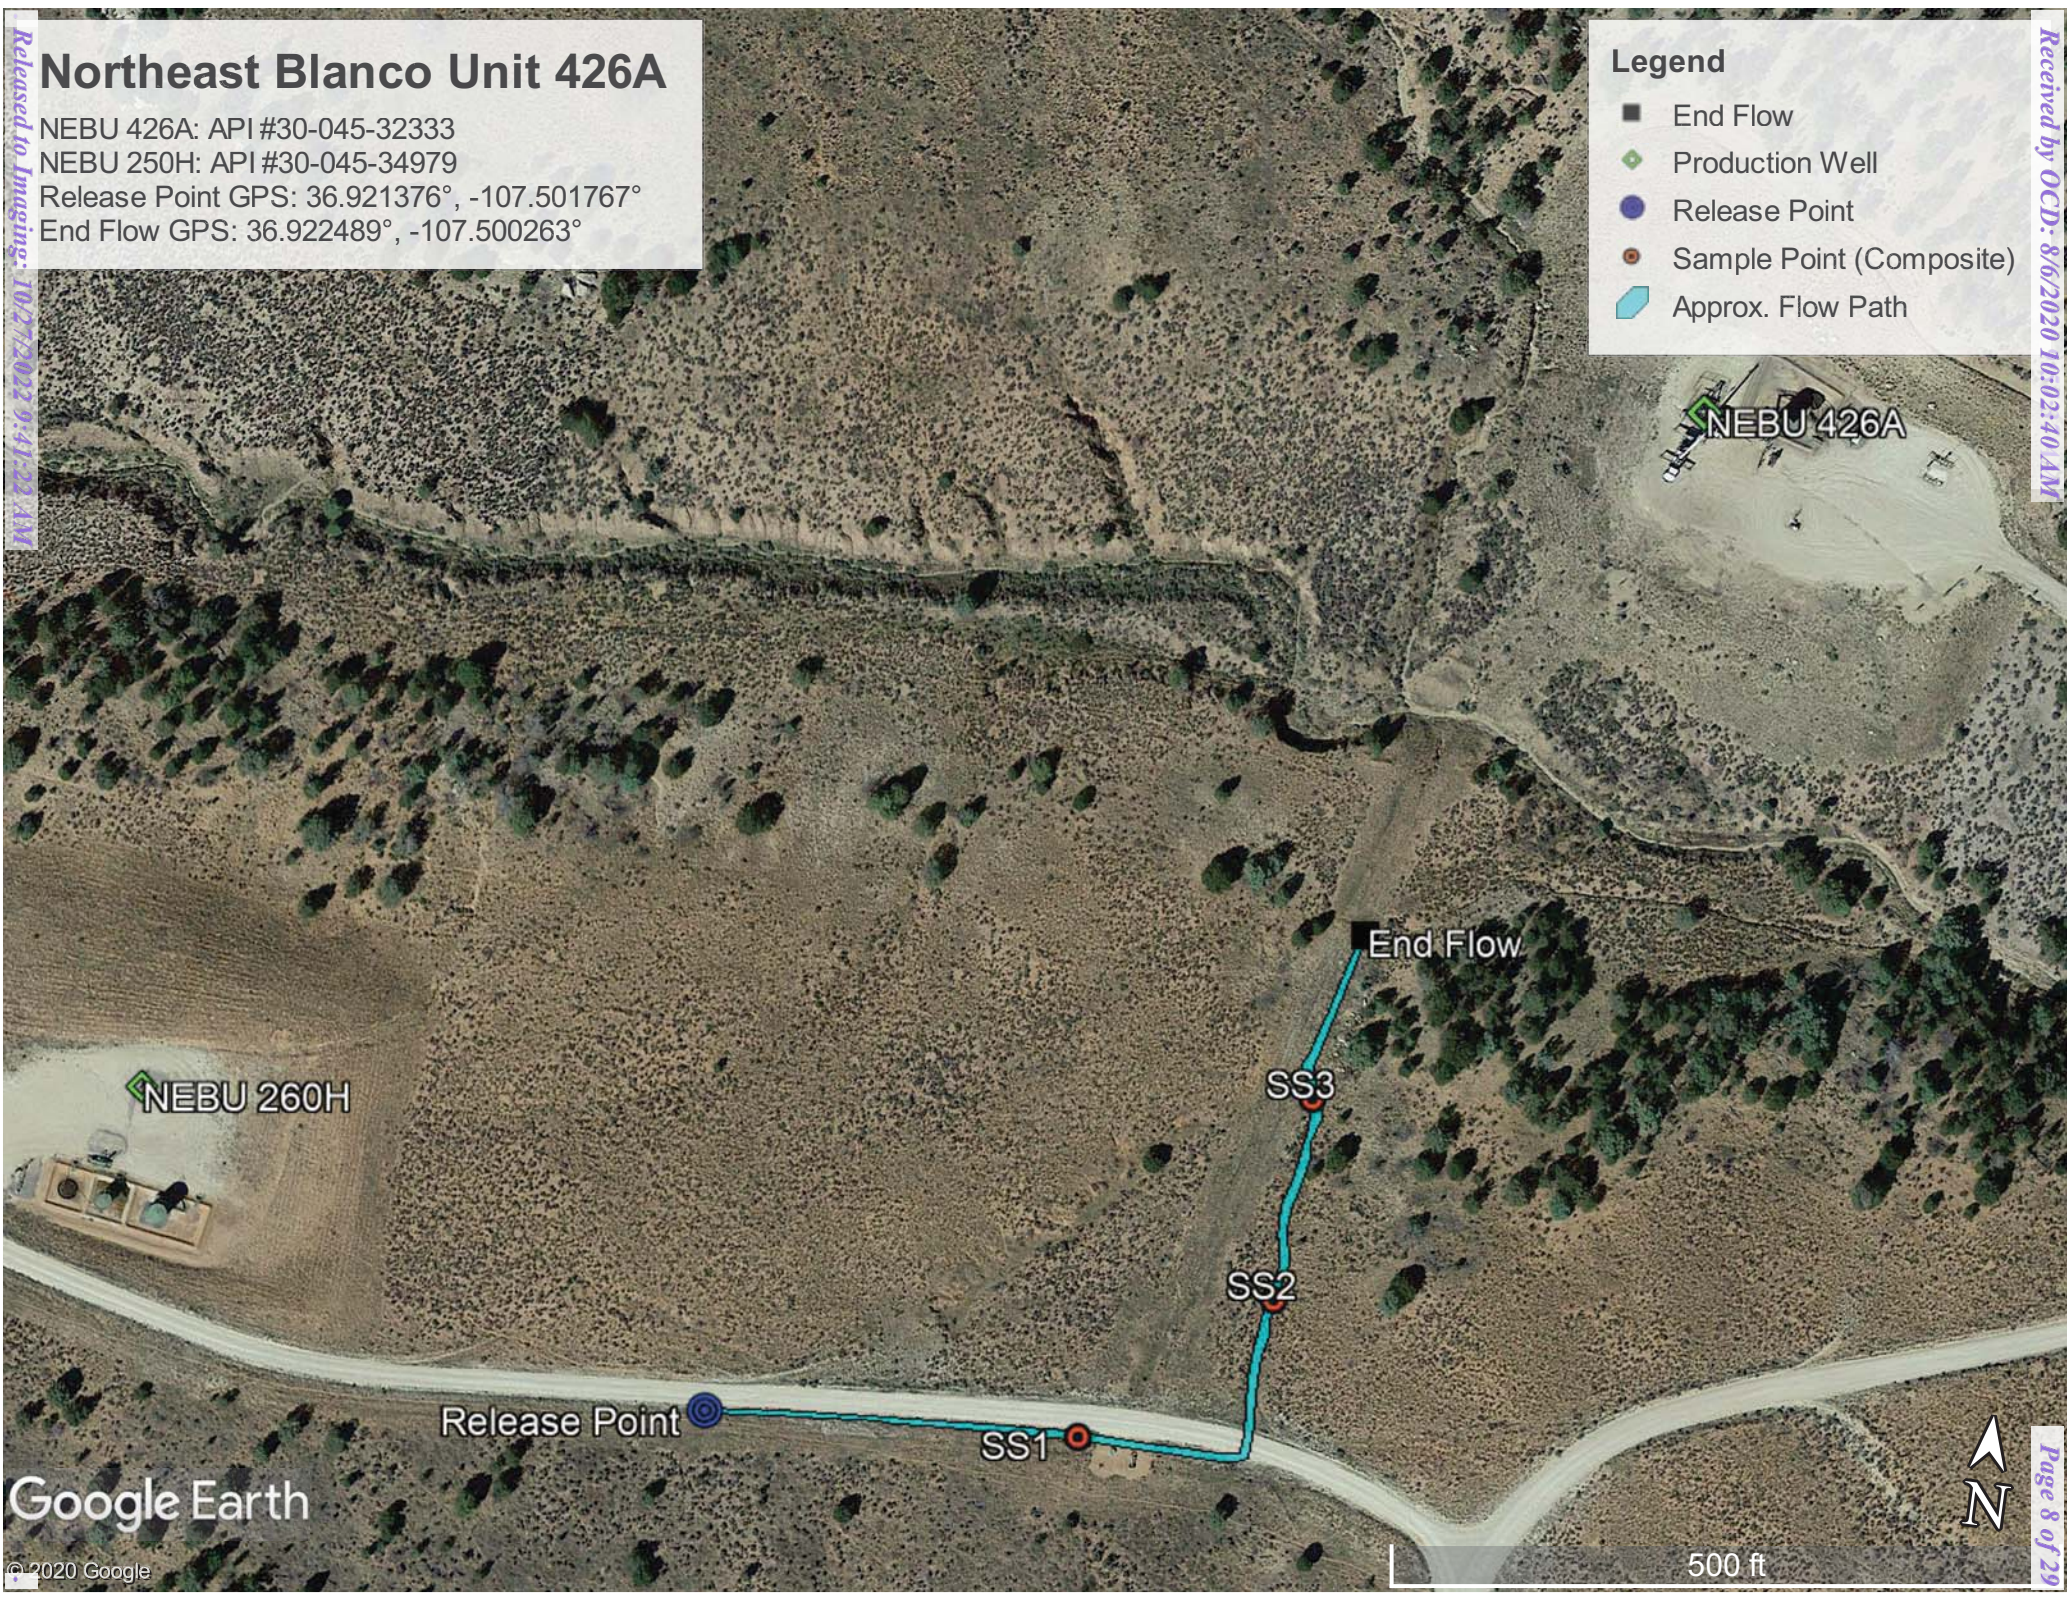
Northeast Blanco Unit 426A

NEBU 426A: API #30-045-32333
NEBU 250H: API #30-045-34979
Release Point GPS: 36.921376°, -107.501767°
End Flow GPS: 36.922489°, -107.500263°

- End Flow
- ◆ Production Well
- Release Point
- Sample Point (Composite)
- ▬ Approx. Flow Path
