September 23, 2020

Vertex Project #: 20E-00141-027

**Spill Closure Report:** Rio Blanco 4 Fed Com #003  
Unit J, Section 4, Township 23 South, Range 34 East  
County: Lea  
API: 30-025-36425  
Incident Tracking Number: NKL1626534300

**Prepared For:** Devon Energy Production Company  
6488 Seven Rivers Highway  
Artesia, New Mexico 88210

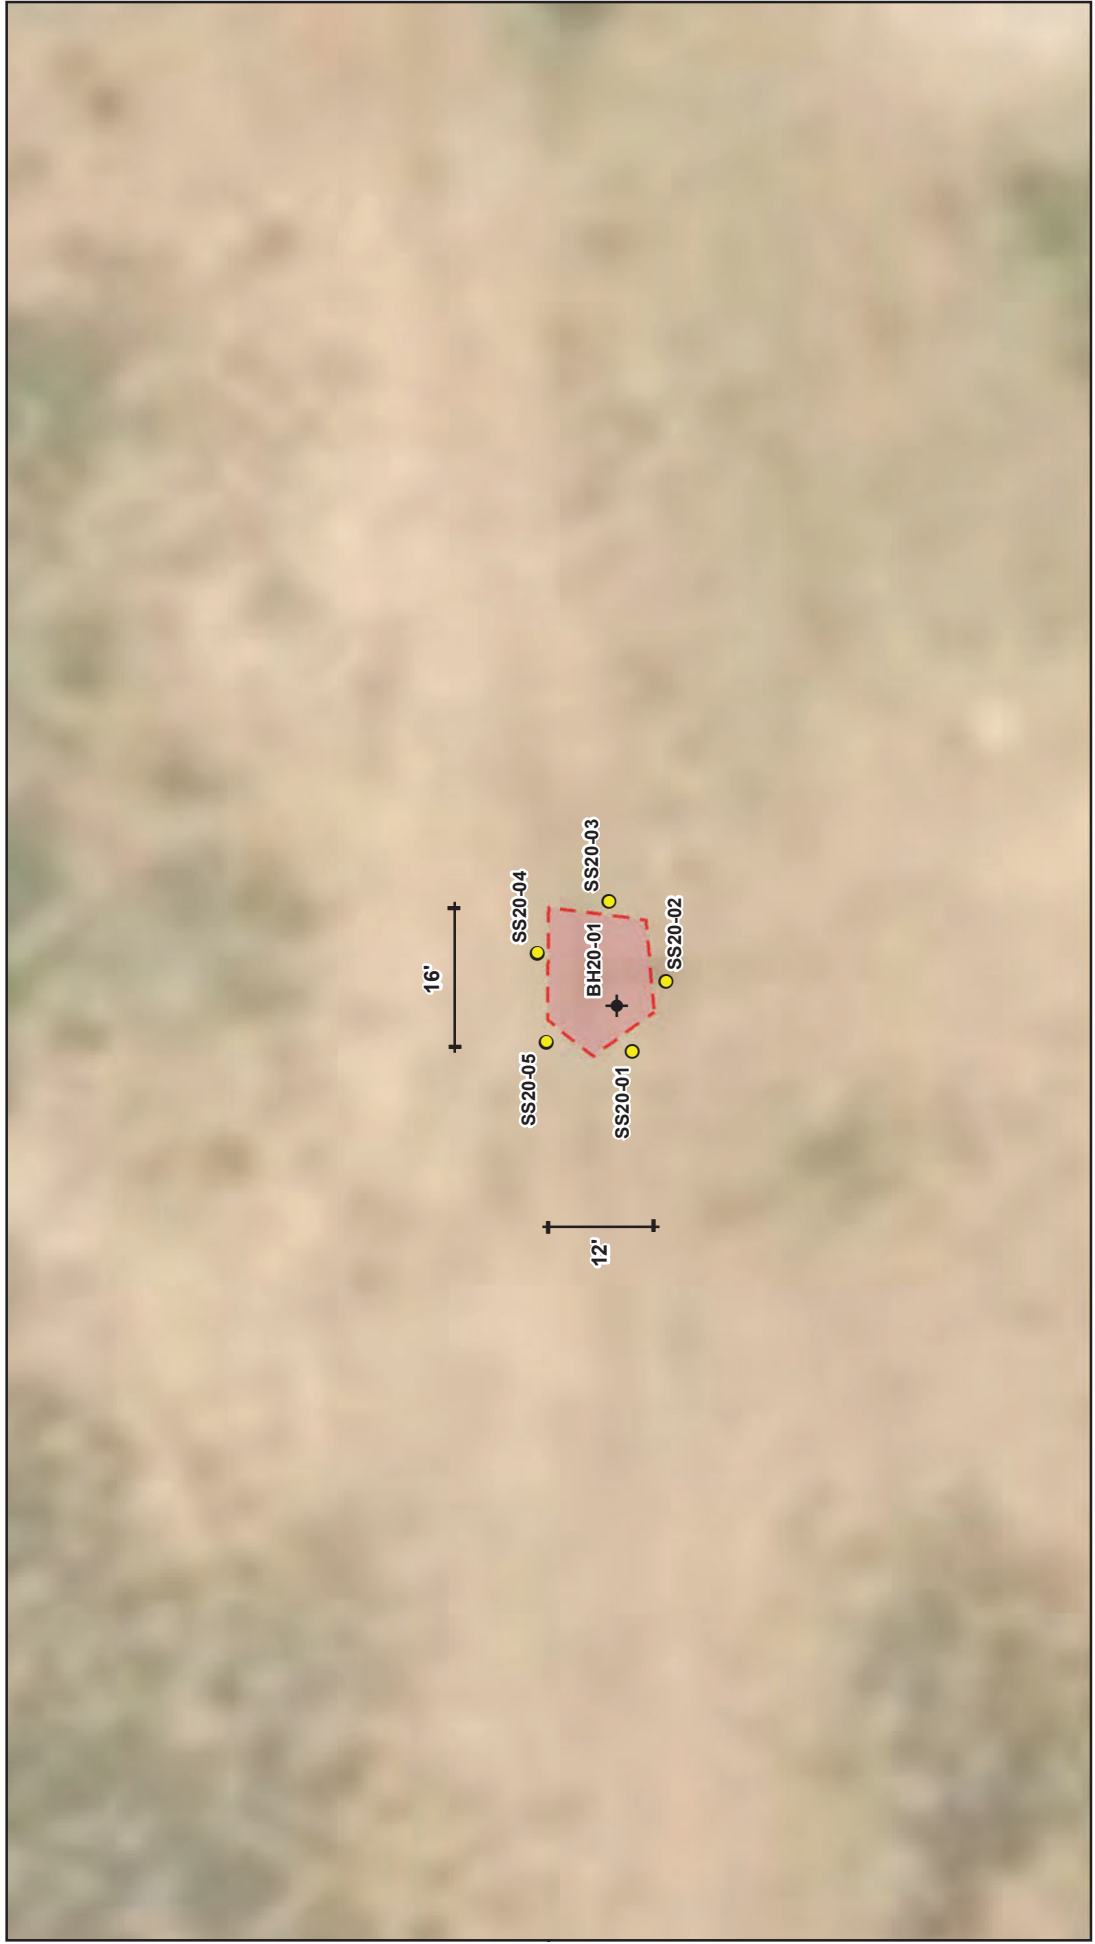
used for oil and gas exploration and production. An aerial photograph and site schematic are included in Attachment 2 (Figure 1).

- Borehole
- Surface Sample
- Approximate Spill Area (~148 sq. ft.)

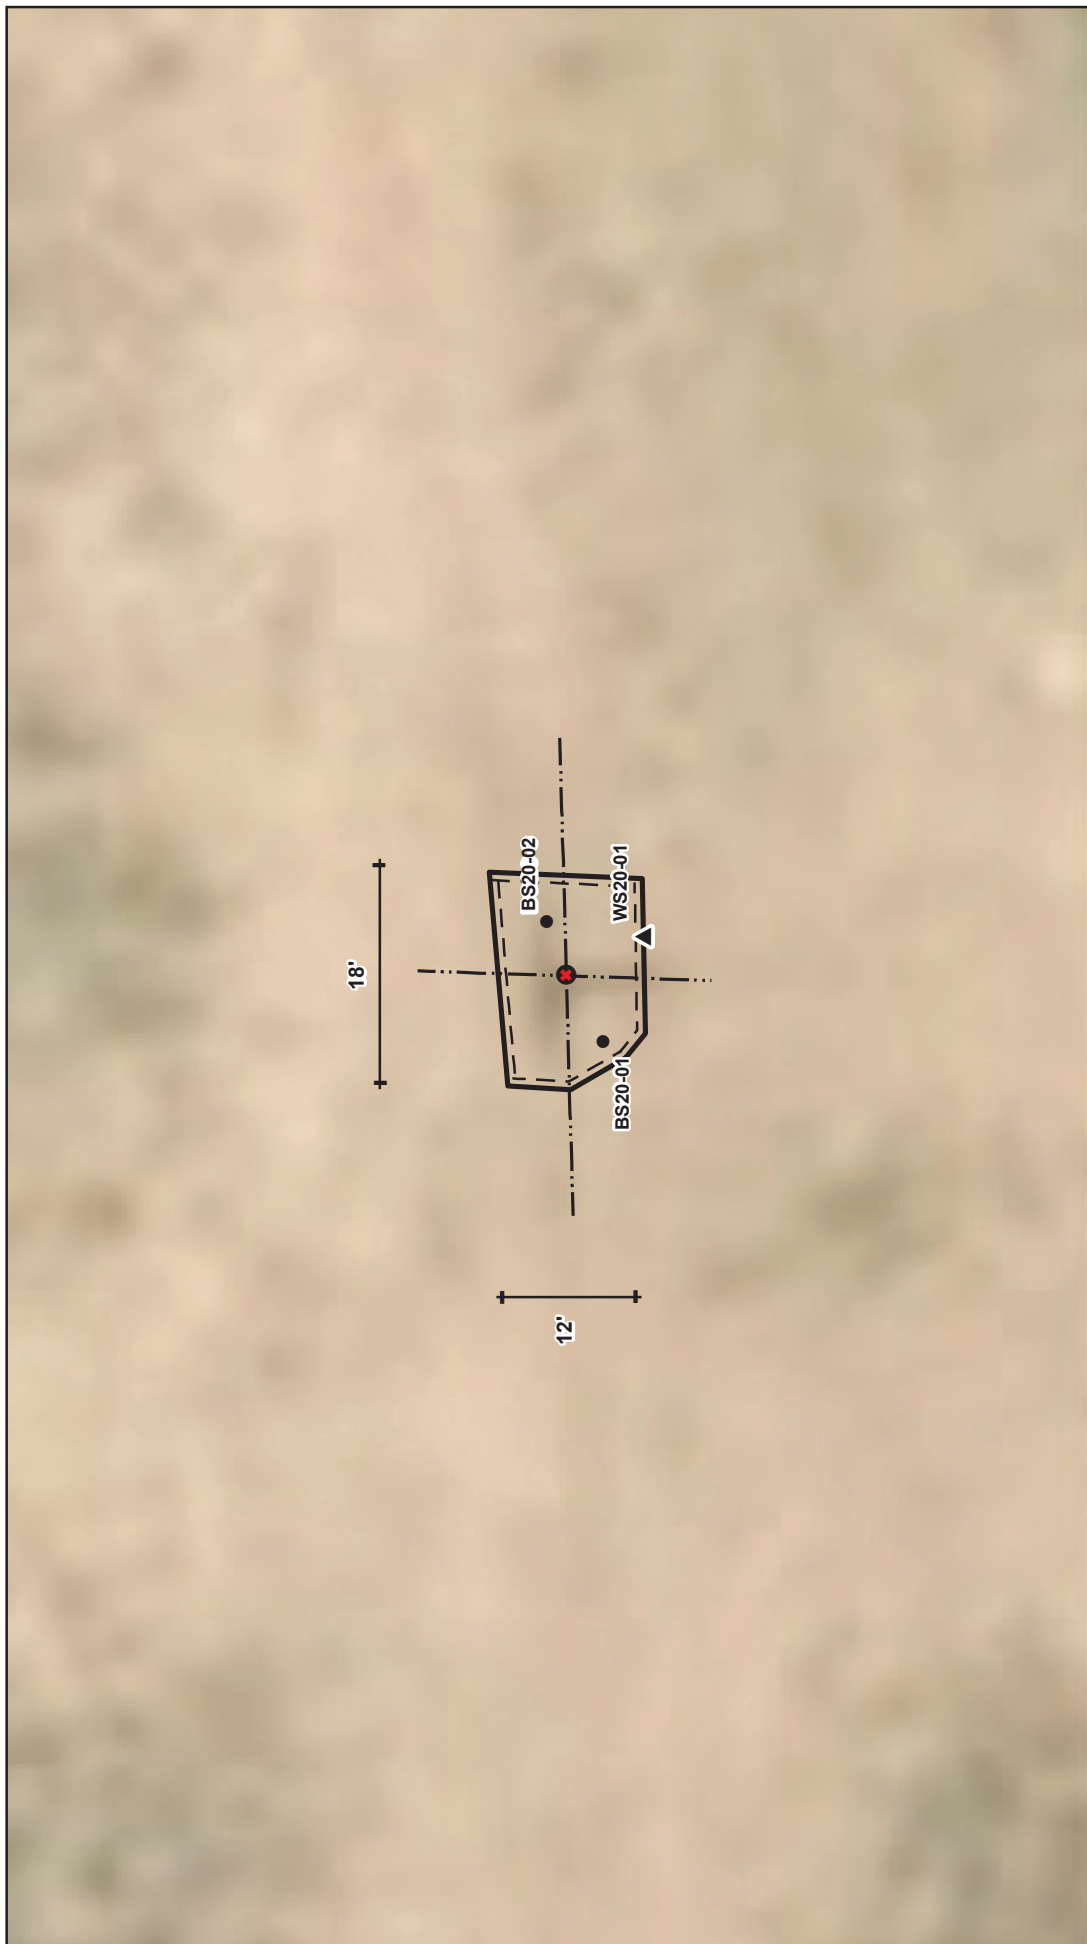
A GeoExplorer 7000 Series Trimble global positioning system (GPS) unit was used to map the approximate center of each of the five-point composite samples. The confirmatory sample locations are presented on Figure 2 (Attachment 2).

- Base Sample
- Point of Release (Pipeline Riser)
- ▲ Wall Sample
- Pipeline (Underground)
-

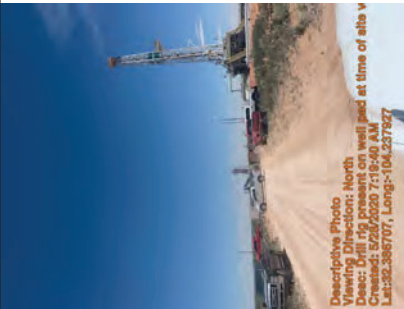
<p>Descriptive Photo Viewing Direction: North Desc: Drill rig present on well pad at time of site visit Created: 9/29/2020 7:19:40 AM Lat:32.386707, Long:-104.237927</p>	<b>Viewing Direction: North</b>

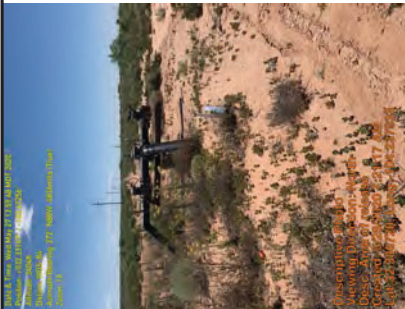
<p>Descriptive Photo Viewing Direction: West Desc: Drill rig present on well pad at time of site visit Created: 9/29/2020 7:22:14 AM Lat:32.386707, Long:-104.237927</p>	<b>Viewing Direction: Southwest</b>

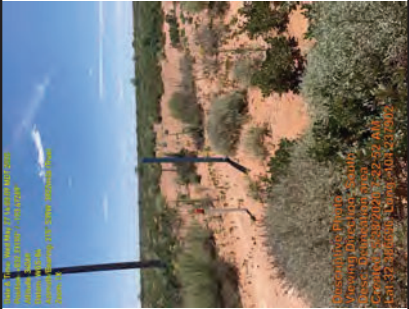
<p>Area 4 Photo, Area 4, 9/29/2020 11:02:29 AM Viewing Direction: South Camera: 1080p, 30 FPS GPS: 33.4411, -111.9111 Description: Photo of wellhead in Area 4, viewed from the south. The wellhead is a large metal structure with pipes. The background shows dry vegetation and a clear sky. Metadata text is overlaid on the bottom right of the image.</p>	
Delineation area	
Viewing Direction: Southeast

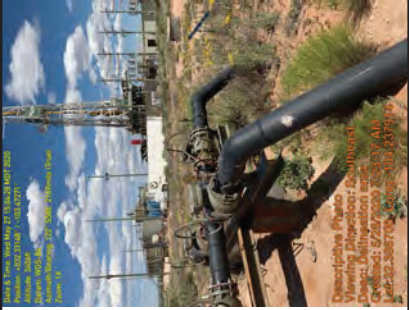
<p>Area 4 Photo, Area 4, 9/29/2020 11:03:09 AM Viewing Direction: Southeast Camera: 1080p, 30 FPS GPS: 33.4411, -111.9111 Description: Photo of wellhead in Area 4, viewed from the southeast. The wellhead is a large metal structure with pipes. The background shows dry vegetation and a clear sky. Metadata text is overlaid on the bottom right of the image.</p>	
Delineation area	
Viewing Direction: Southwest

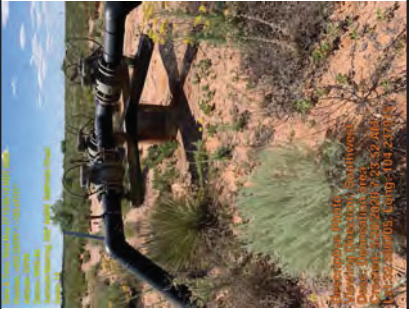
<p>Area 4 Photo, Area 4, 9/29/2020 11:02:29 AM Viewing Direction: Southwest Camera: 1080p, 30 FPS GPS: 33.4411, -111.9111 Description: Photo of wellhead in Area 4, viewed from the southwest. The wellhead is a large metal structure with pipes. The background shows dry vegetation and a clear sky. Metadata text is overlaid on the bottom right of the image.</p>

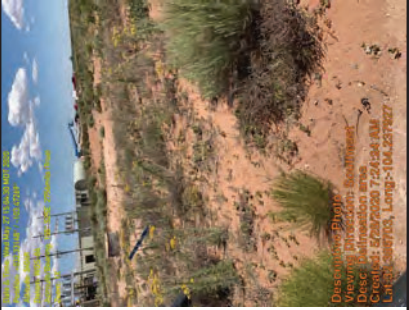
<p>Area 4 Photo, Area 4, 9/29/2020 11:03:09 AM Viewing Direction: Southeast Camera: 1080p, 30 FPS GPS: 33.4411, -111.9111 Description: Photo of wellhead in Area 4, viewed from the southeast. The wellhead is a large metal structure with pipes. The background shows dry vegetation and a clear sky. Metadata text is overlaid on the bottom right of the image.</p>	
Delineation area

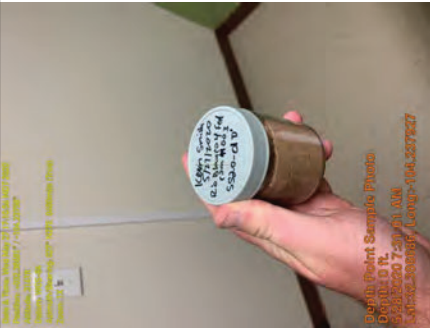
<p><b>Sample Point ID: SS20-01</b></p>

<p>Depth: 0 ft.</p>	<p><b>Sample Point ID: SS20-02</b></p>

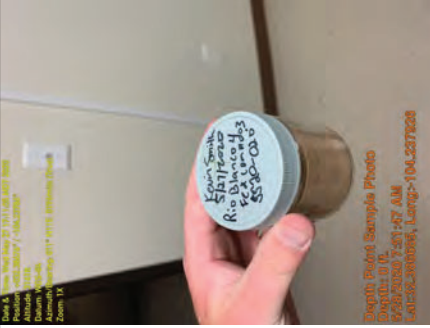
<p>Depth: 0 ft.</p>
<p><b>Sample Point ID: SS20-03</b></p>

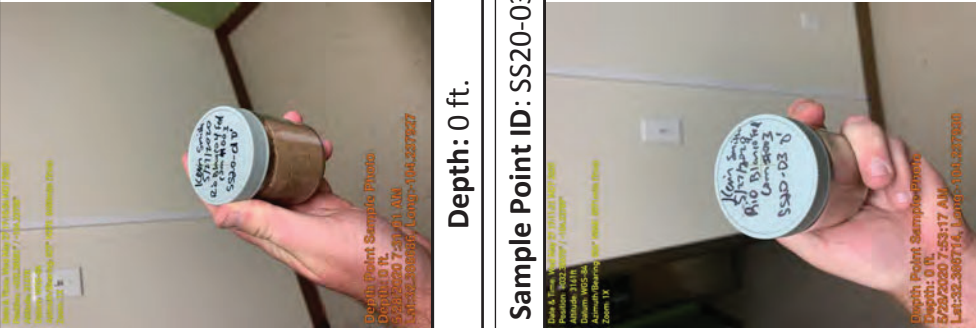
<p>Depth: 0 ft.</p>	<p><b>Sample Point ID: SS20-04</b></p>

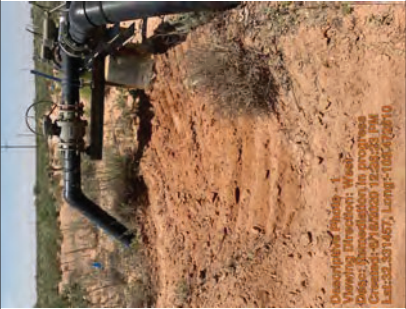
<div>Sample Photo 13 Viewing Direction: West Date: 9/29/2020 12:46:25 PM Created: 9/29/2020 12:46:25 PM Lat: 33.371455, Long: -103.472891</div></div> <div>Remediation in progress</div>	<div>Viewing Direction: South</div> <div>

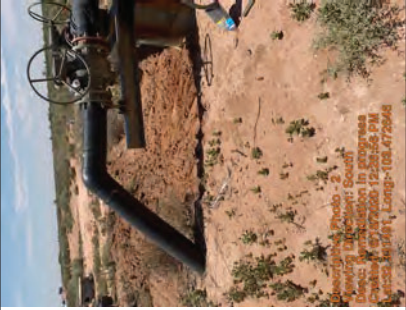
<div>Sample Photo 4 Viewing Direction: South Date: 9/29/2020 12:46:25 PM Created: 9/29/2020 12:46:25 PM Lat: 33.371455, Long: -103.472891</div></div> <div>Remediation in progress</div>
<div>Viewing Direction: East</div> <div>

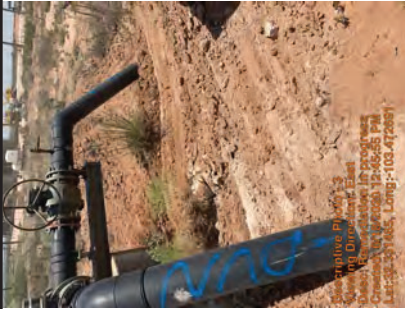
<div>Sample Photo 13 Viewing Direction: East Date: 9/29/2020 12:46:25 PM Created: 9/29/2020 12:46:25 PM Lat: 33.371455, Long: -103.472891</div></div> <div>Remediation in progress</div>	<div>Viewing Direction: East</div> <div>

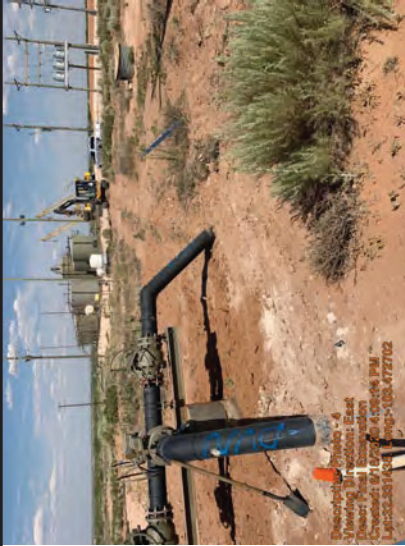
<div>Sample Photo 4 Viewing Direction: East Date: 9/29/2020 12:46:25 PM Created: 9/29/2020 12:46:25 PM Lat: 33.371455, Long: -103.472891</div></div> <div>Final Excavation</div>

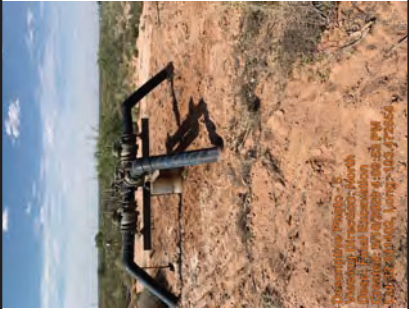
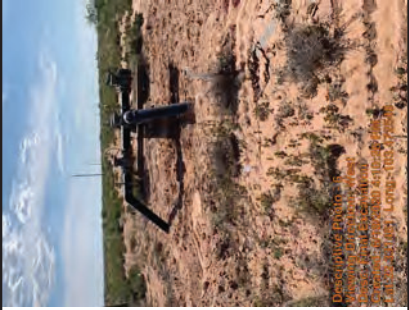
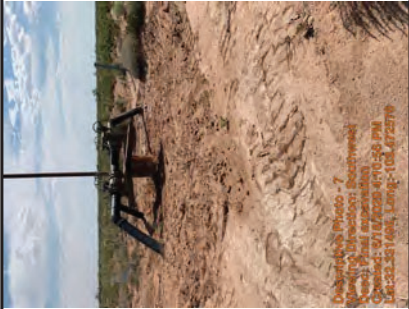
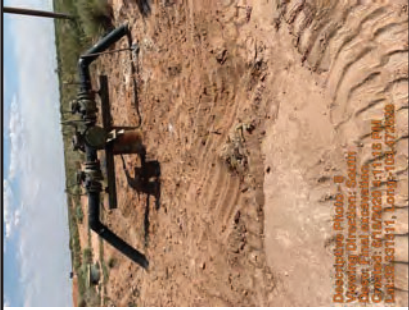
Final Excavation	Final Excavation
Viewing Direction: Southwest	Viewing Direction: South

Final excavation	Final excavation
