Release Notification

Natural gas 2"-pipeline leak discovered during a proactive leak survey. A leak occurred on the well tie line for the Hargrave 1. Final investigation determined the pipe failure was caused by external corrosion and it has been repaired.

**RE: CLOSURE REPORT (REVISED)**  
**Hanks 2 Pipeline Release**  
**NMOCD Incident No. NRM2027337168**  
**NW¼ NW¼, Section 6, T27N, R9W**  
**San Juan County, New Mexico**

## Hanks 2 Pipeline Excavation Clearance Report - REVISED

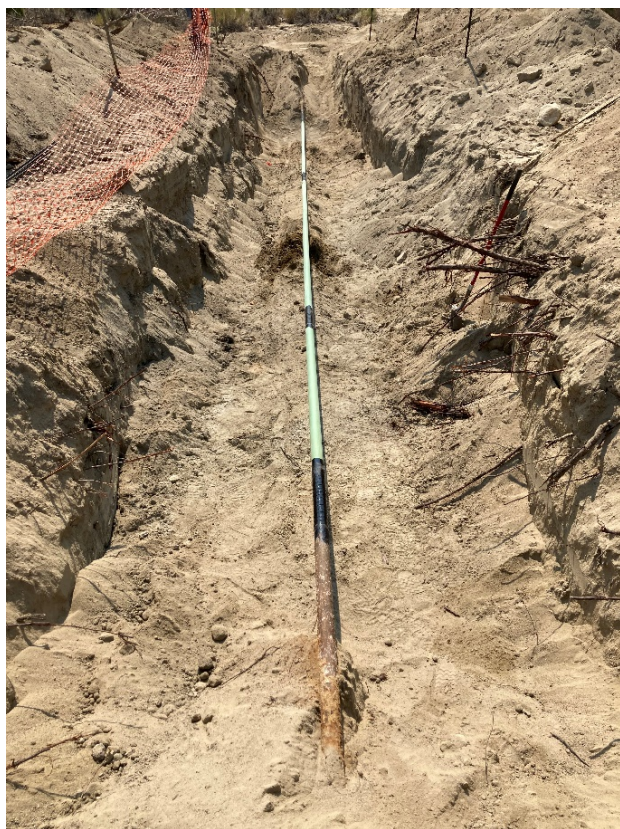
Photo 1: Excavated pipeline, October 1, 2020.

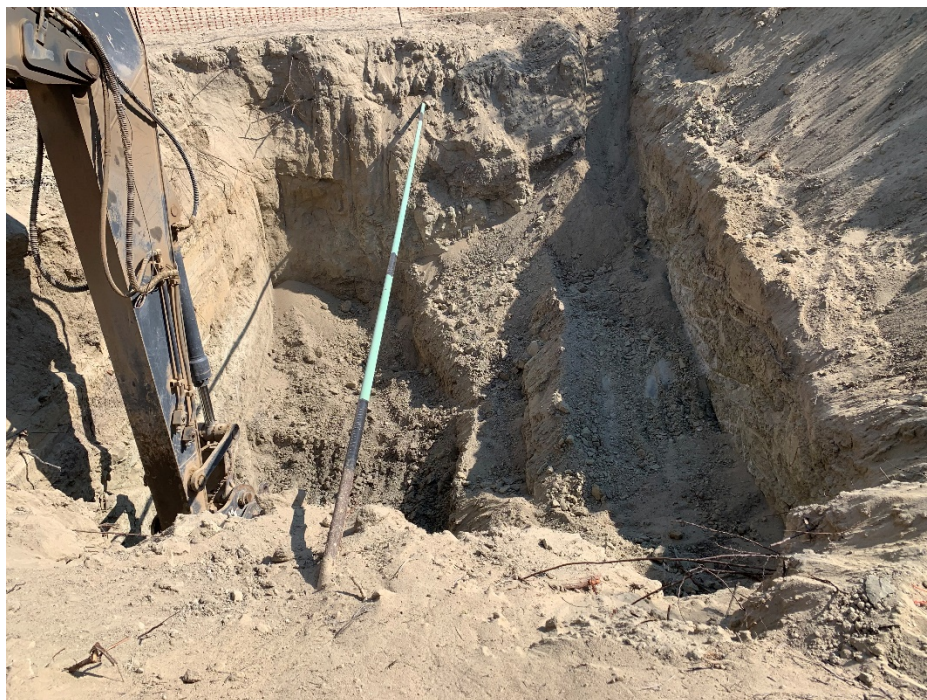
Photo 2: Final excavation extents, October 5, 2020.

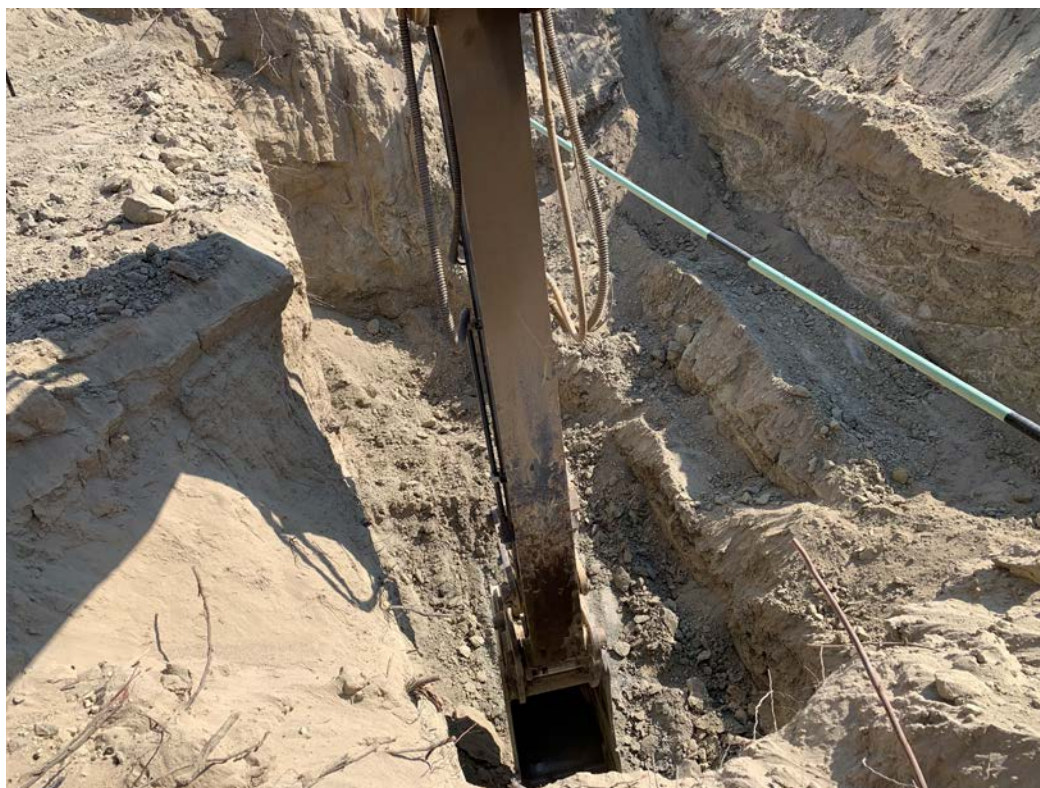
Photo 3: Final excavation extents, October 5, 2020.

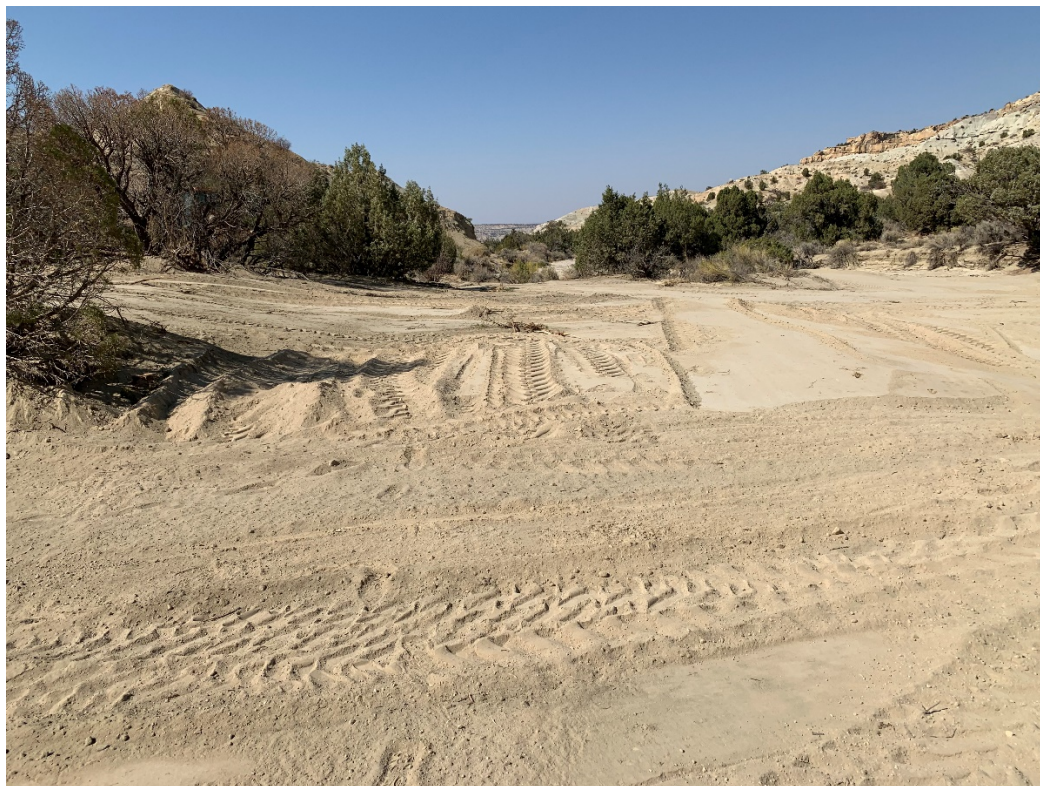
Photo 4: Backfilled excavation, October 7, 2020.
