Remediation and Closure Report

Parkway 17 State Com 4H-7H Battery
Eddy County, New Mexico
Incident # nAPP2206234416

Cimarex Energy Company of Colorado
600 N. Marienfeld Street, Ste. 600
Midland, TX 79701

July 11, 2022

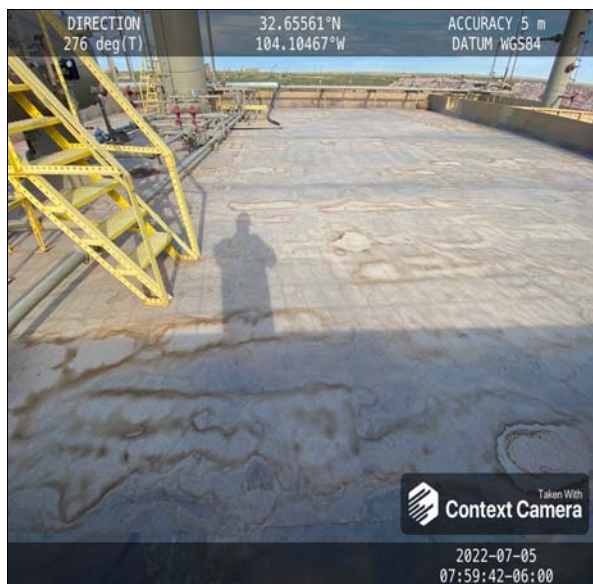
Photograph No.3 Description:

West side of liner

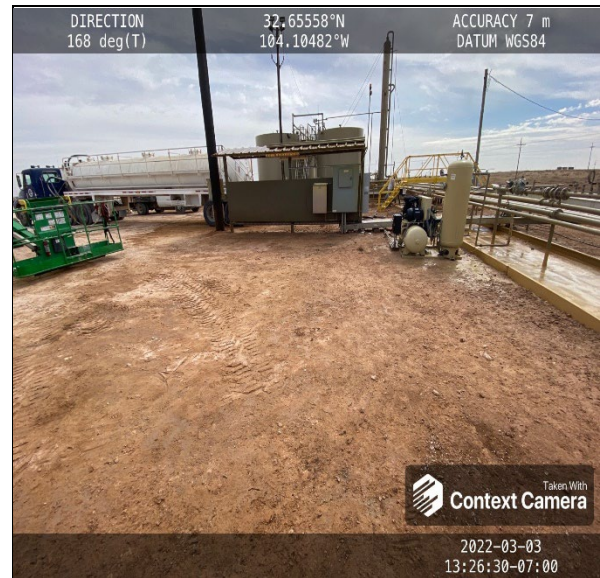
**Photograph No.2 Description:**

Impacted Area around utility panel.

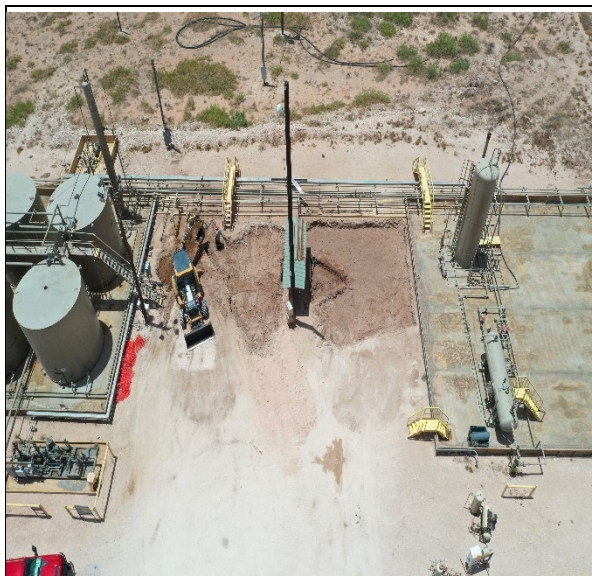
Photograph No.5 Description:

Aerial photo of excavated area.
