CARMONA RESOURCES

**Work Plan**  
**Horse 29 State #1H**  
**Lea County, New Mexico**  
**Incident ID: NAPP2228545175**  
**Unit D Sec 29 T25S R34E**  
**32.108063°, -103.506677°**

**Produced Water Release**  
**Point of Release: Produced Water Line**  
**Release Date: 07/09/2022**  
**Volume Released: >5 barrels of Produced Water**  
**Volume Recovered: 0 barrels of Produced Water**

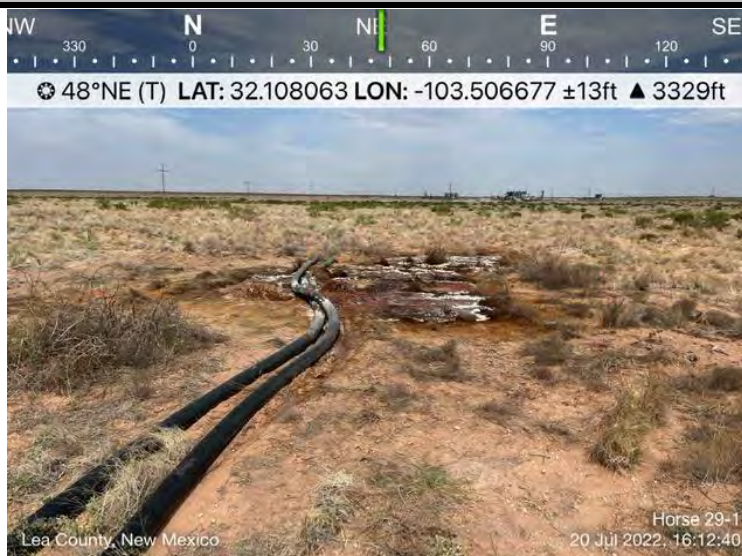
**Photograph No. 1****Facility:** Horse 29 State #1H**County:** Lea County, New Mexico**Description:**View Northeast, areas of S-1/T-1/BH-1  
and S-2/T-2/BH-2.

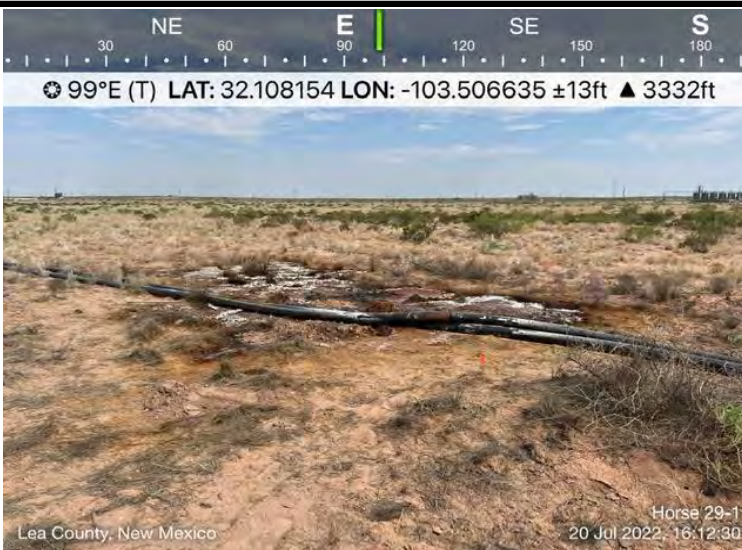
**Photograph No. 2****Facility:** Horse 29 State #1H**County:** Lea County, New Mexico**Description:**View Northeast, areas of S-1/T-1/BH-1  
and S-2/T-2/BH-2.

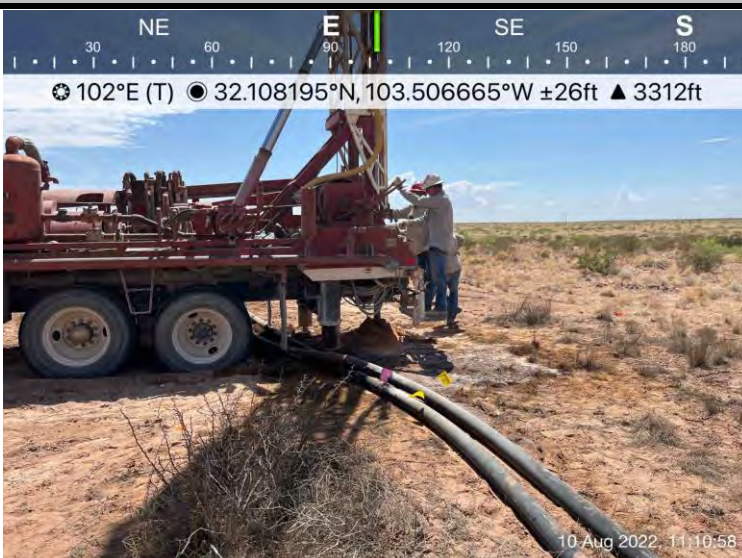
**Photograph No. 3****Facility:** Horse 29 State #1H**County:** Lea County, New Mexico**Description:**

View East, of drilling activities.
