Pima Environmental Services
5614 N. Lovington Highway
Hobbs, NM 88240
575-964-7740

June 22, 2022

Re: Site Assessment, Remediation, and Closure Report (Revised)
Boyd X State #010 Battery
API No. 30-015-28541
GPS: Latitude 32.65550 Longitude -104.48760
UL- O, Sec. 16, T19S, R25E
Eddy County, NM
NMOCD Ref. No. NCS2002754182

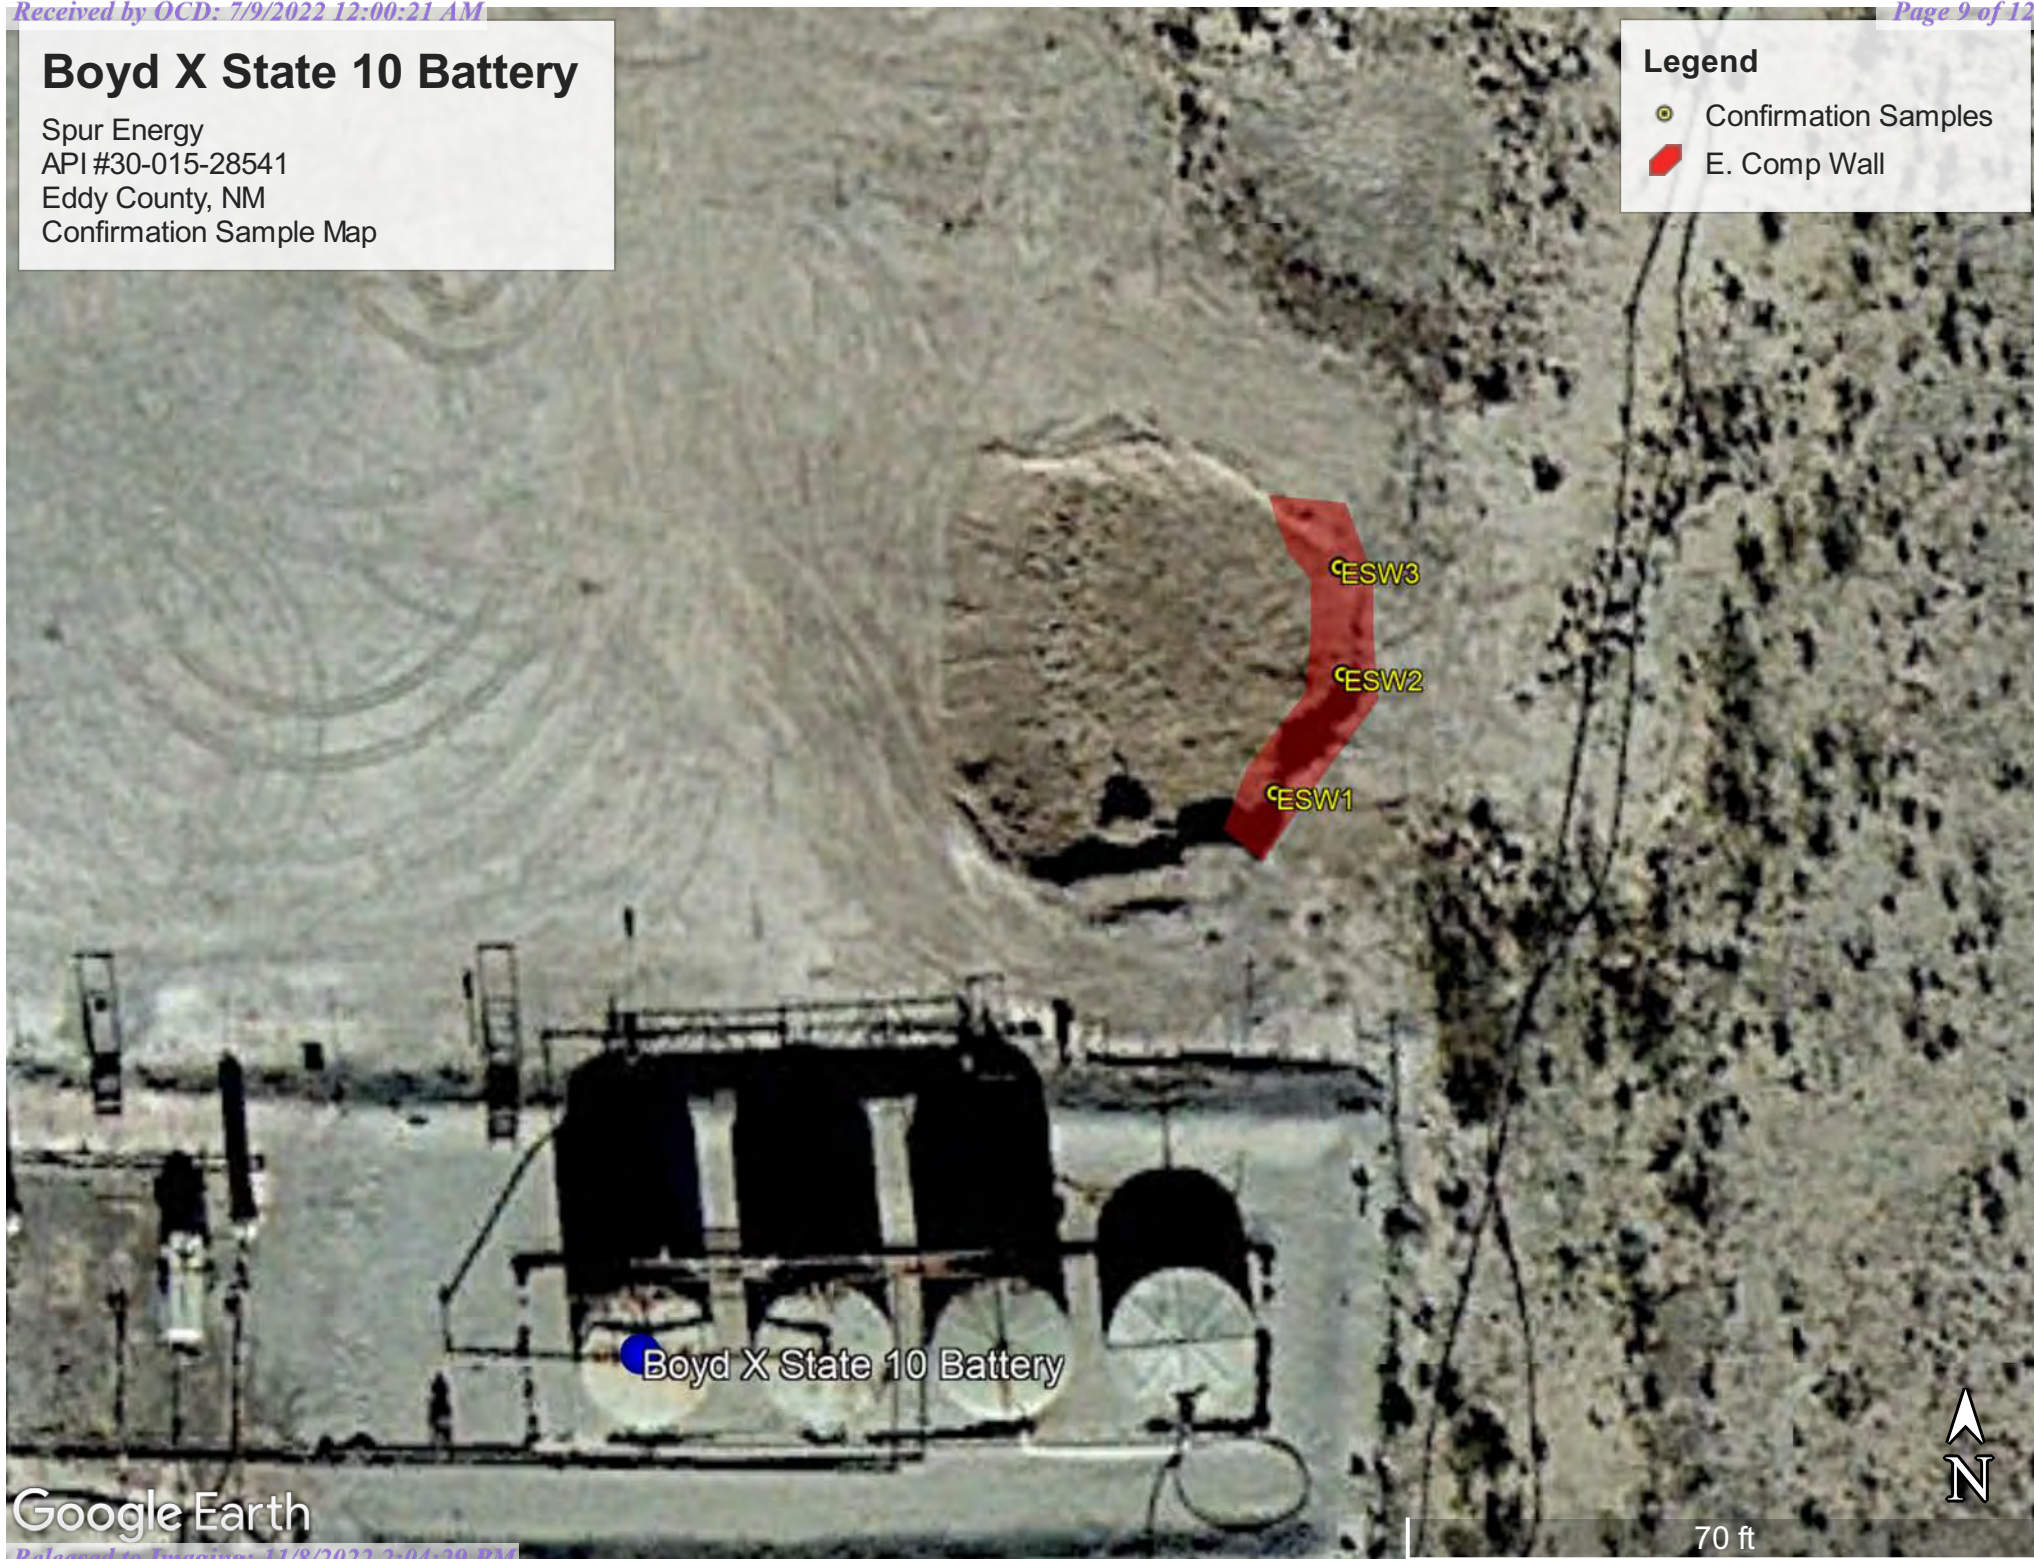
Spur Energy
API #30-015-28541
Eddy County, NM
Confirmation Sample Map

- Confirmation Samples
- E. Comp Wall

On June 12, 2022, Pima returned to the site due to an OCD rejection to conduct further remedial activities. We excavated the E. Comp Wall area to a depth of 4', then collected confirmation samples from the area and beyond to verify all soil was under the regulatory limits. The contaminated soil was hauled to an approved, lined disposal facility and clean backfill material was brought in. A Confirmation Sample Map can be found in Figure 5.

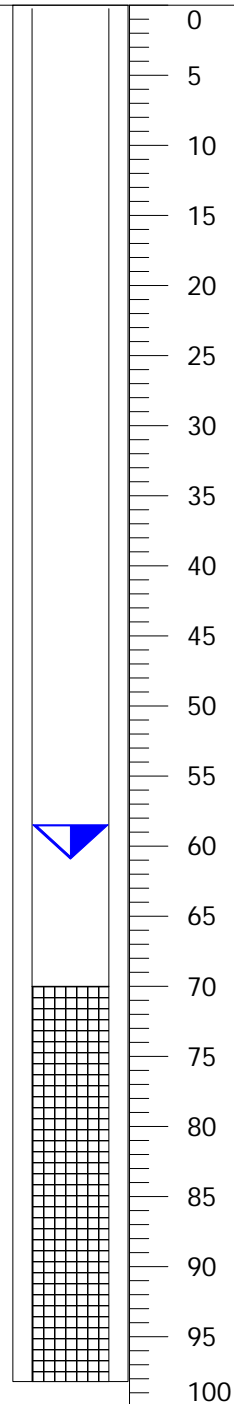
MW-1
Boyd X State #10
Camera (Heron)
8/4/21 7:30am

Water Level 61.2

NOTES- Casing was 2" Certa-Loc, only the casing was gauged and viewed via Heron down hole camera
approx location is 32.655787 -104.487946, well construction is unknown
