Closure Report

Tenneco SWD Battery
Lea County, New Mexico
API # 30-025-25762
nAPP2226431261

EOG Resources Inc.
104 S. 4th Street
Artesia, NM 88210

Talon/LPE
408 W. Texas Avenue
Artesia, New Mexico 88210

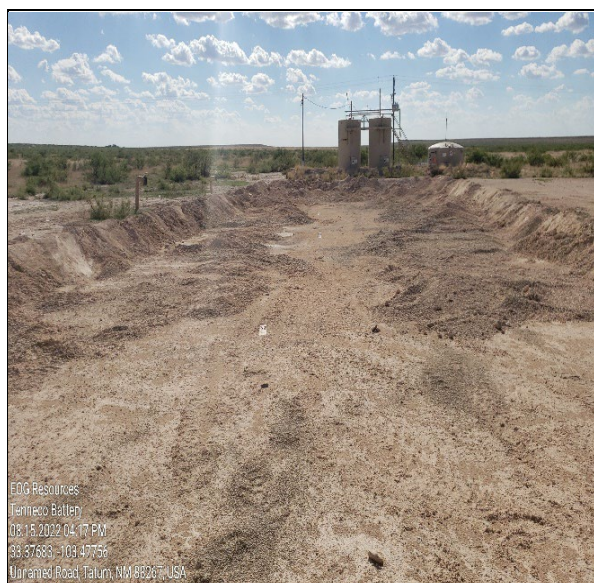
Photograph No.1 Description:

Pad Impact-Sample Positions

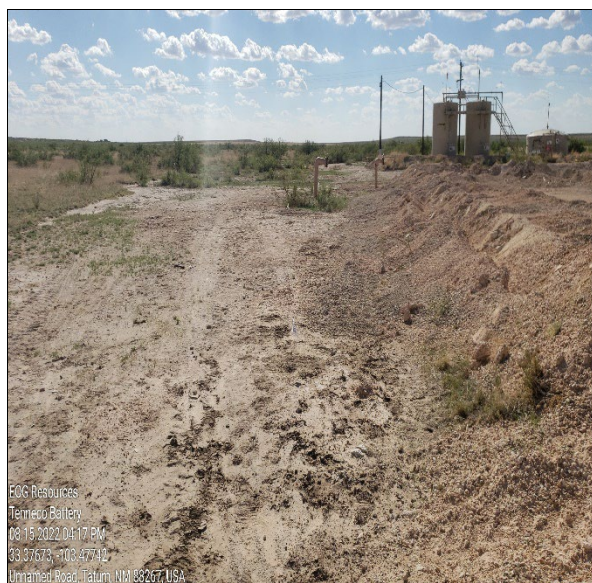
Photograph No.2 Description:

Impacted Pasture Area-Sample Positions

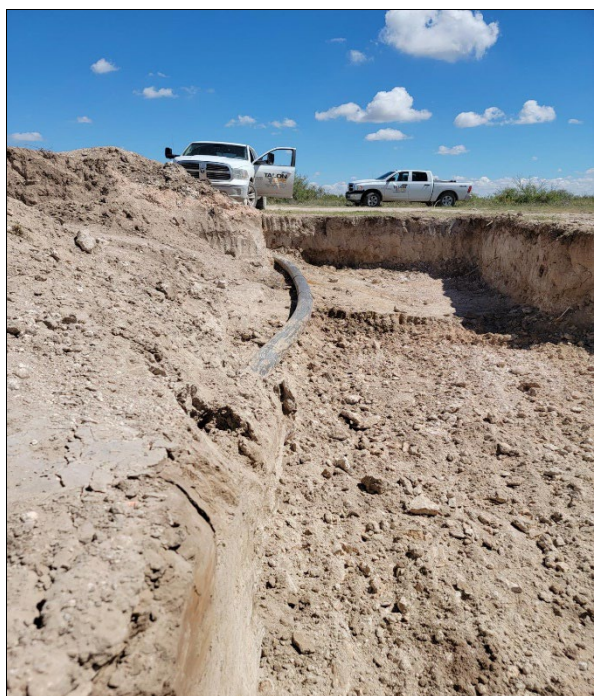
Photograph No.3 Description:

Excavation of Pad Impact HP Flow line

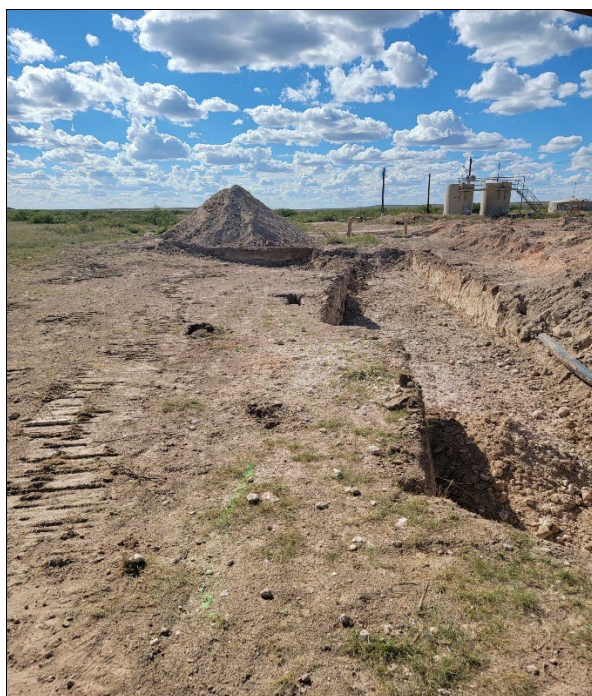
Photograph No.4 Description:

Excavation of Pasture Area exit flow line.

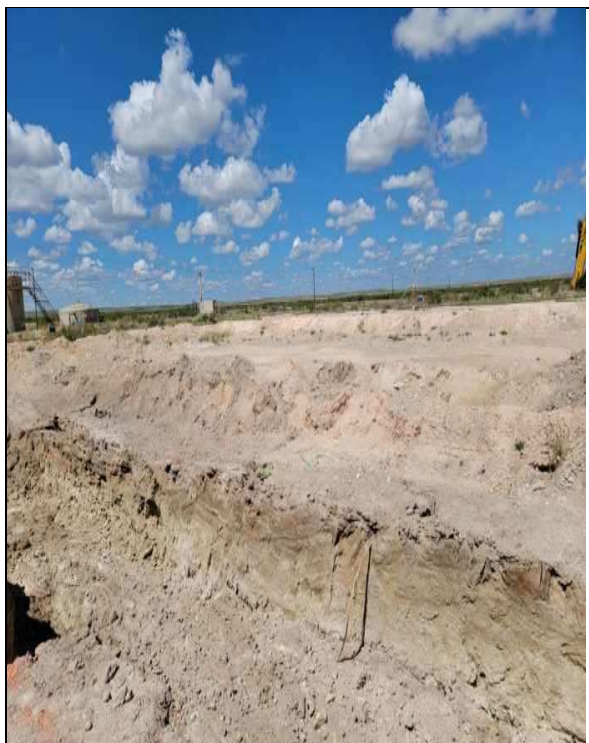
Photograph No.5 Description:

Pasture Excavation

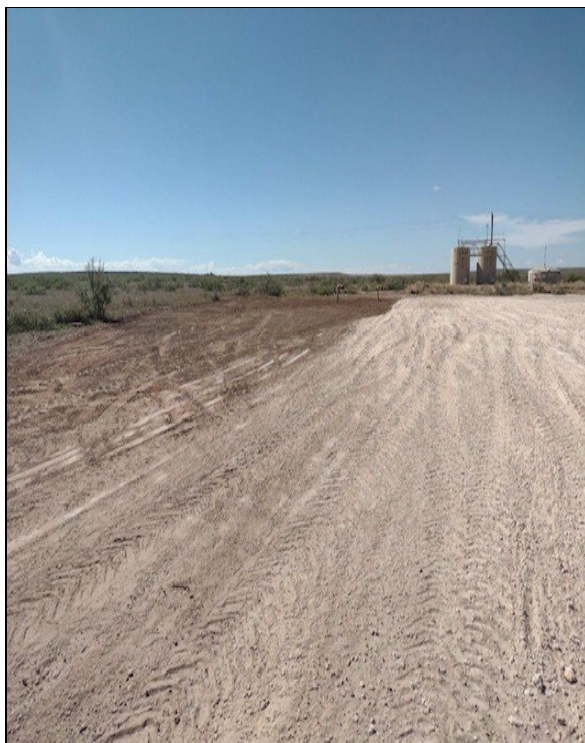
Photograph No.6 Description:

Pasture Backfilled with Topsoil-Seeded

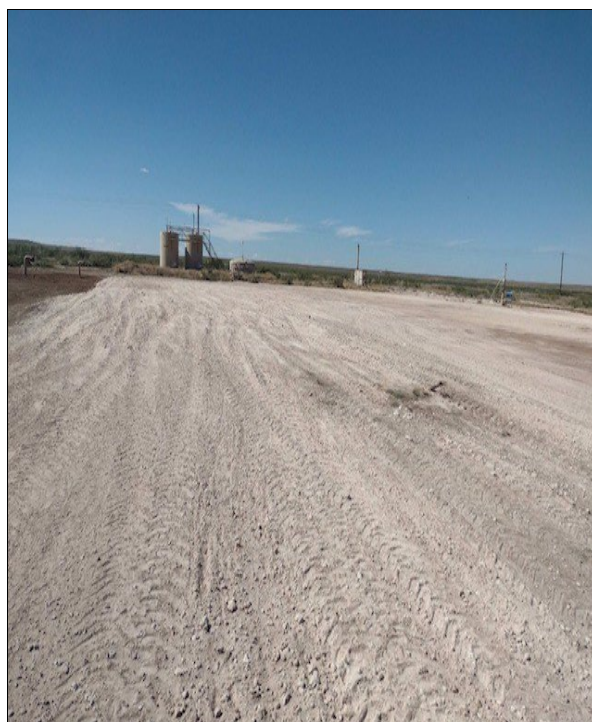
Photograph No. 7 Description:

Pad Area Backfilled-Compacted to Grade
