CLOSURE REPORT

**Trunk K 16 Inch (11/23/21)
Unit Letter N, S5 T26N R7W
Rio Arriba County, New Mexico**

NM EMNRD OCD Incident ID No. NAPP2132760865

September 27, 2022
Ensolum Project No. 05A1226169

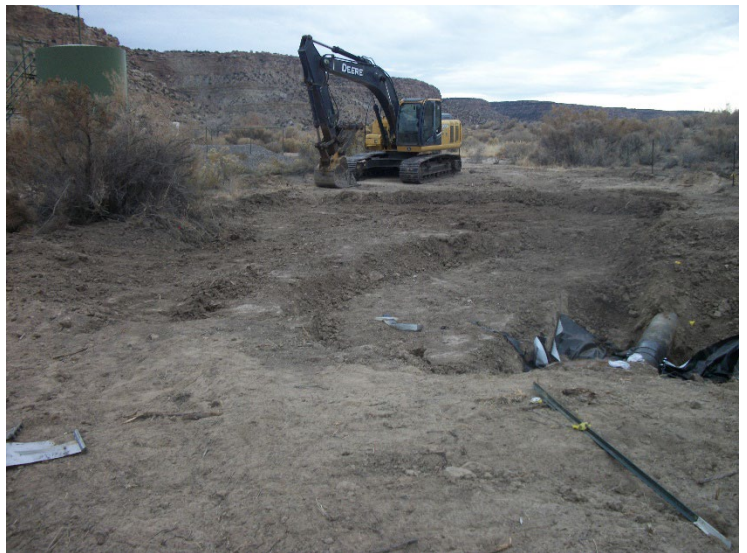
**Photograph 2**

Photograph Description: View of the excavated flow path.

The flow path excavation was backfilled with imported fill and was then contoured to surrounding grade. Enterprise has been unable to obtain suitable pipe to complete pipeline repairs, therefore a portion of the excavation remains open. Once the permanent pipeline repairs are completed, Enterprise will backfill the excavation with imported fill and then contour to the surrounding grade. Enterprise will re-seed the Site with an approved seeding mixture.

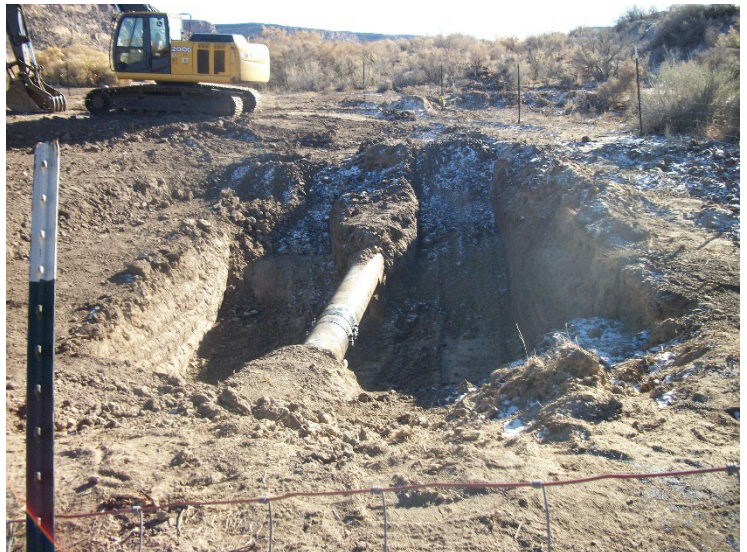
**Photograph 3**

The final excavation measured approximately 25 feet long and 25 feet wide at the maximum extents. The maximum depth of the excavation measured approximately six feet bgs. The lithology encountered during the completion of remediation activities consisted primarily of unconsolidated silty sand underlain by silty clay.

Photograph Description: View of the final excavation.

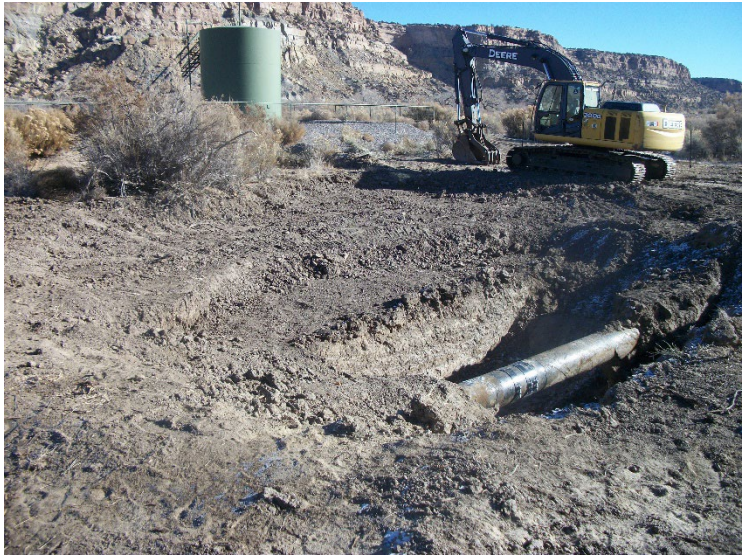
Photograph 4

Photograph Description: View of the final excavation.
