CLOSURE REPORT

Hughes #14 (08/04/22)
Unit Letter K, S30 T26N R7W
Rio Arriba County, New Mexico

New Mexico EMNRD OCD Incident ID No. NAPP2222032322

October 27, 2022

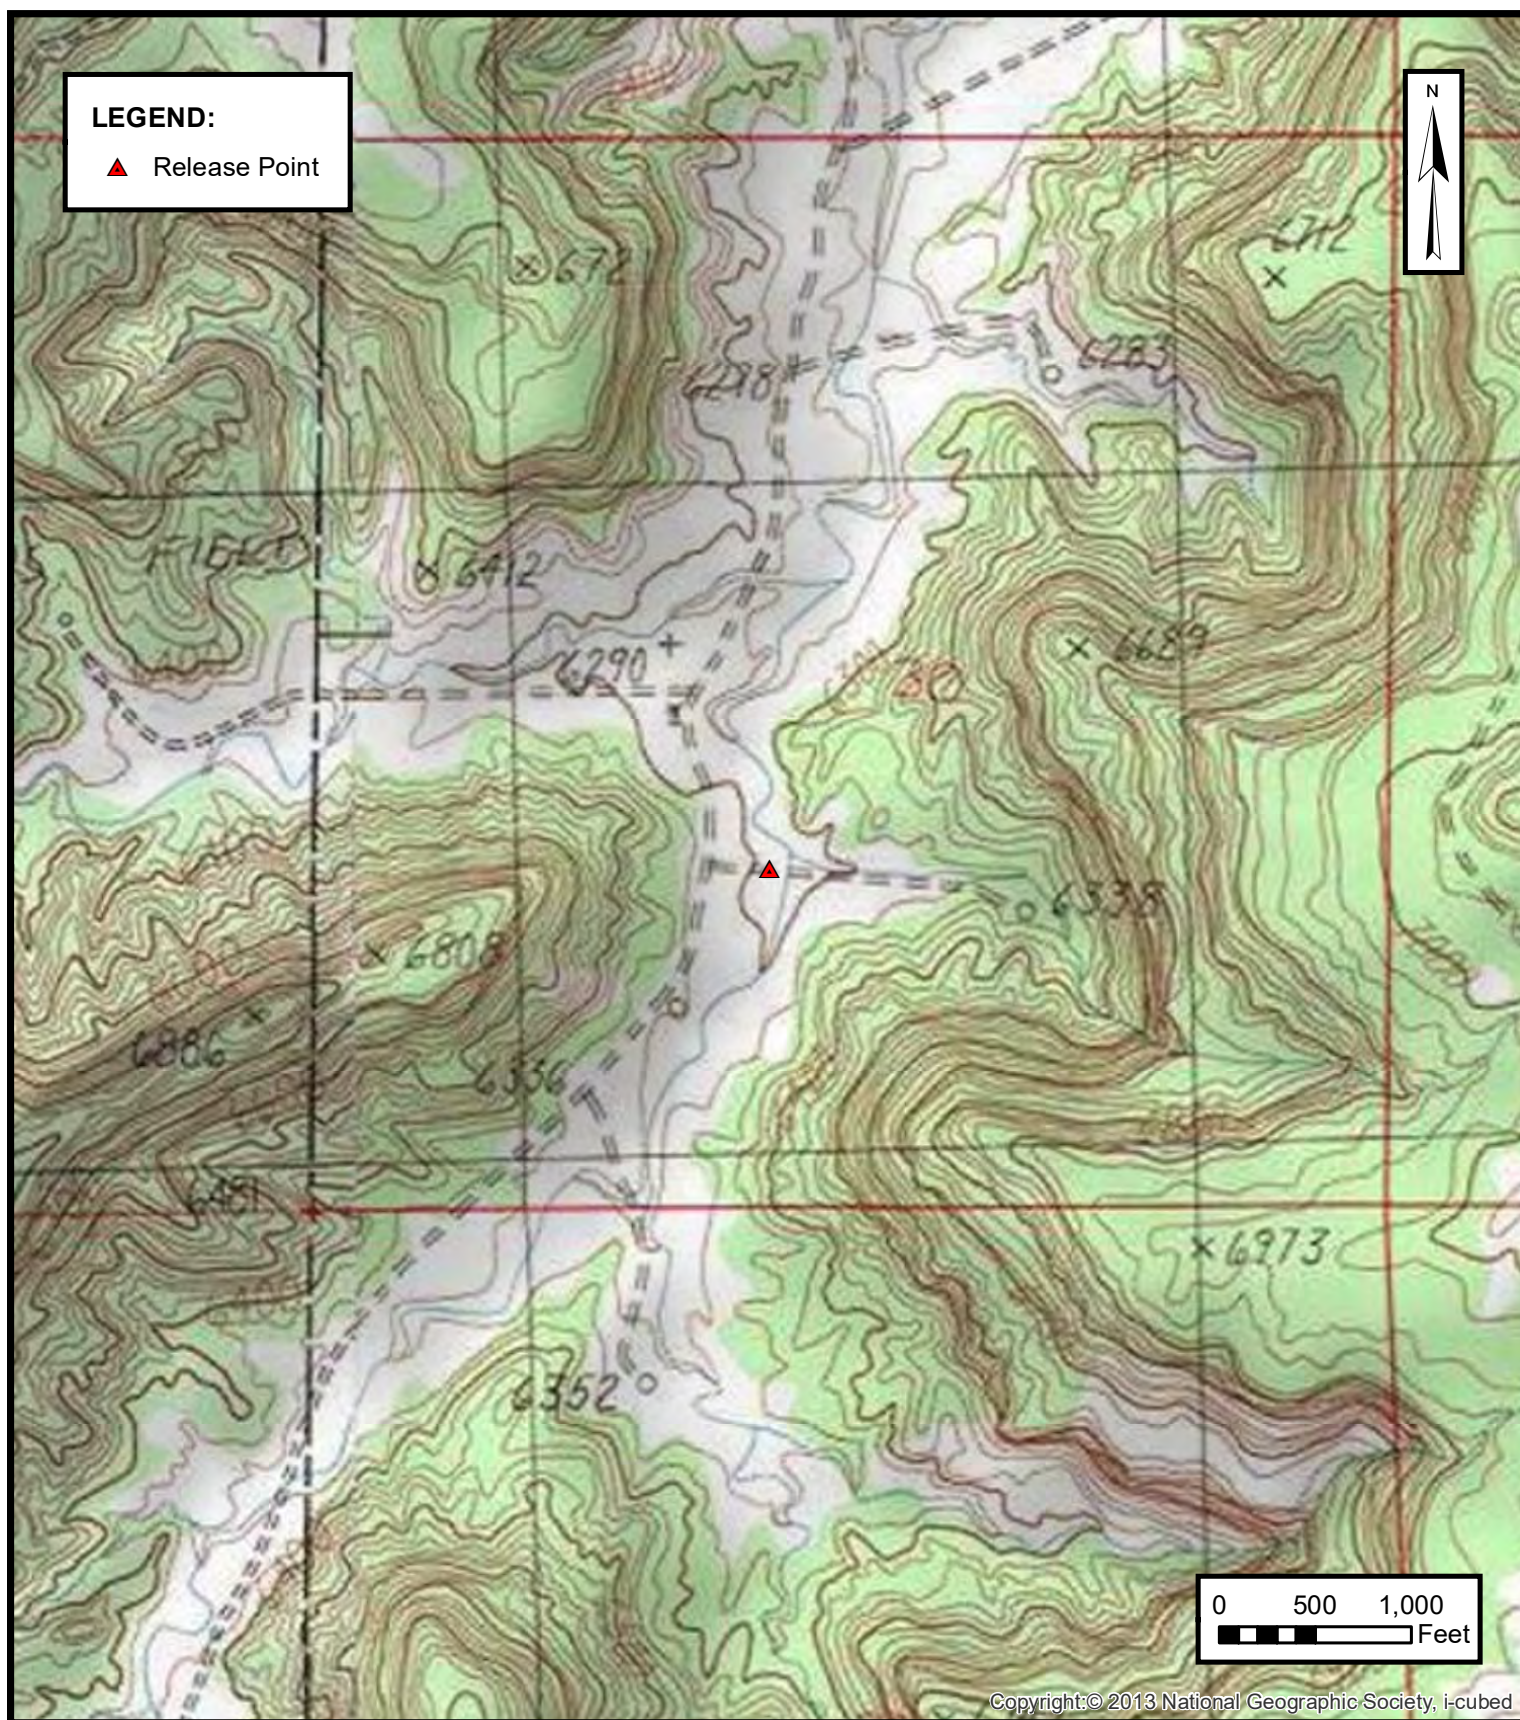
A **Topographic Map** depicting the location of the Site is included as **Figure 1**, and a **Site Vicinity Map** is included as **Figure 2** in **Appendix A**.

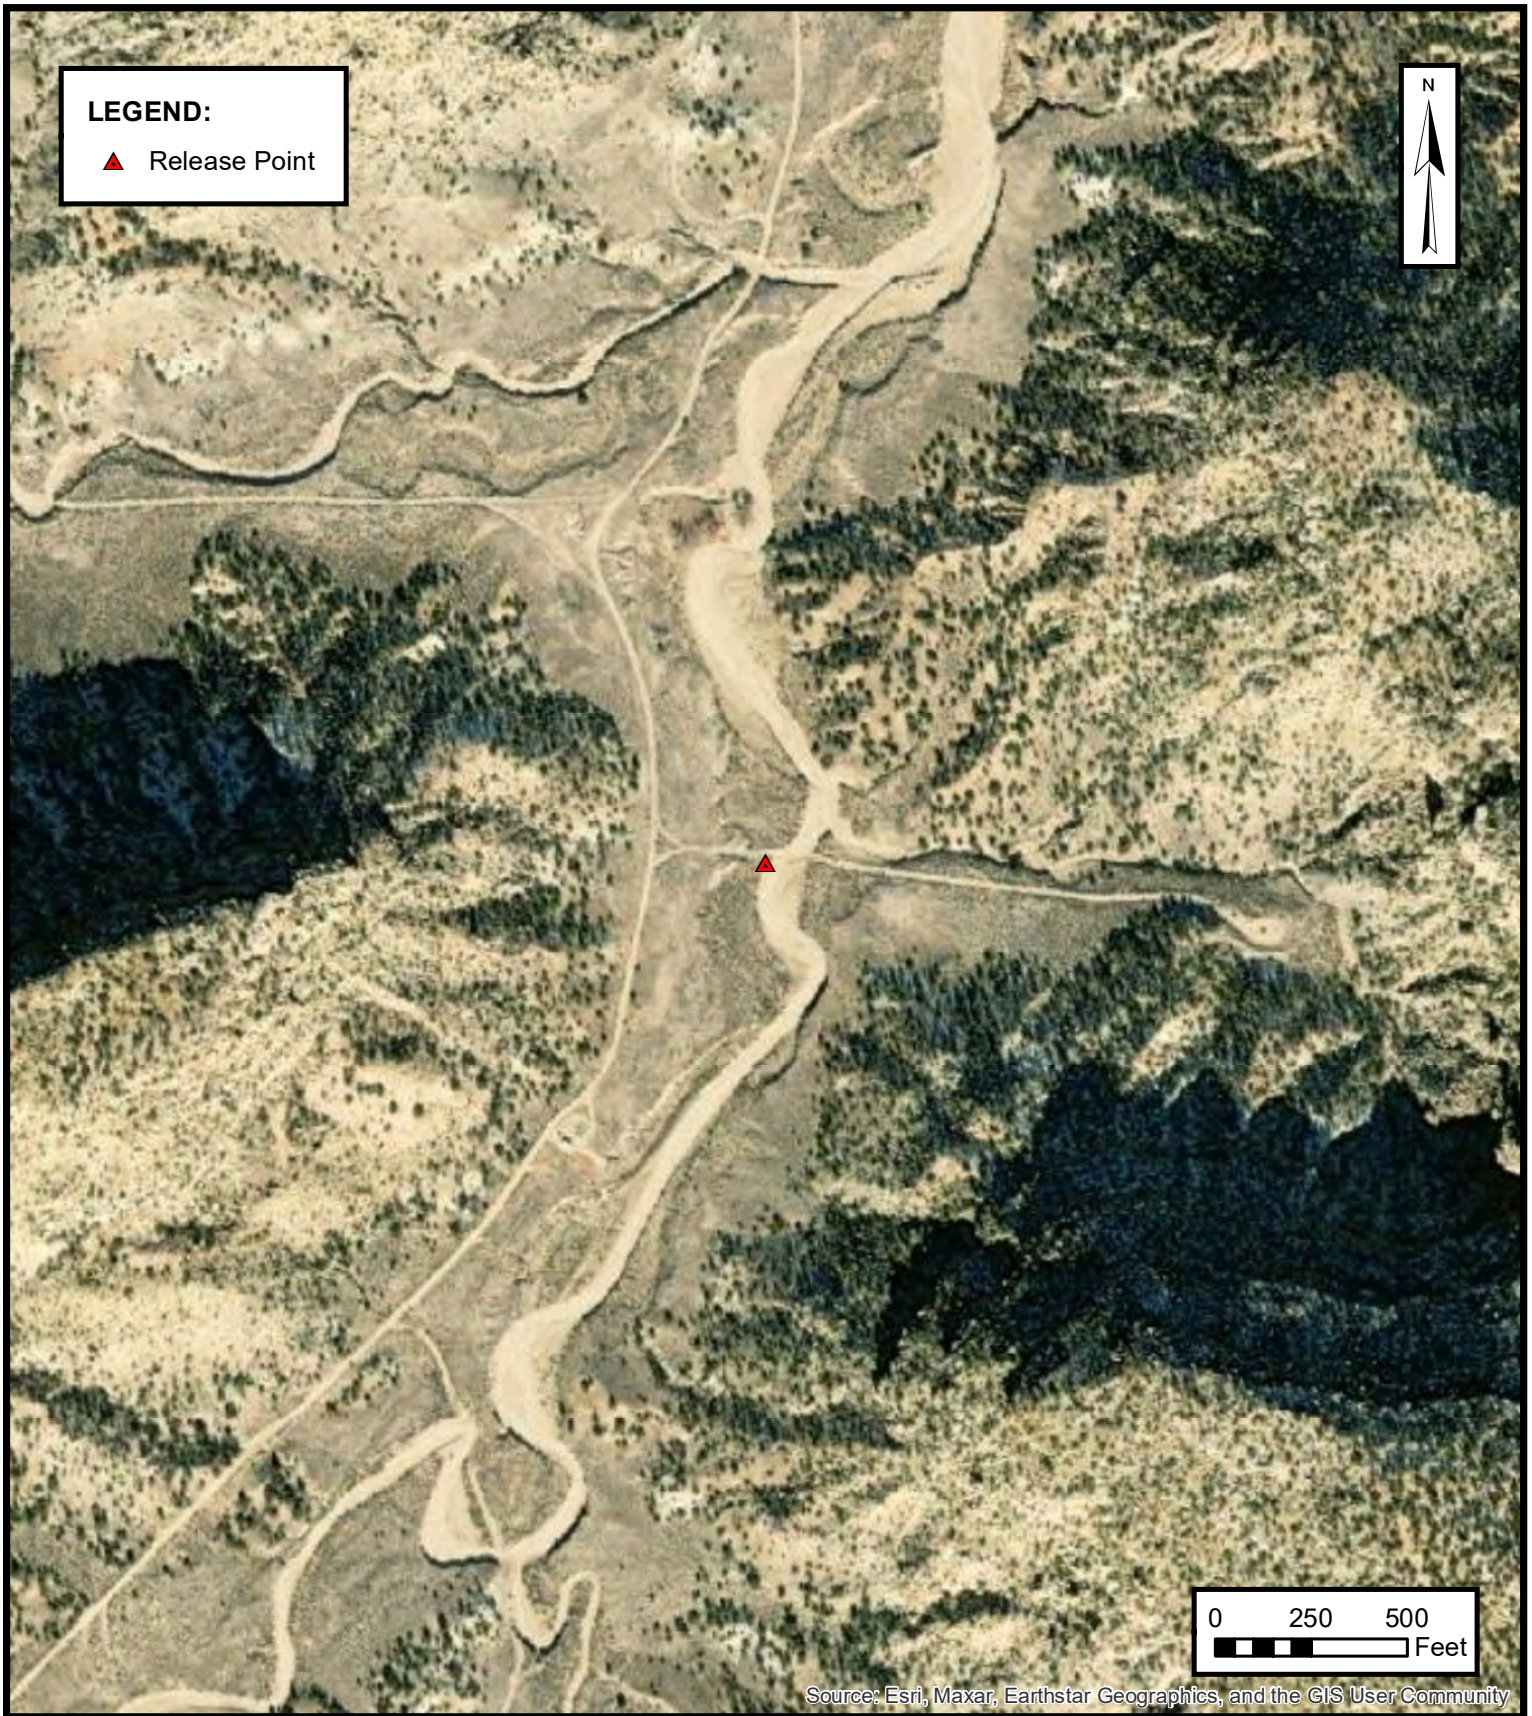
FIGURE

SITE VICINITY MAP

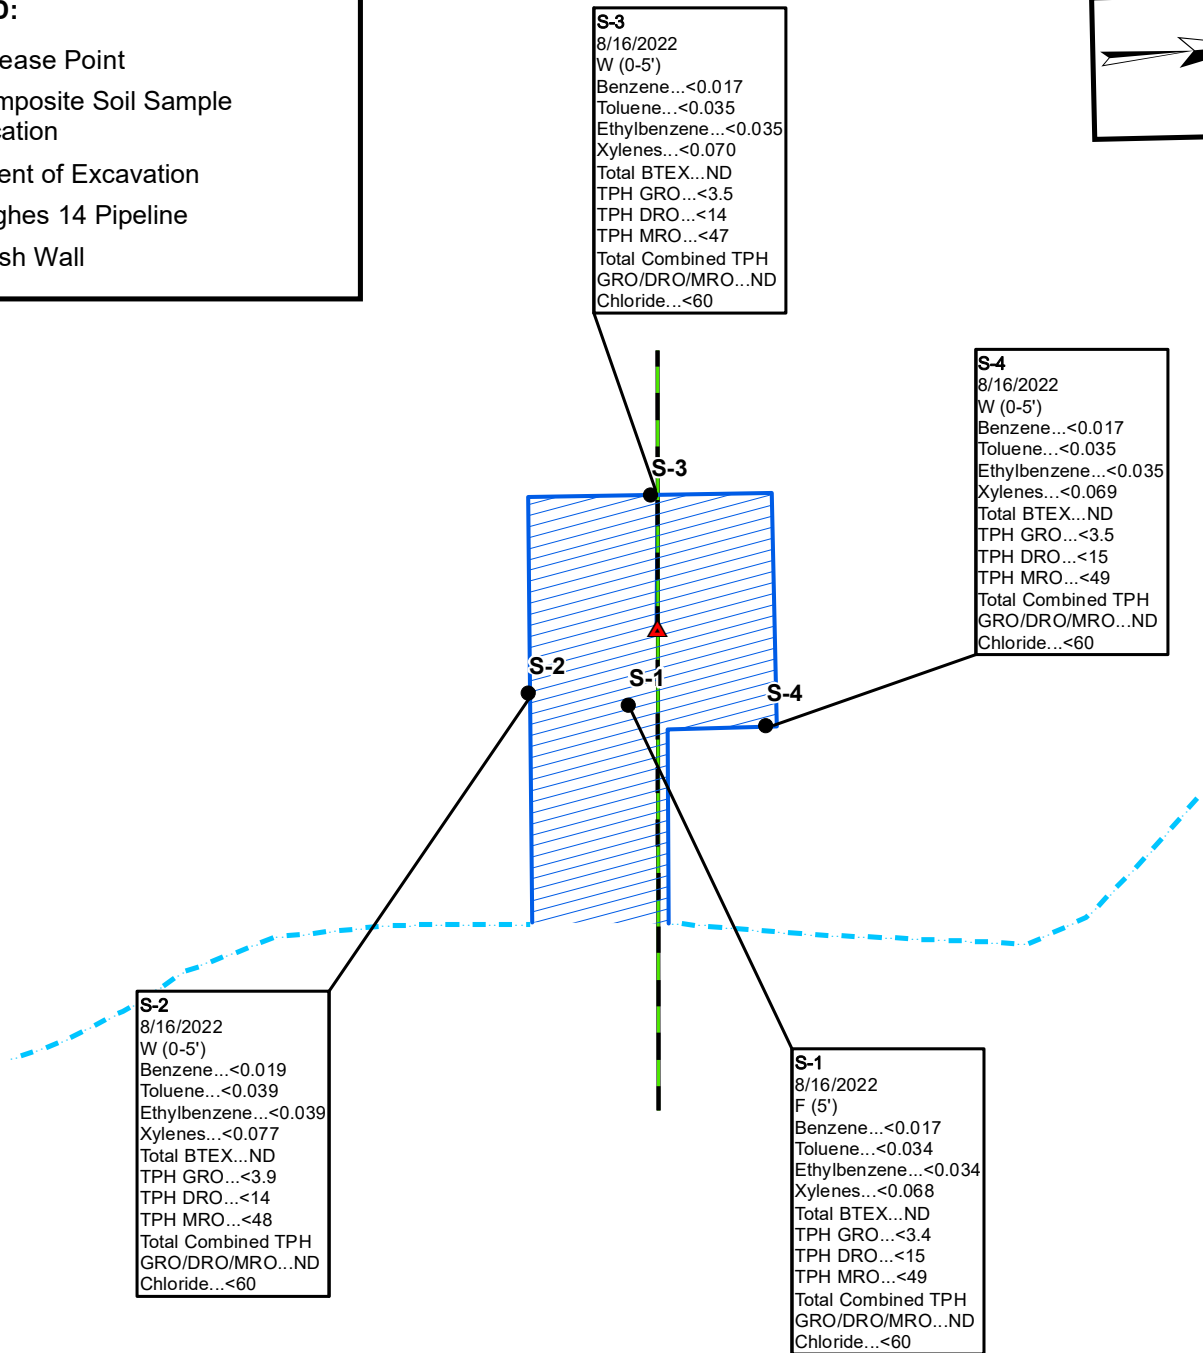
FIGURE
3

The final excavation measured approximately 12 feet long and 6 feet wide at the maximum extents. The maximum depth of the excavation measured approximately five feet bgs. The lithology encountered during the completion of remediation activities consisted primarily of silty sand.

Figure 3 is a map that identifies approximate soil sample locations and depicts the approximate dimensions of the excavation with respect to the pipeline (**Appendix A**). Photographic documentation of the field activities is included in **Appendix C**.

**SITE MAP WITH SOIL ANALYTICAL RESULTS**

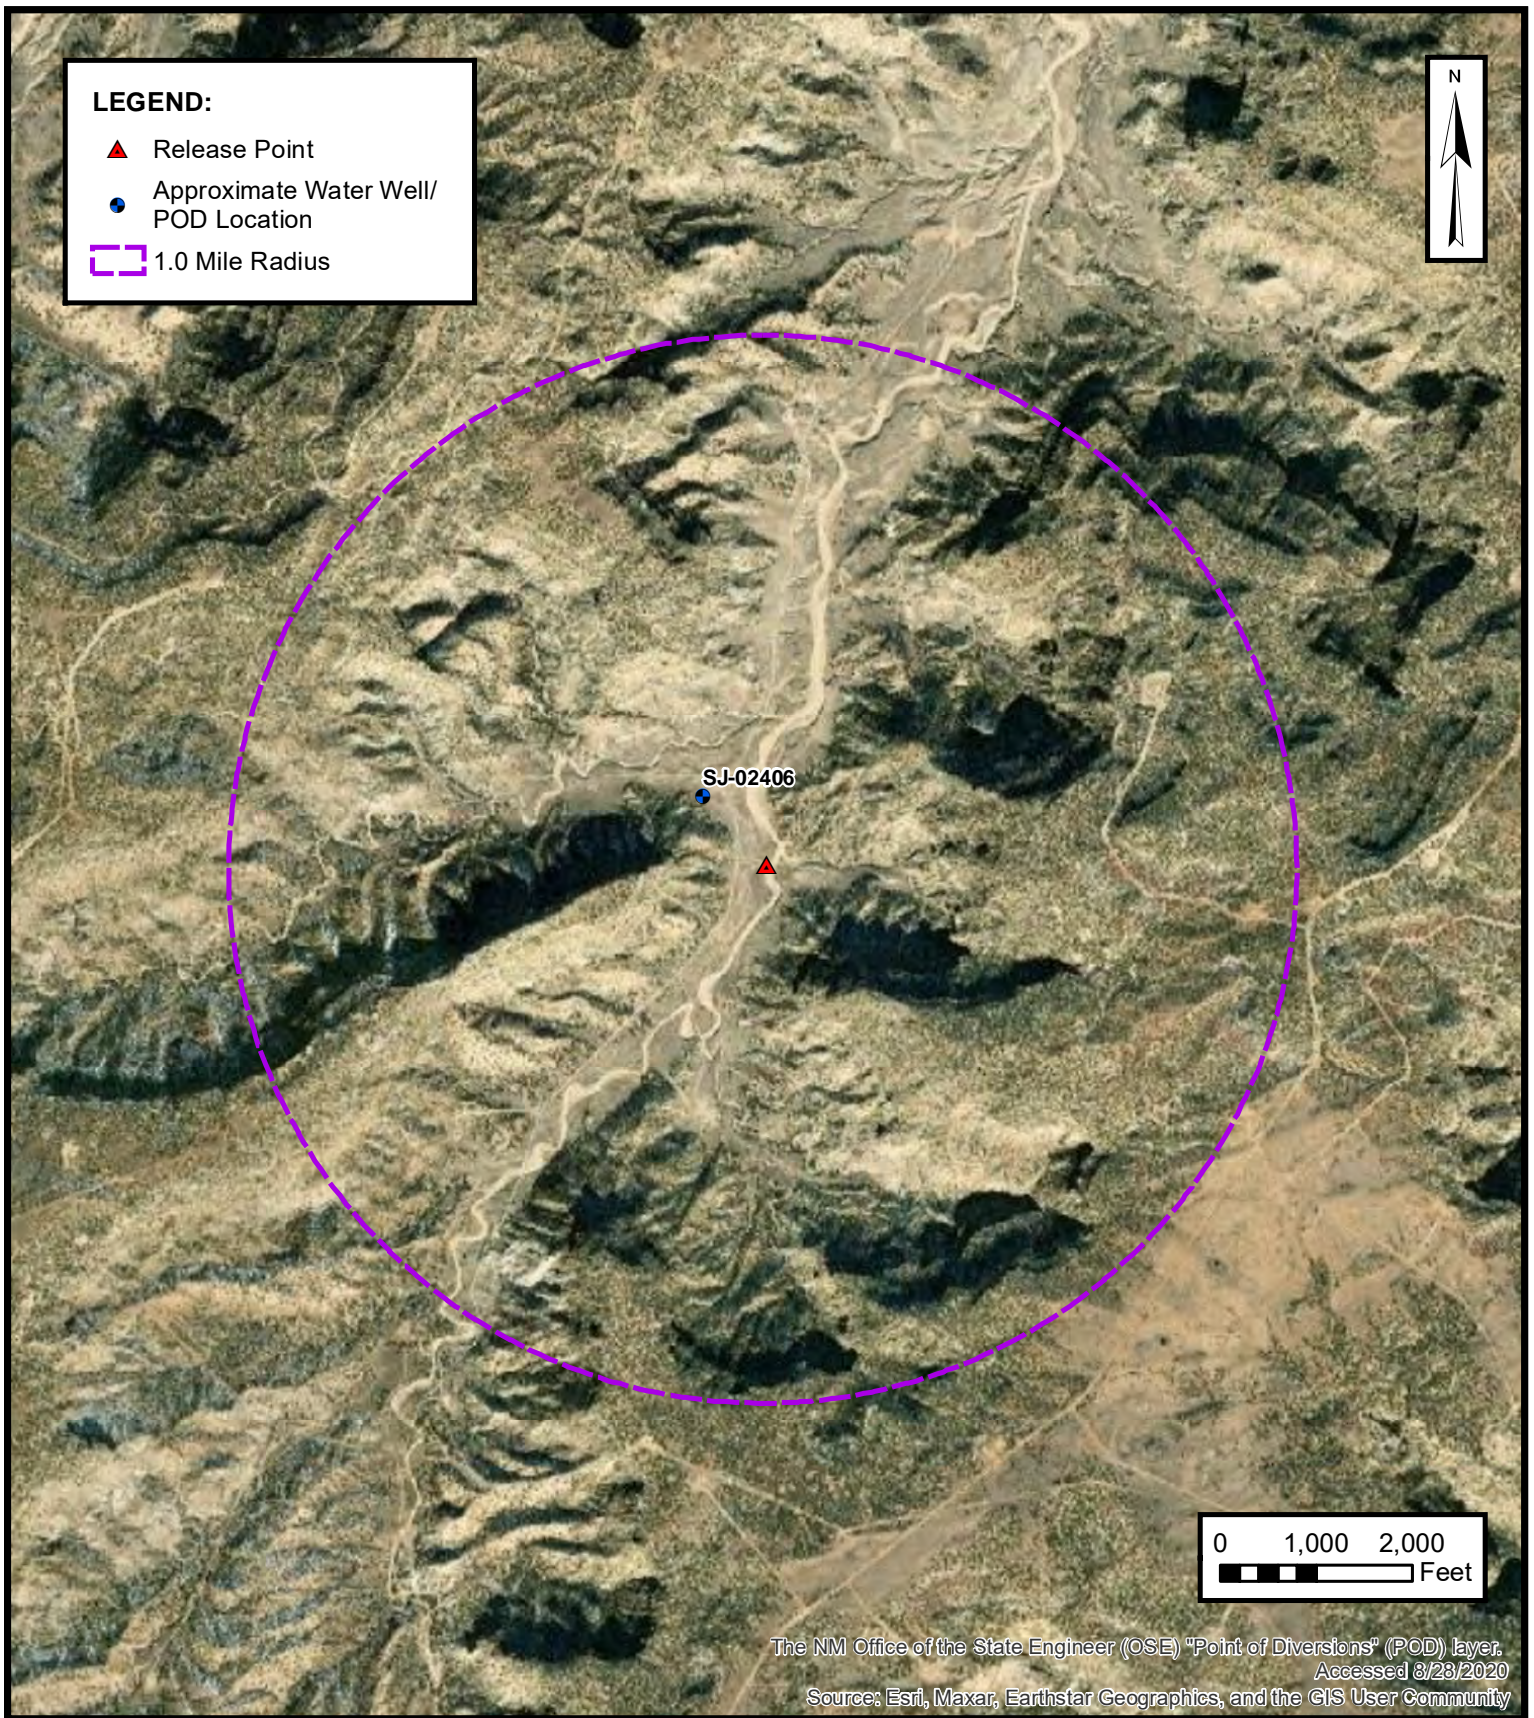
FIGURE
A

- The NM Office of the State Engineer (OSE) tracks the usage and assignment of water rights and water well installations and records this information in the Water Rights Reporting System (WRRS) database. Water wells and other points of diversion (PODs) are each assigned POD numbers in the database (which is searchable and includes an interactive map). One POD (SJ-02406) was identified in the same Public Land Survey System (PLSS) section as the Site. This POD is located approximately 0.2 miles northwest of the Site and approximately two feet lower in elevation than the Site. The recorded depth to water is 180 feet below grade surface (bgs). No PODS were identified in the adjacent PLSS sections (**Figure A, Appendix B**).

**1.0 MILE RADIUS WATER WELL/ POD LOCATION MAP**

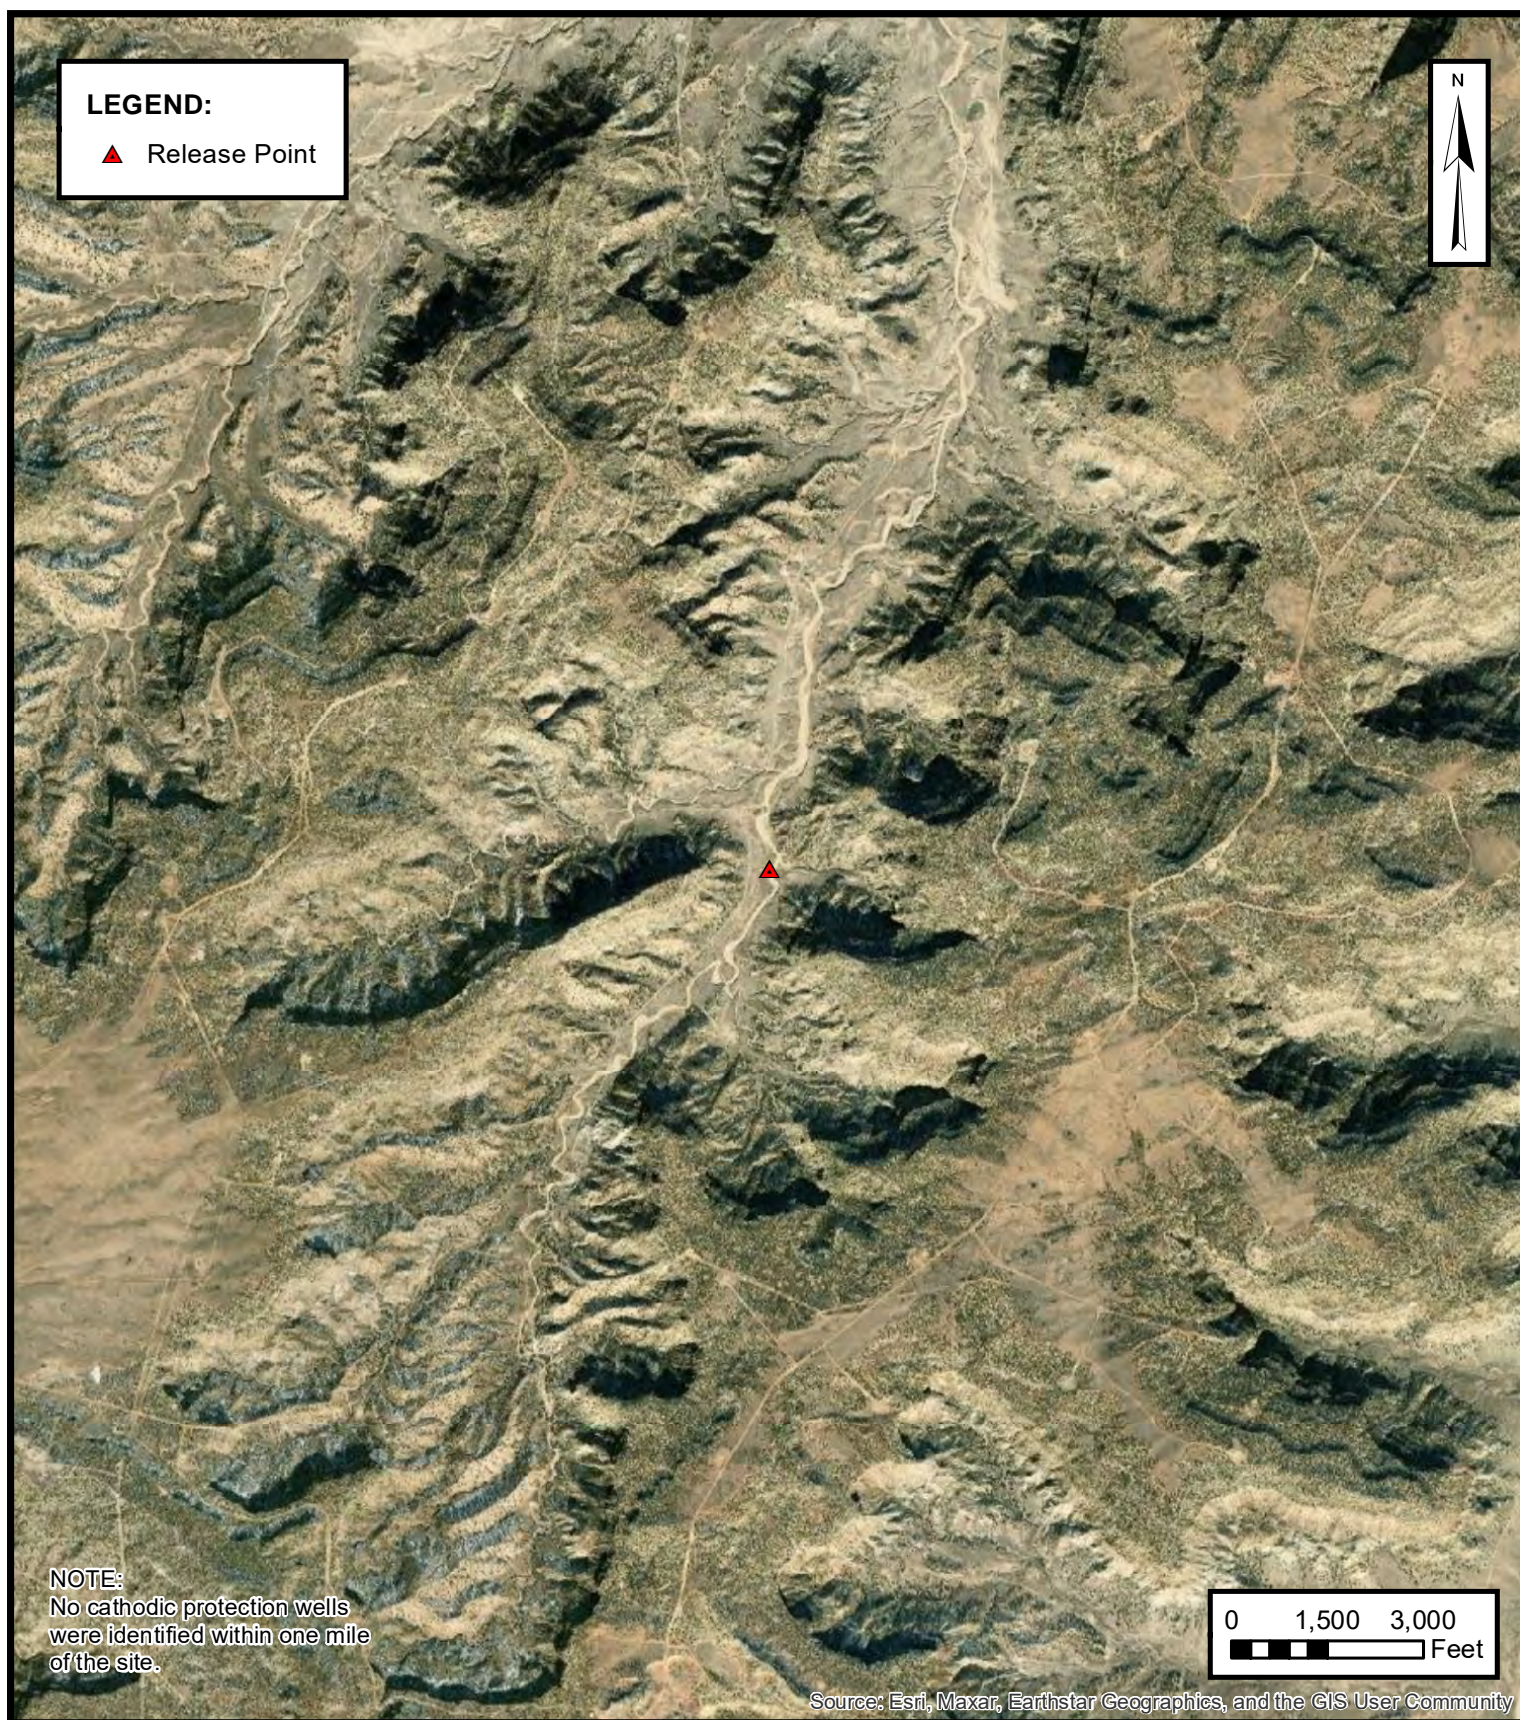
**FIGURE
B**

- No cathodic protection wells (CPWs) were identified in the same PLSS section as the Site, and no CPWs were identified in the adjacent PLSS sections in the NM EMNRD OCD imaging database (**Figure B, Appendix B**).

**CATHODIC PROTECTION WELL RECORDED
DEPTH TO WATER**
ENTERPRISE FIELD SERVICES, LLC
HUGHES #14 (08/04/22)
Unit Letter K, S30 T26N R7W, Rio Arriba County, New Mexico
36.45519° N, 107.61866° W

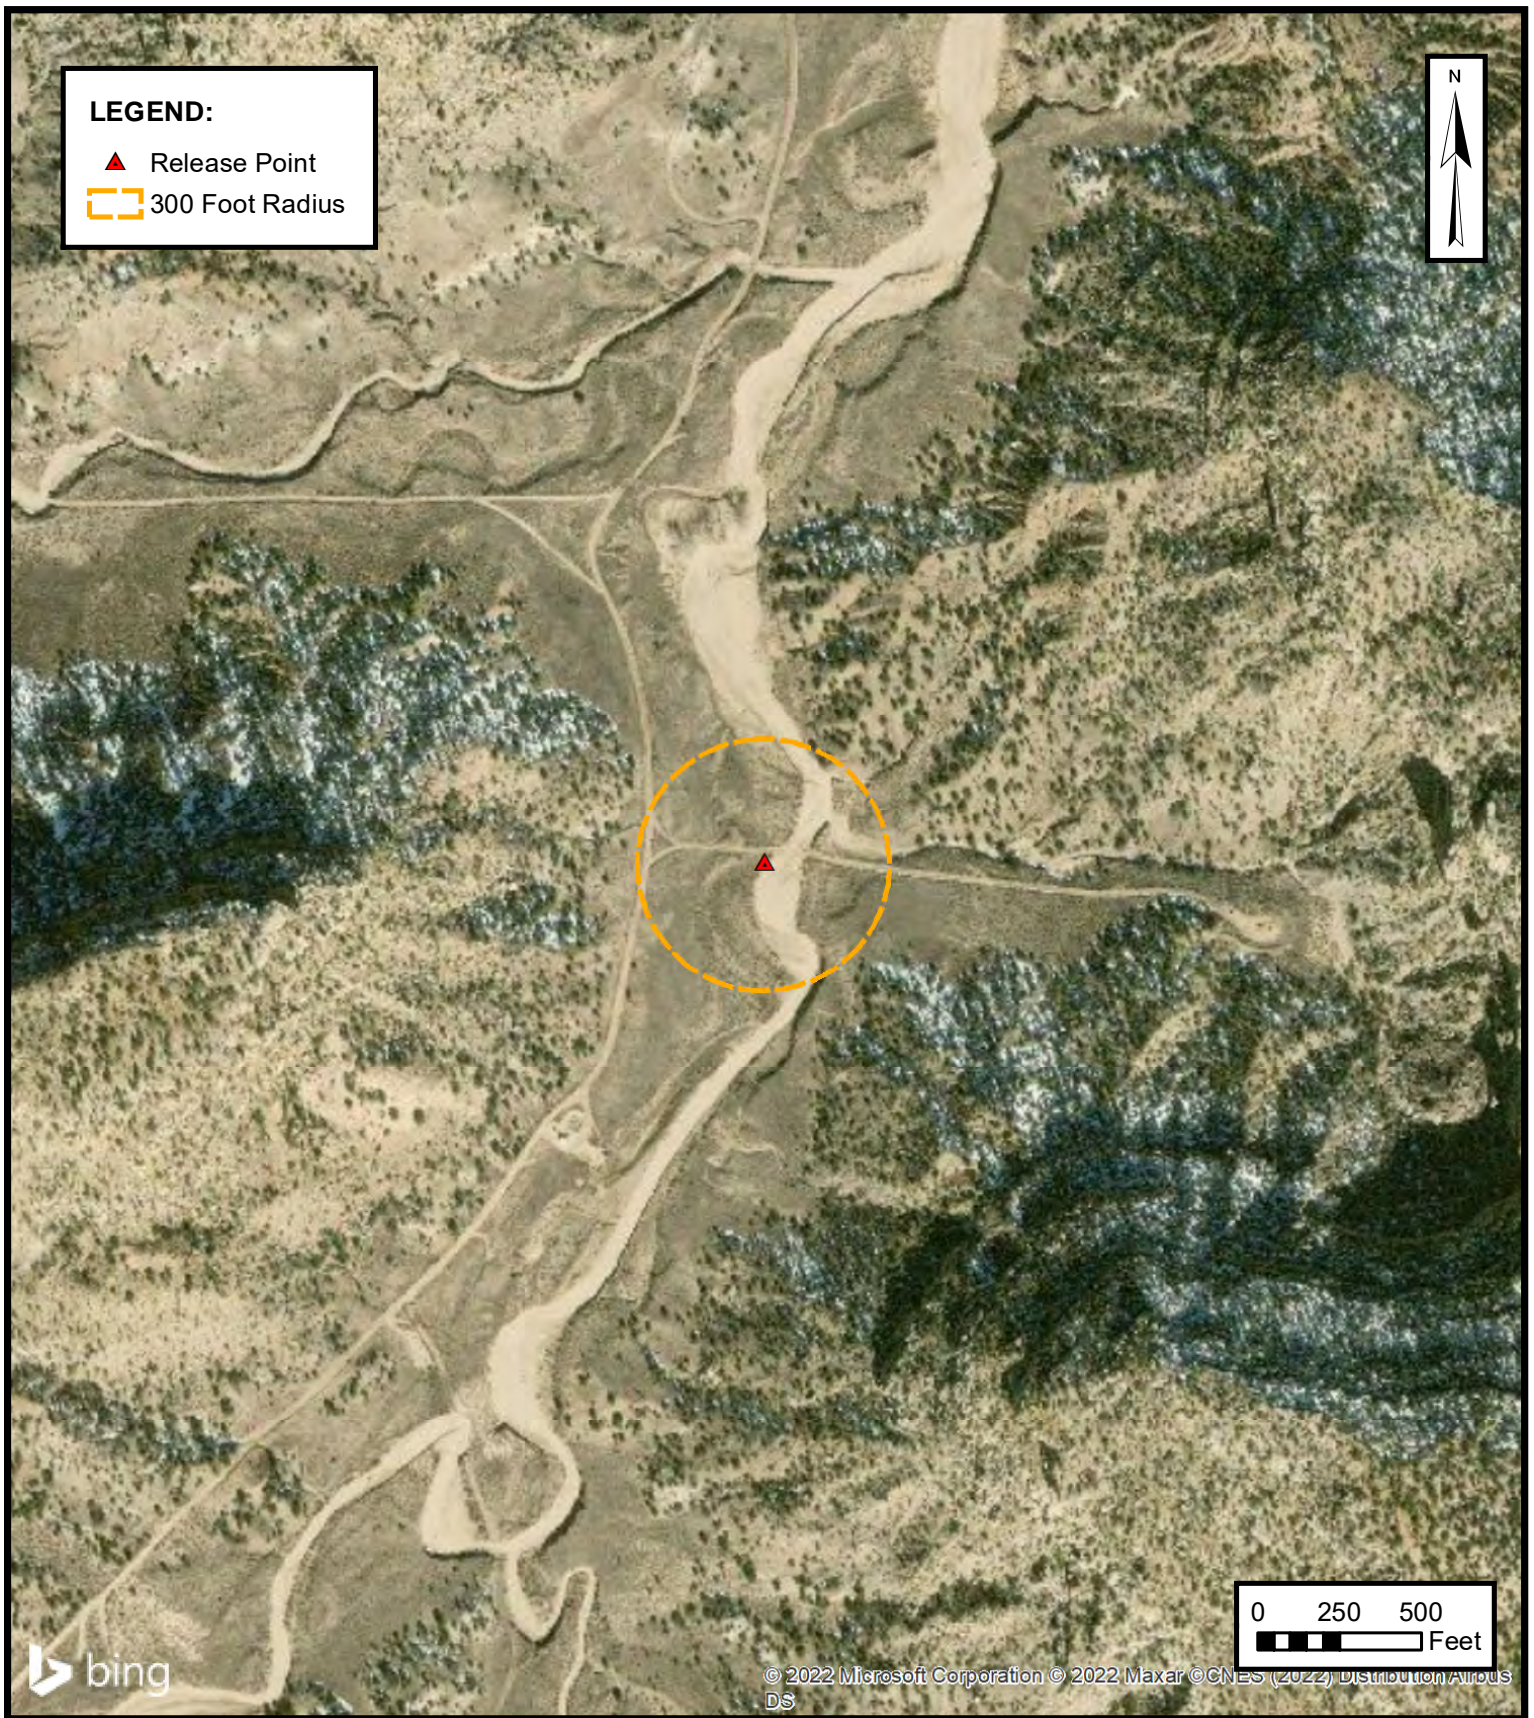
FIGURE

- The Site is located within 300 feet of a NM EMNRD OCD-defined continuously flowing watercourse or significant watercourse (**Figure C, Appendix B**).

**300 FOOT RADIUS
WATERCOURSE AND DRAINAGE IDENTIFICATION**

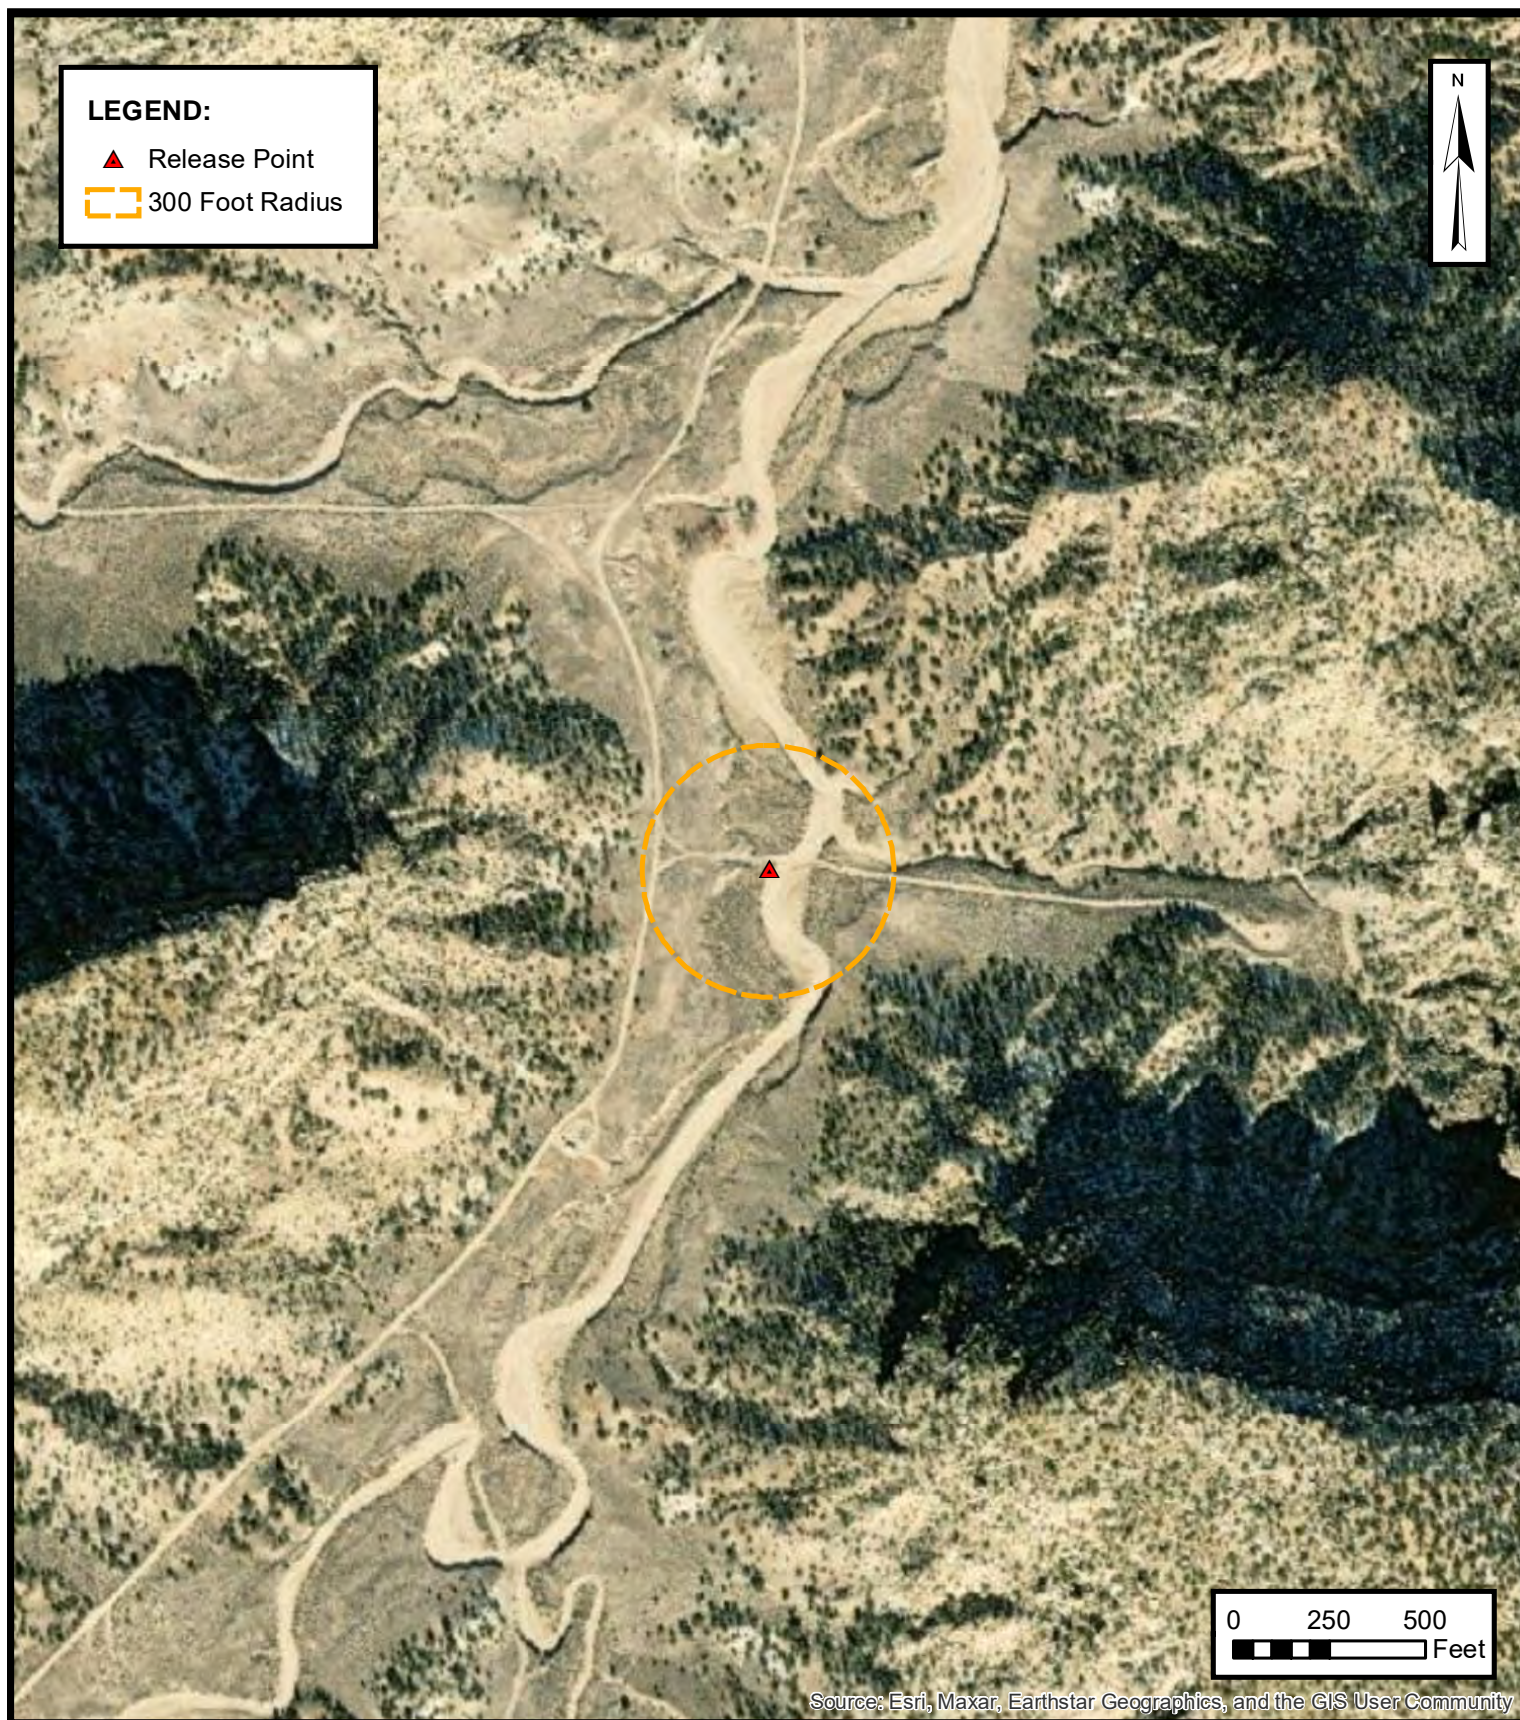
**FIGURE
D**

- The Site is not located within 200 feet of a lakebed, sinkhole, or playa lake.
- The Site is not located within 300 feet of a permanent residence, school, hospital, institution, or church (**Figure D, Appendix B**).

**300 FOOT RADIUS
OCCUPIED STRUCTURE IDENTIFICATION**

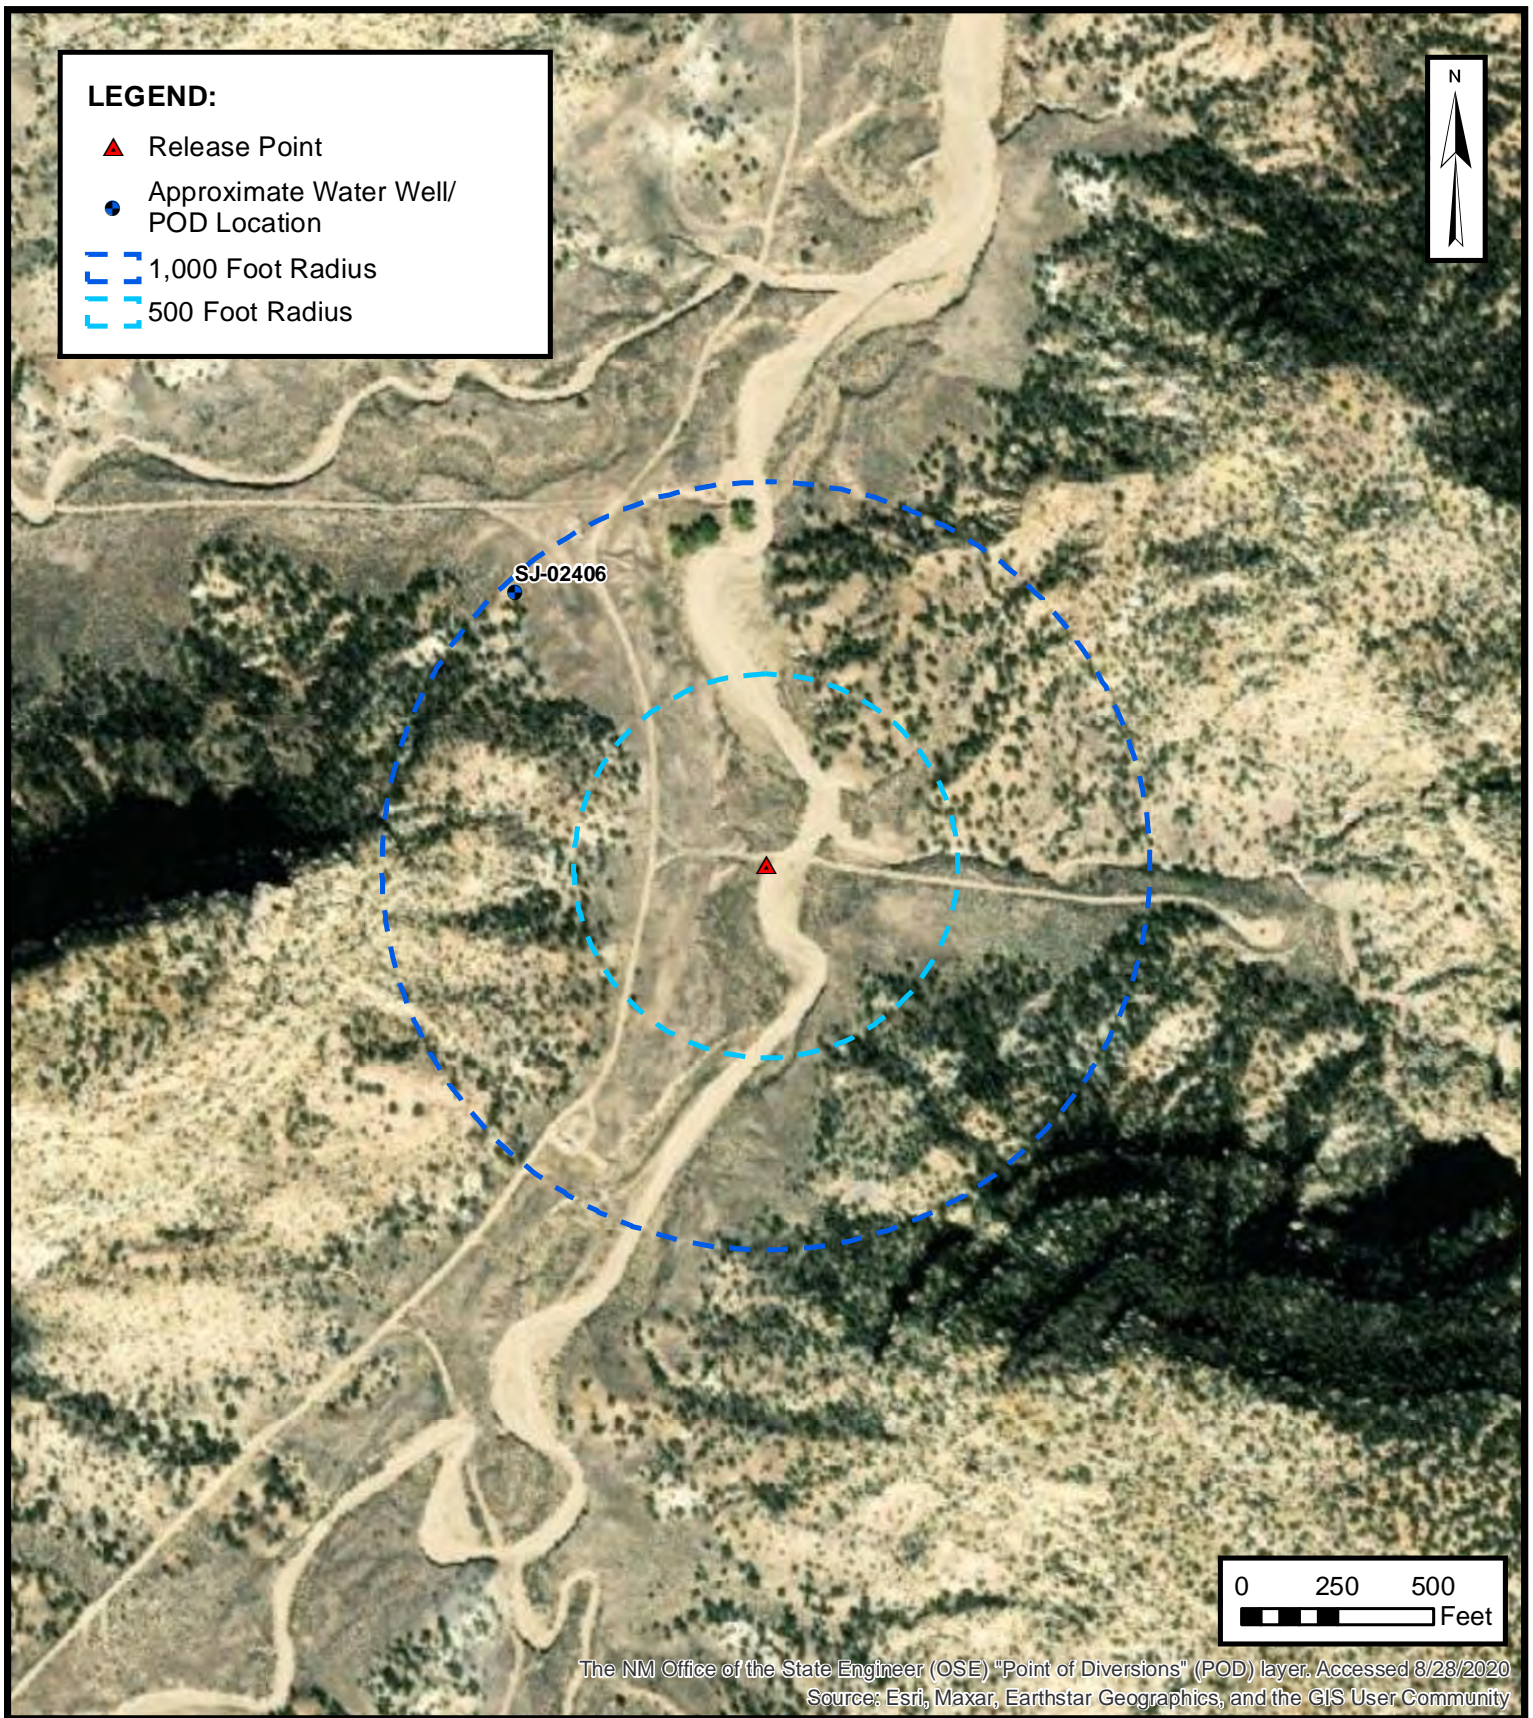
FIGURE
E

- No springs, or private domestic freshwater wells used by less than five households for domestic or stock watering purposes were identified within 500 feet of the Site (**Figure E, Appendix B**). One POD (SJ-02406) is located approximately 900 feet northwest of the Site. According to the records this POD is utilized for livestock water purposes.

- One water well was identified within 1,000 feet of the Site (**Figure E, Appendix B**). This POD (SJ-02406) is located approximately 900 feet northwest of the Site. According to the records this POD is utilized to provide water for livestock .

WATER WELL AND NATURAL SPRING LOCATION
