CLOSURE REPORT

Hughes #14 (08/04/22)
Unit Letter K, S30 T26N R7W
Rio Arriba County, New Mexico

New Mexico EMNRD OCD Incident ID No. NAPP2222032322

October 27, 2022

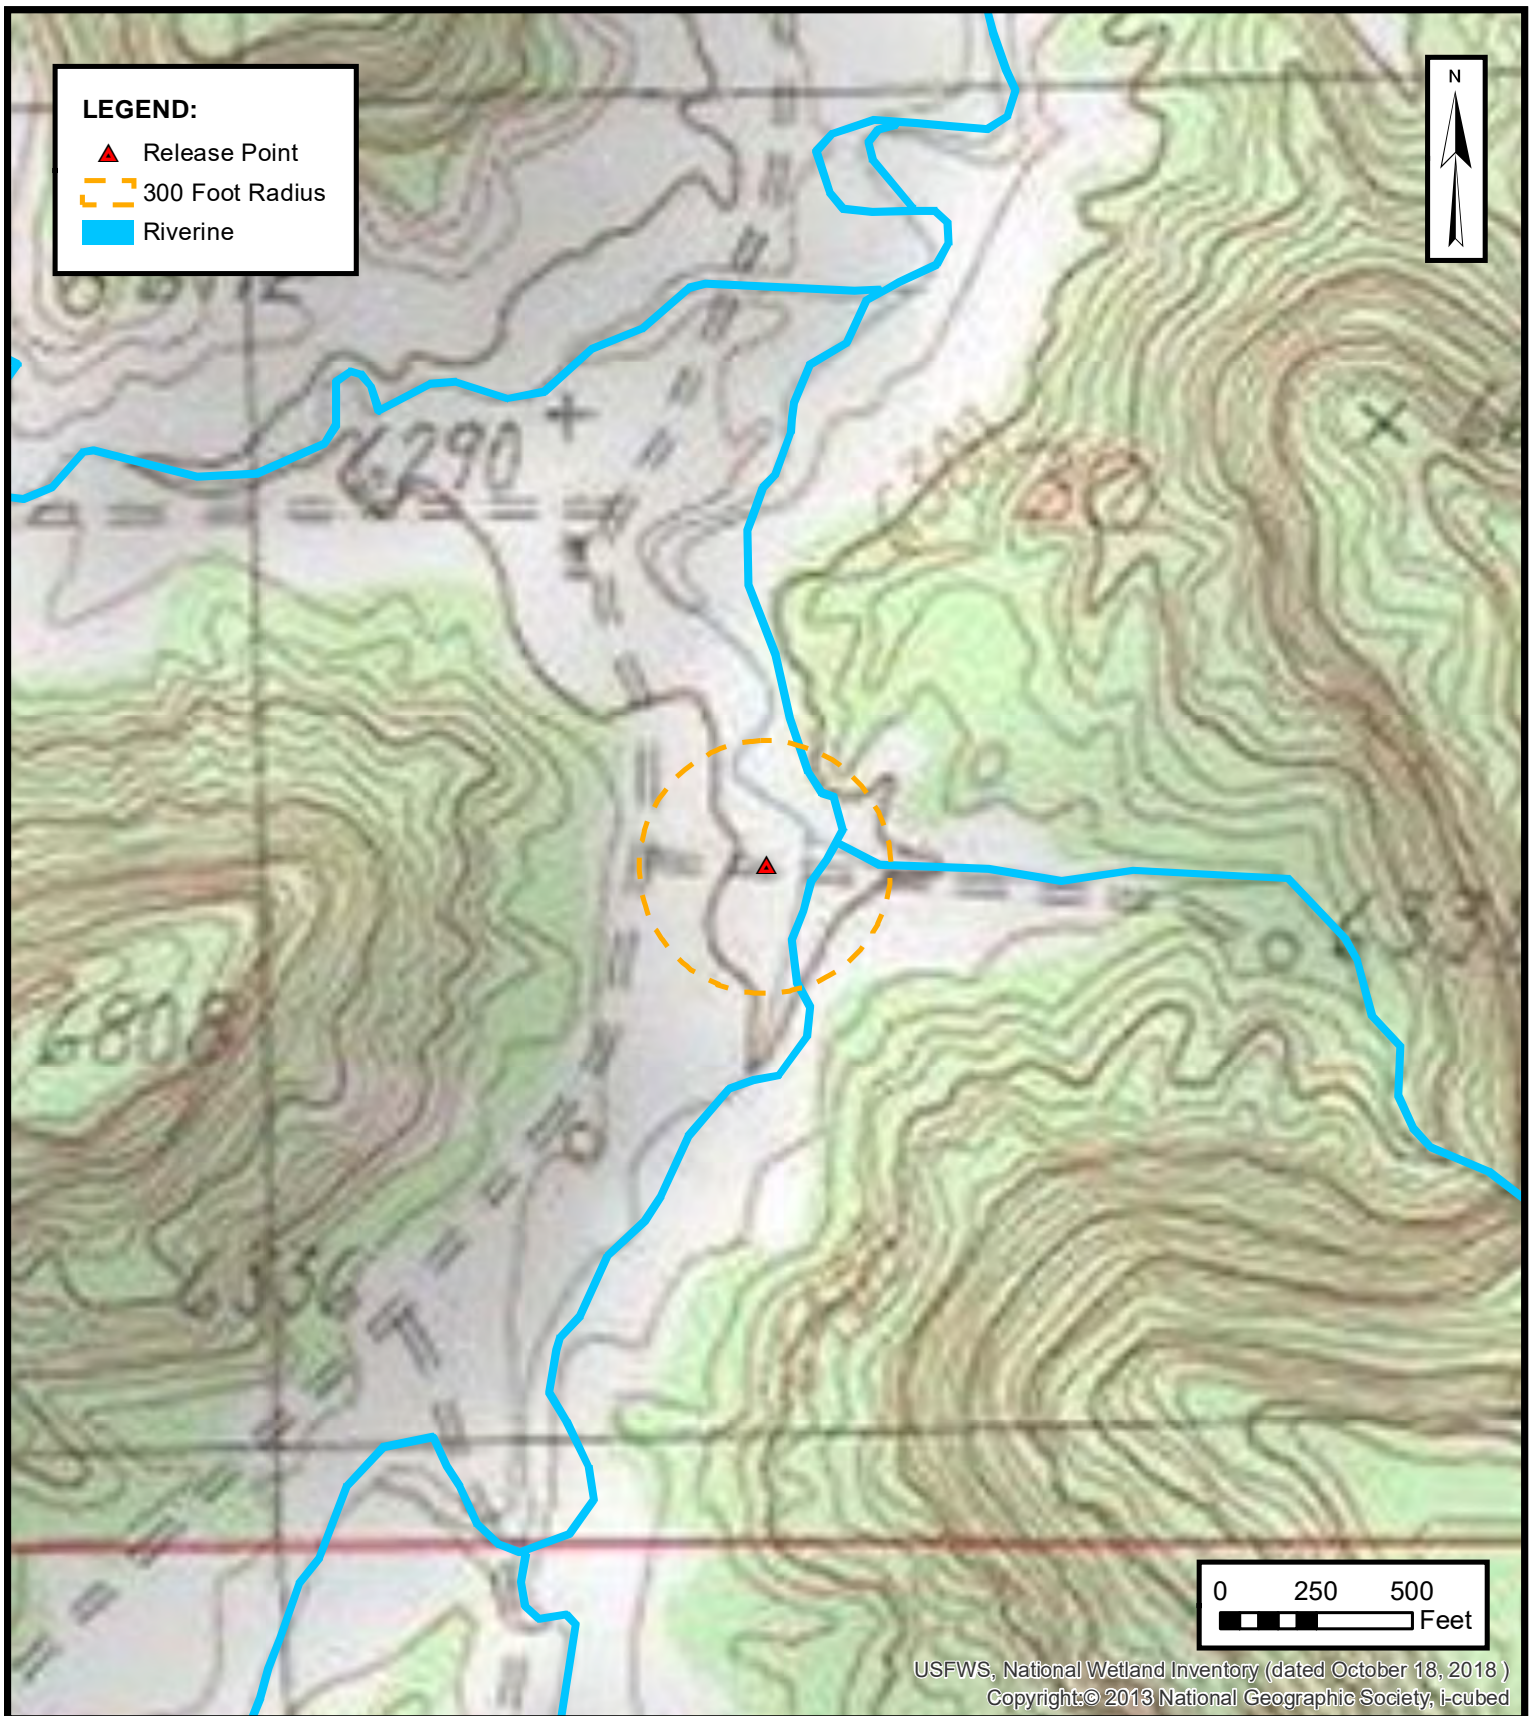
FIGURE
F

- Based on information identified in the U.S. Fish & Wildlife Service National Wetlands Inventory Wetlands Mapper, the Site is not within 300 feet of a wetland (**Figure F, Appendix B**).

WETLANDS

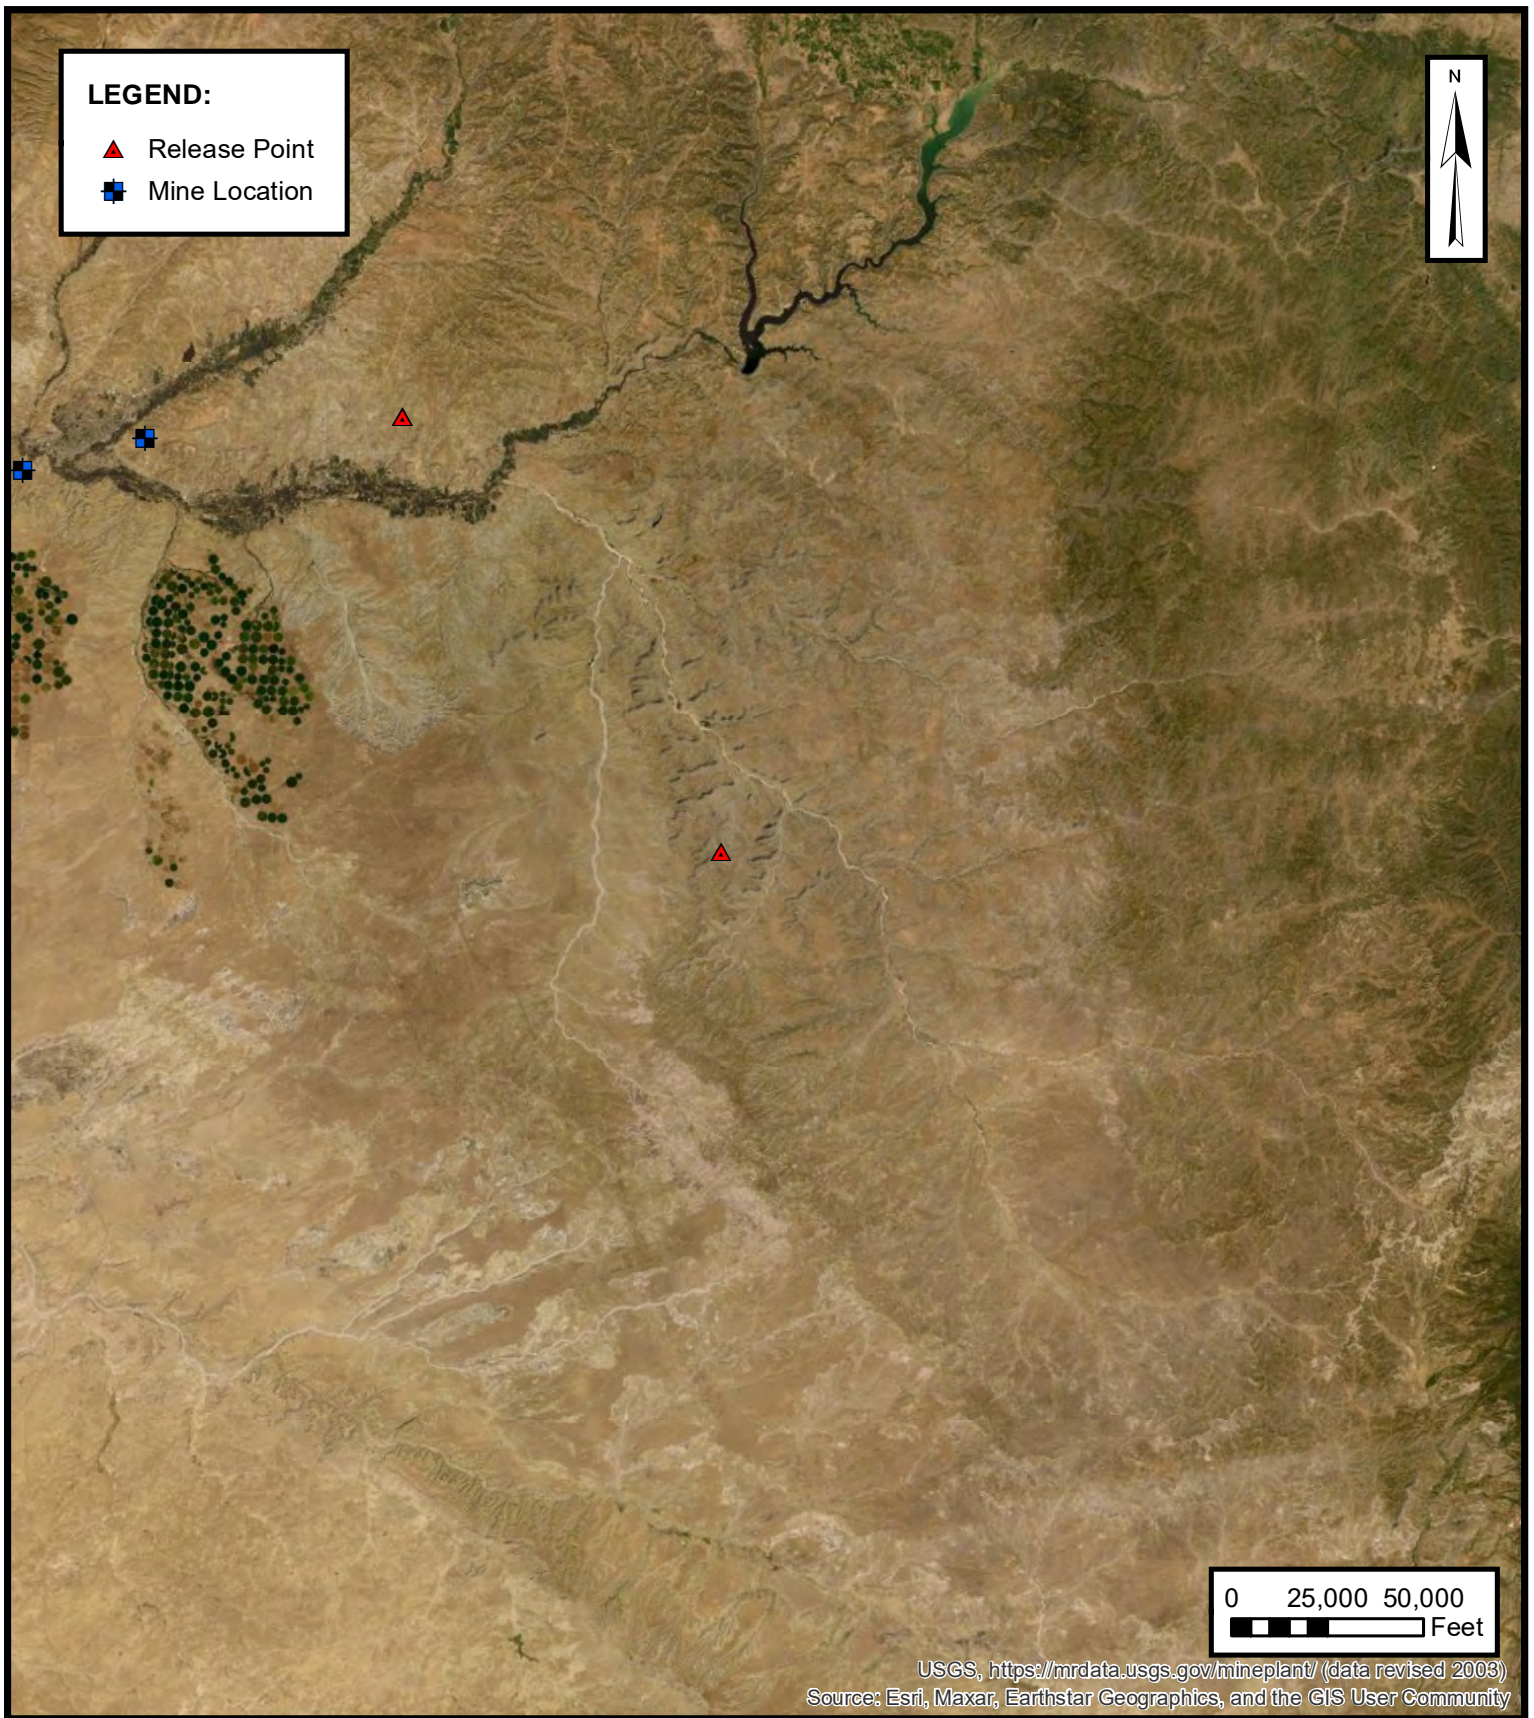
FIGURE**G**

- Based on information identified in the NM Mining and Minerals Division's Geographic Information System (GIS) Maps and Mine Data database, the Site is not within an area overlying a subsurface mine (**Figure G, Appendix B**).

**MINES, MILLS AND QUARRIES**

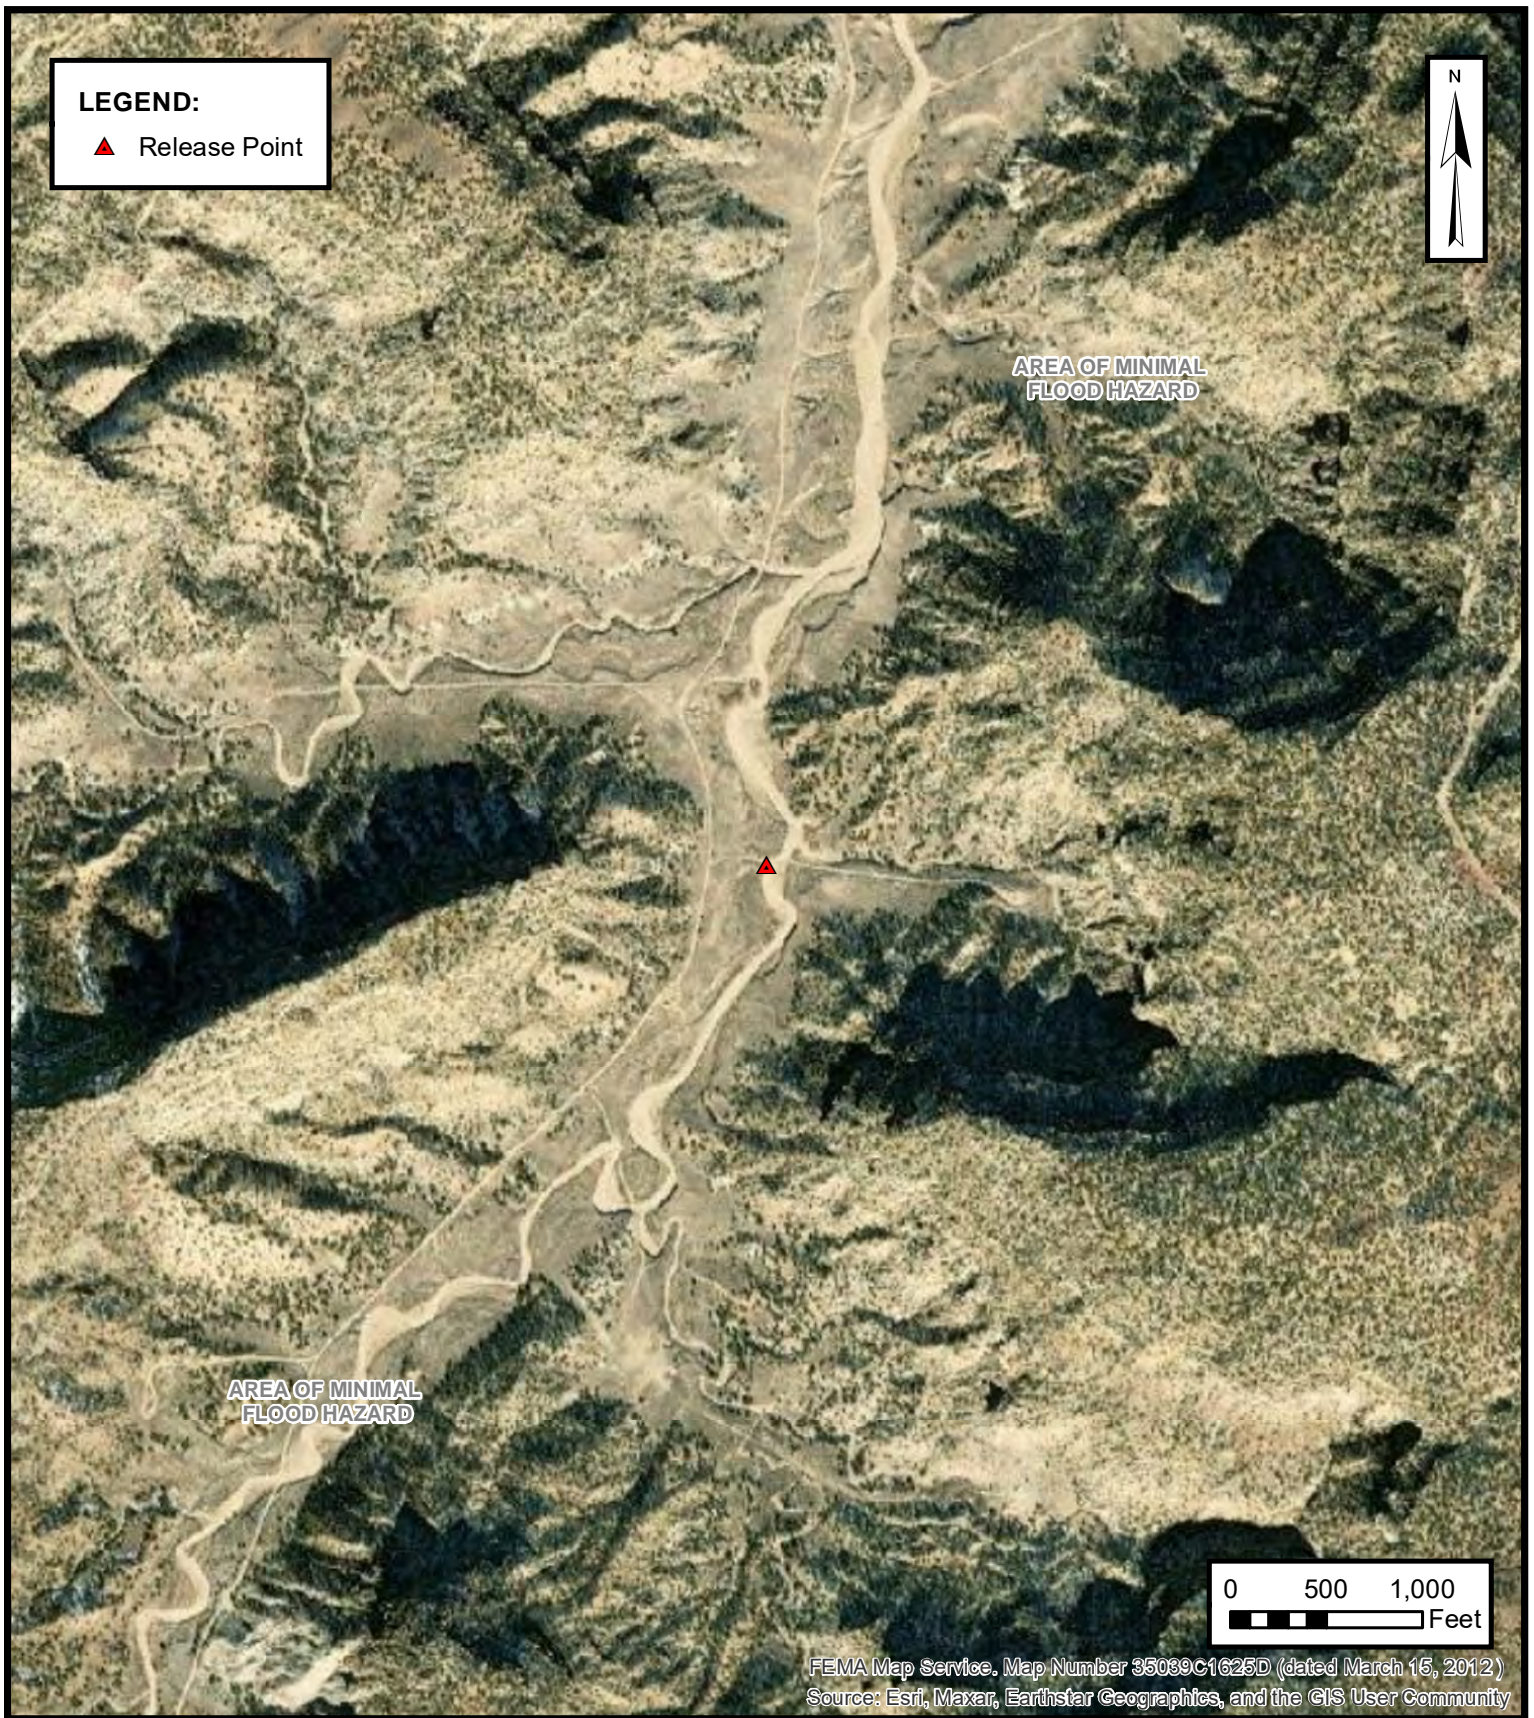
FIGURE
H

- The Site is not located within an unstable area per Paragraph (6) of Subsection U of 19.15.2.7 NMAC.
- Based on information provided by the Federal Emergency Management Agency (FEMA) National Flood Hazard Layer (NFHL) geospatial database, the Site is not within a 100-year floodplain (**Figure H, Appendix B**).

100-YEAR FLOOD PLAIN MAP

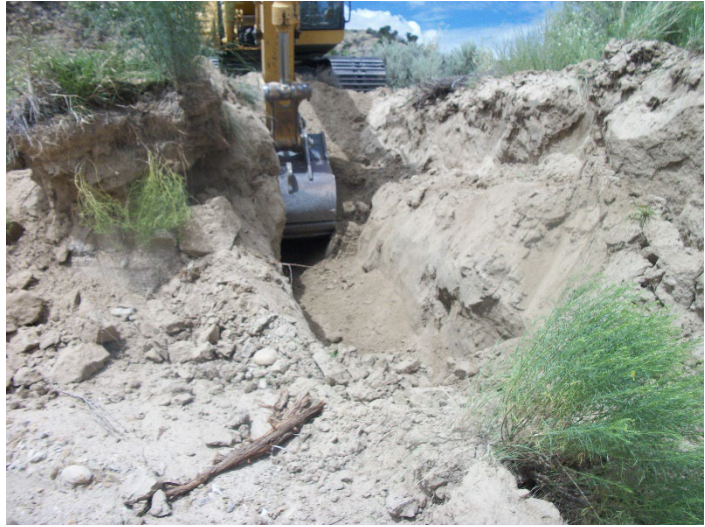
**Photograph 1**

Photograph Description: View of the in-process excavation activities.

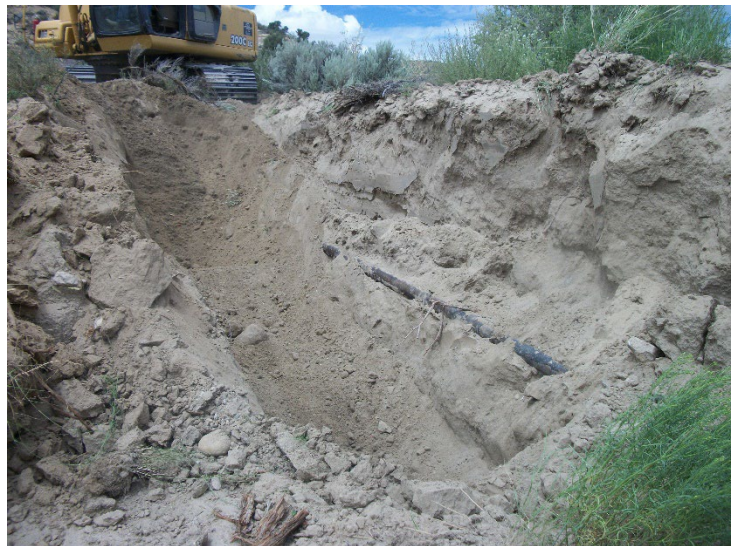
**Photograph 2**

Photograph Description: View of the in-process excavation activities.

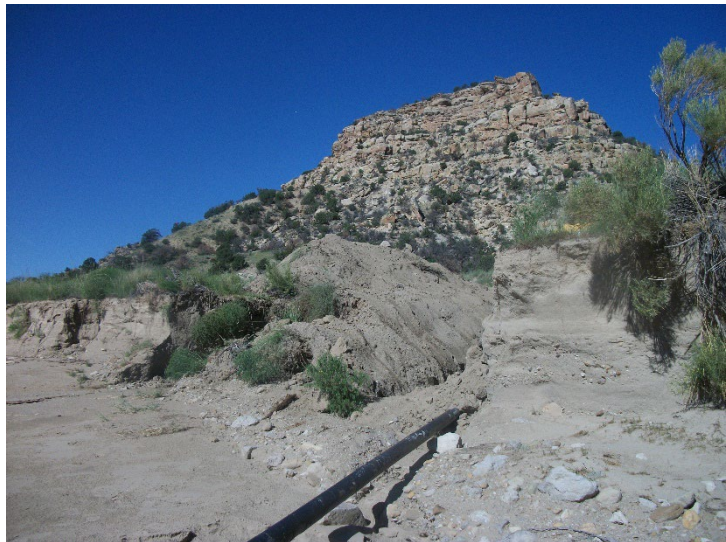
**Photograph 3**

Photograph Description: View of the in-process excavation activities.

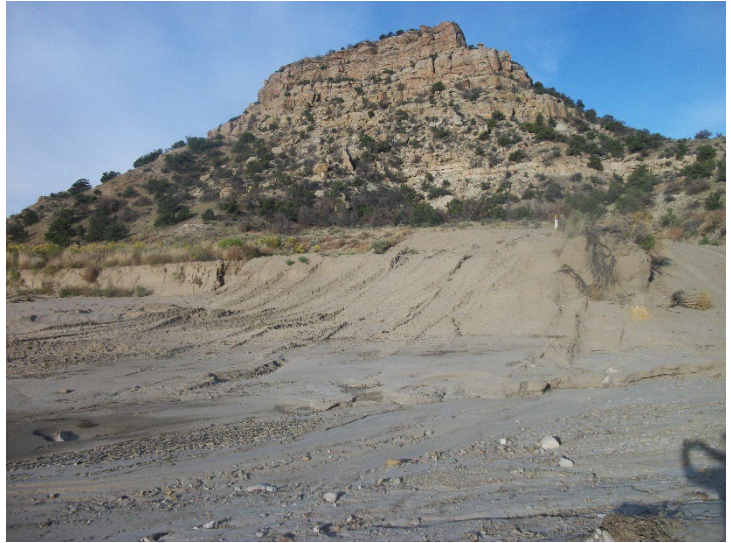
Photograph 4

Photograph Description: View of the site after initial restoration.

The excavation was backfilled with laboratory-confirmed stockpiled soil and was then contoured to the surrounding topography. Enterprise will re-seed the Site with an approved seeding mixture.
