Release Notification

Responsible Party Hilcorp Energy	OGRID 372171
Contact Name Clara Cardoza	Contact Telephone 505.564.0733
Contact email ccardoza@hilcorp.com	Incident # (assigned by OCD)
Contact mailing address 382 CR 3100, Aztec NM 87410

Site Name Howell M 1	Site Type Well Site
Date Release Discovered Historic	API# (if applicable) 30-045-09101

FIGURE 1
SITE LOCATION MAP
HOWELL M #1
LOT 11 SEC 30-T30N-R8W
SAN JUAN COUNTY, NEW MEXICO
HILCORP ENERGY COMPANY

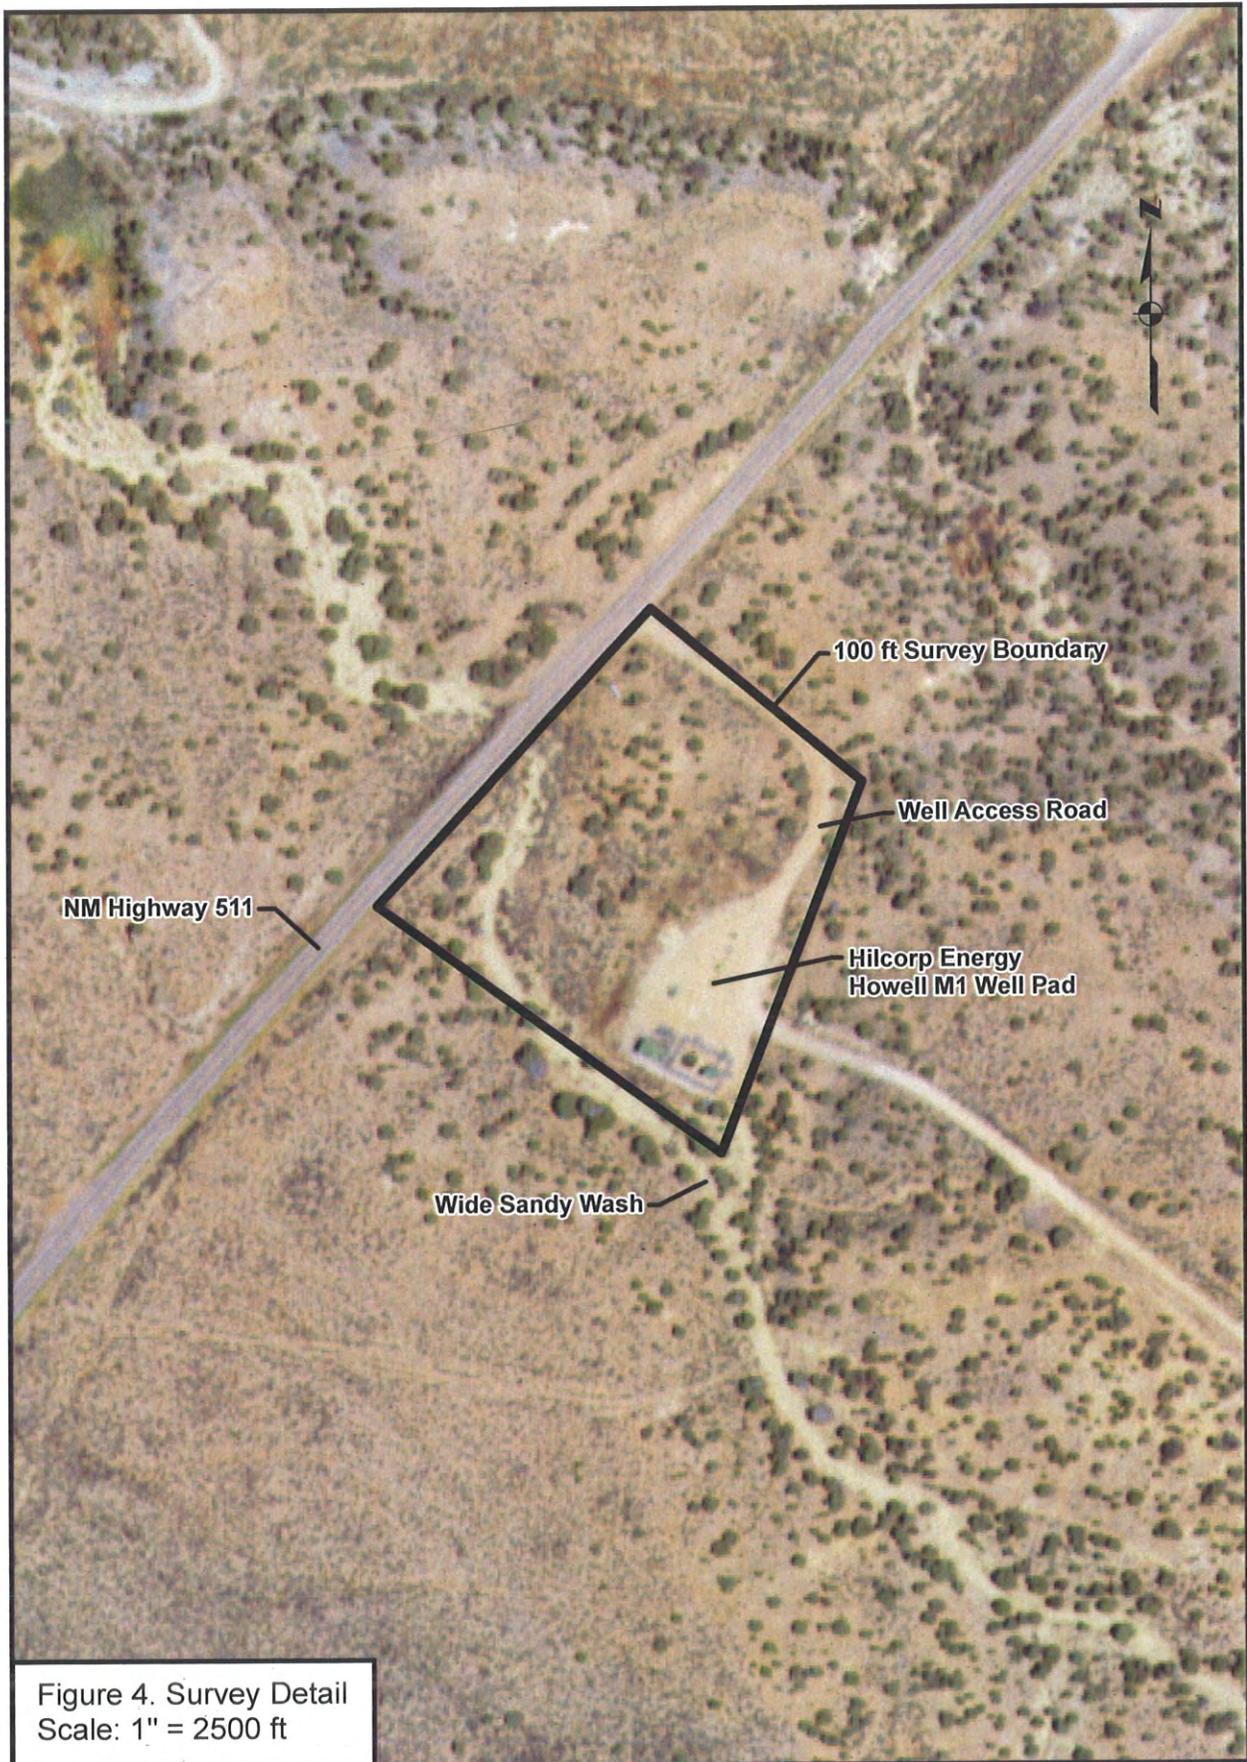
Figure 4. Survey Detail
Scale: 1" = 2500 ft

7. Description of Undertaking (what does the project entail?): The project proposed by Hilcorp Energy is related to the process of delineating an historic spill that was found on the Howell M1 well pad by a midstream company. Full horizontal and vertical delineation of the extent of the spill was not reached on the well pad itself. Additional boring is needed just off the north-northwest edge of the well pad to complete delineation of the spill so that a remediation plan can be completed. Hilcorp proposes to complete as many as four more bore holes, located just outside the fill of the pad on the downslope(northwest) side. Including a 100 ft buffer zone, a 4.079 acre polygon was surveyed for cultural resources, encompassing the area of the proposed bore holes plus at least 100 ft outside of the area of expected disturbance. The survey encompassed the well pad and all previous construction disturbance, and extended from a wide sandy wash southwest of the pad, to the northeast side of the well access road, and the southeast edge of NM Highway 511. Two previously recorded sites are just inside the area of the survey, and both were updated. See Figures 1 and 2 for project location, and Figure 4 for the survey area detail.		8. Dates of Investigation: February 25-26, 2021

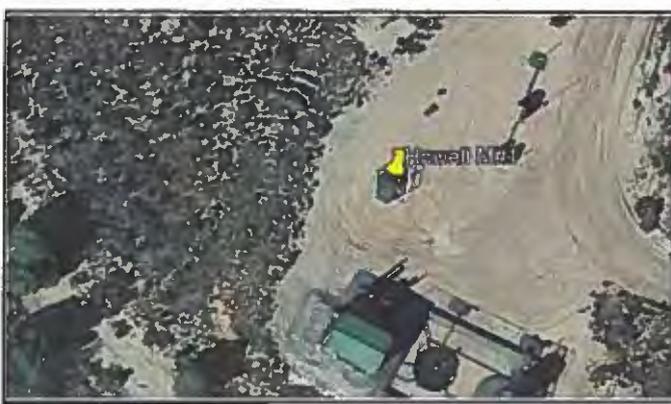
Penetration Resistance	Moisture Content	Vapor (ppm)	HC Staining?	Sample #	Depth (ft. bgs.)	Sample Run	Recovery	Soil/Rock Type	Lithology/Remarks	Well Completion
					0					
					1					
					2					
	Dry	0.0	No		3		X	SM	Lt. Brown silty fn. sand w/ gravel, some cobble.	
					4				Backfill material, loose, unconsolidated. No stain/odor.	
					5					
					6					
					7					
	Dry	0.0	No		8		X	SM	SAA, backfill material	
					9				No s/o.	
					10					
					11					
					12				SAA.	
					13					
	Dry	0.0	No		14		X		Backfill	
					15				No s/o

Penetration Resistance	Moisture Content	Vapor (ppm)	Staining	Sample #	Depth (ft. bgs.)	Sample Run	Recovery	Soil/Rock Type	Lithology/Remarks	Well Completion
					15					
					16					
					17			SM	Backfill, mixing into Native.	
					18					
	Dry	44.6	No		19			SP	Lt. Brown + gray fn-med sand w/ silt. Poorly graded. No stain. Silt Silt. odor.	
					20			-SM		
					21					
					22					
					23					
	Dry	1,450	Yes Silt.		24			SP	Lt. Brown + Lt. gray Medium sand. Tr. silt. Silt. stain, Mod. odor	
					25					
					26					
					27					
				BH01 @ 25'-30' 09.45	28					
	Dry	1,757	Yes Mod.		29			SP	Lt. gray med-med coarse sand. Tr. silt. Mod. stain/odor.	
					30					
					31			SM	Dark gray silty fn. sand. Mod s/o.	
	Dry	1,648	Yes MOD		32			SP	Lt. gray coarse sand, dense silt. cement. Refusal w/ continuous sampler. Mod odor. No stain.	
					33					
					34				Put in plug, drilled to 35', tried continuous sampler again. Successful.

35					
					36					
	Dry	1,026	Yes		37			SM/ML	Dark gray fn silty sand. Mod stain/odor.

Penetration Resistance	Moisture Content	Vapor (ppm)	Staining	Sample #	Depth (ft. bgs.)	Sample Run	Recovery	Soil/Rock Type	Lithology/Remarks	Well Completion
					37					
					38					
				BH01 @ 38'-43'	39			ML	Lt. gray silt. w/ fn. sand. Dense but fissile. No stain/odor.	
	Dry	24.6	No	16.30	40					
					41					
					42					
					43					
	Dry		Yes		44			SW	Gray well grad. DB, meant for BH02	
					45					
					46					
					47					
					48					
					49					
					50					
					51					
					52					
					53					
					54					
					55					
					56					
					57					
					58					
					59

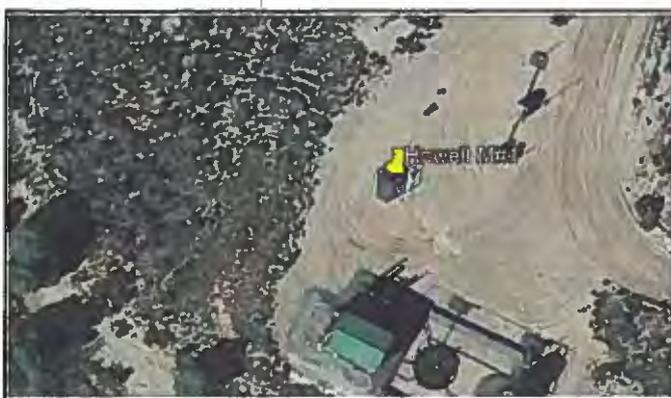
Penetration Resistance	Moisture Content	Vapor (ppm)	HC Staining?	Sample #	Depth (ft. bgs.)	Sample Run	Recovery	Soil/Rock Type	Lithology/Remarks	Well Completion
					0					
					1					
					2					
					3					
	Dry	3.7	No		4		X	SW SM	Lt. Brown med fn. sand w/ silt. Fill material on pad. No s/o.	No well set.
					5					
					6					
					7					
	Dry	12	No		8		X	SW -SM	SAA. No s/o.	
					9					
					10					
					11					
					12					
	Dry	3.3	No		13		X	SW -SM	SAA. No s/o	
					14					
					15

Penetration Resistance	Moisture Content	Vapor (ppm)	Staining	Sample #	Depth (ft. bgs.)	Sample Run	Recovery	Soil/Rock Type	Lithology/Remarks	Well Completion
					15					
					16					
	Dry	3.7	No	BH 04 @ 15'-20'	17			SW -SM	Lt. Brown / tan Med. med coarse sand. w/ silt. No s/o	
					18					
					19					
					20			GW -GM	Tan coarse sand + gravel w/ silt., cobbles. No s/o	
				13:45	21					
					22					
	Dry	2.3	No		23			GW -GM	SAA. No s/o	
					24					
					25					
					26					
					27					
	Dry	3.4	No		28			SM	Lt. Brown fn-med fn silty sand. No s/o.	
					29					
					30					
					31					
					32					
	Dry	1.1	No		33			SM	SAA. No s/o	
					34					
					35					
					36					
					37

Penetration Resistance	Moisture Content	Vapor (ppm)	Staining	Sample #	Depth (ft. bgs.)	Sample Run	Recovery	Soil/Rock Type	Lithology/Remarks	Well Completion
					37					
					38			SM	SAA Lt. Brown fn silty sand. No s/o	
	Dry	1.8	No		39			ML	fn sandy silt. No s/o	
					40					
					41					
					42					
					43					
				BH04 @ 43'-45' 14:20	44			SW-SM	Tan + Lt. gray med-coarse sand + gravel w/ silt + cobb. No s/o.	
	Dry	2.5	No		45				Refusal @ 45' w/ H.I.T.	
					46				No well set.	
					47					
					48					
					49					
					50					
					51					
					52					
					53					
					54					
					55					
					56					
					57					
					58					
					59

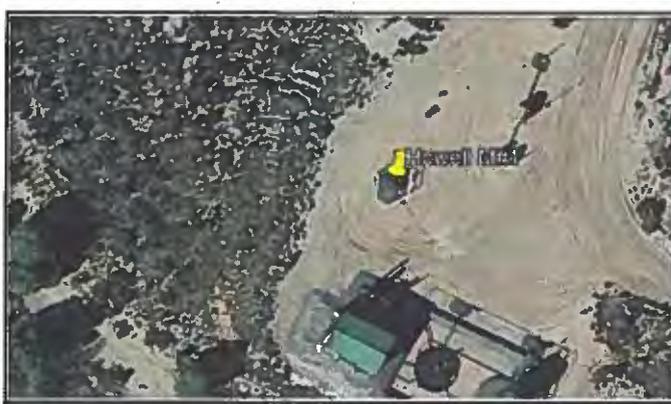
Penetration Resistance	Moisture Content	Vapor (ppm)	HC Staining?	Sample #	Depth (ft. bgs.)	Sample Run	Recovery	Soil/Rock Type	Lithology/Remarks	Well Completion
					0					
					1					
					2					
	Dry	1.4	No		3			SW	Lt. Brown med. sand w/ silt. No s/o	No Well set
					4			SM		
					5					
					6					
					7					
	Dry	1.3	No		8			GW	Lt. brown sandy gravel w/ silt. No s/o	
					9			-GM		
					10					
					11					
					12					
					13					
	Dry	0.0	No		14			SW	Brown med. med coarse sand w/ silt. some gravel No s/o	
					15			SM

Penetration Resistance	Moisture Content	Vapor (ppm)	Staining	Sample #	Depth (ft. bgs.)	Sample Run	Recovery	Soil/Rock Type	Lithology/Remarks	Well Completion
					15					
					16					
					17					
	Dry	0.9	No		18			SW	Brown med sand w/ silt & Tr. gravel. Well Gr. No s/o.	
					19			-SM		
					20					
					21					
					22					
	Dry	0.3	No		23			SW	Brown-dark brown med. to med-coarse sand w/ silt. No s/o	
					24			-SM		
					25					
	Dry	0.0	No		26			X	Lt gray coarse sand silt cement. No s/o Refusal w/ continuous sampler.	
					27				put in plug, drill to 30' and put continuous sampler back on	
	No	Recovery			28					
					29					
					30					
					31					
	Dry	0.4	No		32			SM/ML	Lt gray alternating sandy silt and silty sand. Some v. Dense. No s/o.	
					33					
					34					
					35					
	Dry		No		36			SM/ML	SAA No s/o	
					37

Penetration Resistance	Moisture Content	Vapor (ppm)	Staining	Sample #	Depth (ft. bgs.)	Sample Run	Recovery	Soil/Rock Type	Lithology/Remarks	Well Completion
					37					
					38					
	Dry	14.9	No	BH05 @ 35-40'	39			ML	Gray silt w/ sand. Dense. No s/o.	
				16.20	40					
					41					
					42				Gray v. fn. sandy silt.	
	Dry	0.7	No	BH05 @ 40'-45'	43			ML	v. Dense. No s/o.	
					44					
				16.30	45				Refusal @45', clean hole. w! HSA No wellset.	
					46					
					47					
					48					
					49					
					50					
					51					
					52					
					53					
					54					
					55					
					56					
					57					
					58					
					59

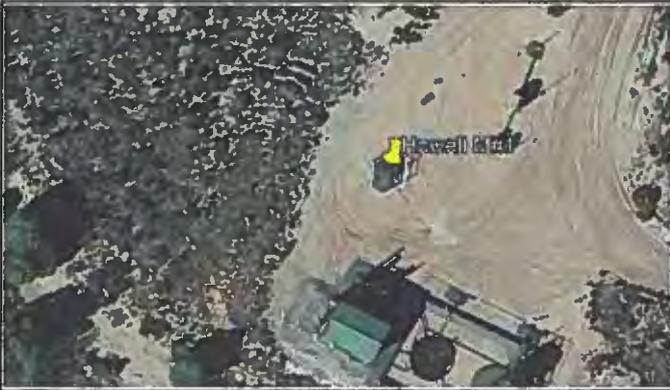
Penetration Resistance	Moisture Content	Vapor (ppm)	Staining	Sample #	Depth (ft. bgs.)	Sample Run	Recovery	Soil/Rock Type	Lithology/Remarks	Well Completion
					37					
				BH06 @ 35'	38			ML	Lt. + dark gray silty clay, w/ v. fn sand. Sandy clay. Dense. No s/o	
	Dry	10.7	No	-40'	39			CL		
				1126	40					
					41					
				BH06 @ 40'-45'	42			ML CL	SAA. Dense, shiny silty clay, Tr. sand. No s/o.	
	Dry	2.9	No		43					
					44					
				1130	45				- Lt. bluish gray siltstone. cemented No s/o. - Refusal @ 45'	
					46				No well set.	
					47					
					48					
					49					
					50					
					51					
					52					
					53					
					54					
					55					
					56					
					57					
					58					
					59

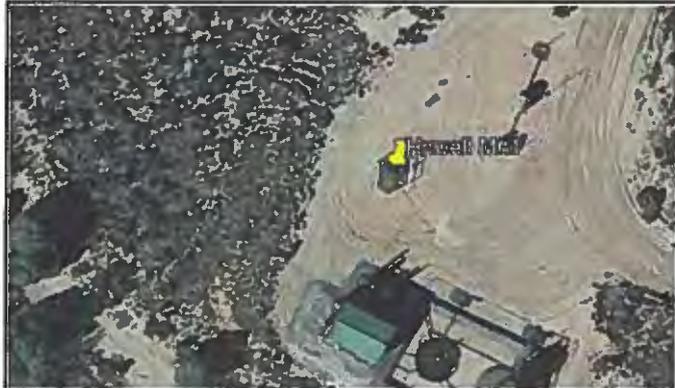
Penetration Resistance	Moisture Content	Vapor (ppm)	Staining	Sample #	Depth (ft. bgs.)	Sample Run	Recovery	Soil/Rock Type	Lithology/Remarks	Well Completion
	Dry	1494	No	BH 09	37		<input checked="" type="checkbox"/>		Lt. Brown med sand w/ silt + gravel. No stain, slt. gassy odor. Refusal due to cobble @ 38', using plug to get to 40'	
				@ 35'-38'	38	<input checked="" type="checkbox"/>				
				1200	39	<input checked="" type="checkbox"/>				
					40	<input checked="" type="checkbox"/>				
	Dry	546	No	BH 09	41		<input checked="" type="checkbox"/>	SW Lt. grayish tan med-coarse sand w/ gravel/cobbles. Lt. grayish white, dense med s. sth. Refusal @ 43'		
				@ 40'-43'	42	<input checked="" type="checkbox"/>				
				1220	43	<input checked="" type="checkbox"/>				
					44	<input checked="" type="checkbox"/>				
					45					
					46					
					47					
					48					
					49					
					50					
					51					
					52

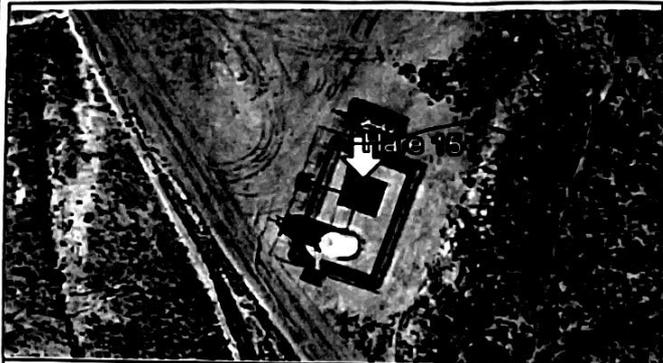
Penetration Resistance	Moisture Content	Vapor (ppm)	Staining	Sample #	Depth (ft. bgs.)	Sample Run	Recovery	Soil/Rock Type	Lithology/Remarks	Well Completion
	moist	14.2	N		37					
					38			GP	Gravel & cobbles	
					39					
					40					
					41					
					42					
	moist	371	Y		43			SP	moist, dense hard, gray, coarse sand, HC stain, slight odor	
					44					
					45					
					46					
					47					
					48					
					49					
					50					
					51					
					52					
					53					
					54					
					55					
					56					
					57					
					58					
					59

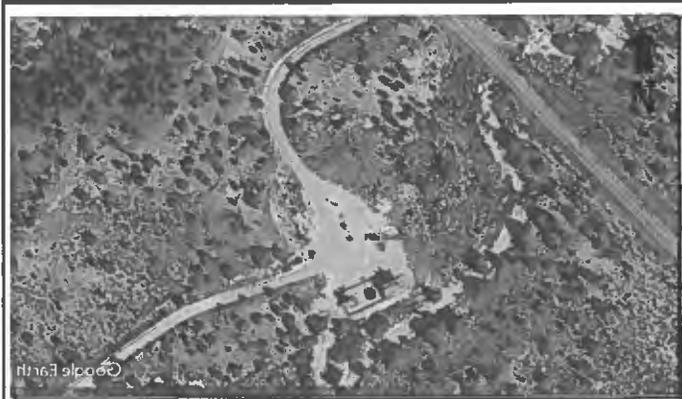
WSP USA INC 848 East 2nd Avenue Durango, CO 81301					Boring/Well #	BH15				
					Project	Howell Howell				
					Project #	01234567				
					Date	9-17-21				
Penetration Resistance	Moisture Content	Vapor (ppm)	Staining	Sample #	Depth (ft. bgs.)	Sample Run	Recovery	Soil/Rock Type	Lithology/Remarks	Well Completion
					15					
					16					
					17			SM	SAA	
	Dry	0.2	NO		18	15-20				
					19					
					20					
					21					
	Dry	0.1	NO		22	20-25		SM	SAA, many large cobbles	NO well
					23					
					24					
	Dry	1.5	NO		25	25-28		SM	light grey/brown SAA, many large cobbles	
					26				2YR 6/1	
					27					
	Dry	1.0	NO		28	28-30		SM	SAA	
					29					
					30				SAA	
					31					
					32				grey claystone, high plastic cohesion	
	M	2.3	NO	BH15 @ 30-35' (1330)	33	30-35		CH	no stain/odor	
					34				2.5YR5/1	
					35					
	M		NO		36			CH	SAA	
					37	35-40

WSP USA INC 848 East 2nd Avenue Durango, CO 81301					Boring/Well #	BH15				
					Project	XXXX				
					Project #	01XXXXXX Howell M1				
					Date	9-15-21				
Penetration Resistance	Moisture Content	Vapor (ppm)	Staining	Sample #	Depth (ft. bgs.)	Sample Run	Recovery	Soil/Rock Type	Lithology/Remarks	Well Completion
					37					
	M	0.4	NO		38	35-40		CH	SAA	
					39					
					40					
					41					
	M	0.2	NO	BH15 40-45 @ 1350	42	40-45		CH	SAA	
					43	35-40				
					44					
					45					
					46				TD @ 45, no impacts observed clayston	NO well
					47					
					48					
					49					
					50					
					51					
					52					
					53					
					54					
					55					
					56					
					57					
					58					
					59
