Remediation Plan

Site Name: Empire A Federal #2	Site Type: Salt Water Injection and Tank Battery
Date Release Discovered: August 12, 2019 @ 11am by NMOCD	API# 30-015-29618

Site Assessment/Characterization
Empire A Fed #2 Release - NRMXXXXXXXX

Characterization Report

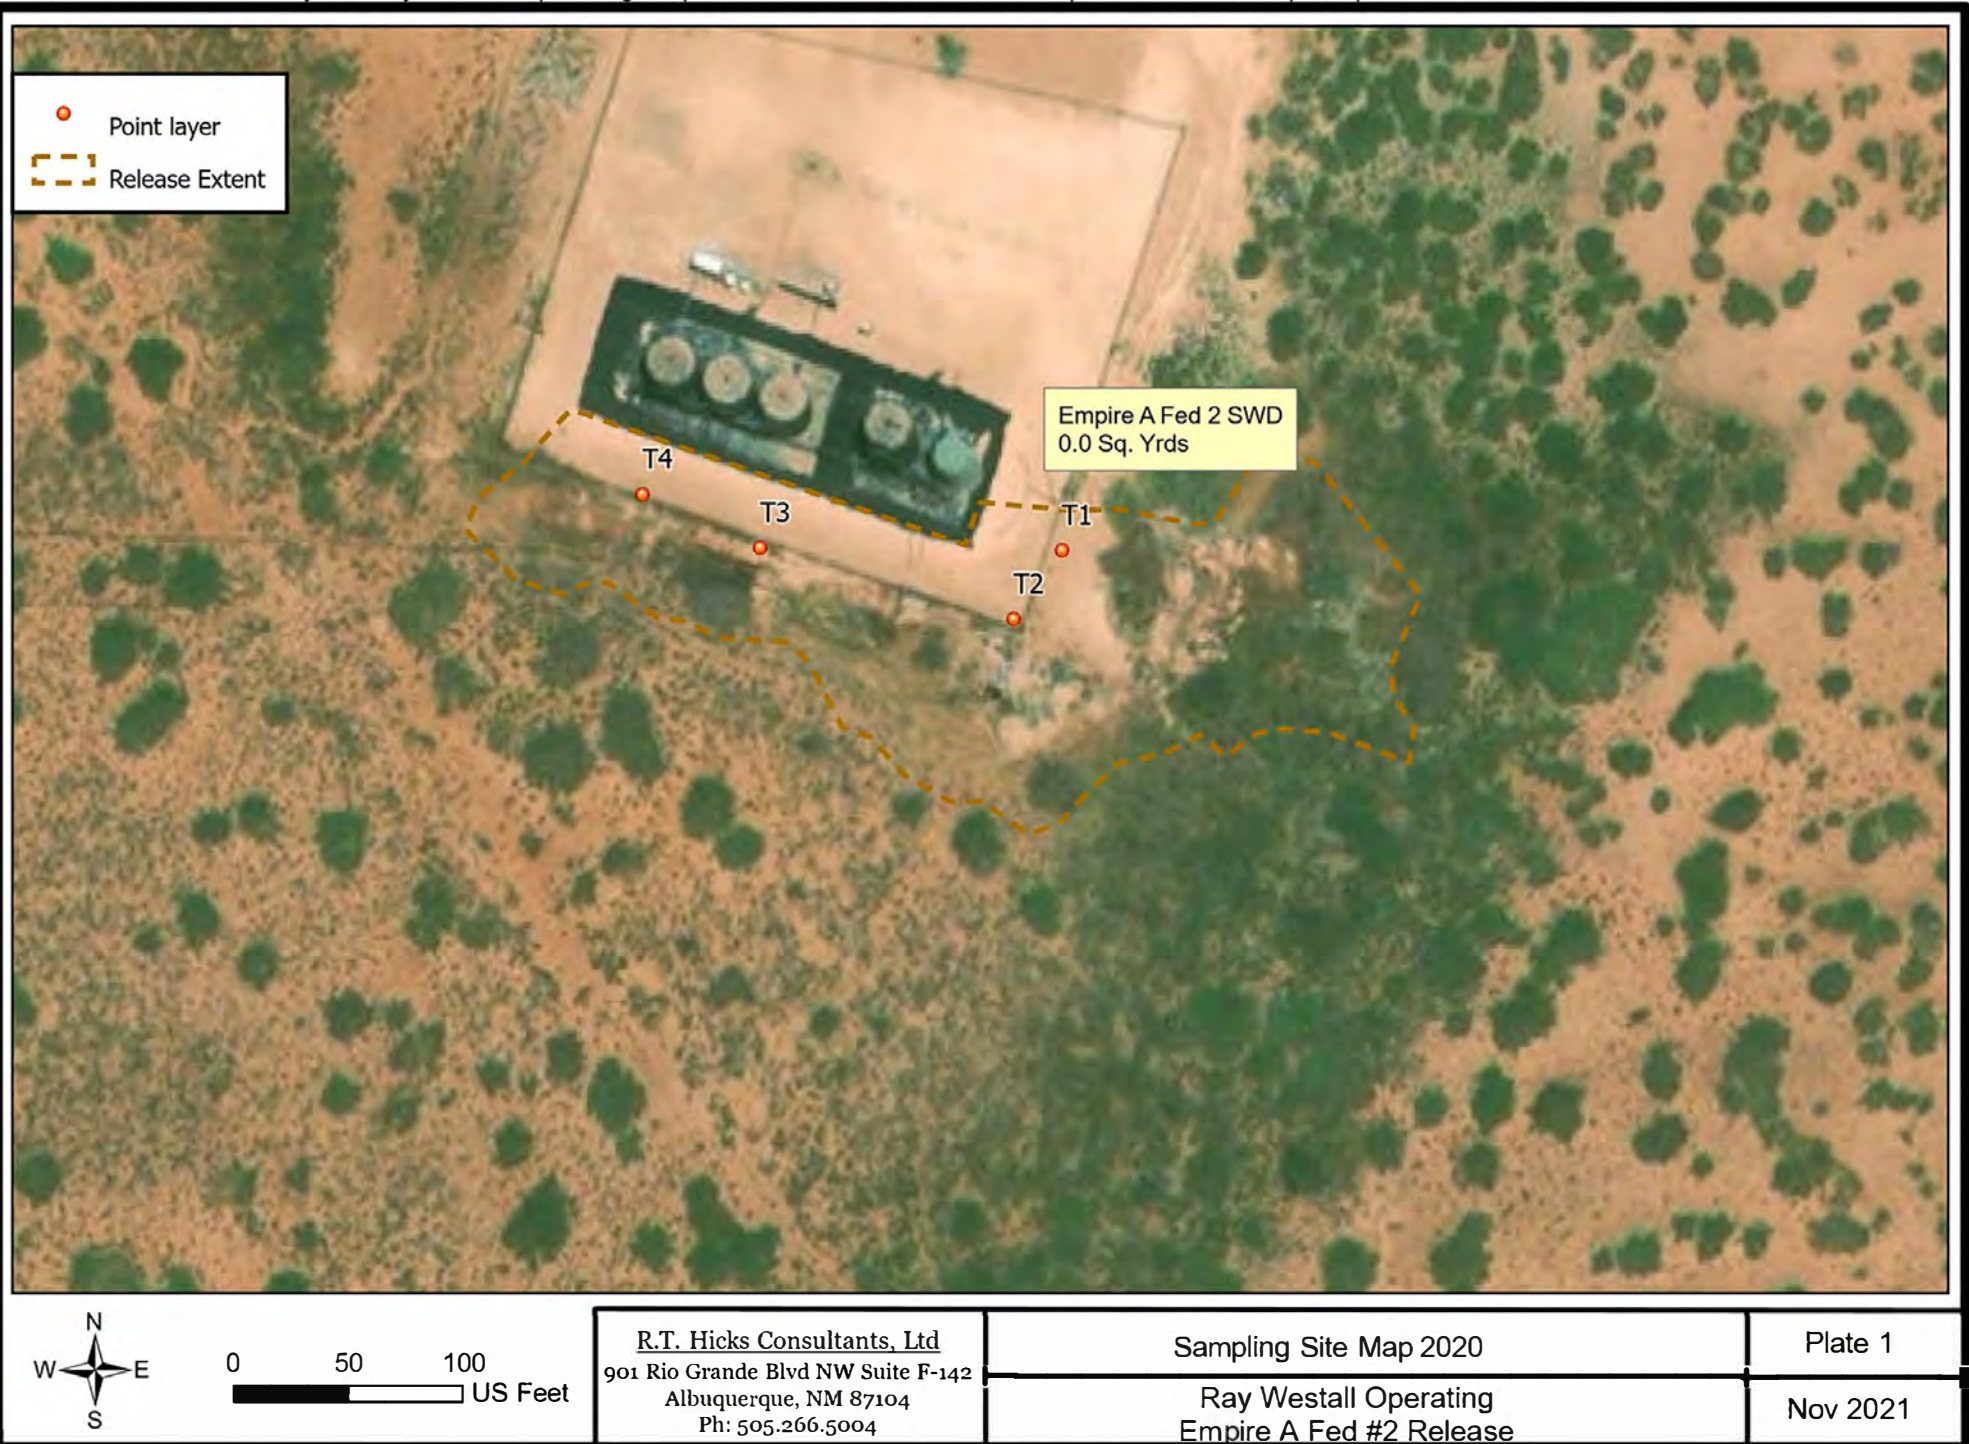
Site Assessment/Characterization
Empire A Fed #2 Release - NRMXXXXXXXX

- The average chloride concentration in the soil and subsoil from surface to a depth of four (4) feet is
 - 490 mg/kg using the 2020 sampling results and assuming 40 mg/kg as the value for T2 at 24 inches
 - 383 mg/kg using the 0-4 composite for T2 and T4 and the average of the two samples from T3

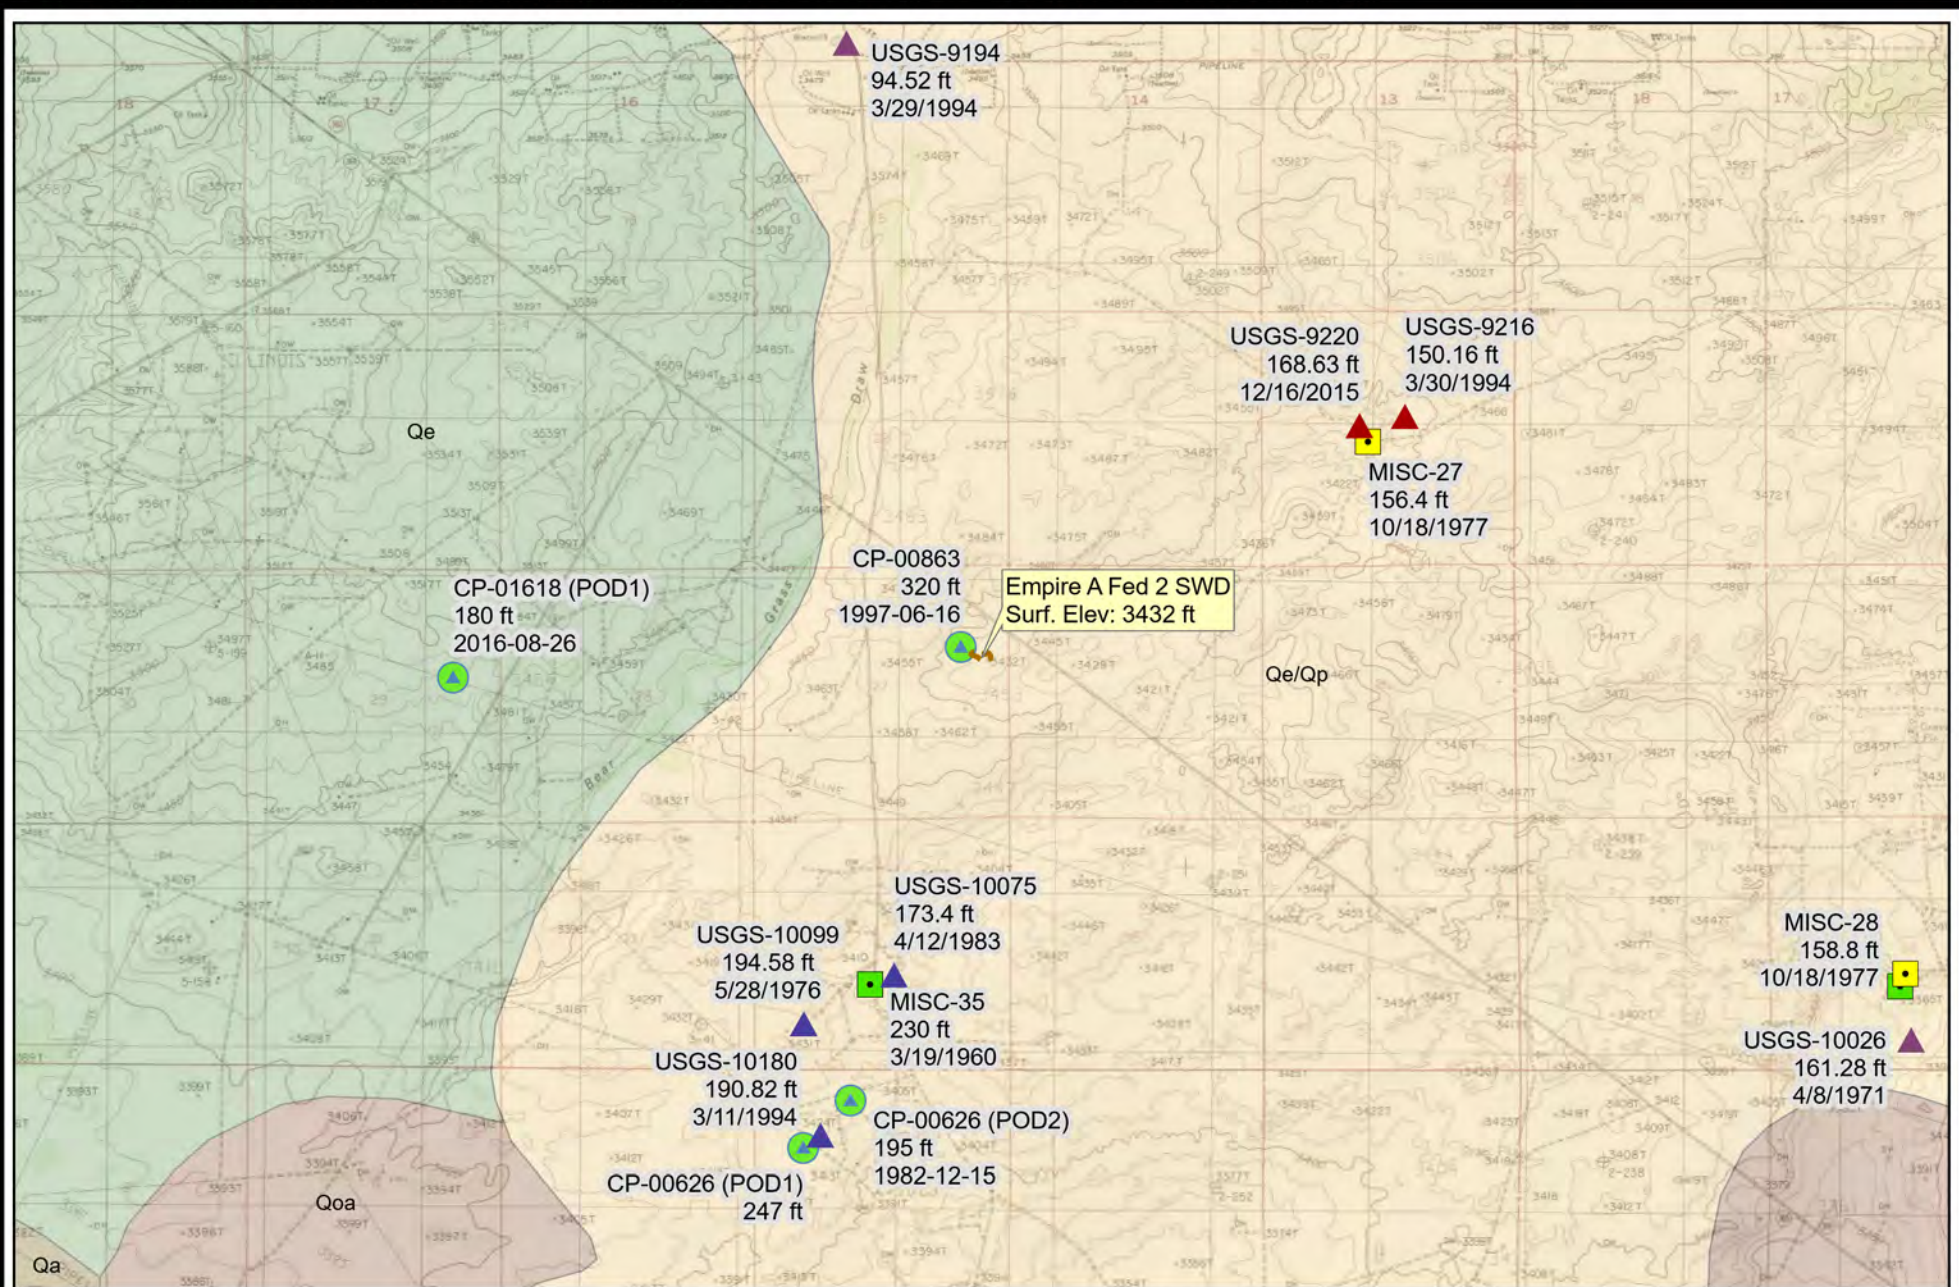
1. The location of the Empire release site labelled with a yellow callout box.
2. Water wells from the USGS database as green with an orange dot, purple, red, and blue triangles. These symbols represent the principal water bearing unit. In this case, the symbols represent Artesia Group, Chinle, Santa Rosa, and Rustler formations. The USGS well number, groundwater elevation measurement, and date the well was completed are also indicated on the Plate.

We relied upon the USGS and MISC wells from the various water bearing units to create the water table elevation map shown in Plate 3. Water level data from the OSE database rely upon observed water levels by drillers during the completion of the water well. The OSE dataset provides some useful data in certain areas.

The data demonstrate that the wells in the southern and western areas of the map are completed in the Permian Rustler formation, and the wells in the northern and eastern areas of the map are completed in the Santa Rosa or Chinle formations. We believe this to be true based on our analysis.

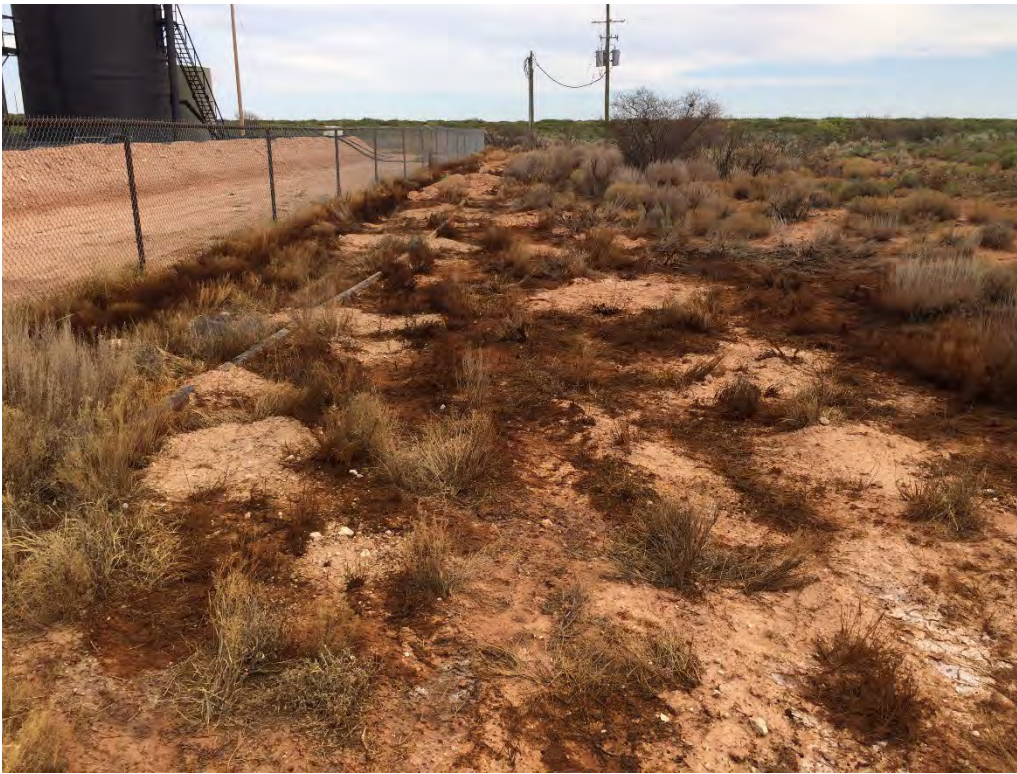
SP1 View southeast along southern fence line showing vegetation impact in 2019.

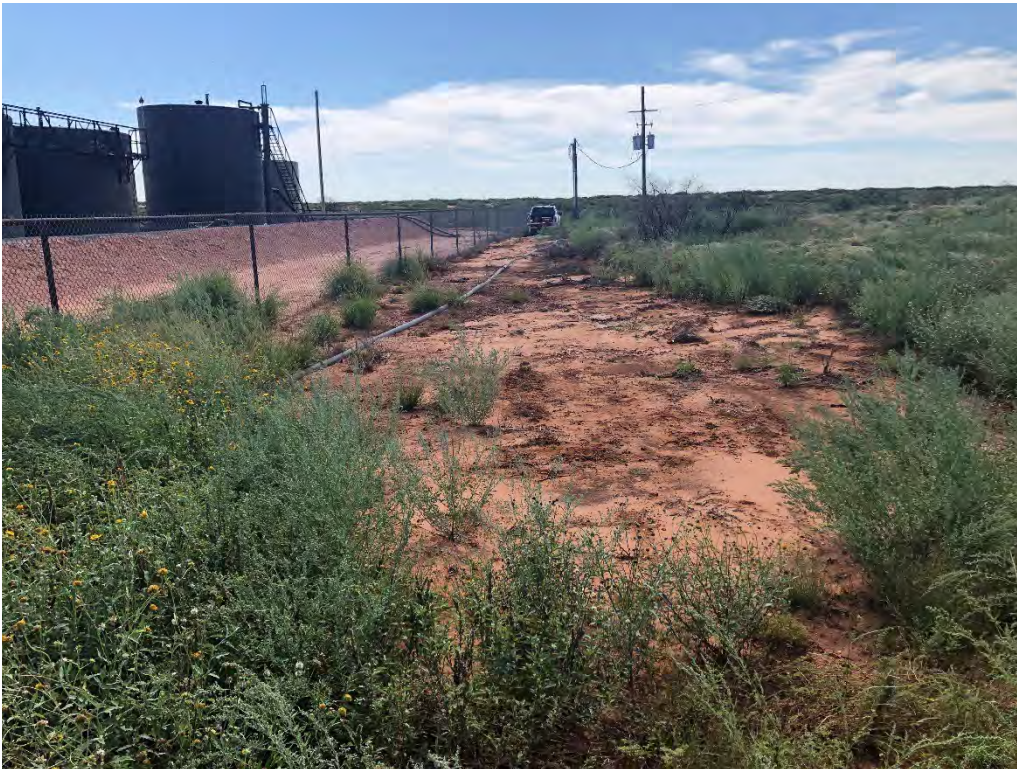
SP2 View in 2021 from the same location as SP1 in 2021. Vegetation growth has covered some of the spill footprint but impairment in some areas remains.

Since the initial site visit in 2019, portions of the impacted area (notably the southwestern portion) have naturally revegetated, albeit with volunteers rather than species in the BLM seed mix. RWO proposes the following reclamation plan:

- Till the affected soil that has not revegetated, including areas impacted with crude oil, and mix in a small volume of straw to improve the soil porosity/permeability
- Prior to seed formation of the volunteer vegetation, till the remaining areas of the spill footprint incorporating the volunteer vegetation into the soil to add biomass and improve porosity
- Seed with the appropriate BLM seed mixture prior to an monsoon rains and
- Monitor re-vegetation and remove any invasive species and other unwanted weeds.

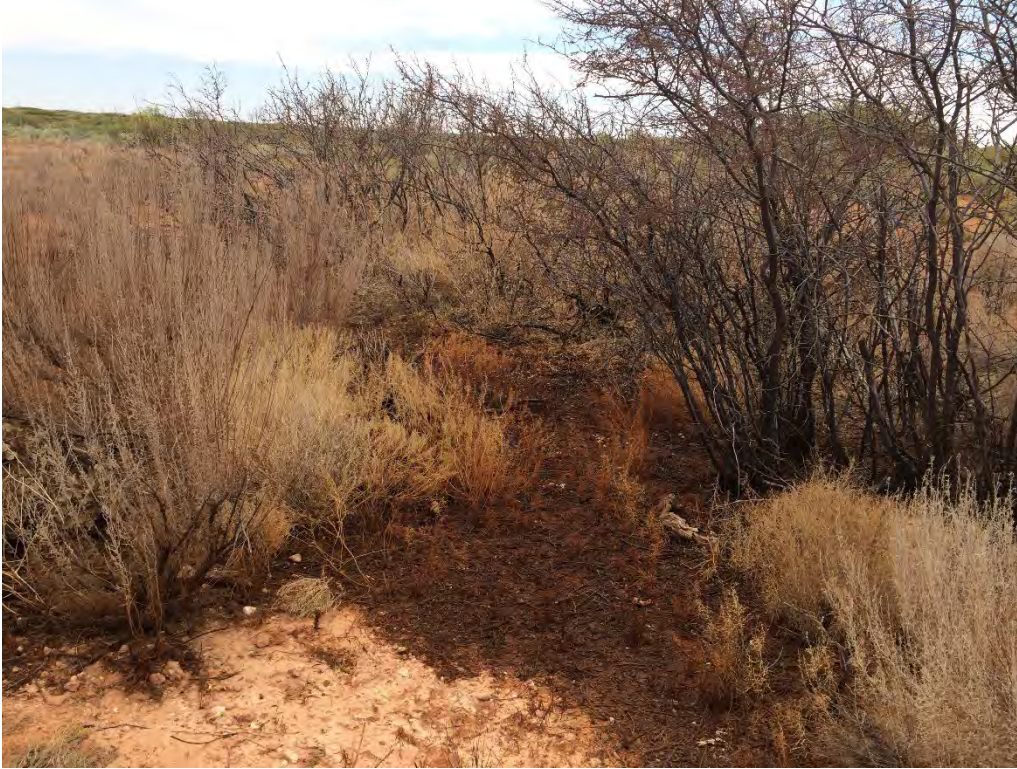
SP3 Soil staining and vegetation impairment allowed an accurate measurement of the spill footprint in 2019 (the date of this image).

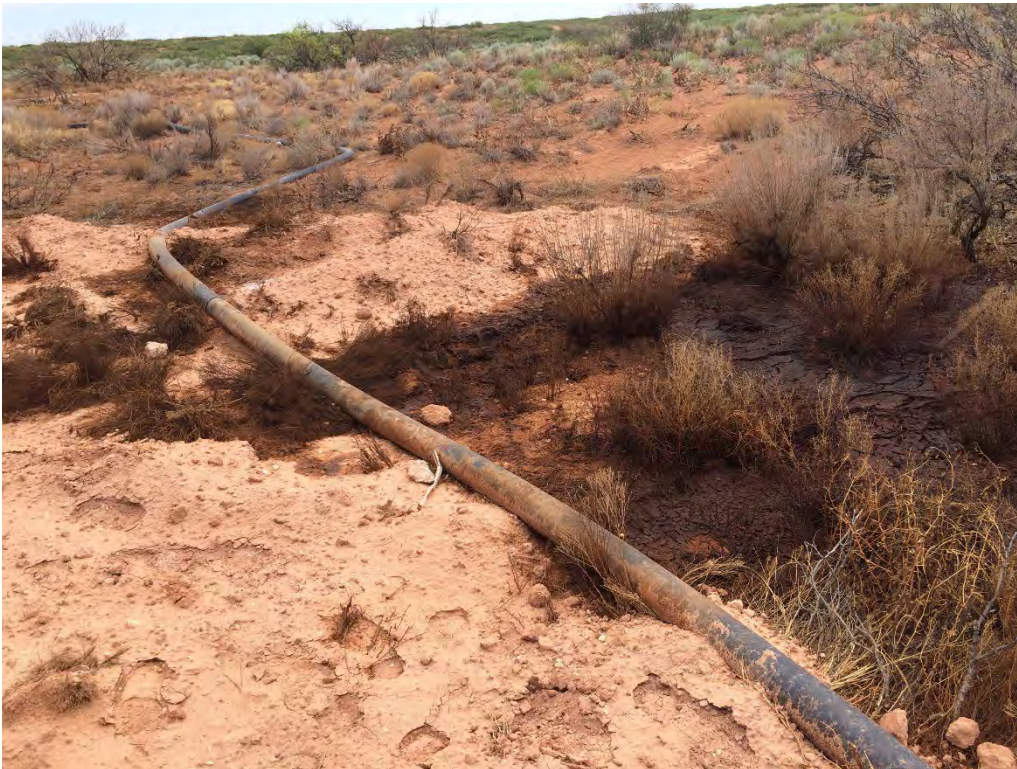
SP4 This 2019 image shows that RWO placed clean soil in certain areas of the release to absorb crude and to stabilize the release.

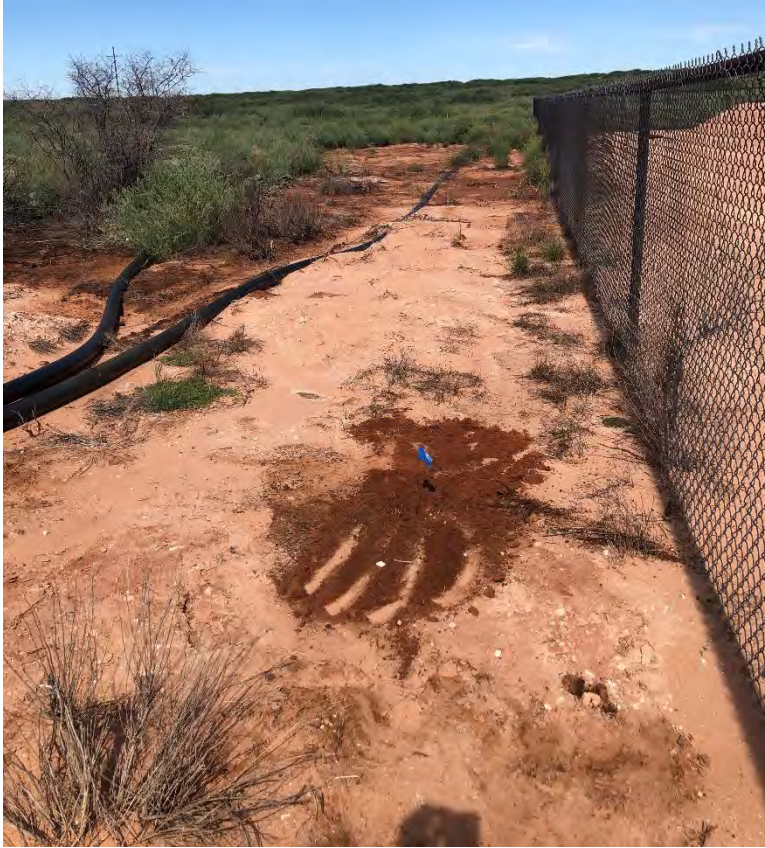
SP5 This 2021 image shows the 2021 sample boring at the same location as the 2020 sample T3. Soil staining and stressed vegetation remains in many areas of the spill footprint while much of the spill footprint is re-vegetated.

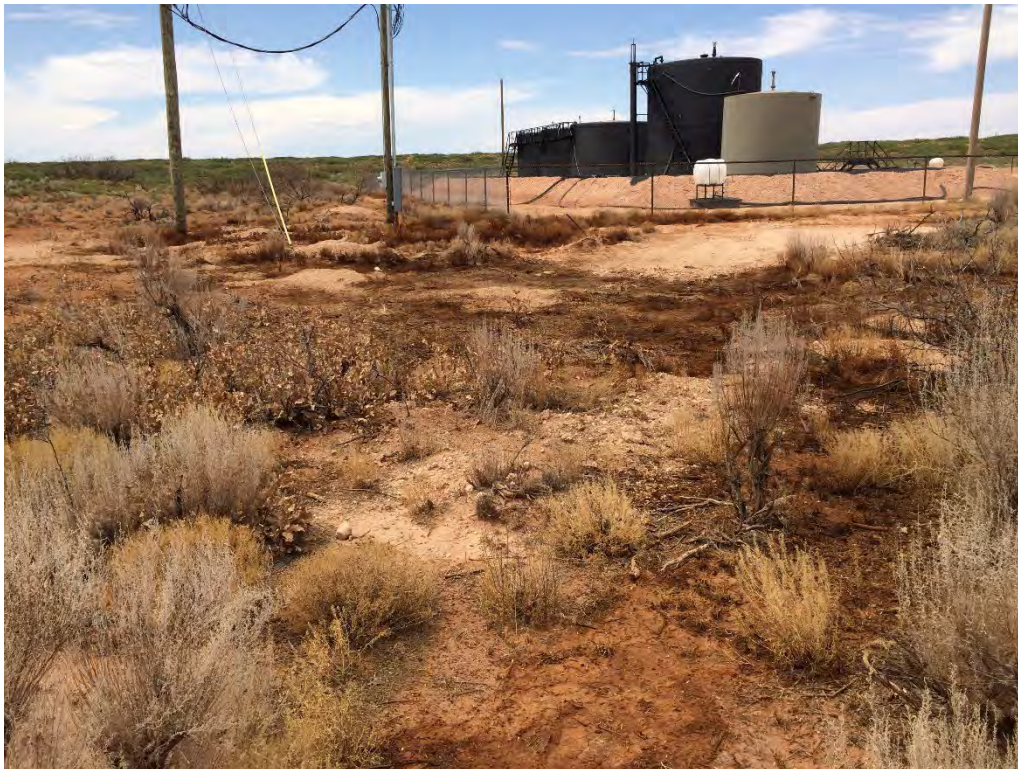
SP6- This 2019 images shows the release footprint to the east of the tank battery.

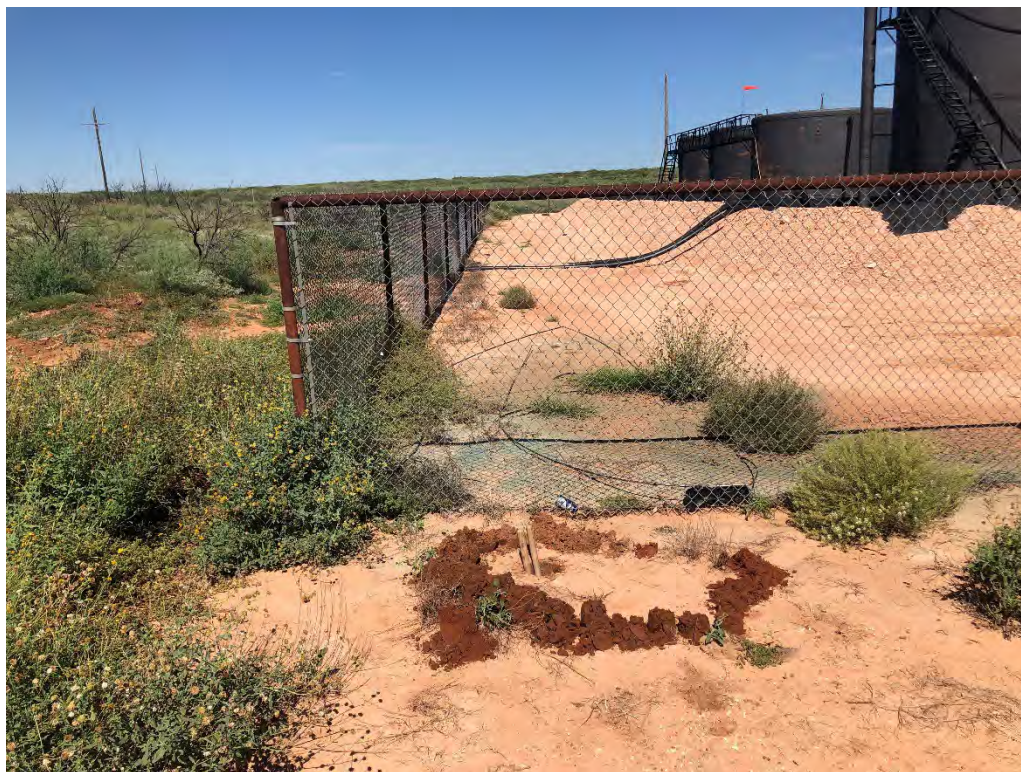
SP7 This image shows the location of the 2021 sample at T2 at the southeast corner of the tank battery. Note that the sample is on clean fill that is not re-vegetated but the vegetation to the left of the sample location lies in a small depression.

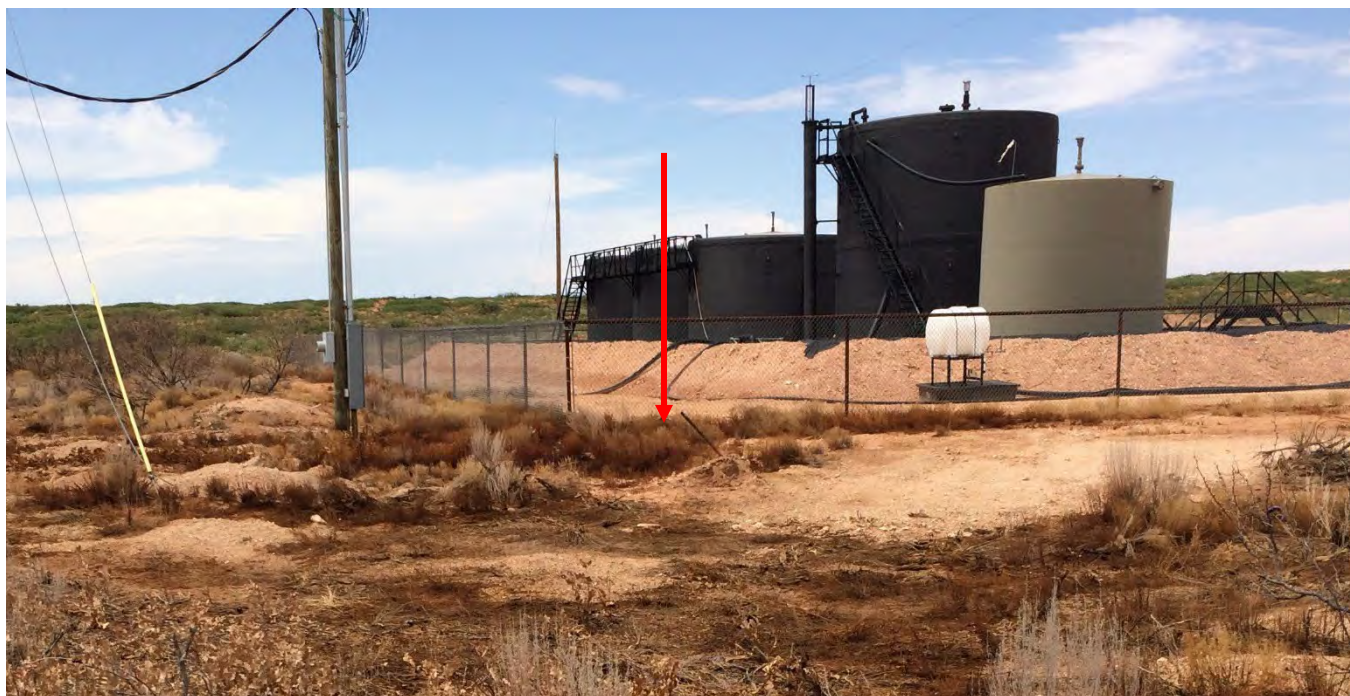
SP8- This 2019 image shows the edge of fill at that time. The red arrow that is the location of T2. The stressed vegetation at the southeast fence corner is healthy in the 2021 image (above).
