Closure Report
Gadwall 18 Fed Com #1
Incident #nAB1628854271
Eddy County, New Mexico
Unit C Sec 18 T25S R37E
32.13486°, -104.23313°

Oil Release
Point of Release: Hole in Oil Tank
Release Date: 10.12.2016
Volume Released: 200 Barrels of Oil
Volume Recovered: 70 Barrels of Oil

**Re: Closure Report
Gadwall 18 Fed Com #1
Cimarex Energy Co. of Colorado
Site Location: Unit C, S18, T25S, R27E
(Lat 32.13486°, Long -104.23313°)
Eddy County, New Mexico**

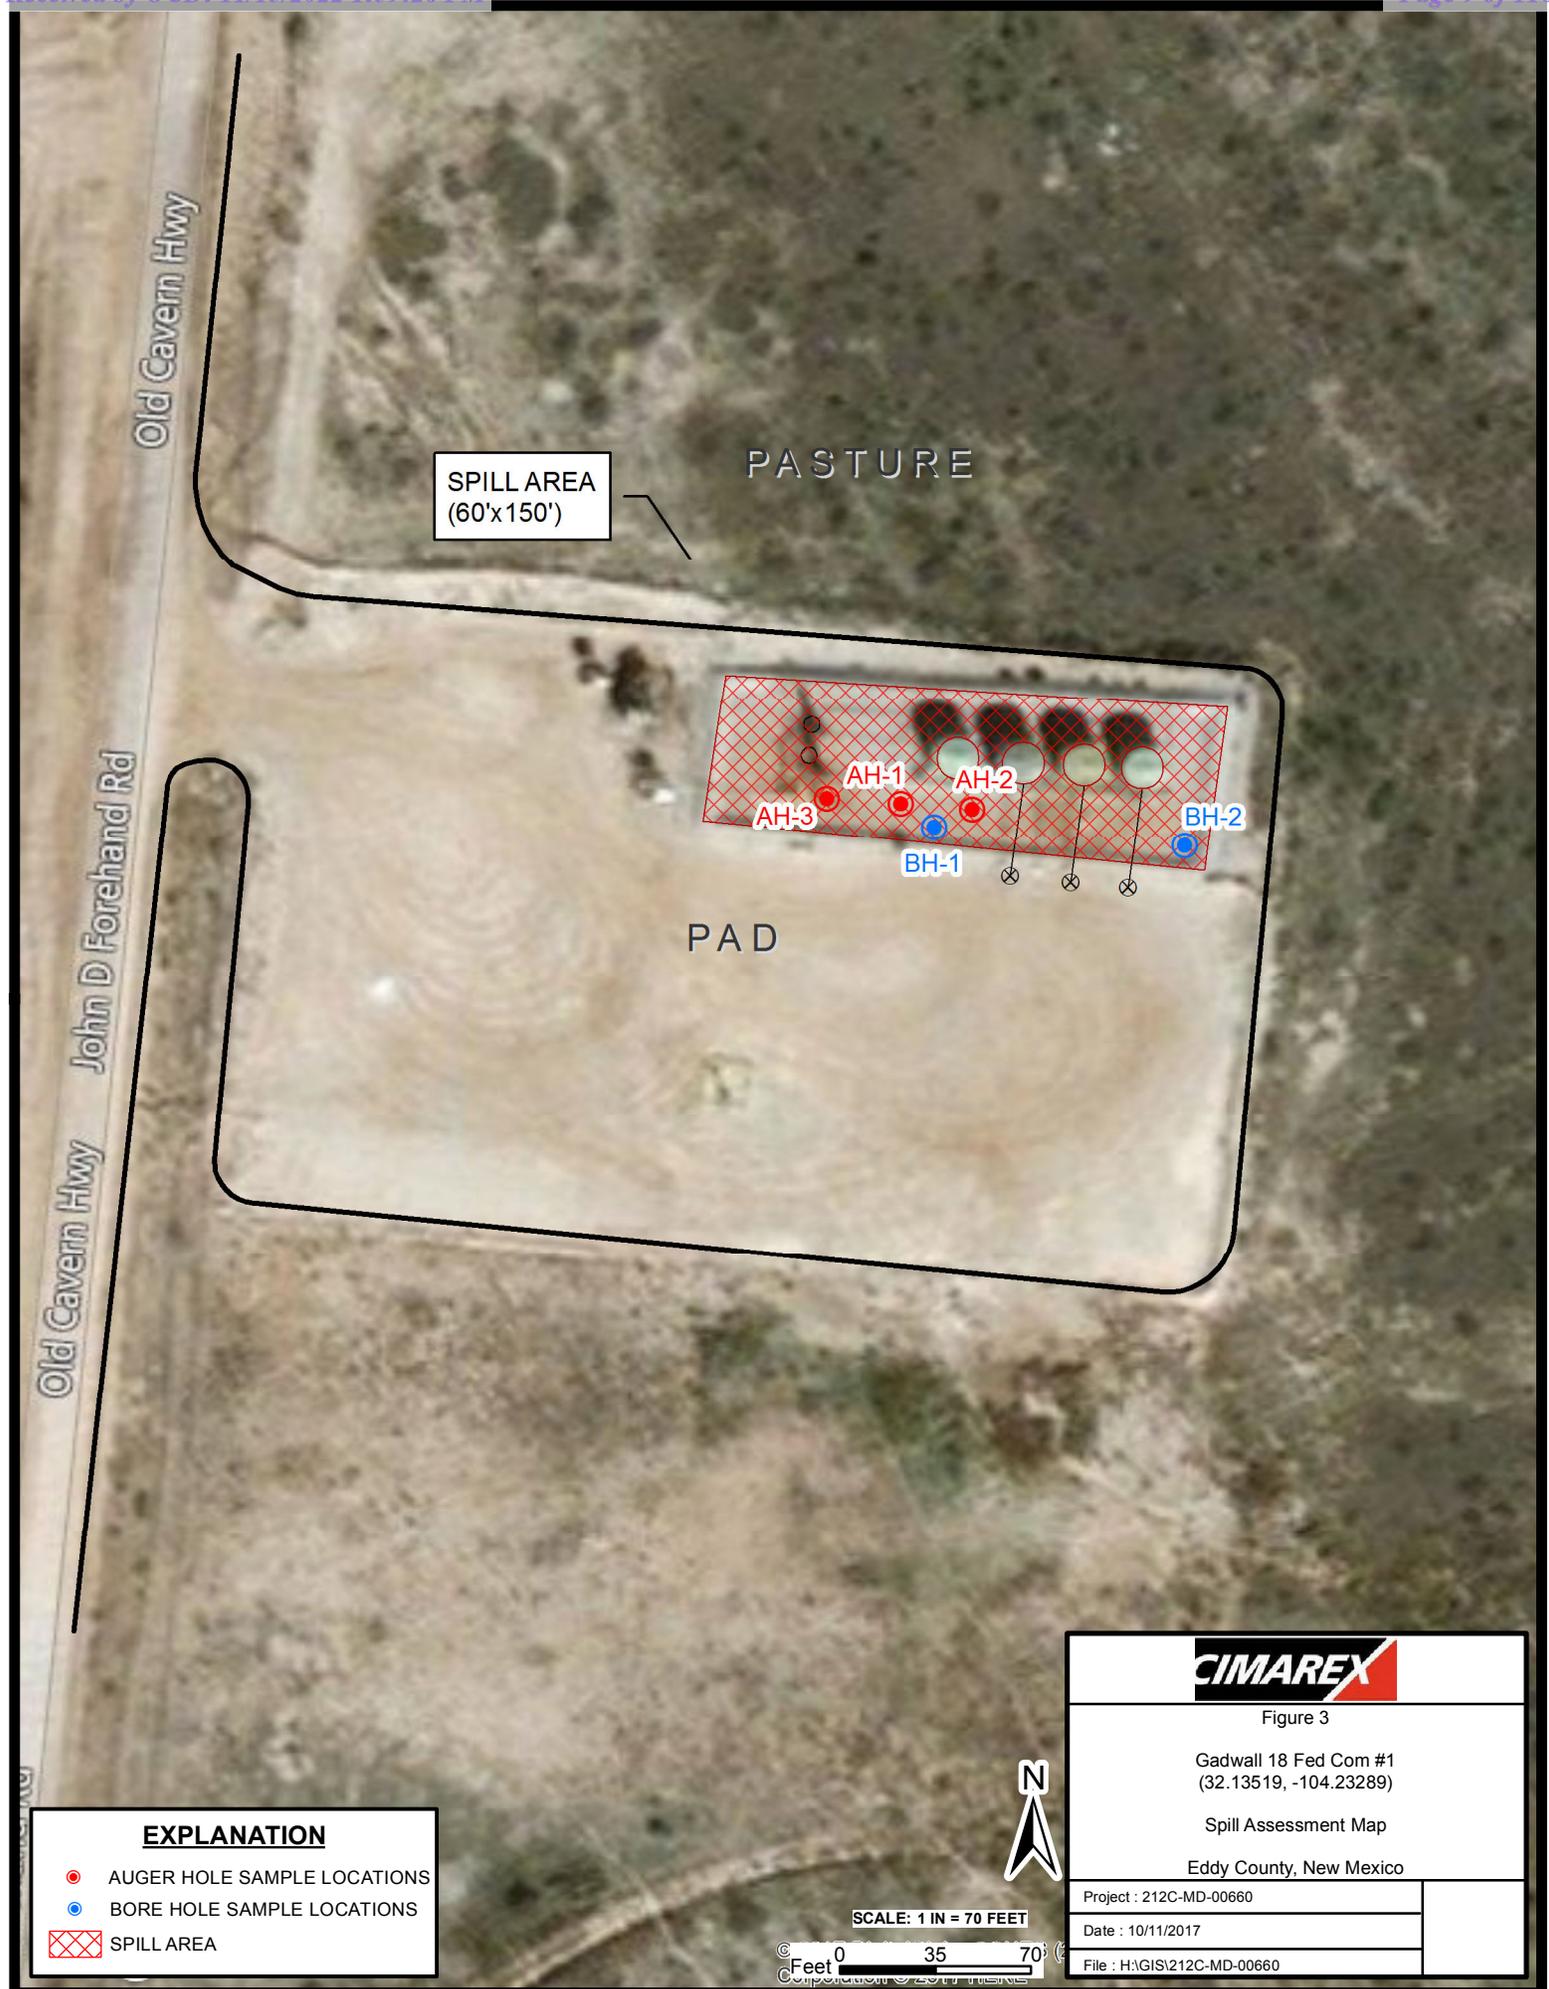
CIMAREX	
Figure 3	
Gadwall 18 Fed Com #1 (32.13519, -104.23289)	
Spill Assessment Map	
Eddy County, New Mexico	
Project : 212C-MD-00660	
Date : 10/11/2017	
File : H:\GIS\212C-MD-00660

Based on the initial C-141 obtained from the New Mexico Oil Conservation Division (NMOCD), the leak was discovered on October 12, 2016, due to corrosion, causing a hole to develop in an oil tank. It resulted in approximately two hundred (200) barrels of oil, and seventy (70) barrels of oil were recovered. The impacted area is located inside a lined facility and is shown on Figure 3. The initial C-141 form is attached in Appendix C.

EXPLANATION	
●	AUGER HOLE SAMPLE LOCATIONS
●	BORE HOLE SAMPLE LOCATIONS
	SPILL AREA

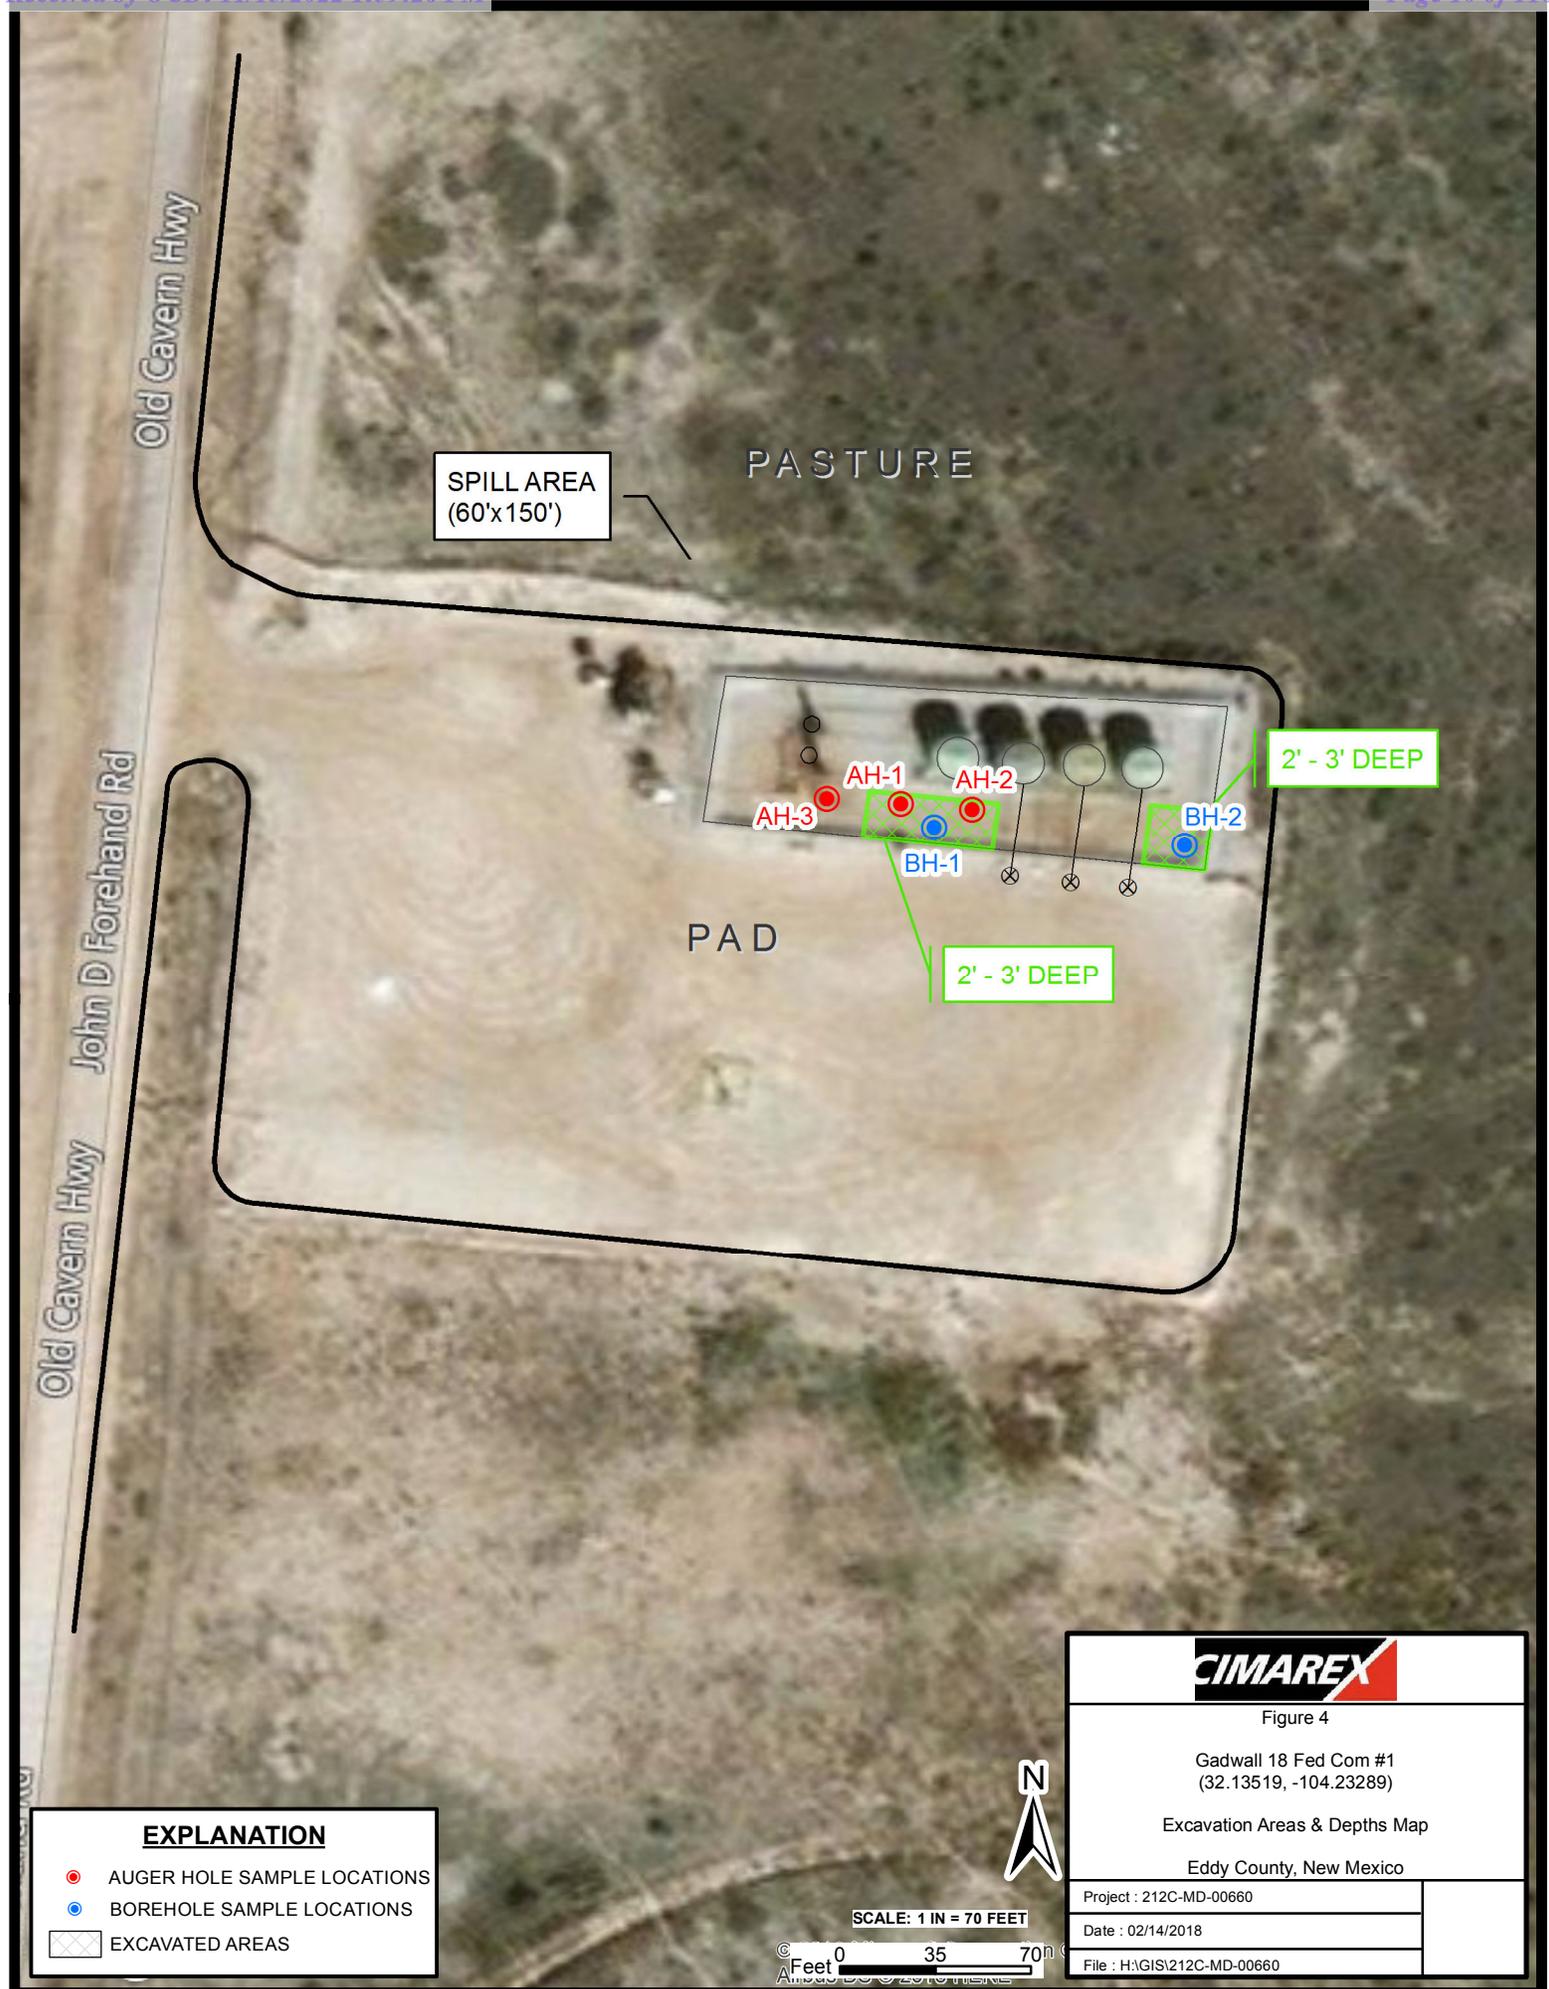
CIMAREX	
Figure 4	
Gadwall 18 Fed Com #1 (32.13519, -104.23289)	
Excavation Areas & Depths Map	
Eddy County, New Mexico	
Project : 212C-MD-00660	
Date : 02/14/2018	
File : H:\GIS\212C-MD-00660

Cimarex pulled the liner in the areas of boreholes (BH-1 and BH-2) to remove 2.0'-3.0' of the impacted material. After the area was excavated to the maximum extent possible and backfilled with clean material, the liner was replaced and repaired. Due to access issues and equipment inside the facility, the remaining impacted areas were deferred until abandonment. Refer to Figure 4.

SPILL AREA
(60'x150')

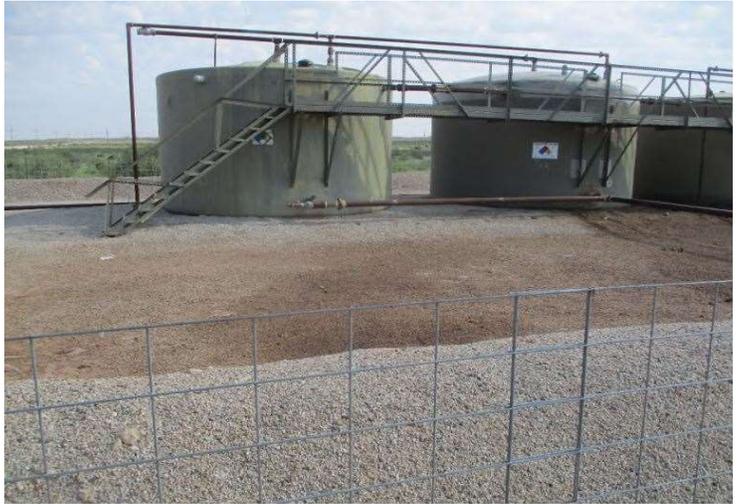
Photograph No. 2

Description:
View North, Area of AH-2. (11/16/2016)

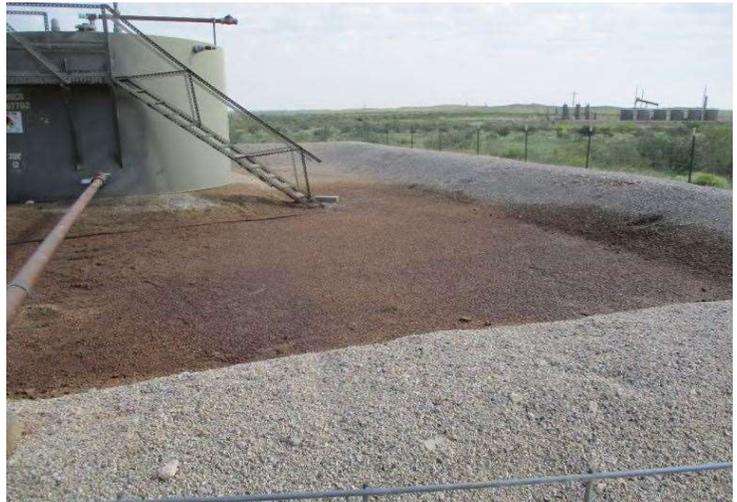
Photograph No. 3

Description:
View West, Area of AH-3. (11/16/2016)

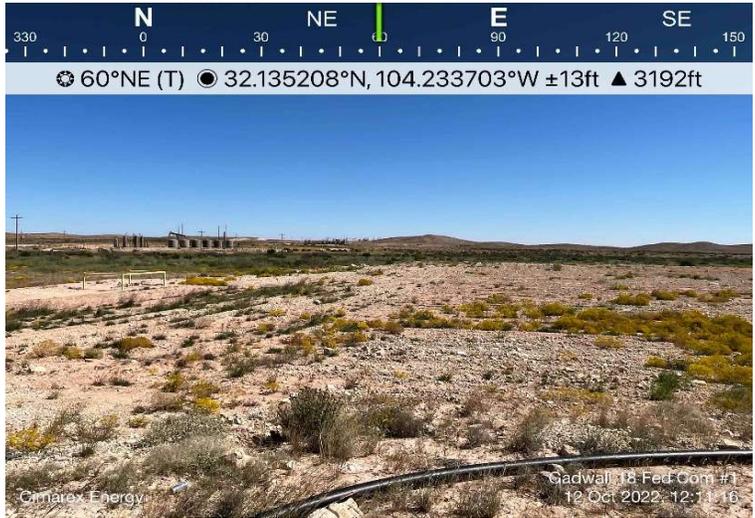
Photograph No. 5

Description:
View East, Area of Reclaimed Pad.

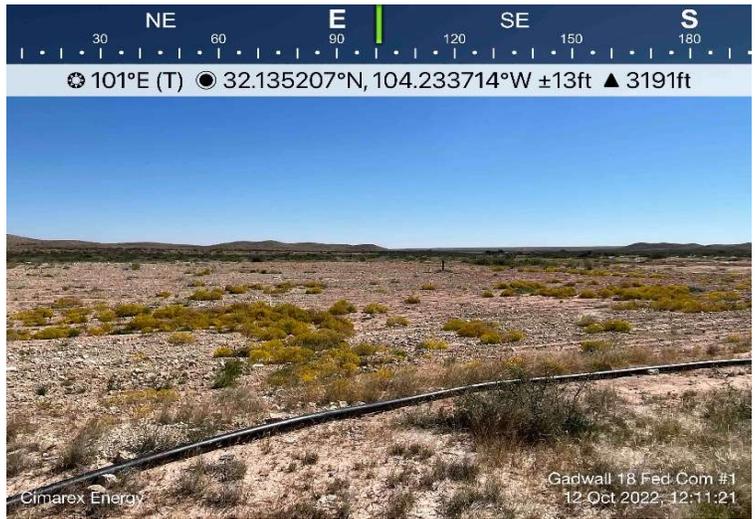
Photograph No. 6

Description:
View of BH-1, 10.21.2022.

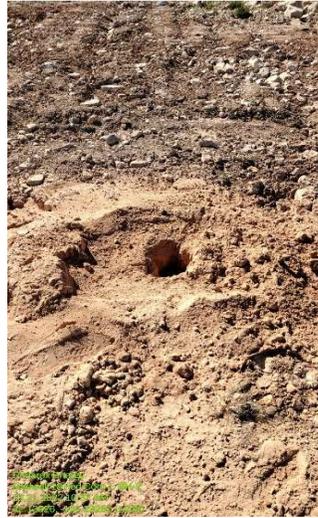
Photograph No. 8

Description:
View of BH-3, 10.21.2022.

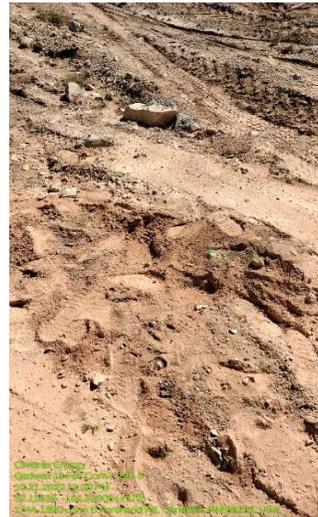
Photograph No. 9

Description:
View of BH-4 & BH-5, 10.21.2022.
