July 18, 2022

**Re: Closure Report  
Spica 25 Fed 1 Battery  
Devon Energy Production Company  
Site Location: Unit A, S26, T19S, R31E  
(Lat 32.637803°, Long -103.832231°)  
Eddy County, New Mexico  
Incident ID: NRM2011329998**

On behalf of Devon Energy Production Company (Devon), New Tech Global Environmental, LLC (NTGE) has prepared this letter to document site assessment and remedial action activities at the Spica 25 Fed 1 Battery (Site). The Site is located approximately 13 miles southeast of Loco Hills, New Mexico in Eddy County (Figures 1 and 2).

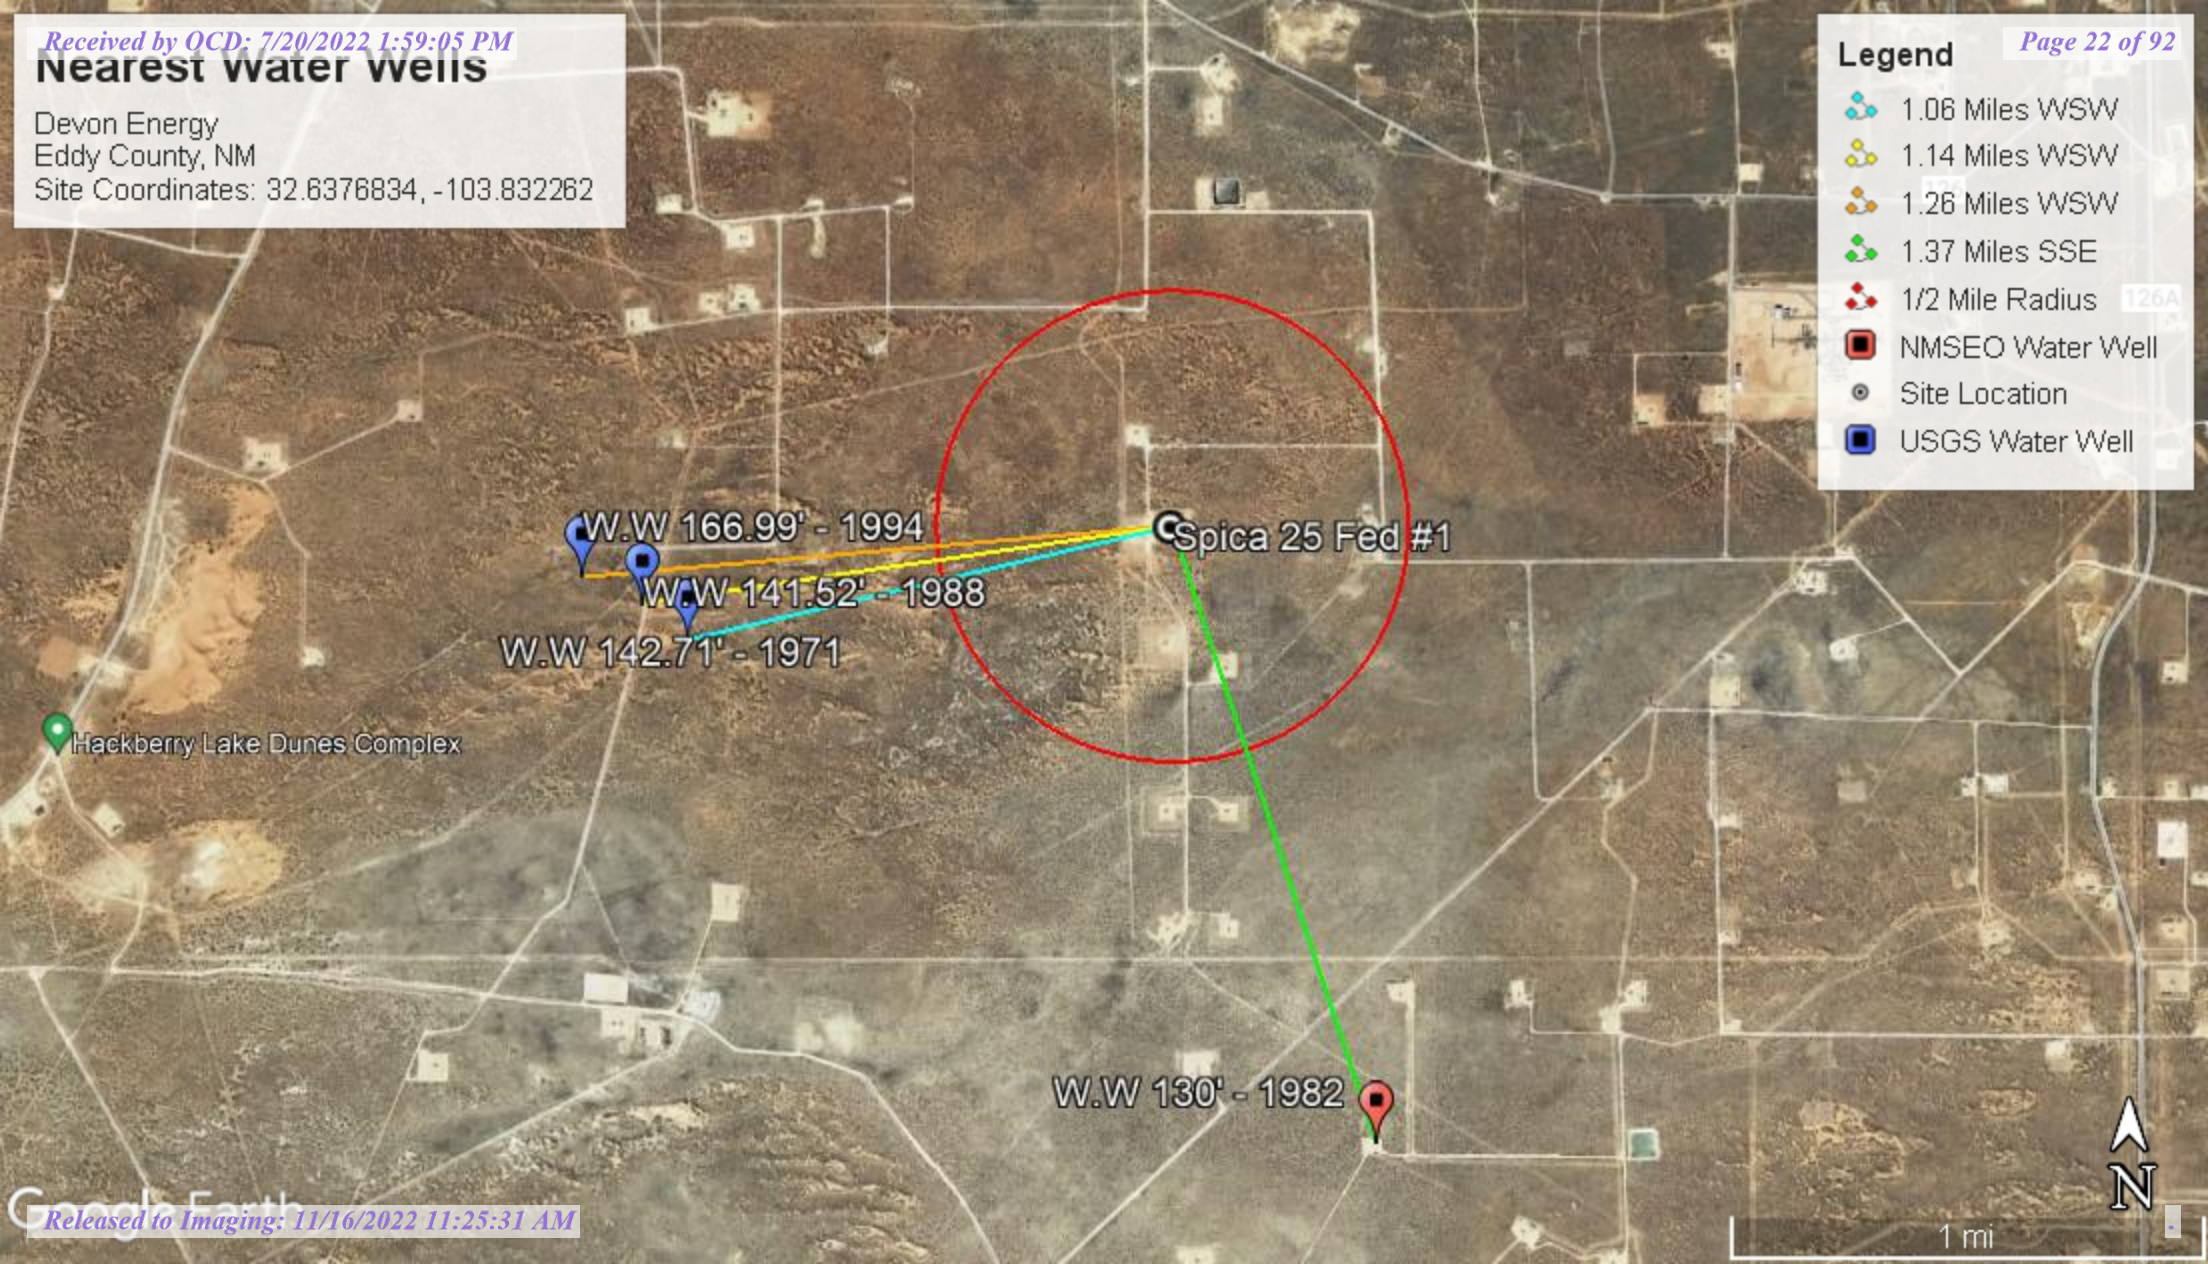
**Legend**

- 1.06 Miles WSW
- 1.14 Miles WSW
- 1.26 Miles WSW
- 1.37 Miles SSE
- 1/2 Mile Radius
- NMSEO Water Well
- Site Location
- USGS Water Well

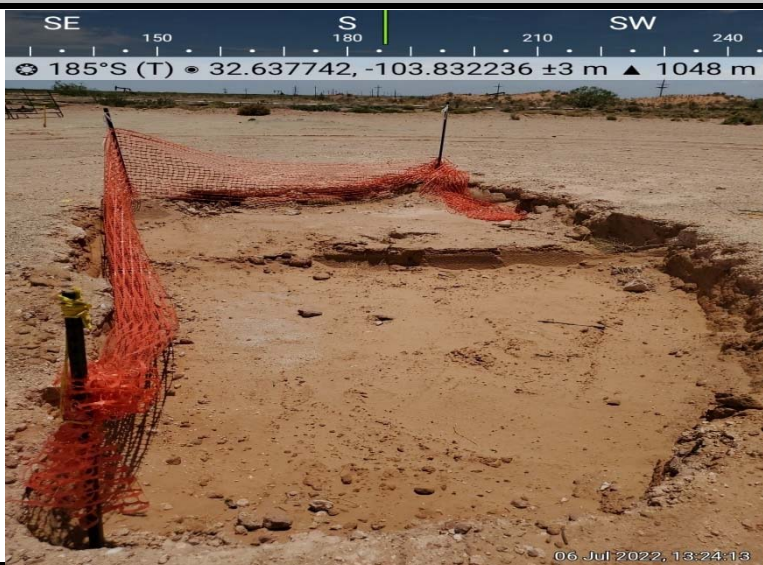
**Photograph No. 3**

Remediated site (after rain event)

Based on the analytical results, Devon proceeded with the remedial actions at the Site to include the excavation and disposal of impacted soils above the regulatory limits. The release area was excavated to a depth of 1.5 ft bgs.

The soils were field screened during excavation activities to aide in determining final excavation depths. On May 24, 2022, a total of 2 confirmation samples were collected from the excavation base (CS-1 - CS-2) and 4 confirmation samples were collected from the excavation sidewalls (SW-1 - SW-4) to ensure impacted soil was removed. Upon receipt of confirmation sampling results, it was noted that TPH concentrations the samples CS-1 and SW-2 were above the regulatory limits.
